Stucco Relief from Structure XIX, Palenque

by: Marcia Valle Rangel and Juan Alfonso Cruz Becerril

Site: Palenque, Group of the Cross

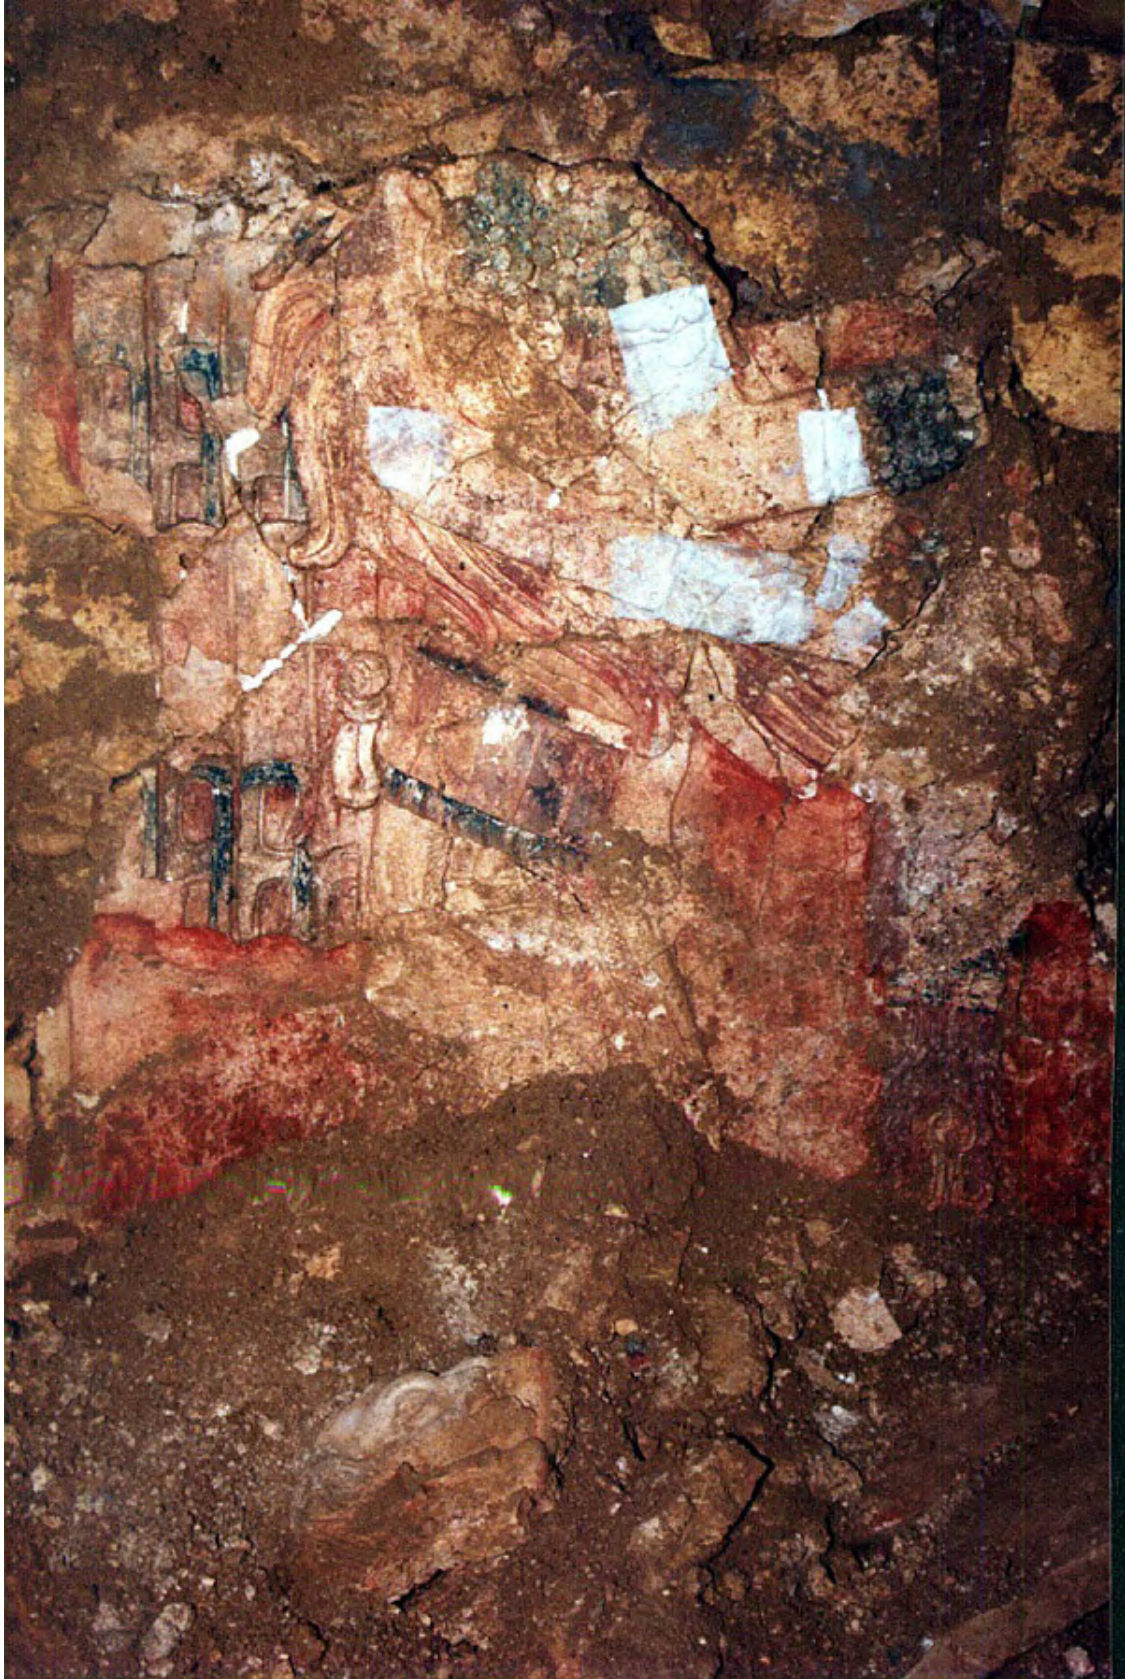
The relief attached to the pilaster had an interior filling of earth and clay, alien to the original support, which were gradually deposited by sliding and filtration caused by rainfall, thus creating deformations and convexities in the stucco, as well as flaws and fissures, while some edges presented exfoliation and pulverization (see [photo 9](#)).

Photo 9. State of preservation of the relief

Because Structure XIX is still in the process of study and structural consolidation, and because the temple lacks a cover of its own, thus making the stucco relief vulnerable to environmental conditions and climatic changes that are at times extreme, in order to prevent the endangering of the physical integrity of the stucco as a consequence of vandalism and looting, as this temple lacks any appropriate security measures, not to mention the lack of maintenance and the passing of time, the restoration team proposes to release the relief still fixed to the wall and move it to the preservation workshop to accomplish all the necessary preservation and restoration procedures the piece requires, and later place it at the site museum for exhibition.

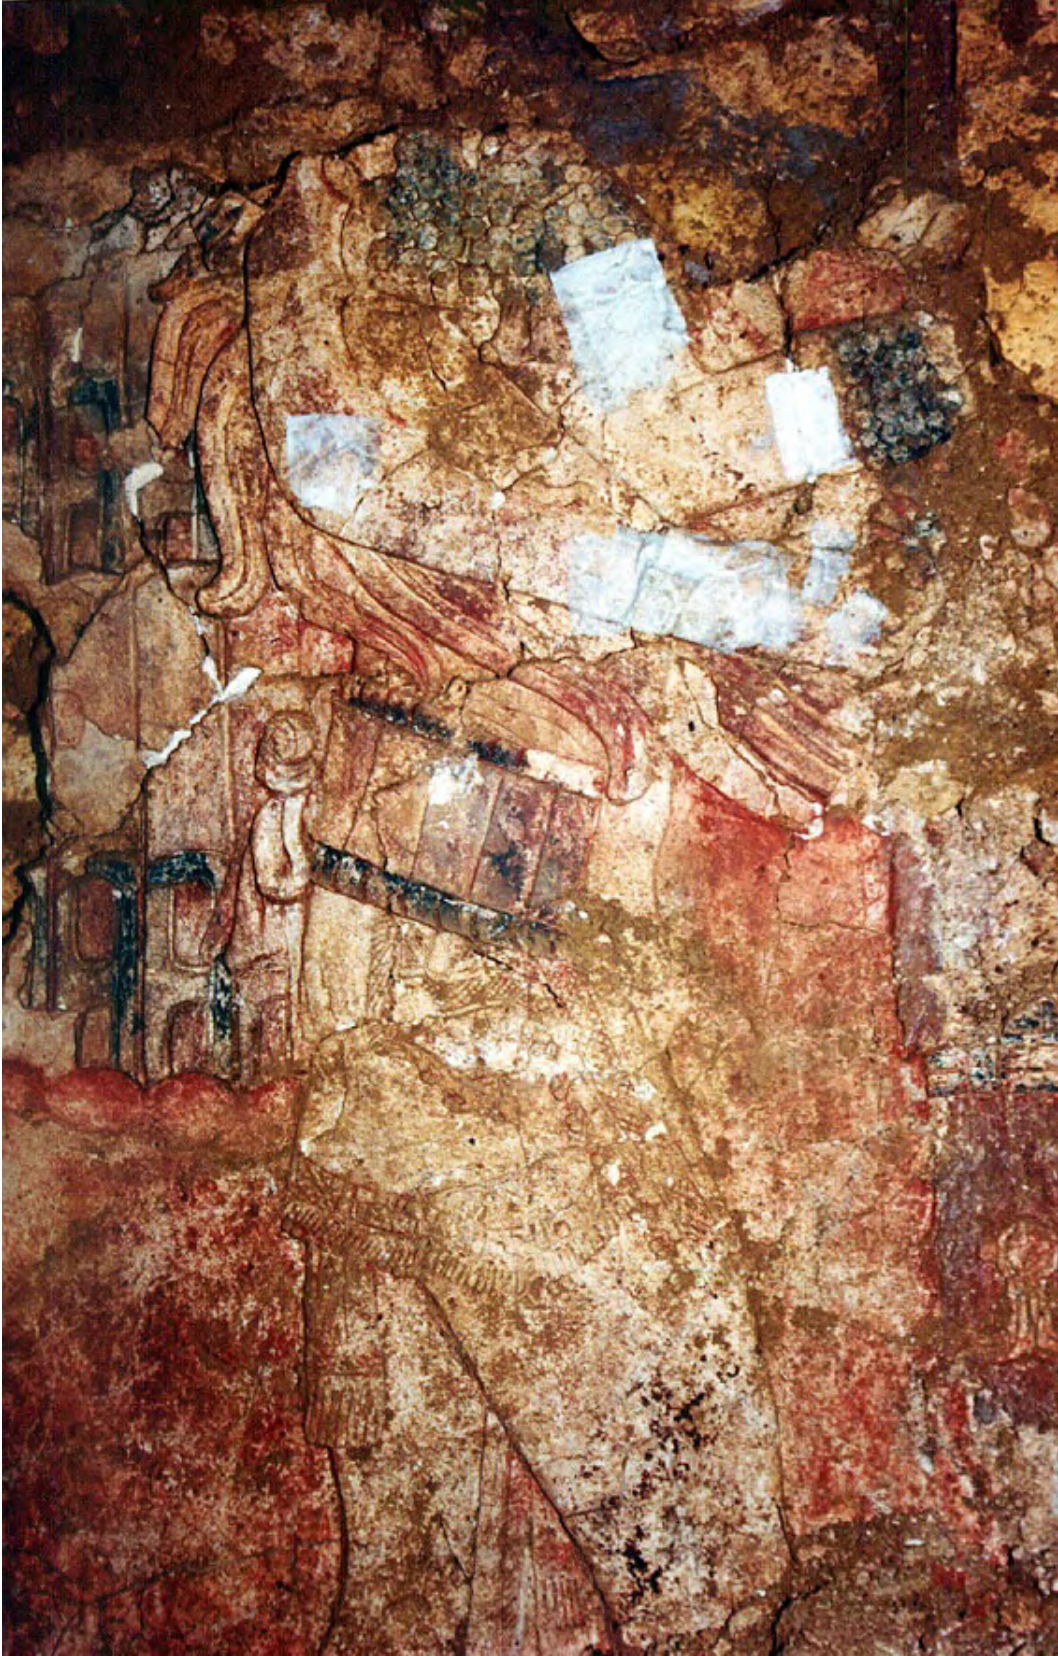
Photo 10. Area covered with Japanese paper

- Fixation of the pictorial layer: The pigment was fixed using Paraloid B72H, in a 5% concentration, applied by sprinkling.
- Partial covers: Loose fragments were partially covered with Japanese paper, using Paraloid B72H, in a 5% concentration, with acetone as the adhesive agent (see [photo 10](#)).

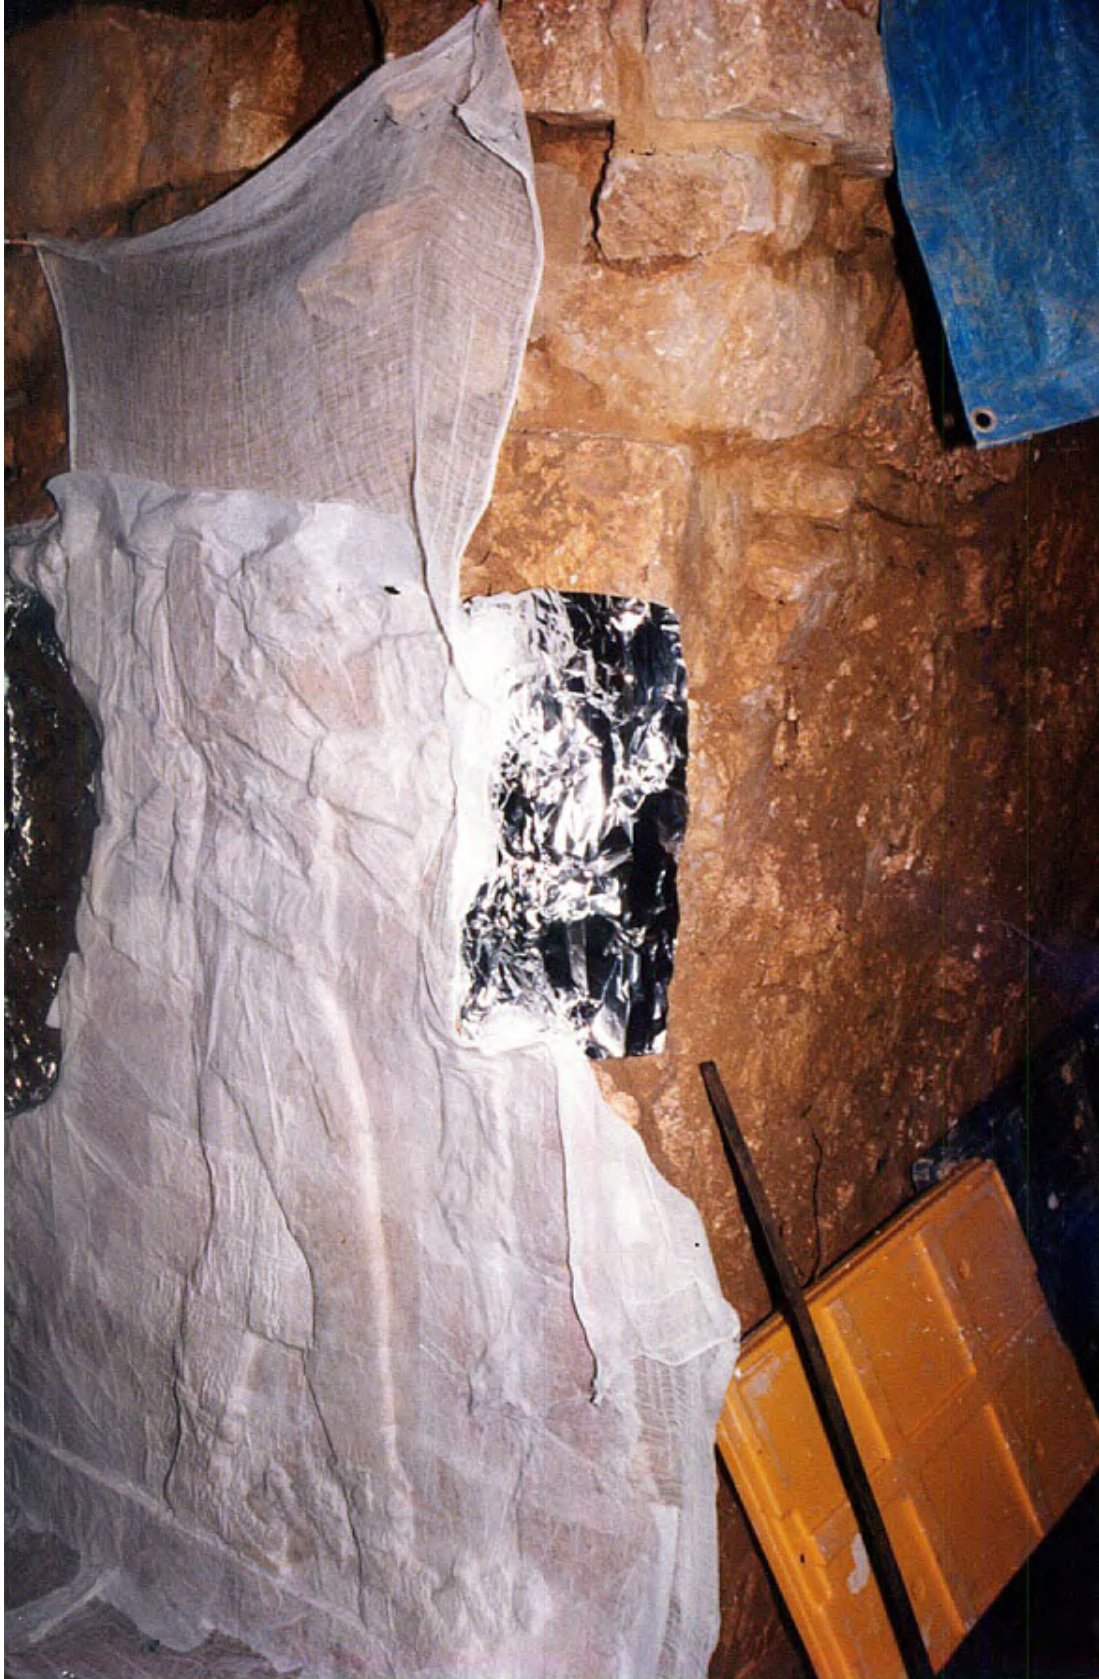
Photo 11. Overall protection covers

- Protection cover: This procedure was carried out by using a first insulating layer of a cheesecloth cover adhered with Paraloid B72H at a concentration of 3% in acetone, and by further placing another layer of China paper using Paraloid B72H at a concentration of 5%, to stick it together (see [photo 11](#)).

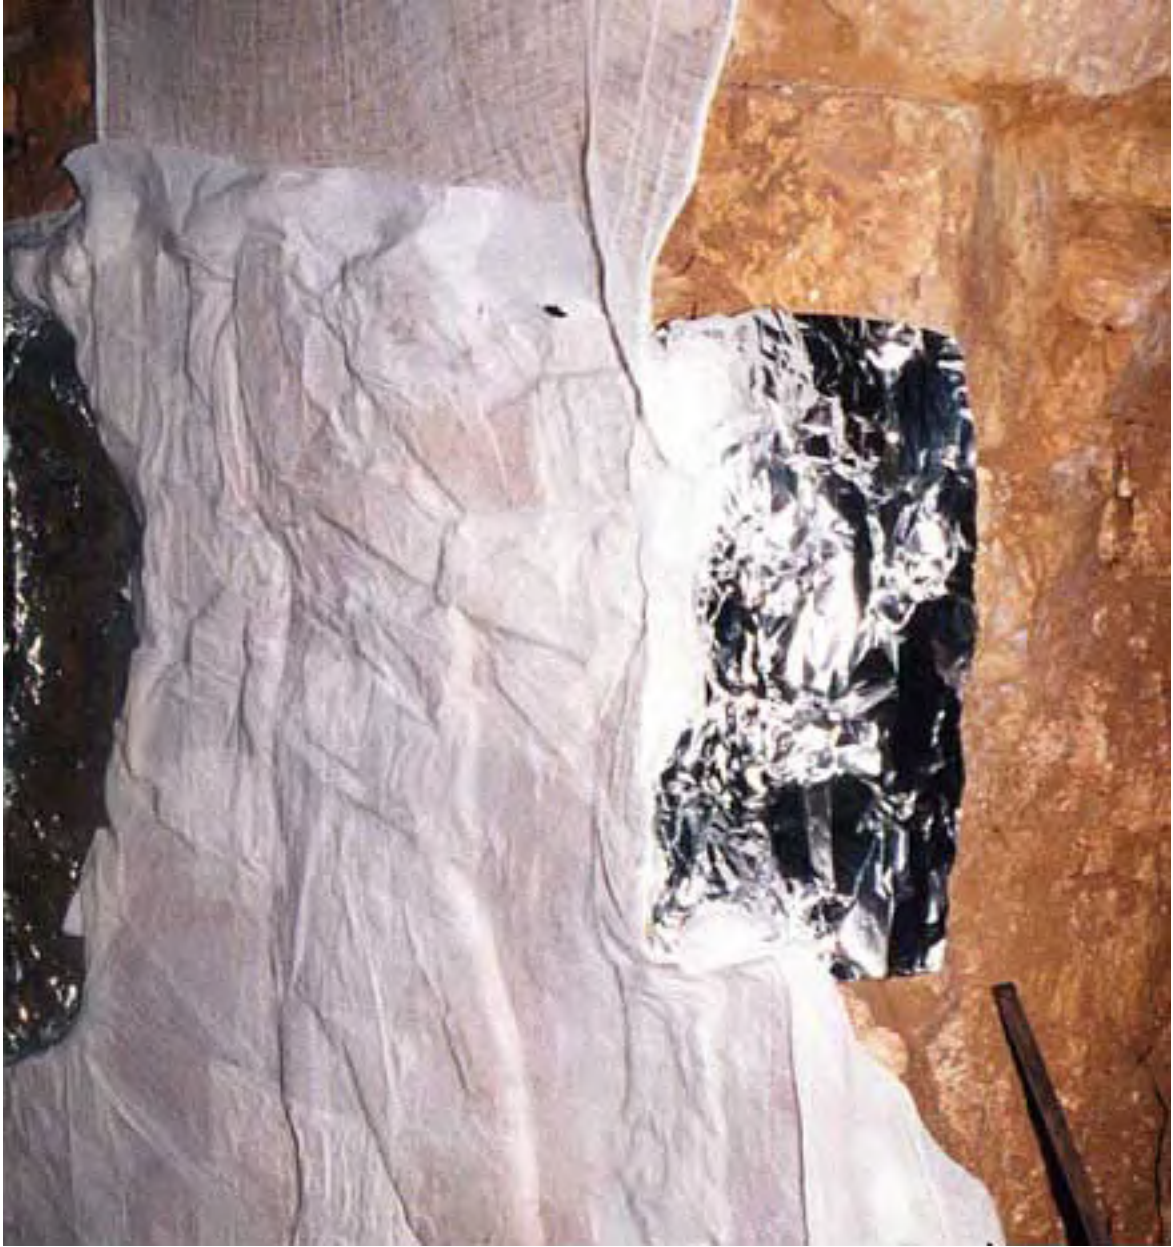
Photo 12. Preparing the stucco relief for detachment

- Insulating layer: Aluminum foil was used as an insulating layer on the entire relief surface, after verifying that the foil was free of perforations (see [photo 12](#)).

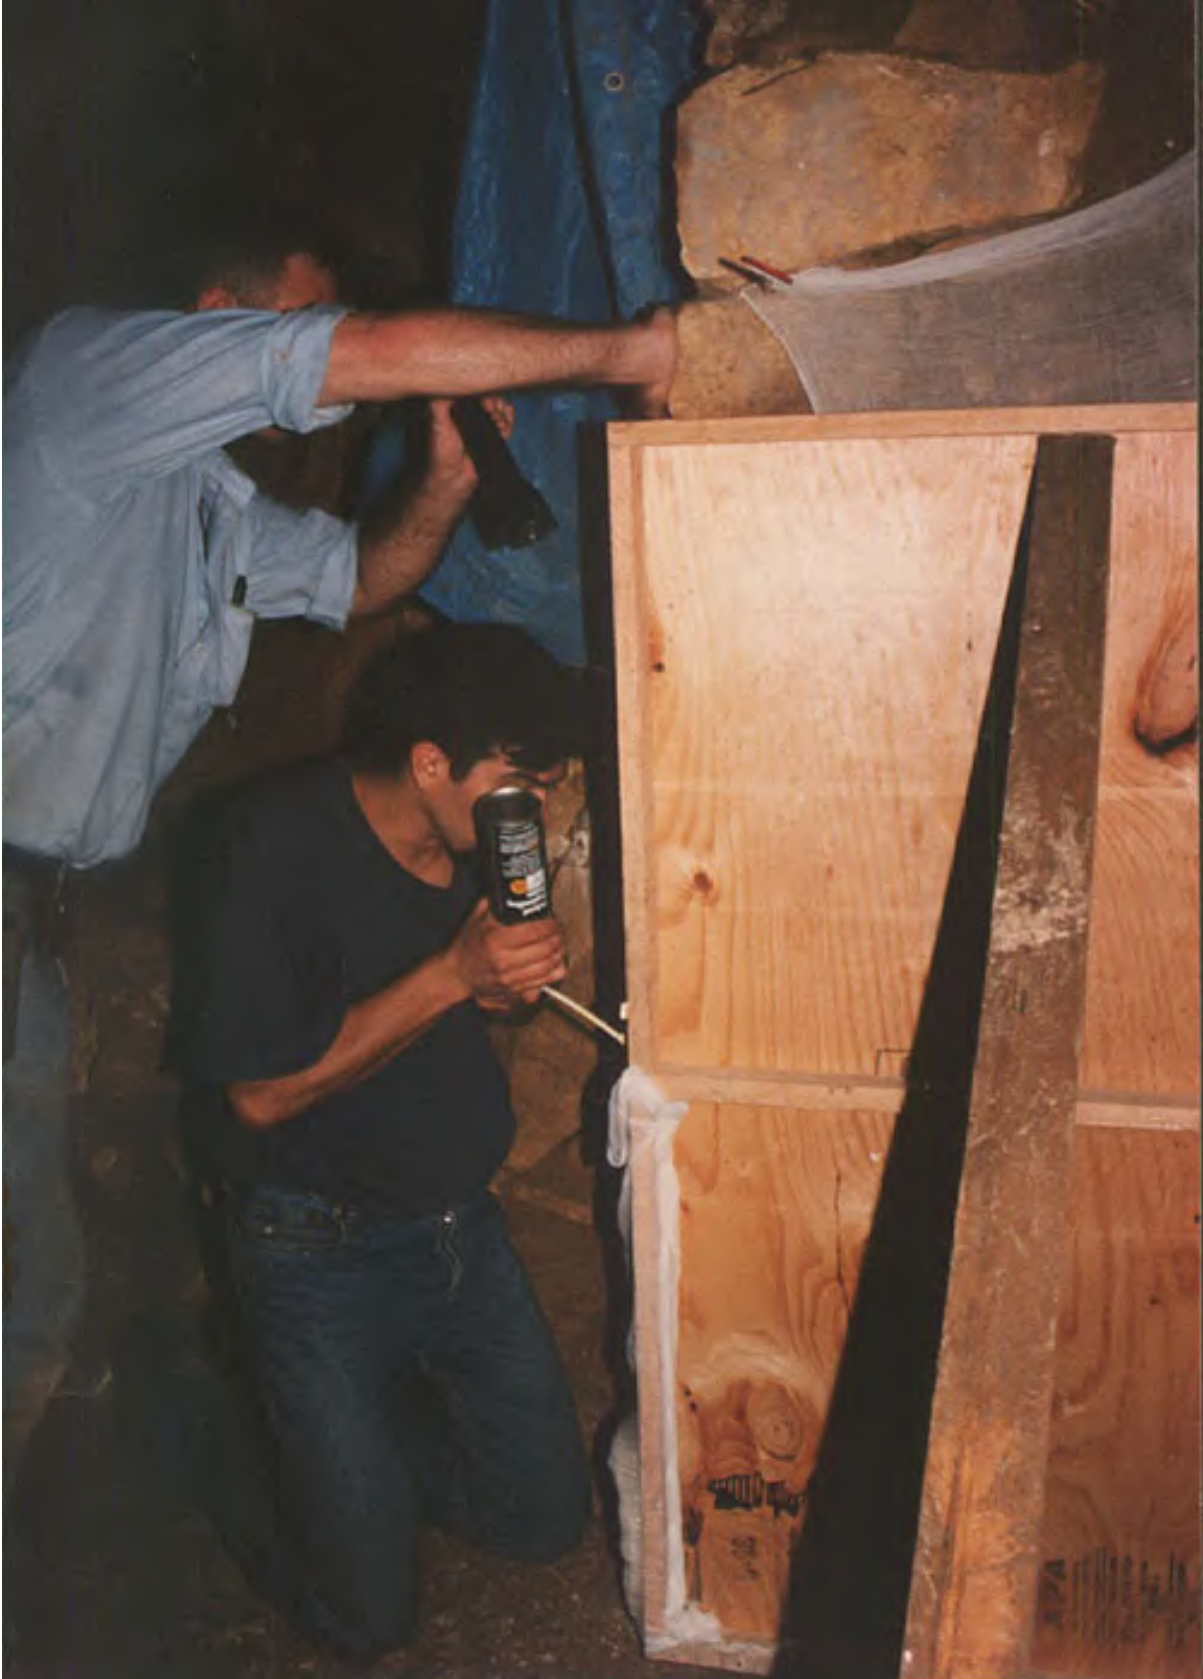
Photo 13. Injection of polyurethane foam

- Provisional support: The provisional support consisted of a rigid layer of polyurethane foam which was injected between the stucco and a wooden frame so that the support would acquire the shape of the relief, thus preventing any movement during its transportation to the restoration workshop (see [photo 13](#)).

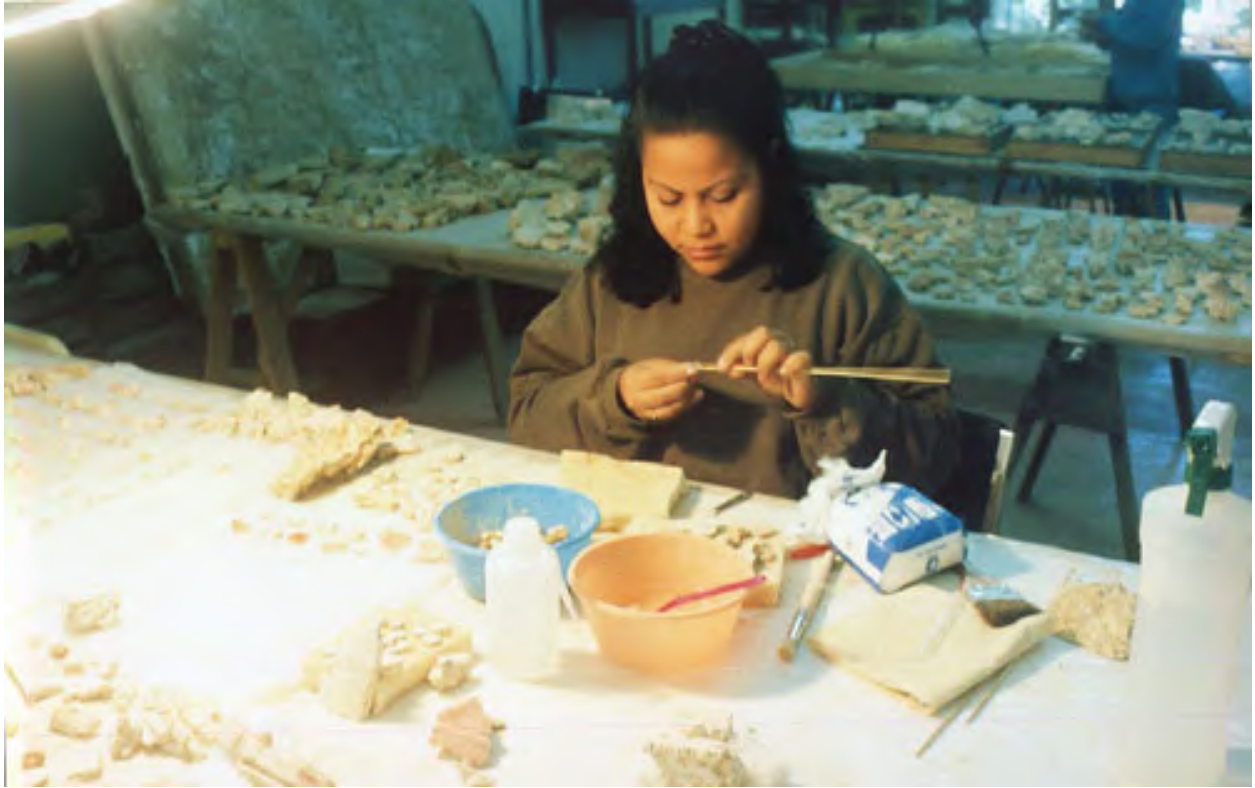
Photo 21. Chemical cleaning of fragments found in rubble

- In the next step, a chemical cleaning was carried out on the fragments recovered from the rubble using a 1:1 solution of water and alcohol, applied with smooth hyssops to eliminate clay and soluble salts (see [photo 21](#)).

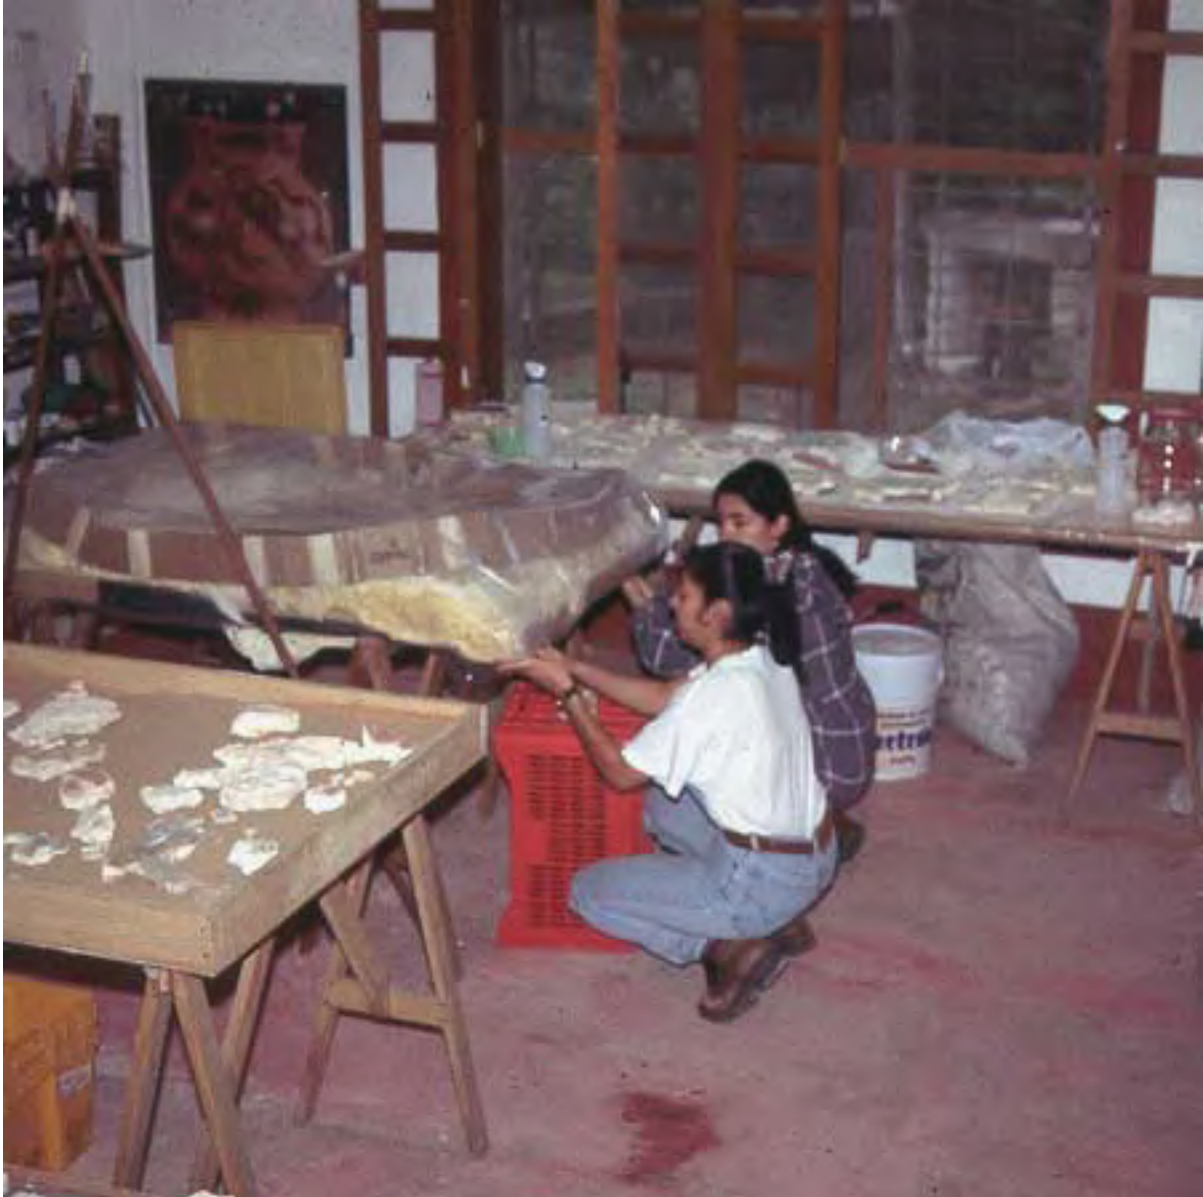
Photo 22. Consolidation of fragments

- Fragments found within the rubble: This process was applied only to the most degraded fragments. Paraloid B72H was used at a concentration of 3%, dissolved in thinner and applied by dripping.
- Detached fragment: The consolidation process of the stucco support was done using Paraloid B72H, at a concentration of 3% in thinner, by dripping through venoclysis, and then with the application of sprinkled alcohol to disrupt the surface tension, inside a slow-dryer chamber (see [photo 22](#)).

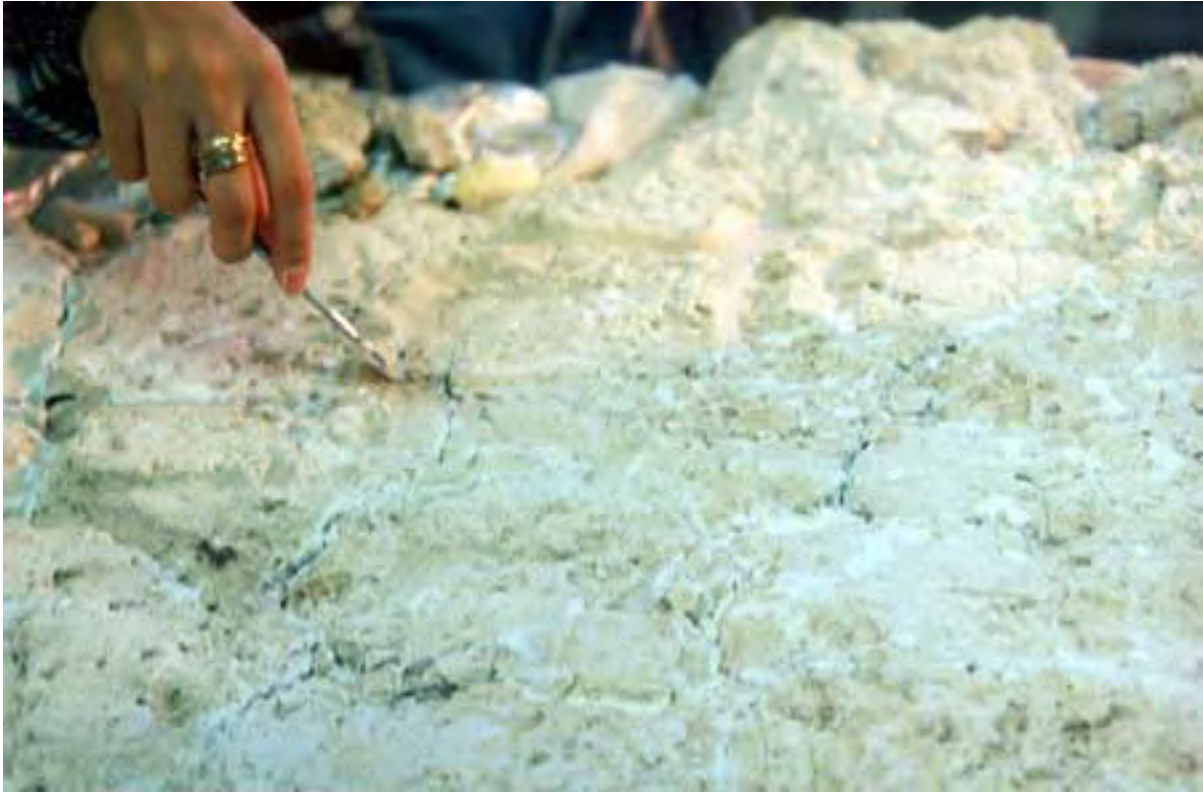
Photo 23. Consolidation of cracks and fissures on the reverse of the detachment

- A solution of calcium caseinate was injected on the reverse of the fragment detached from the jamb of the pilaster (see [photo 23](#)).

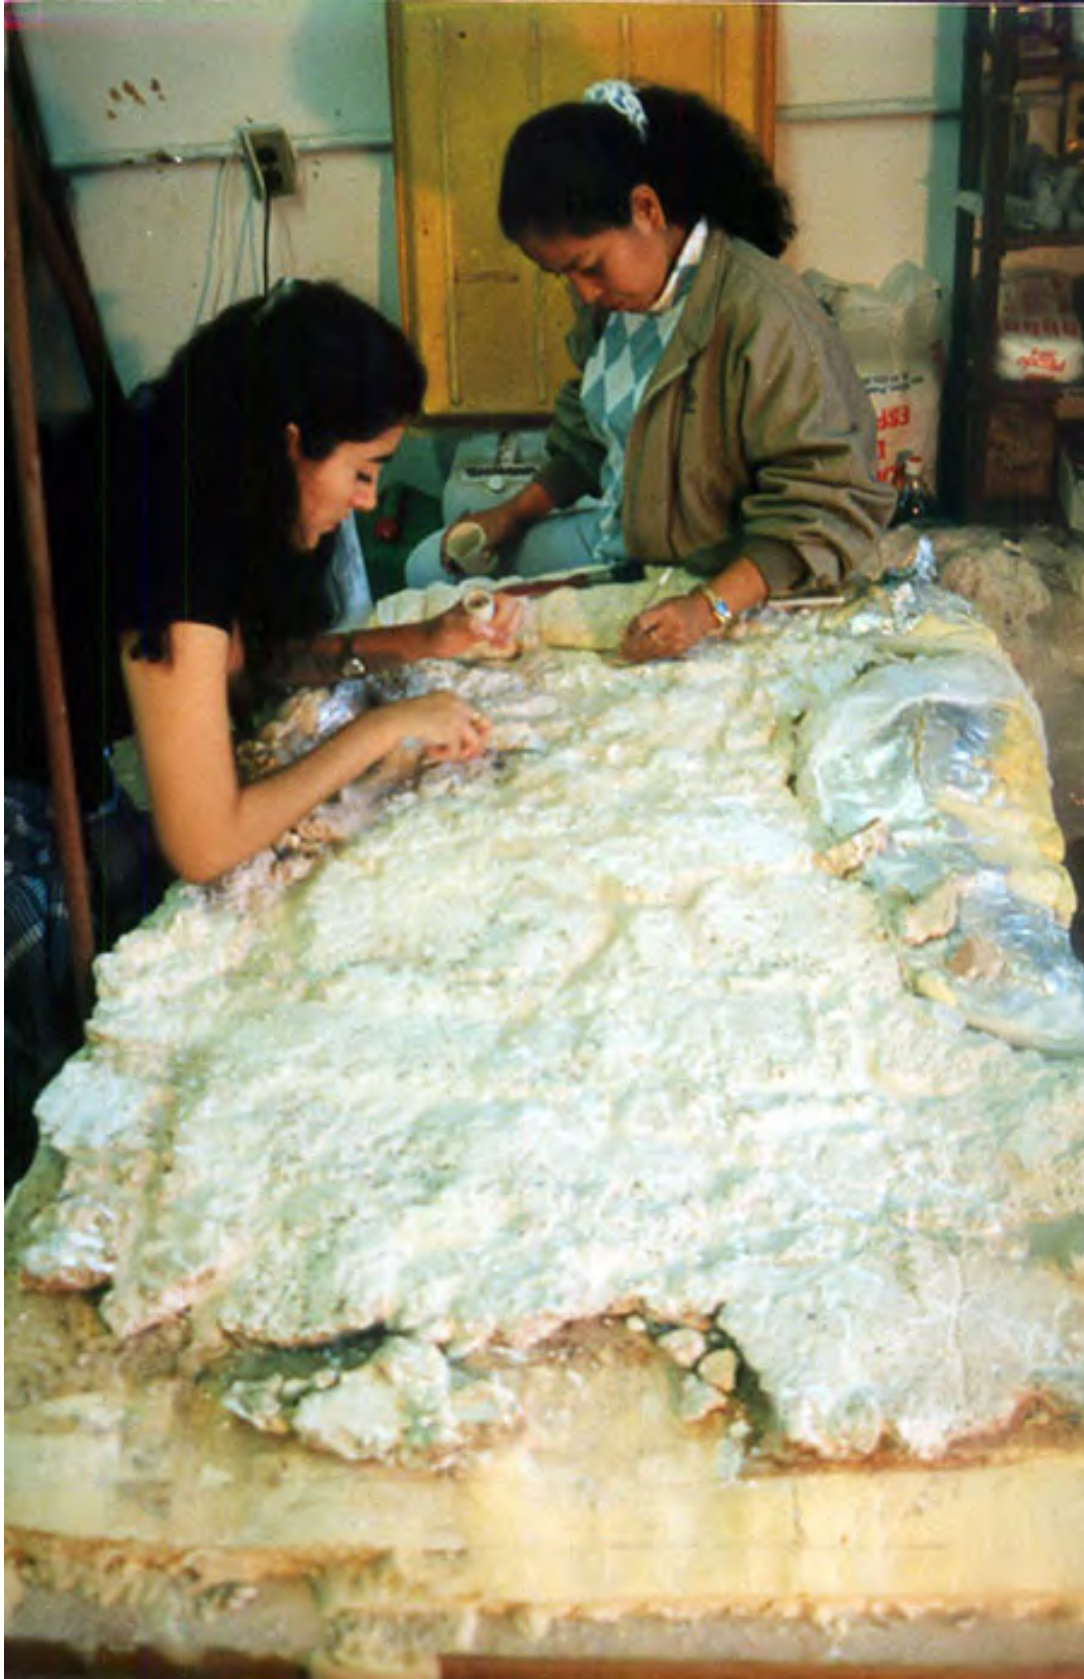
Photo 24. Repair on the reverse of the detached fragment

- With the surgical knife, the back side of the detached piece was leveled, lowering the most pronounced protuberances in order to obtain a surface as uniform as possible; then, the cracks, fractures and fissures were repaired with a repairing paste made of lime and fine limestone powder in a proportion of 1:2 (see [photo 24](#) and [photo 25](#)).

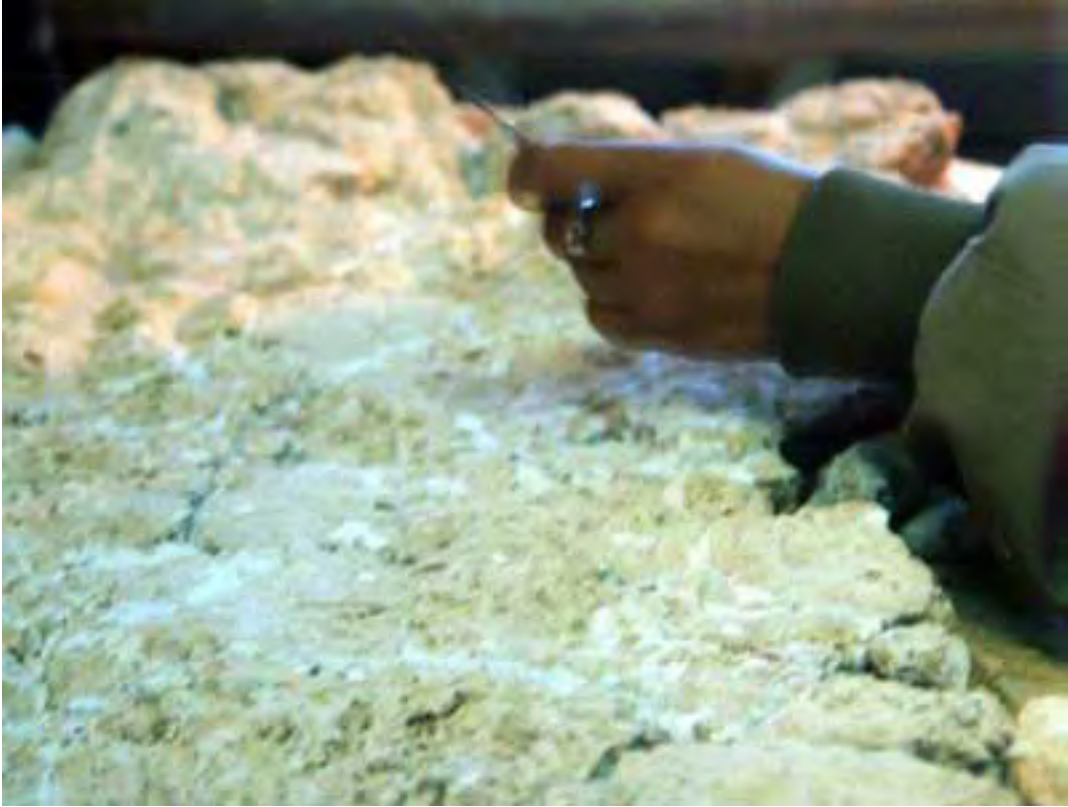
Photo 25. Repair on the reverse of the detached fragment

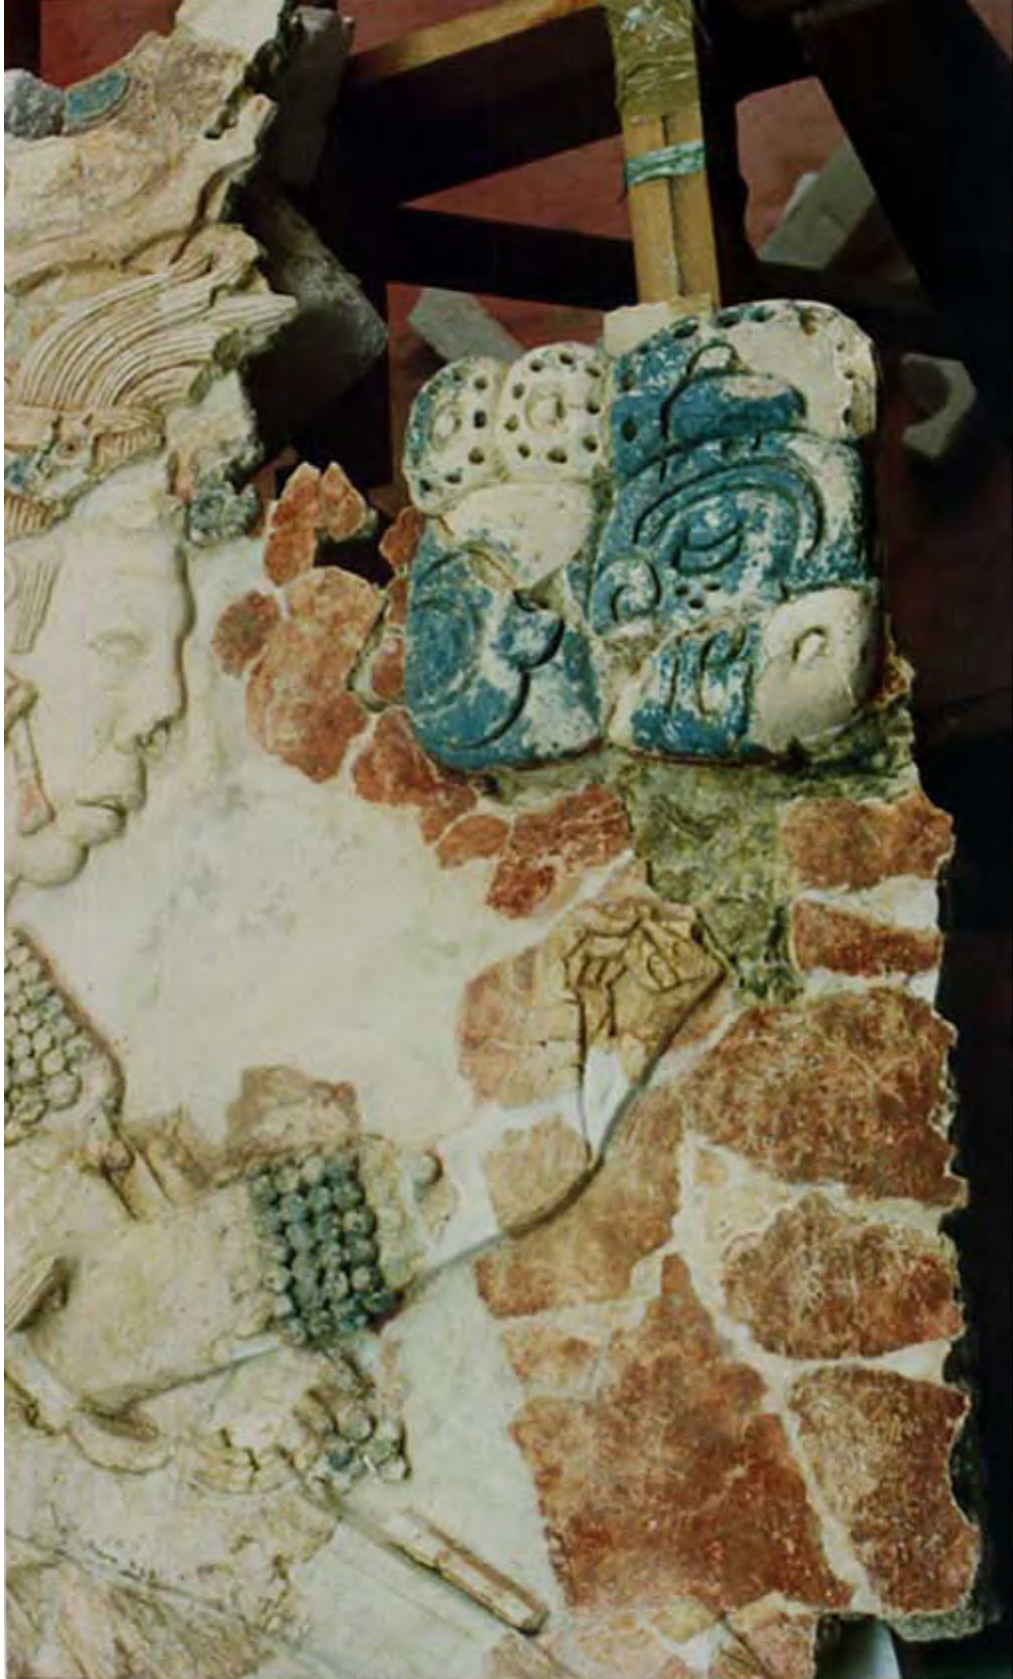
Photo 57. Repairs with ribs paste in the front

Repairs with ribs paste were accomplished in the fragments that were being assembled, both in the joints and the space between fragments (see [photo 57](#)), considering that this paste, when melted with a soldering iron, provides a greater resistance for movements as well as a greater flexibility (see [photo 58](#)).

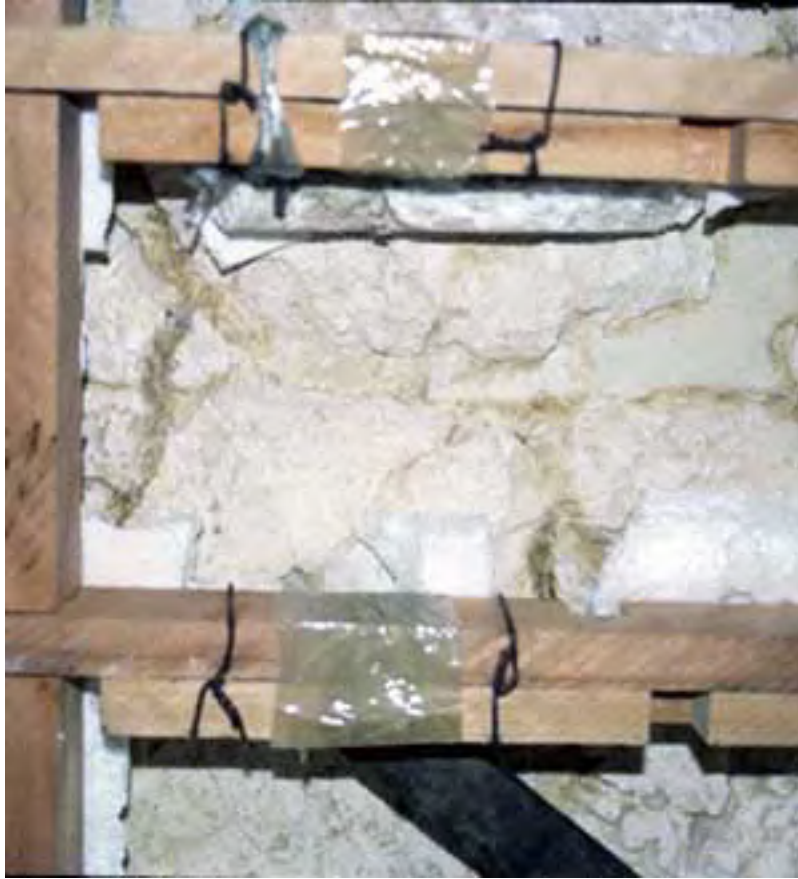
Photo 58. Repairs with ribs paste in the back

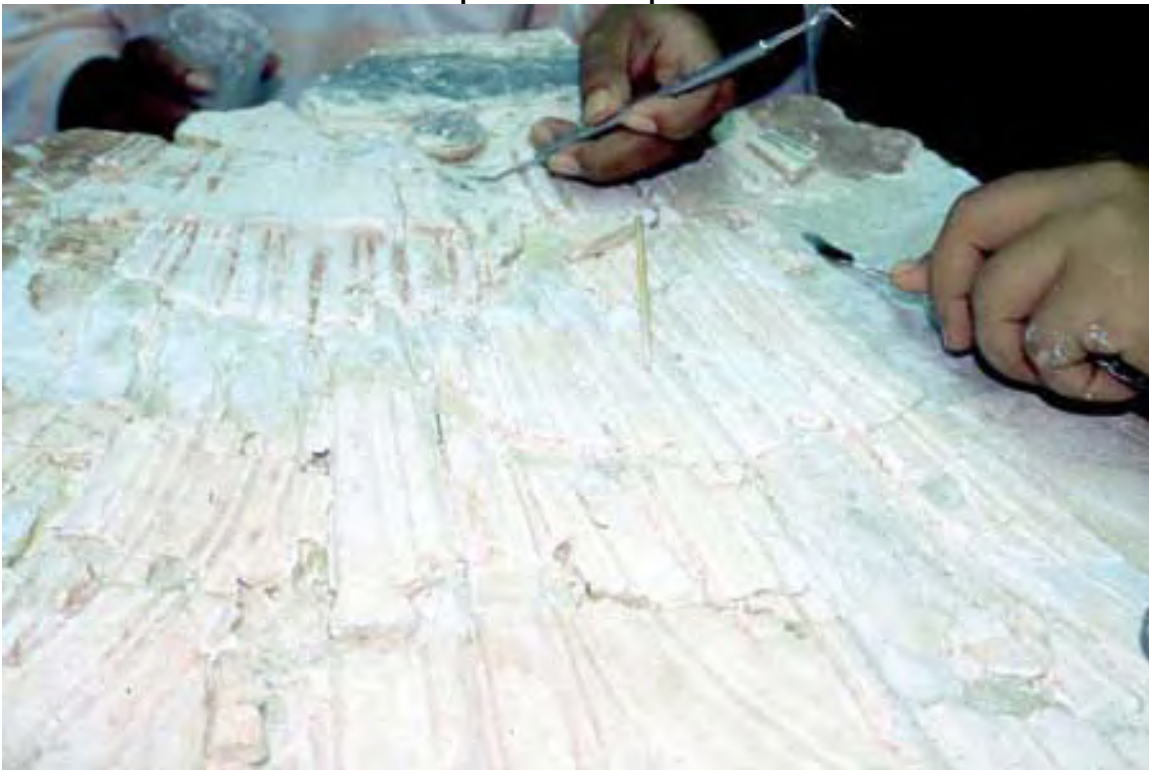
Photo 59. Repairs in joints with ceramic paste

Once repairs with ribs paste were completed, we proceeded with fine repair using a ceramic paste (see [photo 59](#)); this paste was also used to complete a number of forms (see [photo 60](#) and [photo 61](#)).

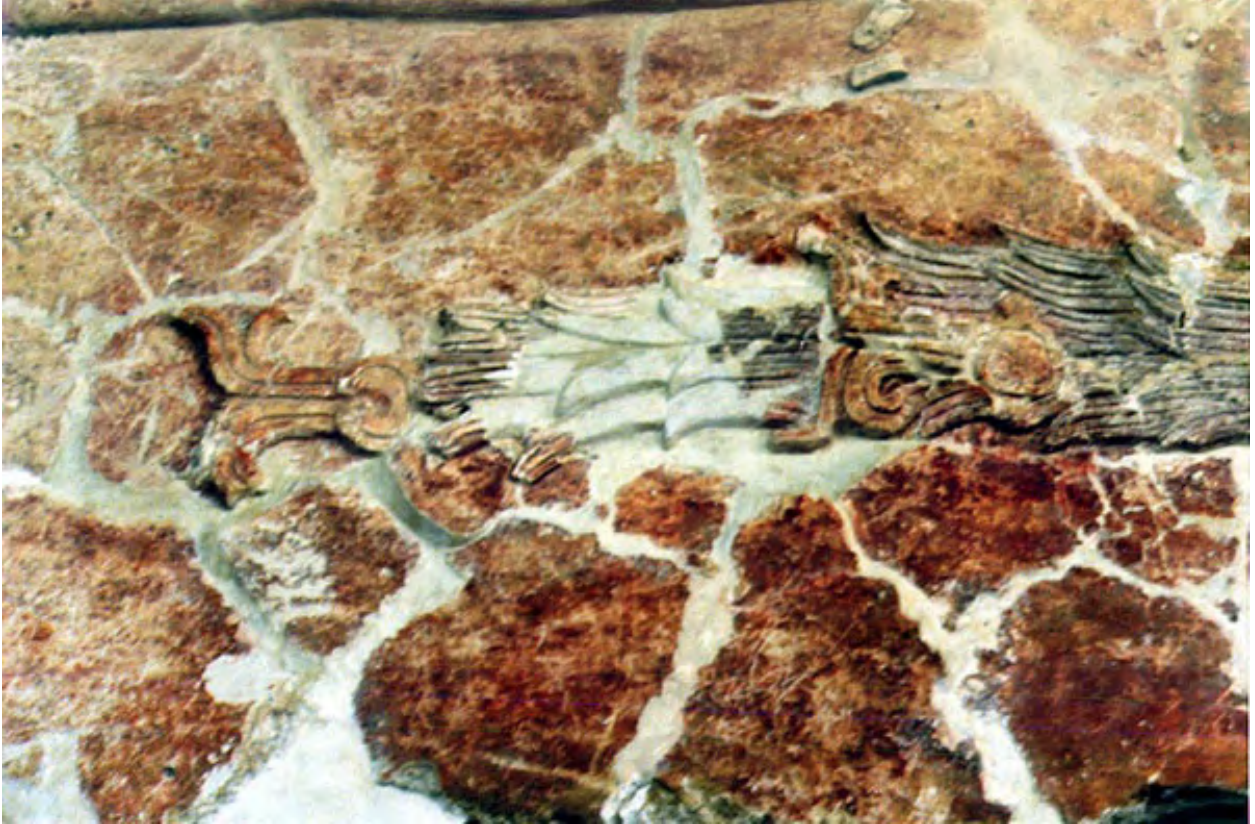
Photo 60. Repairs with ceramic paste

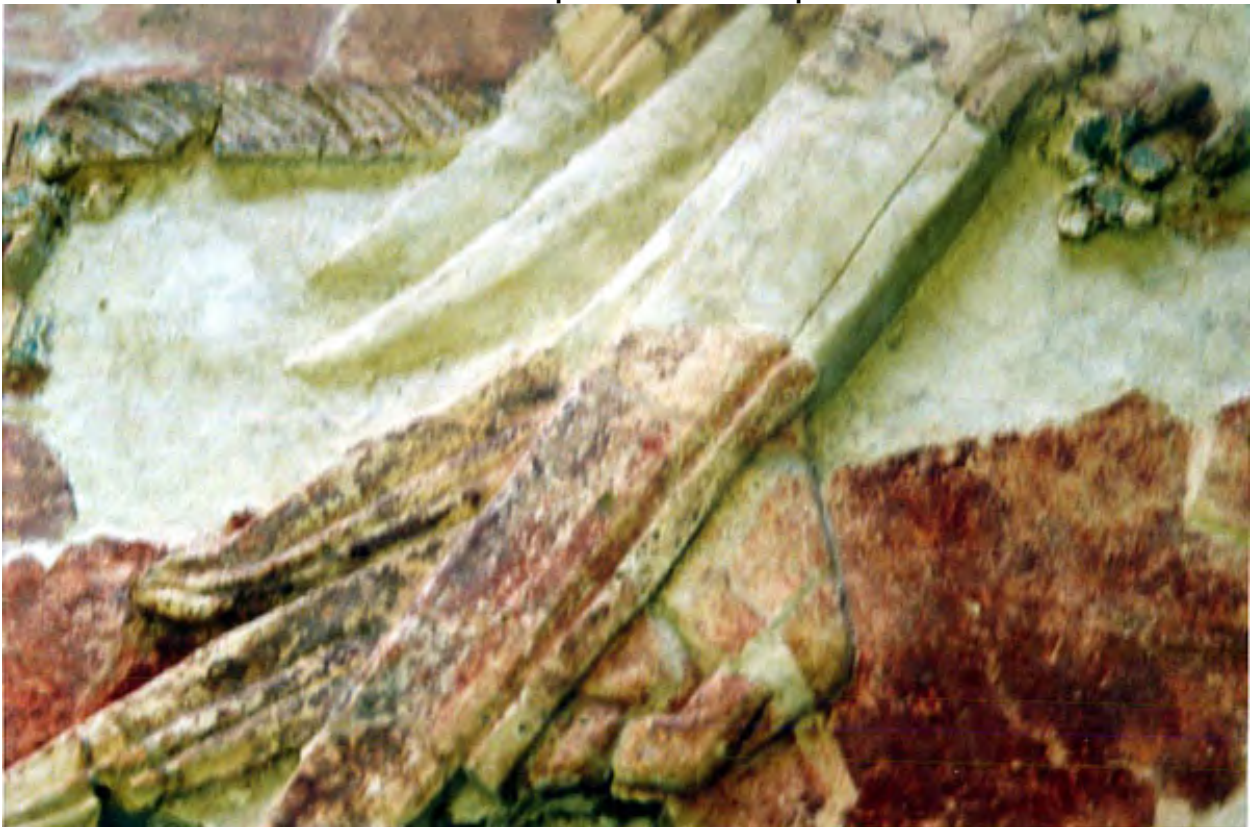
Photo 61. Repairs with ceramic paste
