Stucco Relief from Structure XIX, Palenque

by: Marcia Valle Rangel and Juan Alfonso Cruz Becerril

Site: Palenque, Group of the Cross

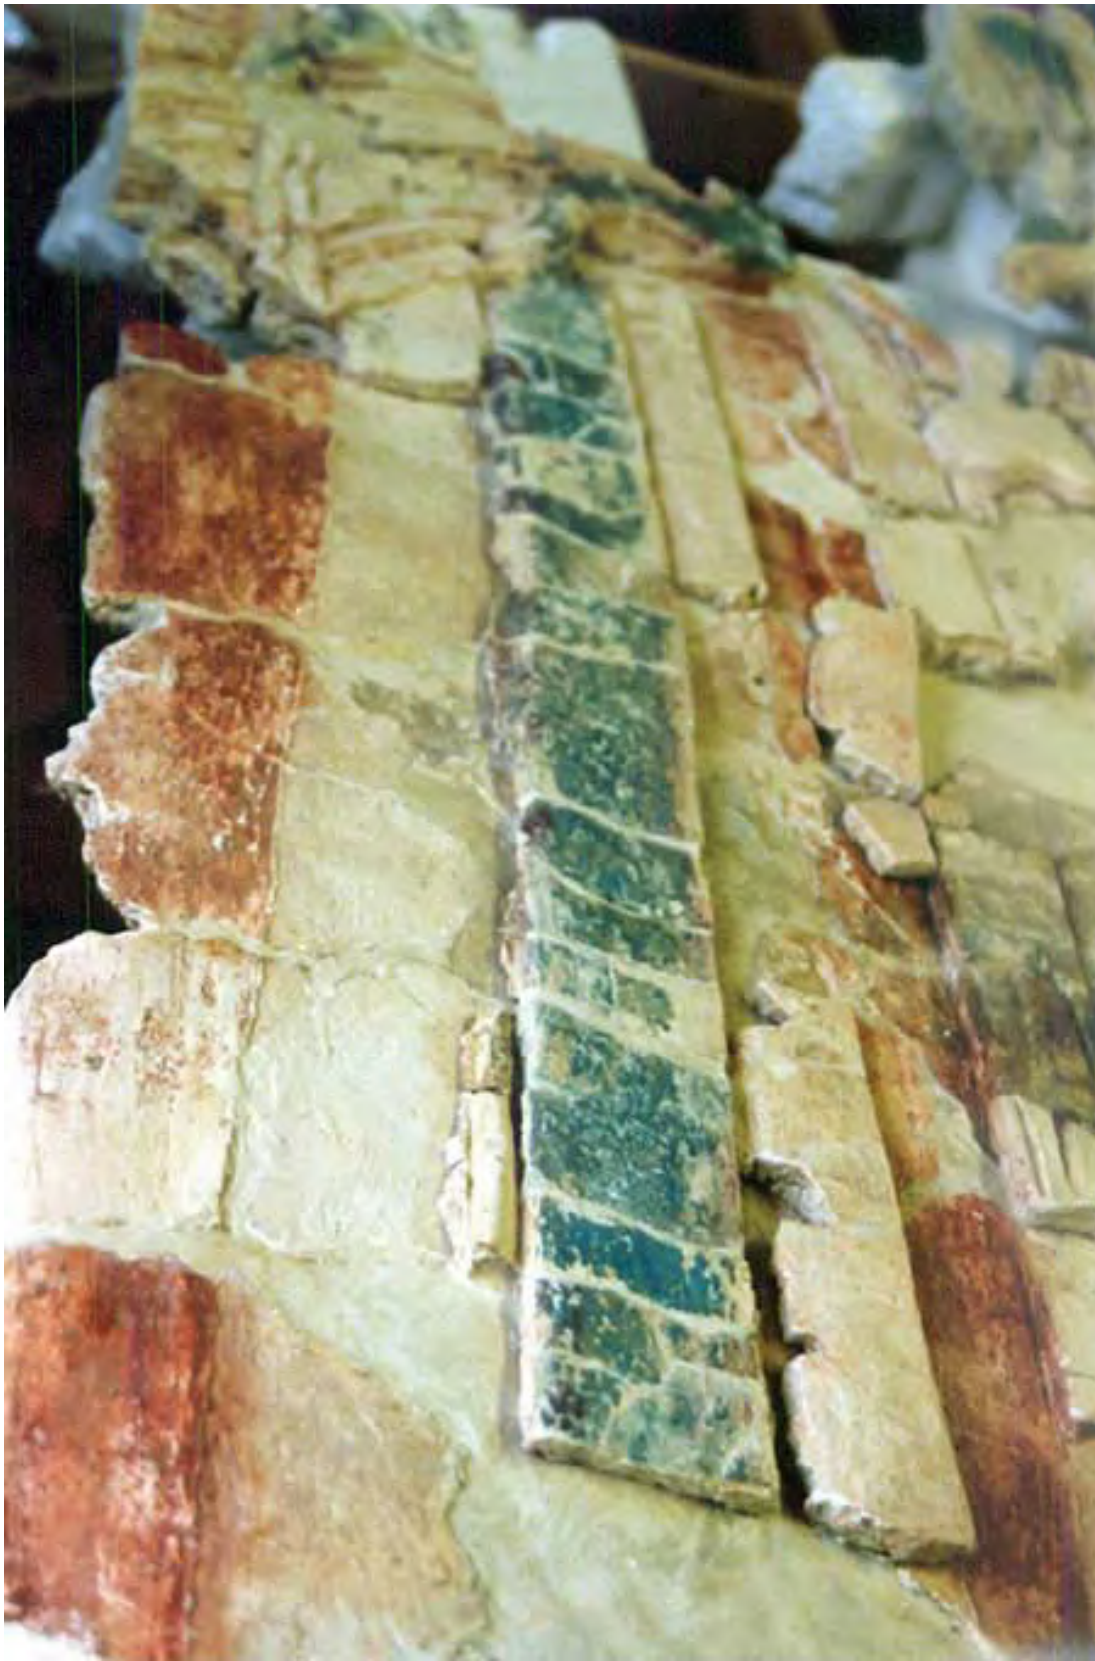
Photo 62. Joining of the *pastillaje*

Parallel to the process of repairing with the ceramic paste, we began with the process of assembling the fragments of embroidered clay (*pastillaje*) by using Mowithal B60H as an adhesive, to later continue the repairs with ceramic repairing paste (see [photo 62](#)).

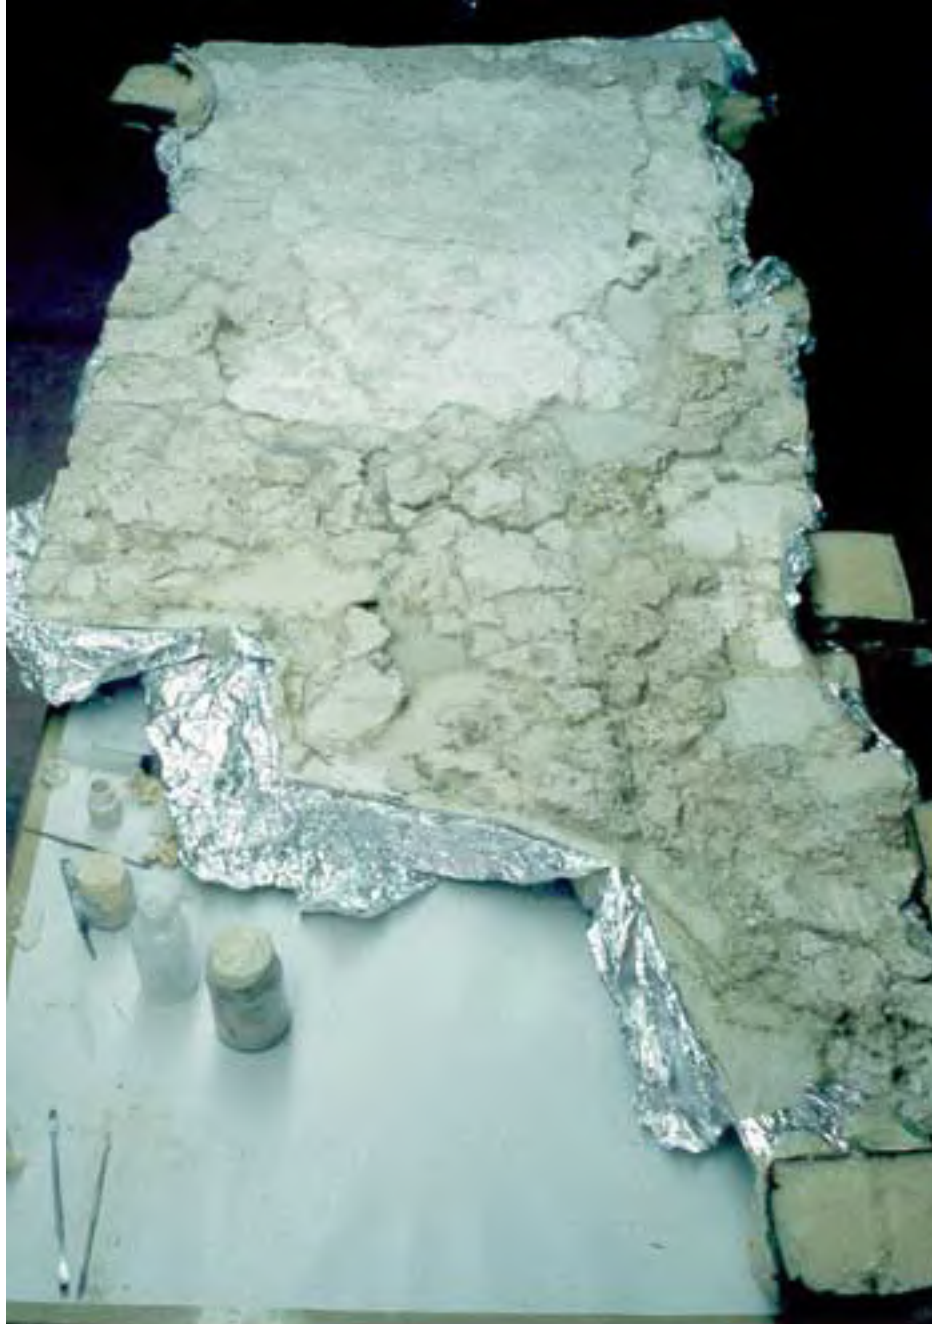
Photo 68. Reverse of panel. Prior to the repair process

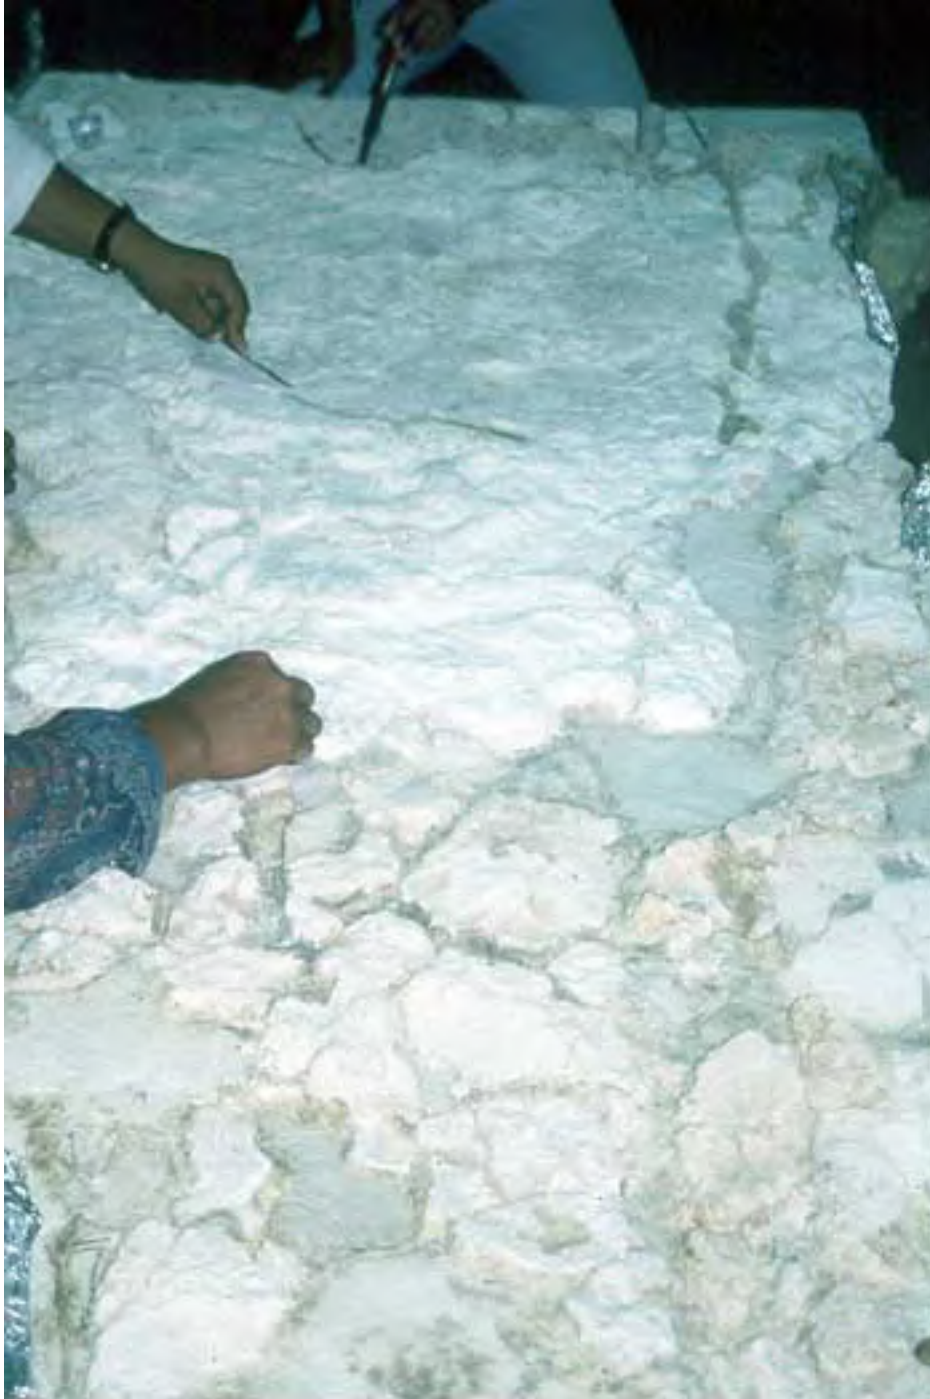
Photo 69. Repairs on the reverse of the stucco panel

With the purpose of obtaining a semi-uniform surface in the back, the largest protuberances were mechanically removed with a surgical knife; later, the cracks and fractures were repaired with ribs paste, heating the largest ones with a soldering iron, and treating in the same way every small hole observed in the stucco (see [photo 69](#)).

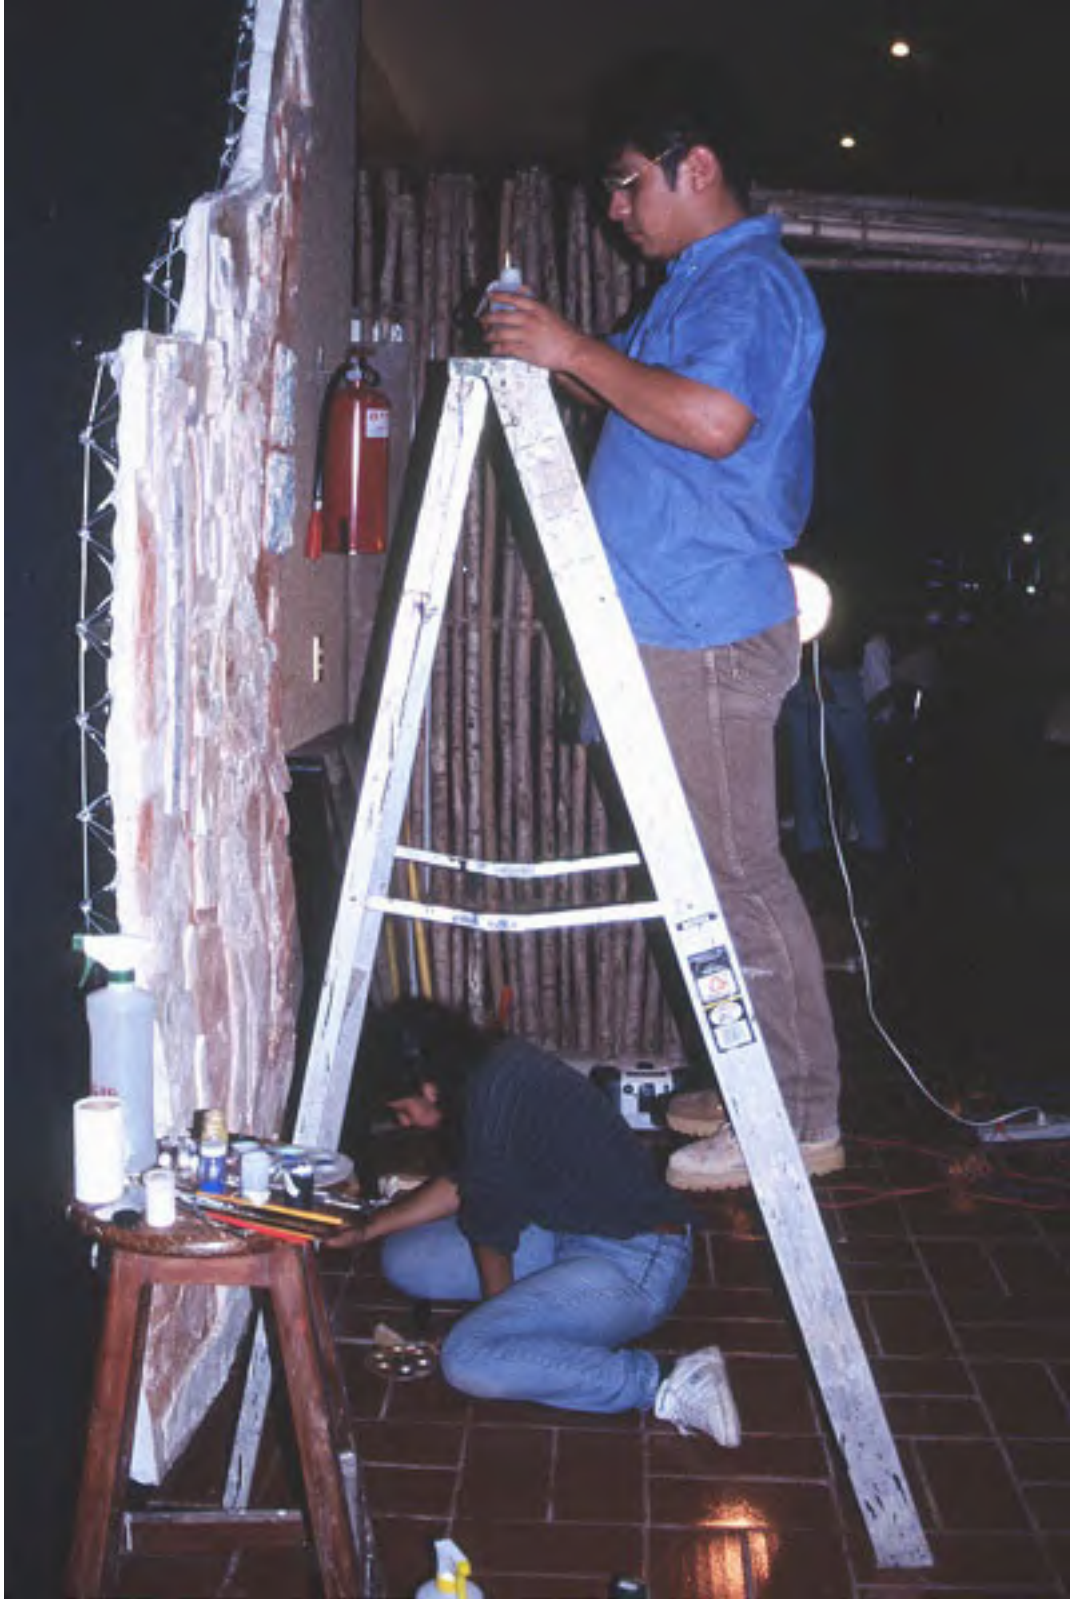
Photo 76. Color reintegration

Mineral pigments were used to attenuate the visibility of the repairs so that they would not be obvious to the eye (see [photo 76](#)).
