FAMSI © 2003: J. Gregory Smith, Ph.D.

Kulubá Archaeological Project 2001 Field Season

Research Year: 2001

Site: Kulubá

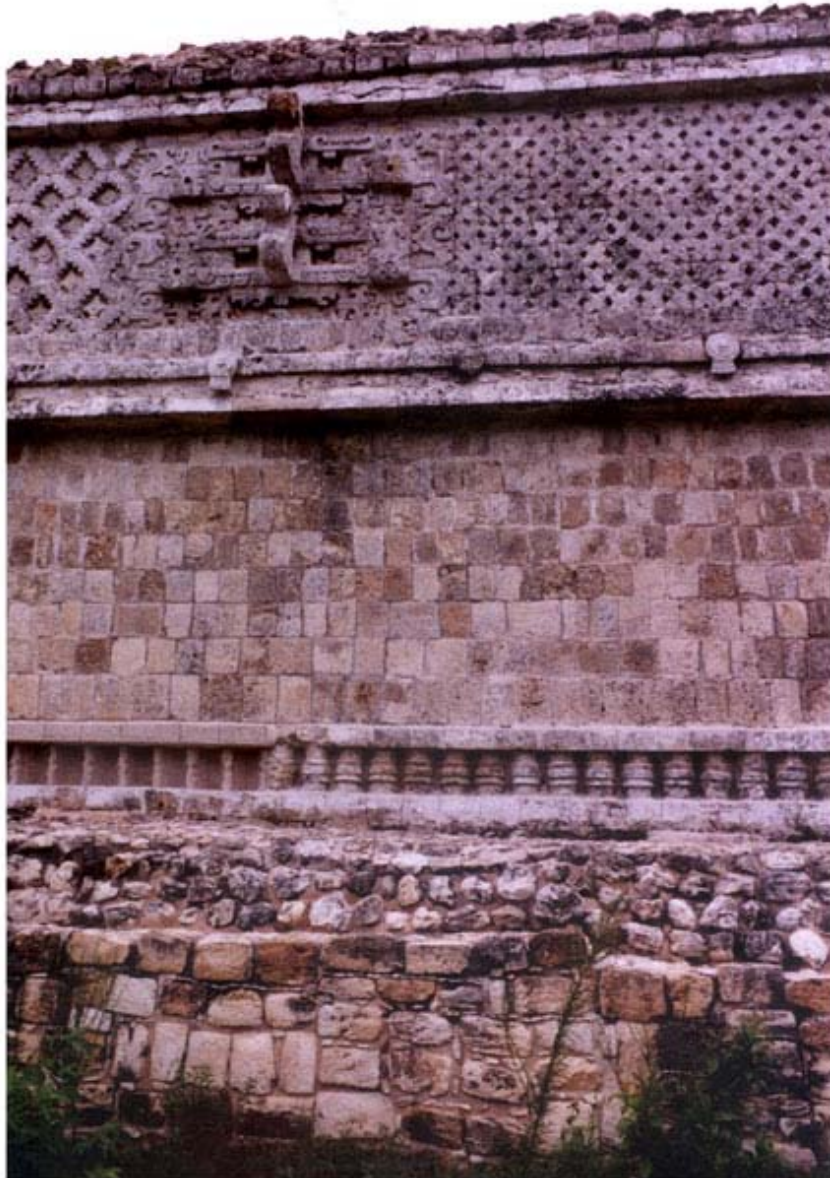
Plate 1.1: The Puuc building (11K2a) at Kulubá after the 2000 restorations (El edificio Puuc (11K2a) de Kulubá, después de las restauraciones del año 2000).

Unlike its large neighbors such as Ek Balam, San Fernando, and Naranjal, the site of Kulubá features a relative abundance of standing architecture ([Plate 1.1](#), shown above). Moreover, architectural studies of these masonry structures have shown that Kulubá has stylistic ties to both the Puuc area and to Chichén Itzá. Since the heart of the Puuc region is over 200km from Kulubá and Chichén is nearly 90km away, this architecture is of considerable interest. It has been the focus of researchers who have visited the site, especially the Chichén-style buildings. The Kulubá Archaeological Project was initiated to better understand the relationship between Kulubá and Chichén Itzá. Most discussions of this relationship have centered on elite-level architectural similarities between the two sites. The 2001 field season approached the problem in a different way by focusing on the lower-order centers in the Kulubá region ([Figure 1.2](#)). Mapping and surface collections at five small sites near Kulubá have revealed a minimal Chichén presence. No Chichén Itzá-style architecture was found at any of the sites we mapped, suggesting that elite ties between the Kulubá and Chichén polities were limited to their respective capitals. The Kulubá Archaeological Project has both increased our knowledge of some heretofore unknown and unmapped sites and has also used this data to examine the Late/Terminal Classic political scene in Yucatán from a different perspective than has been used at Kulubá.

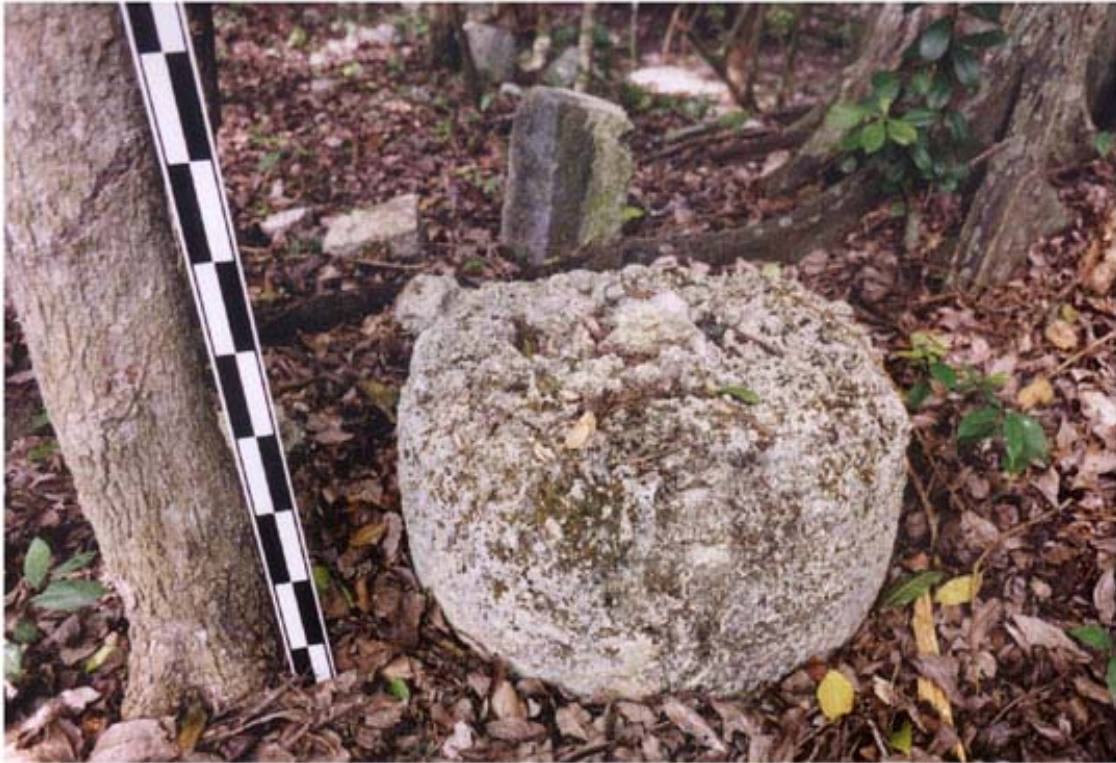
**Plate 1.2: Column drum at Kulubá Group C, Structure 7 [Andrews IV's Structure 9]
(Cuerpo de columna en la Estructura 7 del Grupo C de Kulubá [Estructura 9 de Andrews IV]).**

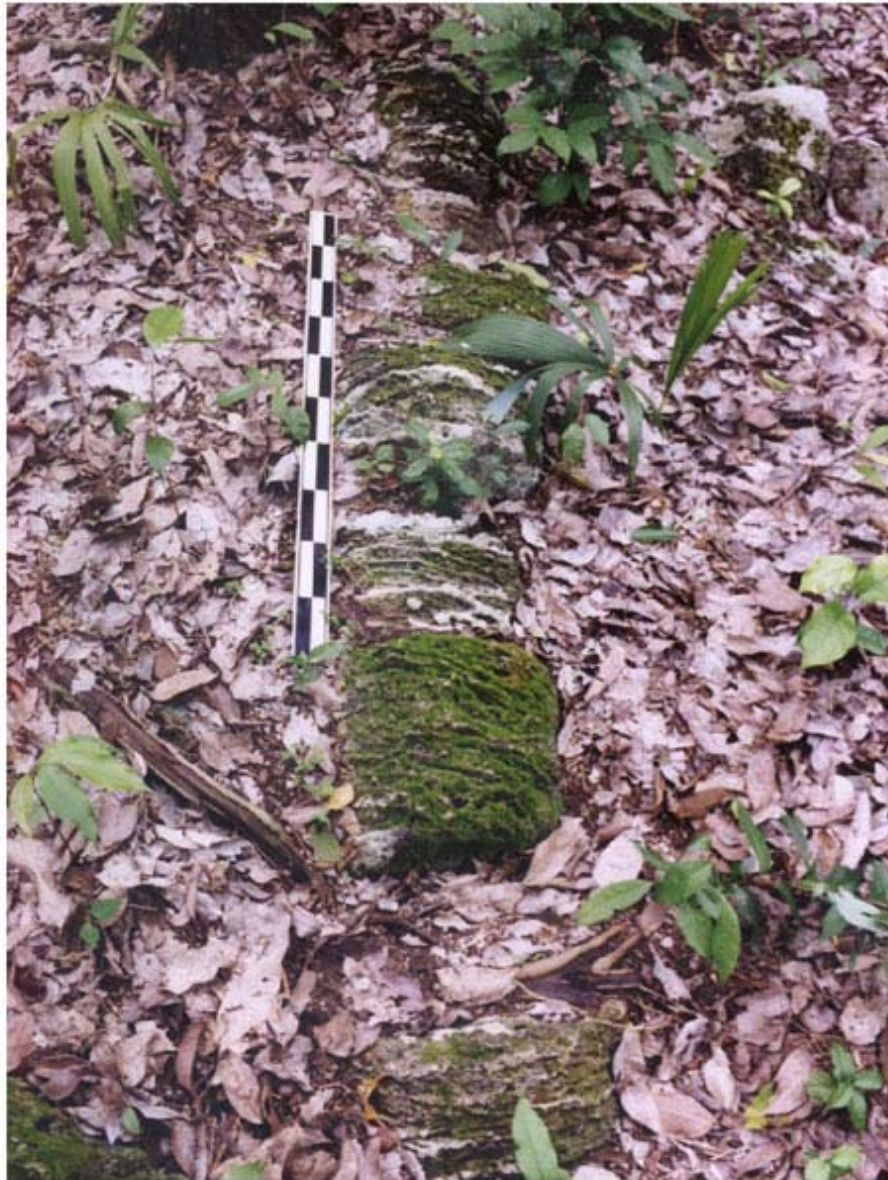
Plate 1.3: Column fallen en bloc at Kulubá Group C, Structure 11
[Andrews IV's Structure 5] (Columna de la Estructura 11 del Grupo C de Kulubá
caída en bloque [Estructura 5 de Andrews IV]).

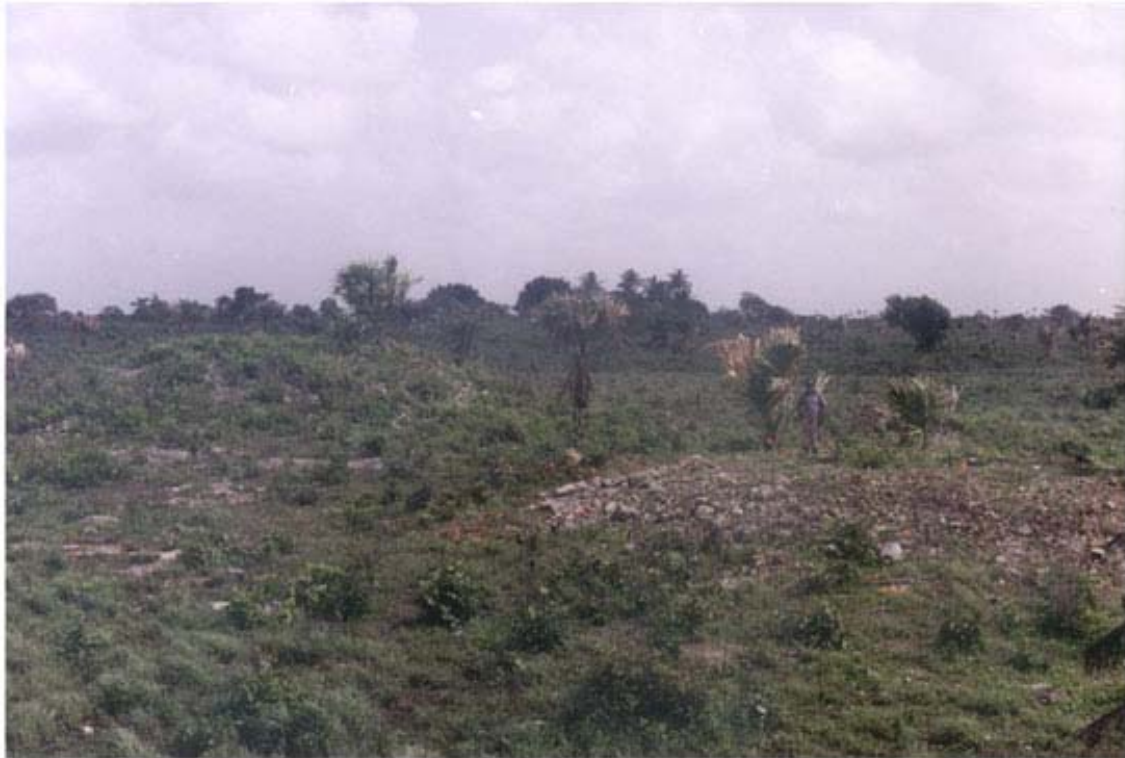
Plate 2.1: View north to San Pedro Structures 16 (l) and 15 (r) from the top of Structure 14 (Vista hacia el norte en dirección a las Estructuras 16 (l) y 15 (r) de San Pedro, desde la cima de la Estructura 14).

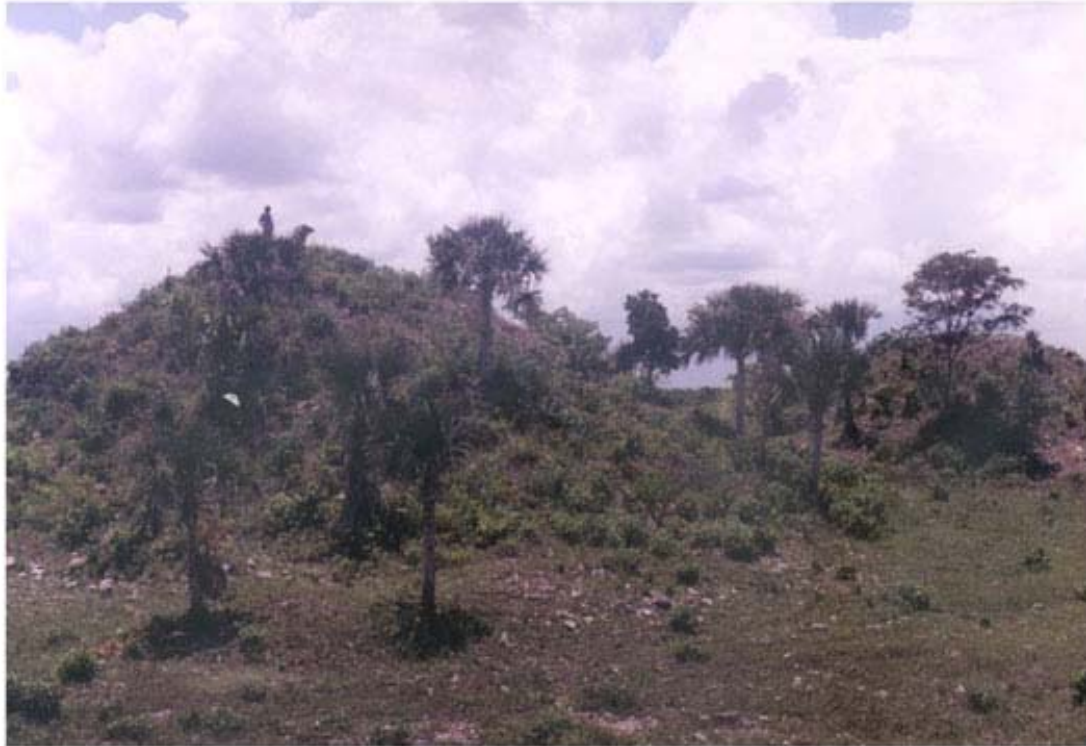
Plate 3.1: View east to Santa Monica Structures 1 (l) and 2 (r) from Structure 3 (Vista hacia el este en dirección a las Estructuras 1 (l) y 2 (r) de Santa Mónica, desde la Estructura 3).

This is the main civic pyramid at Santa Monica, the larger half of a tandem set of civic buildings ([Plate 3.1](#), shown below). It is about 9m in height and has seen extensive stone-robbing on its northwest edge. This saqueo is over 16m wide at the base of the structure and nearly reaches the summit. An 8 × 8m platform extends off the west edge of the structure and features two short *in situ* walls running N-S on top of it. The summit of Structure 1 is heavily looted; two trenches were noted on the south edge of this upper area. Despite the stone robbing and looting, there is some standing architecture still visible on Structure 1 ([Plate 3.2](#), shown below). The stonework features rocks with rounded edges and corners; there is no finely cut Florescent blocks. No one side of Structure 1 has clear indications of a stairway, making the delineation of its original orientation difficult. Its relation to the other large civic structures suggest that it probably faced south onto the plaza formed by it and Structure 2. Another possibility is that it faced west, towards Structure 3.

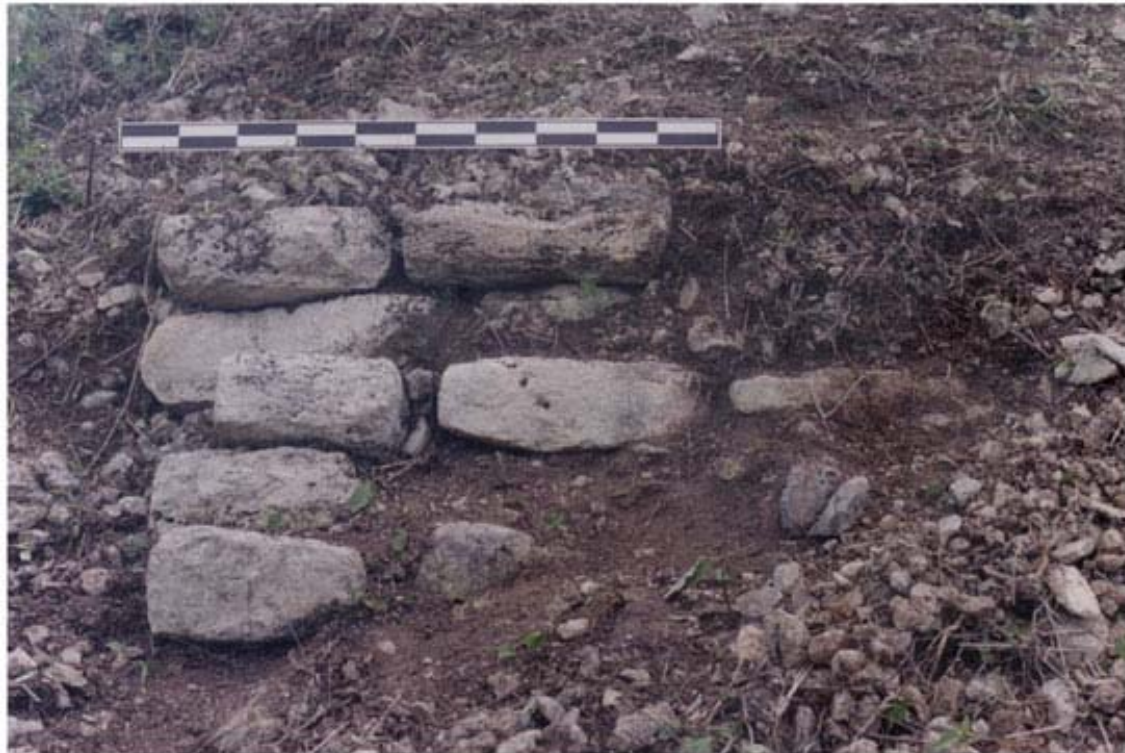
**Plate 3.2: Standing architecture on the south side of Santa Monica Structure 1
(Arquitectura aún en pie en el lado sur de la Estructura 1 de Santa Mónica).**

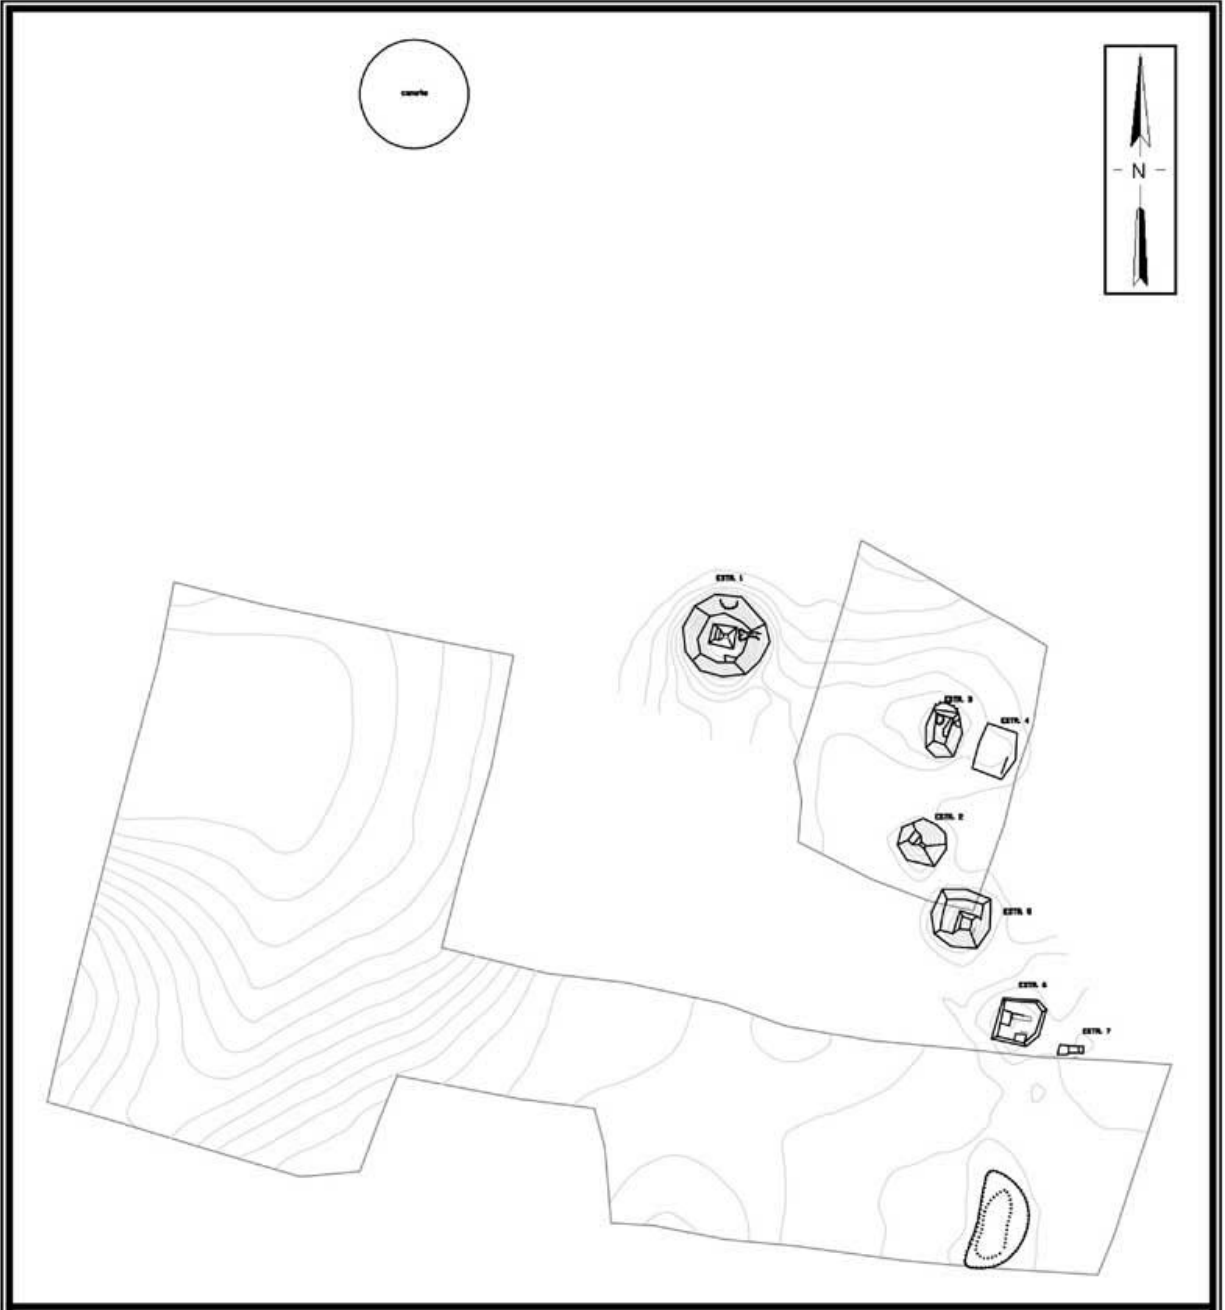
Figure 4.1: Map of Yun Ak (Mapa de Yun Ak).

Mapping at Yun Ak suggests it was a small site ([Figure 4.1](#)). We mapped a large *milpa* some 68,384m² in area south and west of the site center and found no structures within it. Either Yun Ak was a small site with very little residential settlement or the residential settlement is so dispersed that none of the platforms fell within our large *milpa*.

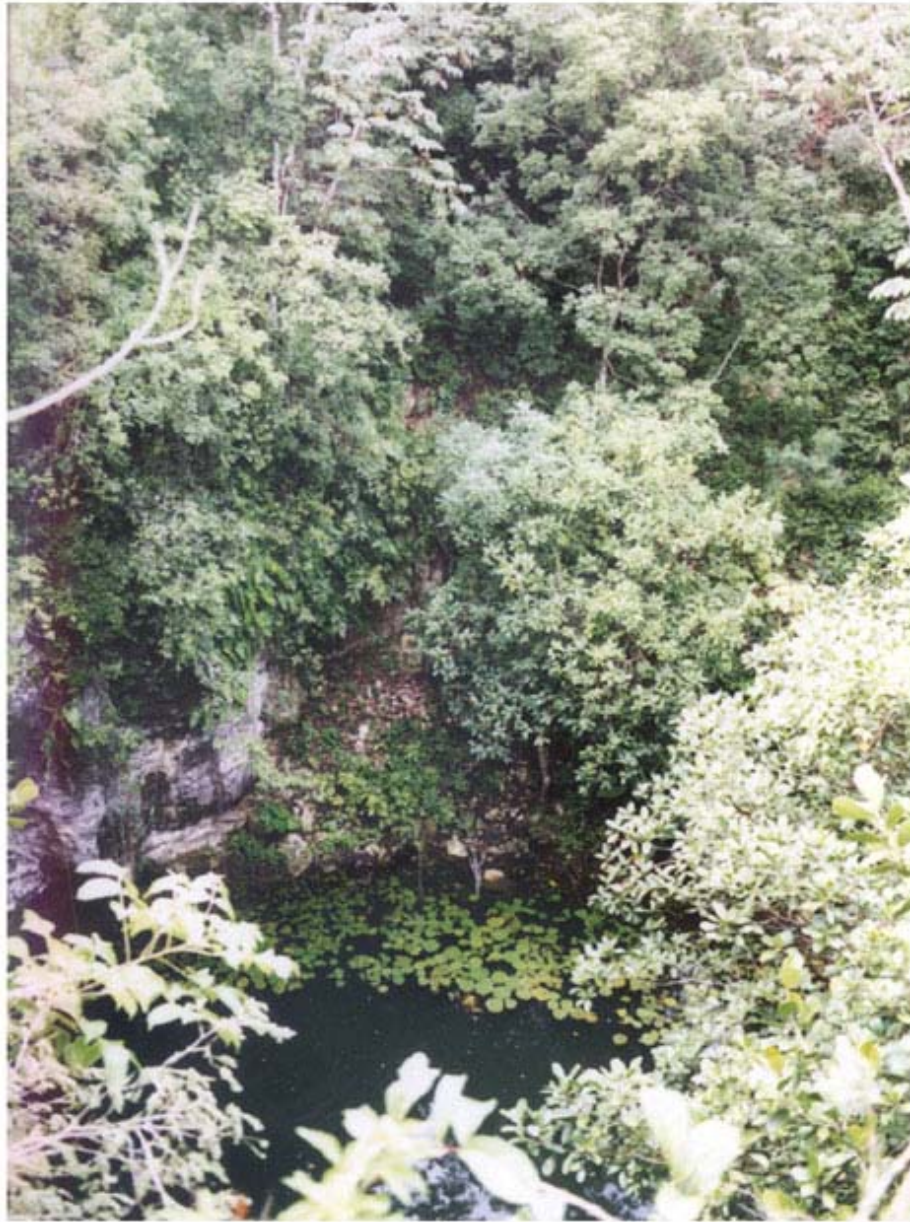
Plate 5.1: The cenote at Yokat (El cenote de Yokat).

A *cenote* found 125m SE of the main civic structure was undoubtedly the primary source of water for the inhabitants of Yokat ([Plate 5.1](#)). Its mouth is elliptical in shape, measuring 25m E-W and 44m N-S. A steep but useable trail down the south side of the *cenote* allowed us to take a point at the water table; this exercise showed that it has an average depth of 16m from the ground surface.

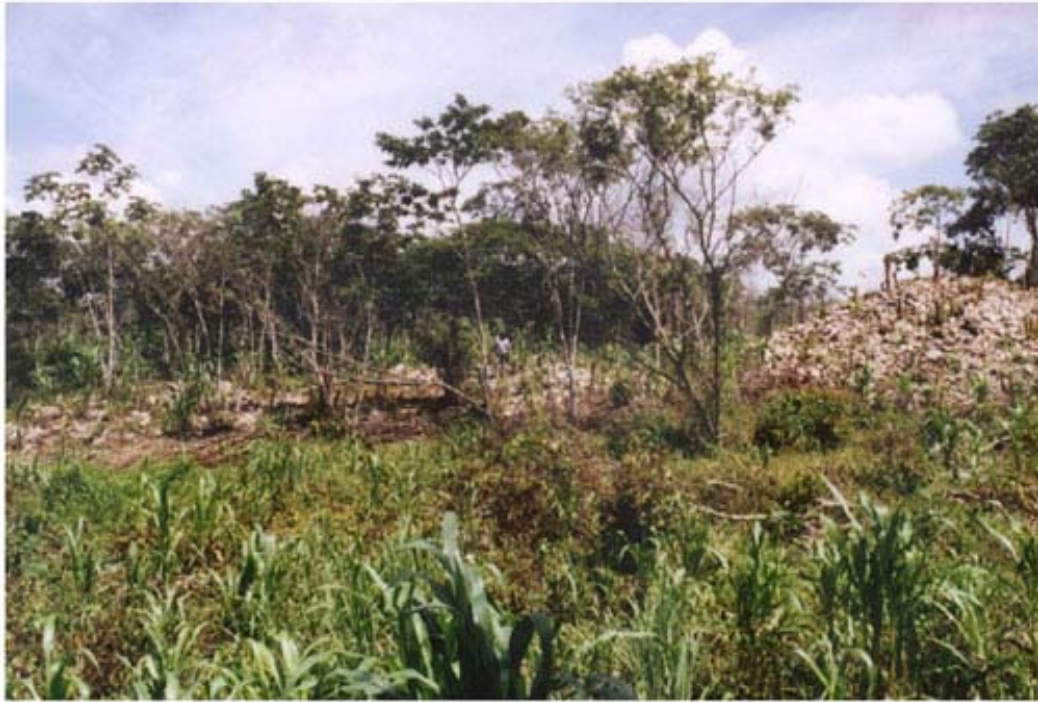
Plate 5.2: View northwest to the Yokat temple assemblage: Structures 4 (l) and 3 (r) from Structure 2 (Vista hacia el noroeste, en dirección al conjunto de templo de Yokat: Estructuras 4 (l) y 3 (r) de la Estructura 2).

This structure is a small pyramid that, along with Structure 4, forms part of what Proskouriakoff (1962) defined as a "temple assemblage" ([Plate 5.2](#), shown below). It is about 4m in height and is roughly 18m N-S × 21m E-W. Like Structure 1, this pyramid also appears to feature rounded or beveled corners. No *in situ* remains were found on the structure; rubble is all that is visible. The upper surface of the pyramid measures 6m N-S × 4.6m E-W. No superstructures were found atop the structure. Two things indicate that the pyramid originally faced east. First, the upper surface area is rectangular with its long axis N-S. This suggests that the superstructure that was built on this surface was most likely also oriented N-S. The second line of evidence concerning the building's orientation is the shape of the pyramid's slump. The east side bulges out

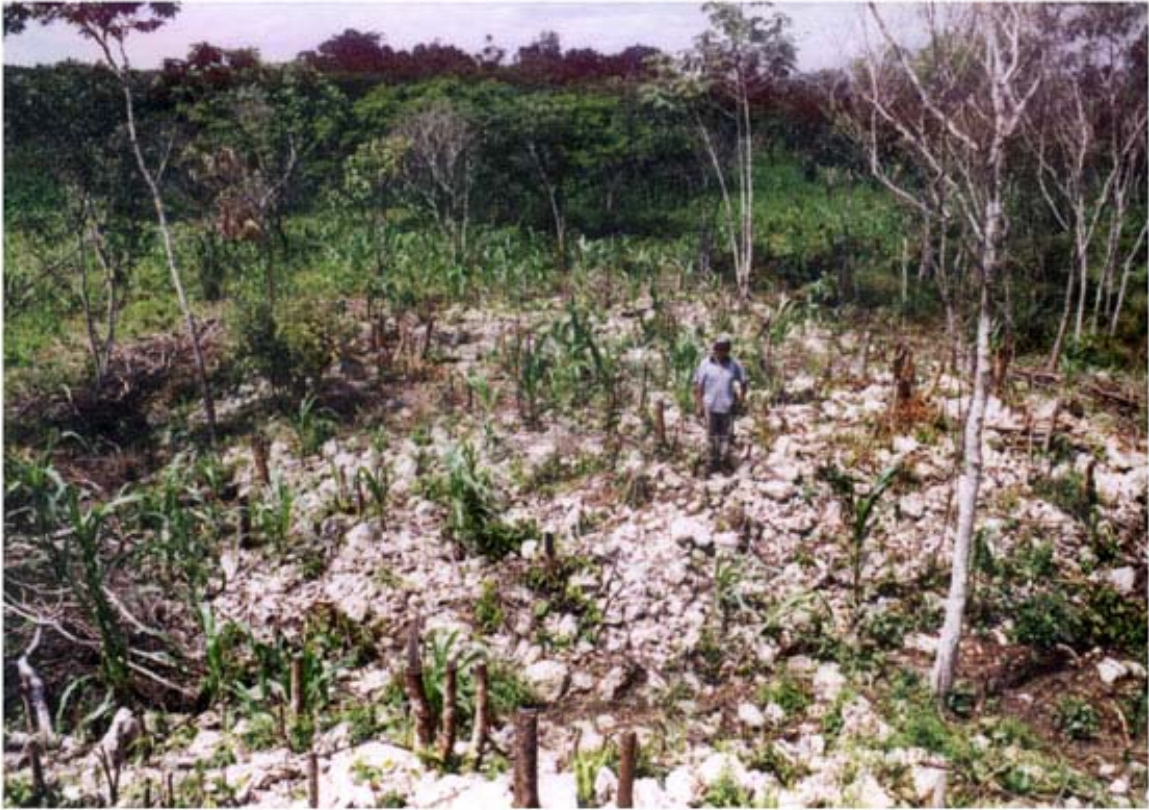
**Plate 5.3: View south to Yokat Structure 4 from the top of Structure 3
(Vista hacia el sur en dirección a la Estructura 4 de Yokat desde la cima de la Estructura 3).**

This is the range structure that flanks the pyramid (Structure 3) to the south ([Figure 5.2](#) and [Plate 5.3](#), shown below). Its north side is only 2m south of the pyramid and the structure measures 21m N-S × 14m E-W. The structure has an average height of 1m and was built on an *altillo* as limestone can be seen in the center of the platform. A short stretch of retaining wall was spotted on the west side of the structure near the SW corner and is non-megalithic in character. At least two and possibly three superstructures are found on the basal platform. The first is a secondary platform that is located on the basal platform's north end. This platform has a few exposed retaining wall stones on its south side and also some cut stones on its surface. A 4.1m long line of stones are roughly in the center of the secondary platform and face south. It seems likely that this was the front wall of a house of some sort and the back wall has slumped down the north edge of the platform. The second superstructure runs along the west side and might be a [-shaped structure, the kind of which has been recently studied at Ek Balam (Bey *et al.* 1997). A line of six stones is offset 2m from the west edge of the platform and these stones face east. Like the superstructure on the secondary platform, it seems likely that this line of stones are the remains of the front wall while the back wall has slumped down the west edge of the platform. No end walls were spotted, either. A third possible superstructure is found along the south edge of the platform. Here there is an accumulation of rubble but with no apparent architectural remains. It could be attached to the superstructure to the west, in which case there would be a single L-shaped superstructure. Another possibility is that the rubble is simply the remnants of an unfinished construction project.

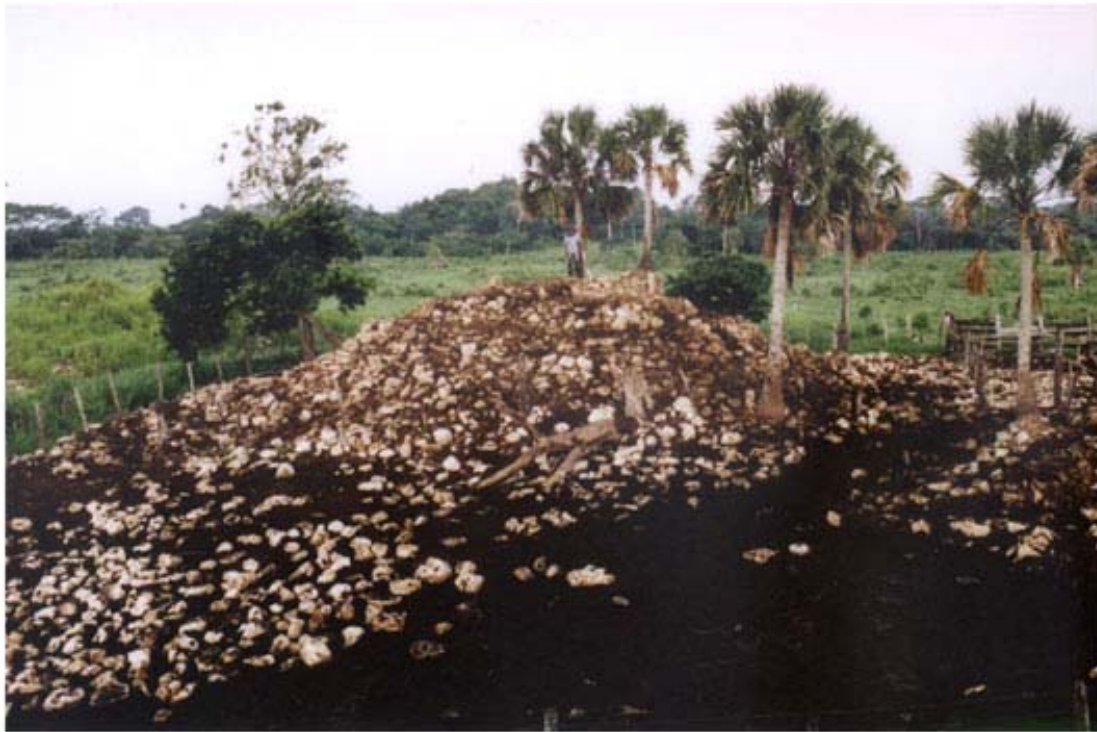
**Plate 6.1: View west to Ichmul de San Jose Structure 4 from Structure 1
(Vista hacia el oeste en dirección a la Estructura 4 de Ichmul de San José, desde la Estructura 1).**
