## RESULTS OF MICRO-MORPHOLOGICAL STUDIES IN SEDIMENTS, STUCCOS AND SOILS AT TRINIDAD, PETÉN

*Ellen Spensley*

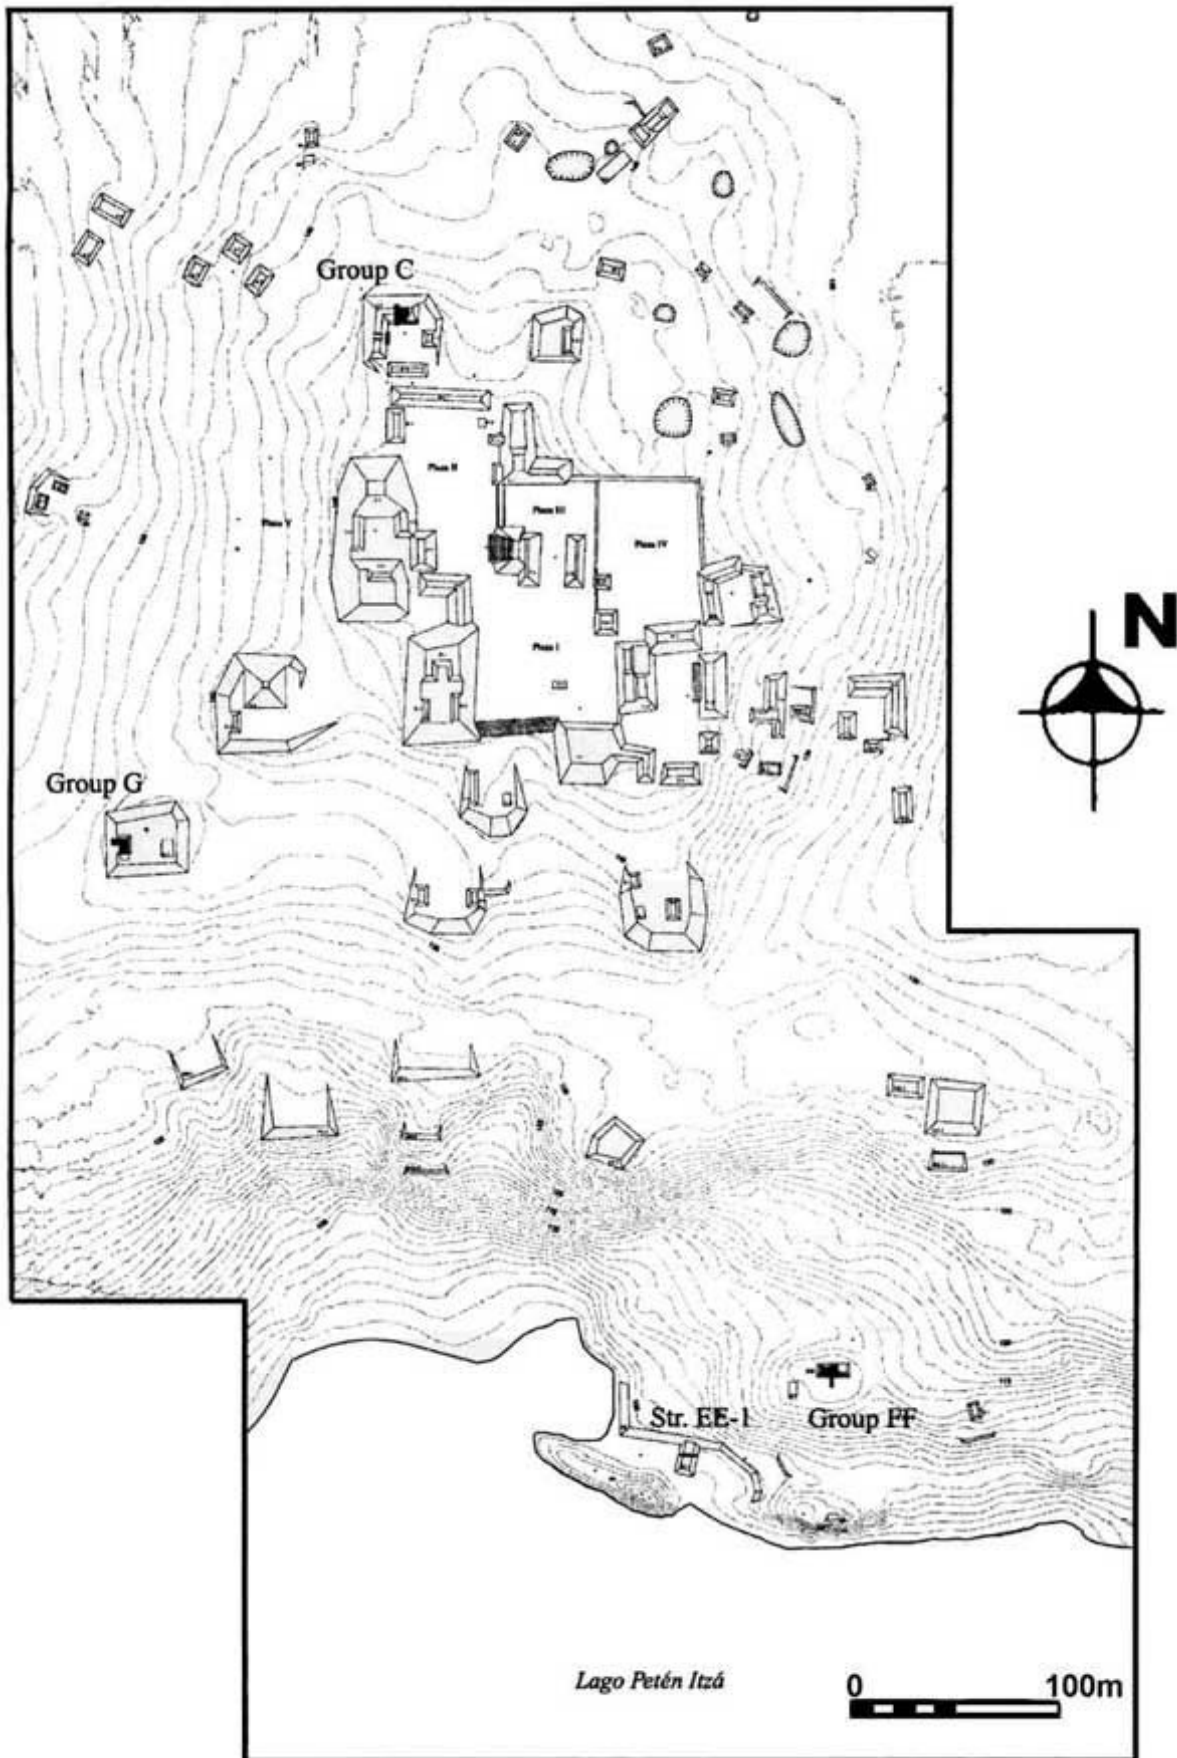
Figure 2. Ground plan of La Trinidad de Nosotros.

The nuclear zone of La Trinidad is located on top of a hill with a view to Lake Petén Itzá, and consists of public architecture with a pyramid 12 m high, a Ballgame and several high ranking residential groups (Figure 2). Two residential structures were partially excavated: C-1, an elite residence, and G-1, a sub-elite residence (Moriarty 2003).

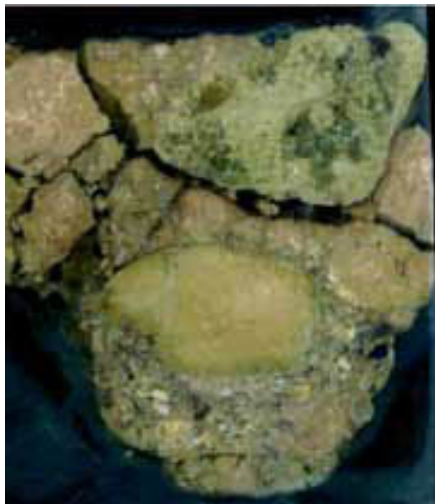
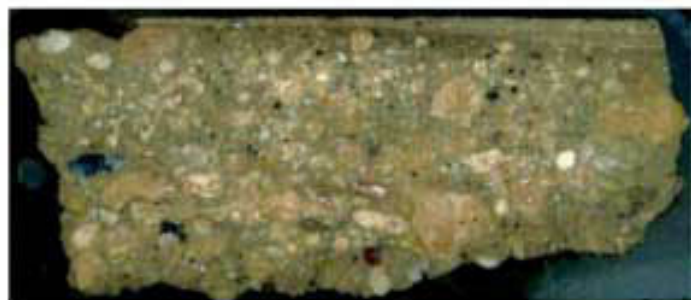
**Figure 3. Details of two stucco floors.**

The aggregates used in the stucco floors within the site core consisted of moderately thermic lime stones or fragments of dolomite, as well as simple calcareous grains of sascab and dirt. In general, these floors were poorly built, with porous spaces that ranged from 5% to 30%. In contrast, the stuccos within the port area included a very large amount of fragments of thermic limestone and were extremely dense, with porous spaces that ranged between 0% and 2%. These floors were also covered with several very thin layers, a unique pattern in La Trinidad (Figure 3).

Piso del núcleo del sitio  
(Estructura G-1)  
7.5 cm x 5.0 cm

Piso del puerto (La “Isla”)  
5.5 cm x 2.0 cm

The presence of highly thermic material in the port floors together with the presence of thin facing layers suggests that different processes were used in the preparation and application of stuccos. However, it is not fully clear whether such trends were of a temporal or functional nature. One possible reason for the differences observed in the preparation processes may have been that the thermic limestone exposed to high temperatures helped to protect the floors from erosion, while the careful construction of facing layers may have accomplished a similar function.

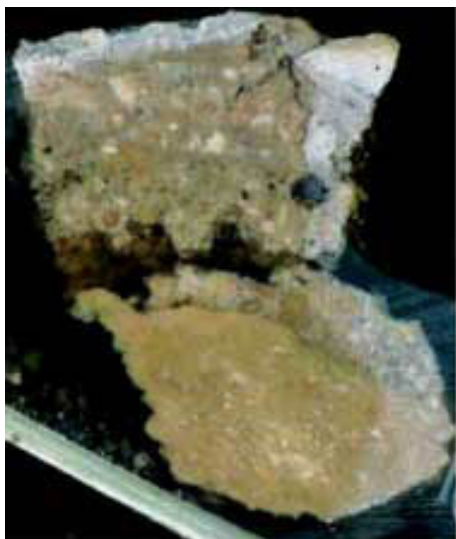
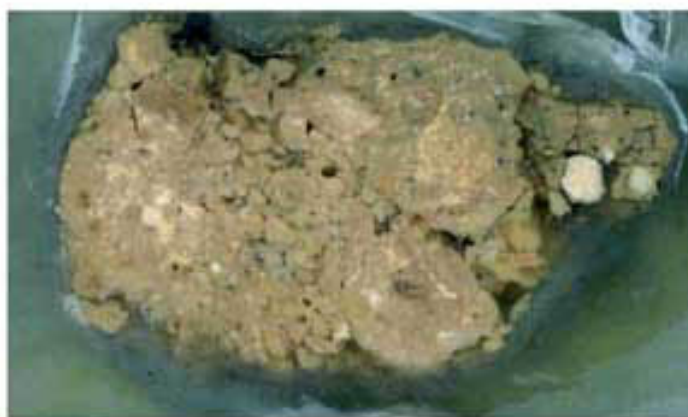
**Figure 4. Details of two stucco floors.**

Ethnographic evidence from Yucatan suggests that the creation of a thick stucco layer is part of the consume process achieved through tamping the floor surface with wooden mallets, for hours (Morris 1931:240). In contrast, the floors of Structure G-1 seem to have accumulated as simple layers with no surface compression. However, the stucco wall removed from Structure G-1 has clearly revealed a construction pattern of sascab alternated with real stucco layers (Figure 4).

Piso de la Estructura C-1,  
construcción capeada

Piso de la Estructura G-1,  
construcción simple

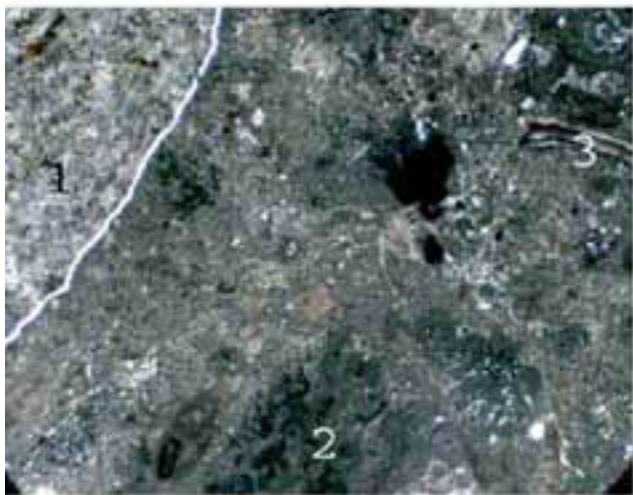
**Figure 5. Details of two stucco floors.**

In comparing the inner floors, the inhabitants of Structure C-1 used slight and low percentages of aggregates (Figure 5). Furthermore, a large number of lime rock fragments were observed on the floors of C-1, while those of G-1 incorporated a larger amount of sascab. The processing of relatively hard stones in fragments of a uniform size compared with an already pulverized material, suggests, again, that a greater labor was involved in the preparation of stuccos with this type of inclusion.

Piso de la Estructura  
C-1, sin agregados

Piso de la Estructura  
G-1, con agregados  
mas grandes:

1= caliza

2= sascab

3= concha

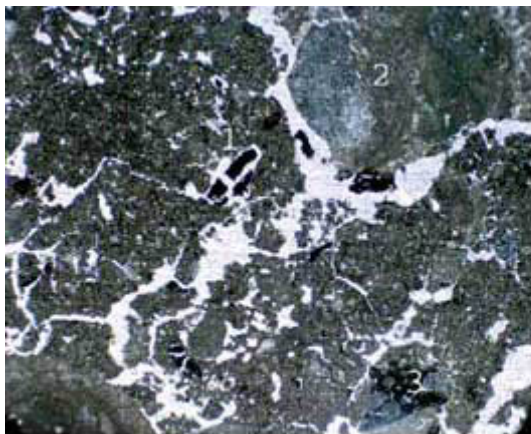
**Figure 7. Details of garbage pit sections.**

The inclusions in the deposits under Structure C-1 consisted primarily of charcoal with minor amounts of stucco, shall fragments, quartz sand and one fragment of burnt ceramic of an unidentified type. The deposits under Structure G-1 mainly contained stucco chunks with significant amounts of quartz sand and flint flakes, and shell and carbon in lesser quantities. The inclusions in the garbage pit under Plaza G consisted mainly of stucco, sascab and charcoal, with a lesser amount of shell and one sherd of red slip and calcareous temper probably of the Mamom phase (Figure 7).

Basurero debajo de la Plaza G, foto 10.0 mm.  
1= carbon, 2= estuco, 3= ceramica

Basurero debajo de la Estructura G-1, foto 10.0 mm.  
1= lasca de pedernal

Basurero debajo de la Estructura C-1, foto 5.0 mm.  
1= carbon, 2= estuco, 3= concha, 4= estuco altamente termico

While these variations could suggest different activities or formation processes, it is important to remember that often, garbage pits are not homogeneous with respect to the distribution of its components, and therefore, these samples may suggest artificial differences in composition. Nevertheless, Group G stands as candidate for a possible production center of lithic artifacts, based on the high density of instruments of different stages of production recovered in the excavation (Halperín and Hernández 2003). This observation has been confirmed at a microscale by the presence of many micro-flakes of flint, in contrast with the deposit under C-1, which was apparently of a more domestic character.
