# The Sociopolitical Configuration in the City of Q'um'arkaj: The Palaces and *Nimja* or Long Houses of the *Chinamit Nija'ib'*

Research Year: 2006 Culture: Maya-k'iche'

Location: El Quiché, Western Highlands of Guatemala

Site: Q'um'arkaj (Utatlán)

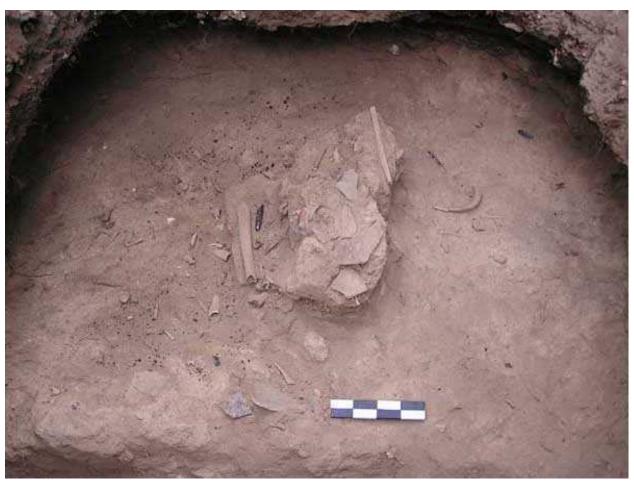
Figure 2. Funerary urn RC6a N1 with several offerings found north of the wall and canal of Platform RC6a.

Figure 3. Detail of funerary urn RC6a N1.

and fibula) and animal bone fragments. All this was associated with the urn and fine artifacts, including a "T" shaped piece of quartz similar to the lk' logogram, a deer antler, obsidian blades and cores (<u>Figure 2</u>, above, and <u>Figure 3</u>). Three structures were recorded which were attached or parallel to this building; their architectural features seem to be similar to the former structure (<u>Figure 4</u>, below).

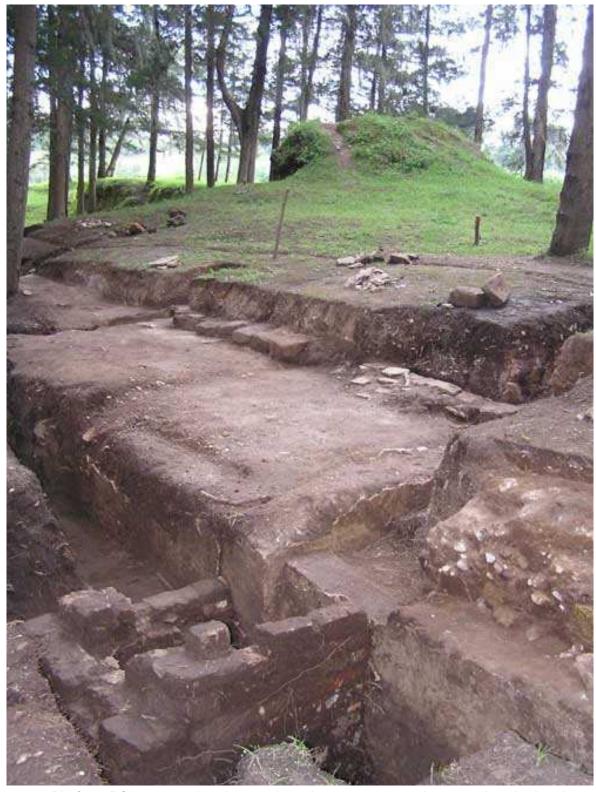
Figure 4. Platform RC6a supporting the temple and superstructure elements. Attached to the west is Platform 1.

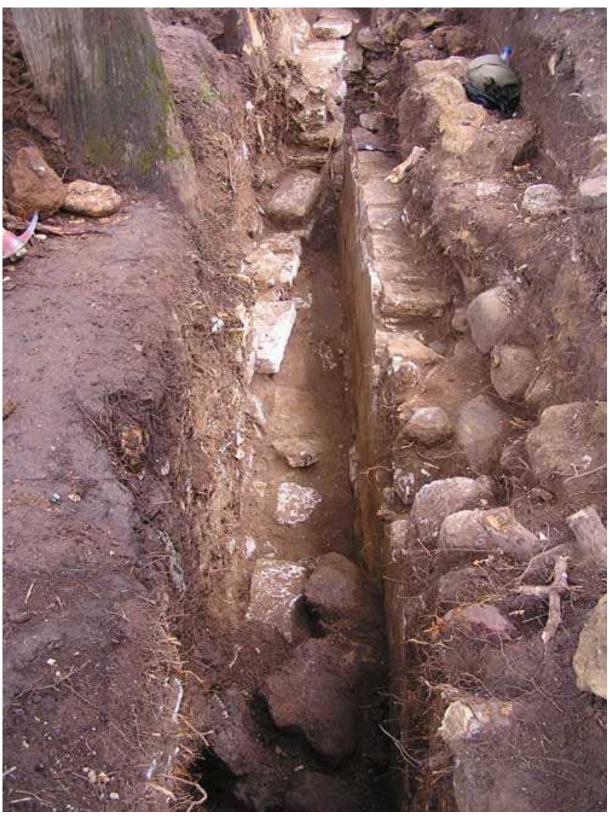
Figure 6. View from the west of walls 1 and 2 of the south façade of Platform RC6a.

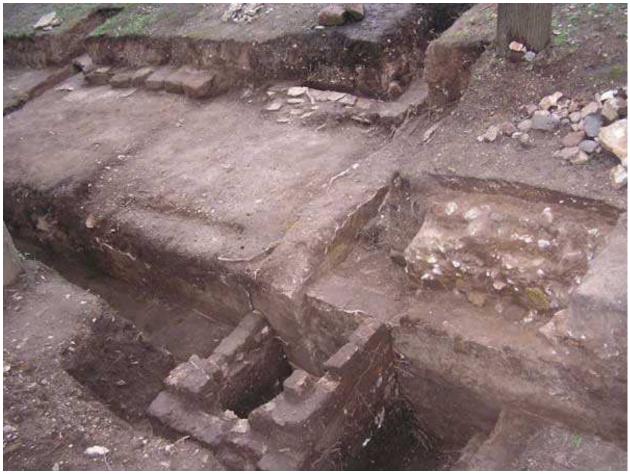
Figure 7. Architectural "defensive" element attached to Platform RC6a and Platform 1, blocking northwest stairway.

Through the depositional analysis of the remains in the RC6a platform we can see that the occupants of this part of the site modified the building on several occasions. In fact, the platform's extension on its southern façade seems to correspond with regulated events whose date is difficult to ascertain due to the dearth of cultural material that would allow to establish a chronology (Figure 5, below). From its first wall (Wall 1) to Wall 3, which was its last modification, the platform was extended toward the south covering a space of 1.80m (Figure 6, below). The movements in the northern façade are shown by profound modifications; the last building stage shows the building of emergency constructions; we can arrive to this conclusion because of the construction of a possible quadrangular defense system which blocked an access system, as well as the construction of a retaining wall which obstructed a water canal that was parallel to the wall. As a result of these seemingly unplanned constructions, two architectural elements were rendered useless: the North access system and the water canal. These modifications could be placed chronologically to shortly before the arrival of the Spaniards (Figure 7, below).

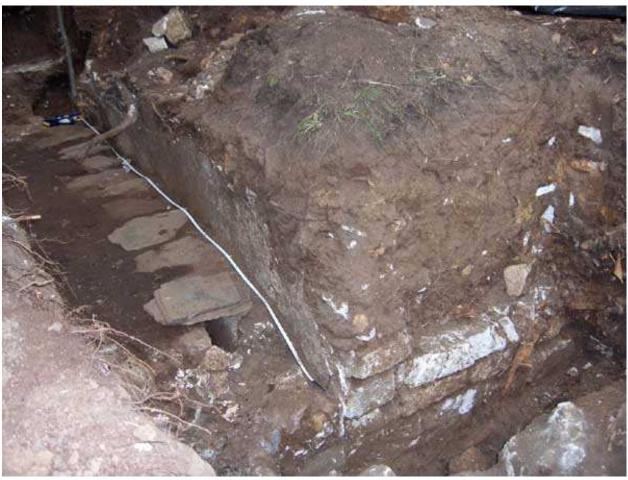
Figure 8. Trench showing stone slabs and river cobbles attached to the east wall of Structure C5a.

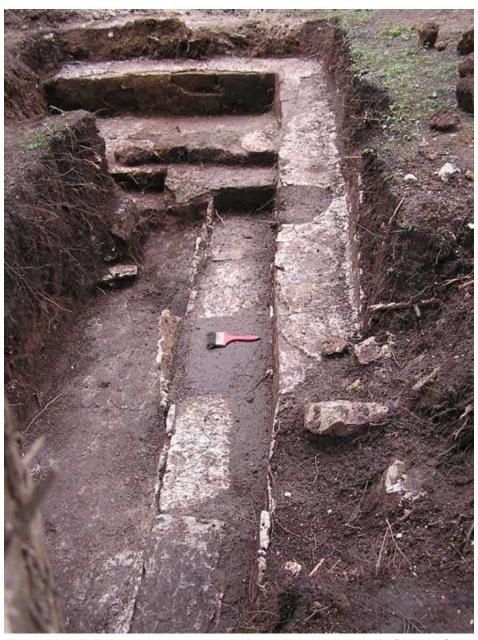
Figure 10. "L" shaped stuccoed bench on the western wall of Nimja C7a.

22.50×12.50m, is "C" shaped and has a long bench which ends in an "L" shape on its western wall (<u>Figure 10</u>, below). We could see inside the structure a dividing wall, with a north-south orientation. In the center of the structure we found a stairway consisting of two steps that gave access to the upper part of the building (<u>Figure 11</u>, below). Finally, on the top of the structure we saw a great deal of its stucco cover as well as five round, concave altars.

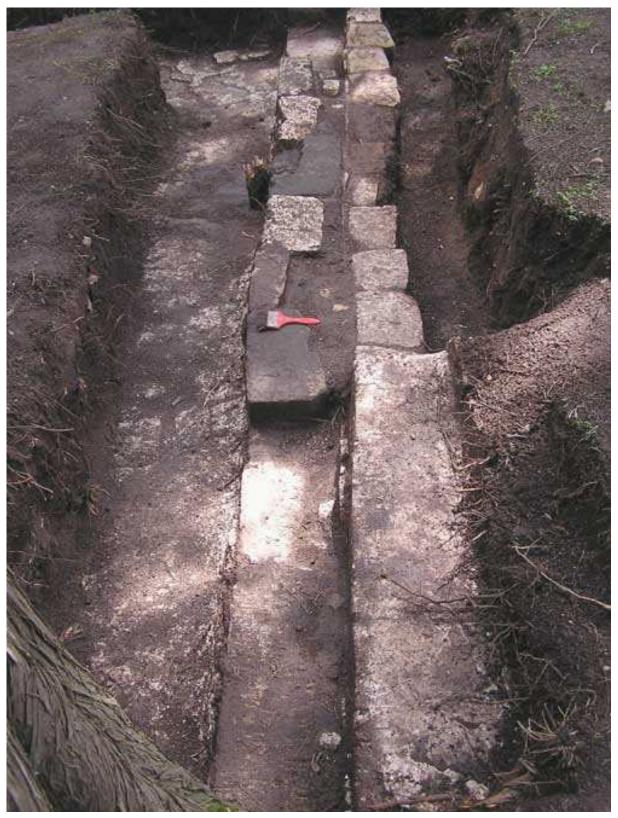
Figure 11. Long bench and central access system to Nimja C7a.

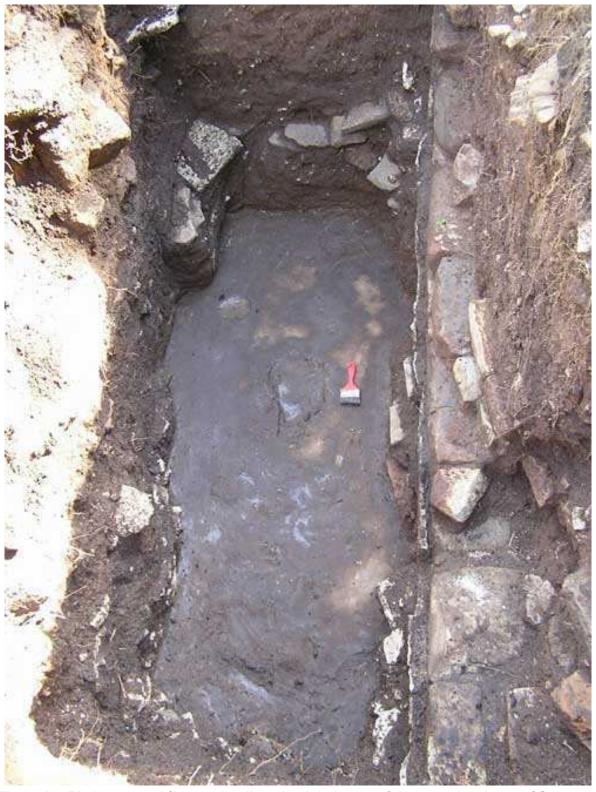
Figure 14. Pit 1: stuccoed floor and wall, to the right is part of the central stairway of Structure P11a.

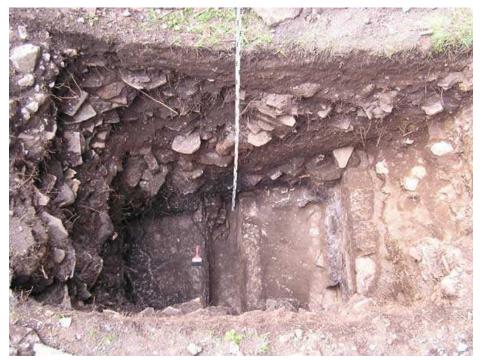
Figure 15. Pit 2: wall of Structure P11a with burned north and northeast areas, stuccoed floor and canal. In the stratification the strong stone slab debris presence is observed.

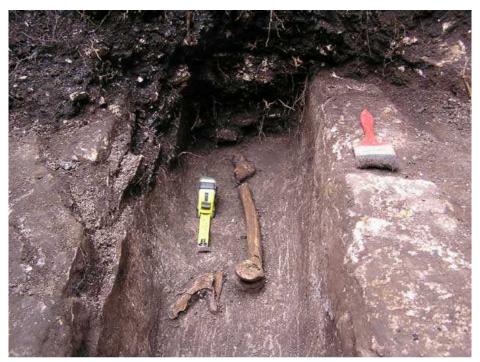
Figure 16. Pit 2: stuccoed canal where we found several fragments of human bone, belonging to several male adults in a burnt context with ash.

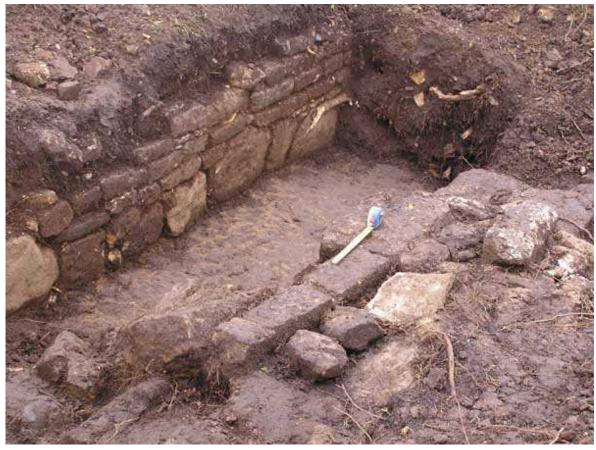
Figure 17. Western wall of the Substructure M2 in front of the Eastern wall of Substructure M7.

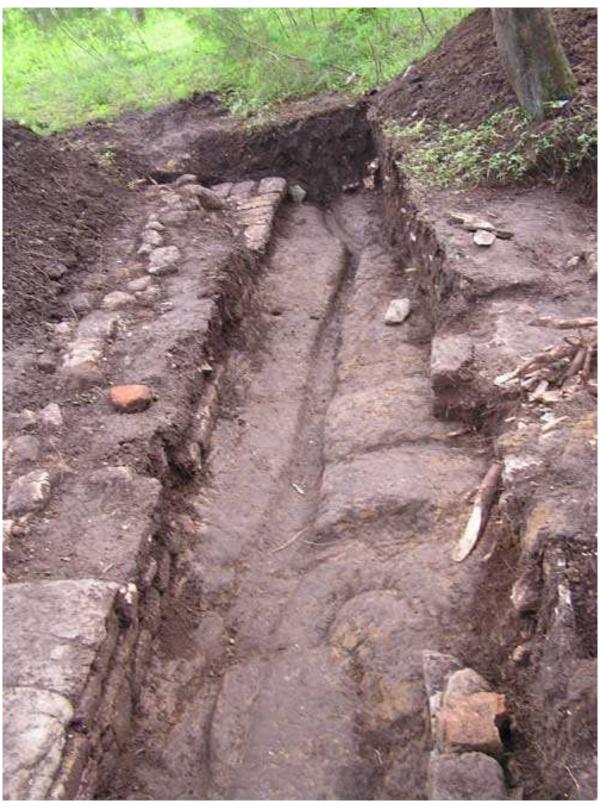
Figure 18. Wall and rounded corner of substructure M7, on which can be seen the remains of the superstructure. Floor and canal made of talpetate.

kind of food or water for domestic or ritual use. One meter to the west of the M2 structure we found Structure M7, which consists of a 18×6m rectangular platform oriented toward the west (Figure 18). Between both structures we found a canal (Figure 19) with three holes on its *talpetate* base or floor (Figure 19). The excavation of these structures, especially the M2 Structure and the corridor, produced more than four thousand potsherds, among them semi complete censers, *comales*, jars, basins and 110 fragments of obsidian artifacts (cores, flakes, blades, etc.) (Figure 20). The analysis of the architectural elements and ceramics seems to support the idea of a domestic-ritual function for Structure M2 (Figure 21), which could have been used for celebrating family rituals (Figure 22).

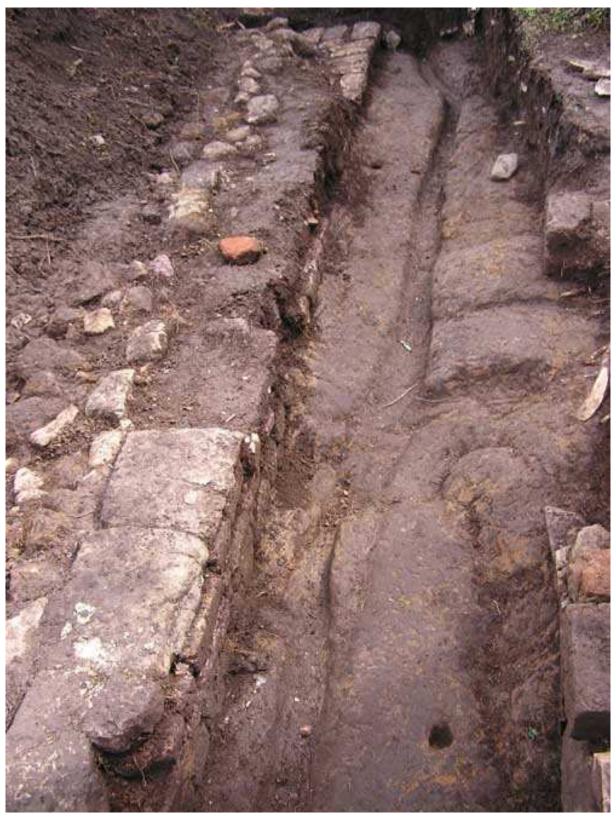
Figure 19. Panoramic view of the canal in the talpetate floor.

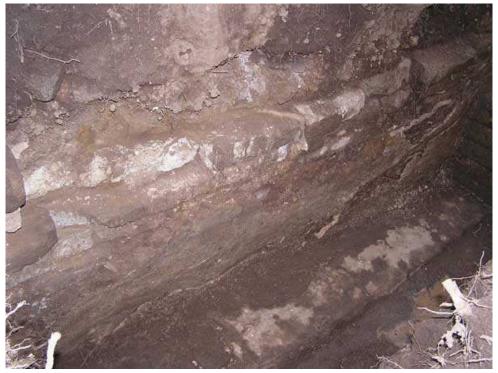
Figure 23. View of the northern wall of Platform RC6a and the emergency retaining wall which cuts across the stuccoed canal.

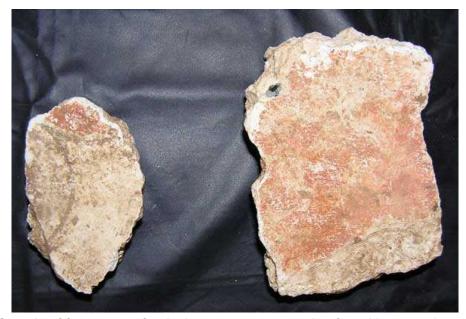
Figure 24. Sample of fragments of polychrome stucco covering found in several operations. One fragment shows a geometric figure, probably a scroll, drawn with black lines which delineate red and dark-yellow surfaces.

By excavating in three different zones we could obtain a good sample of the different types of building found in the city. Through an archaeological approach combined with ethnohistorical data this project has had great achievements. The historical texts helped considerably to understand the behavior of the K'iche' society and its spatial arrangement in Q'um'arkaj, as described in Pedro de Alvarado's accounts: "and like the city of [Q'um'arkaj] is very tight and the streets very narrow there was no way we couldn't suffer without drowning / or falling off the cliff in fleeing the fire. And as we climbed I saw myself inside the fortress so big that inside it we could not use horses because the streets were so narrow and covered with lime / I then decided to get out of it toward the level ground"/... (P. de Alvarado 1934: 12). From an archaeological point of view Pedro de Alvarado's account is confirmed, since the archaeological data show a great preoccupation with the handling and use of space to advantage, which resulted in crowding of the structures in the three investigated sectors. Some buildings were attached while others are separated by a narrow thoroughfare of less than 2.50m, which had at the same time water canals (Figure 23). All structures have stuccoed floors, except for those in the western sector. In some areas we found in situ fragments of floors covered with polychrome stucco (Figure 24, above).

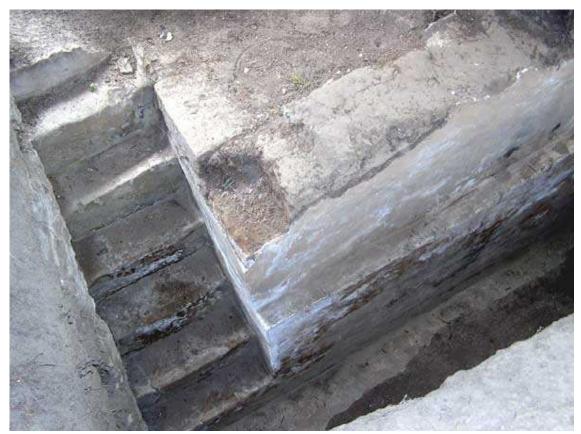
Figure 25. Wall and stairway partially uncovered in the western façade of Platform RC6a. These excavations were probably carried out in 1980.

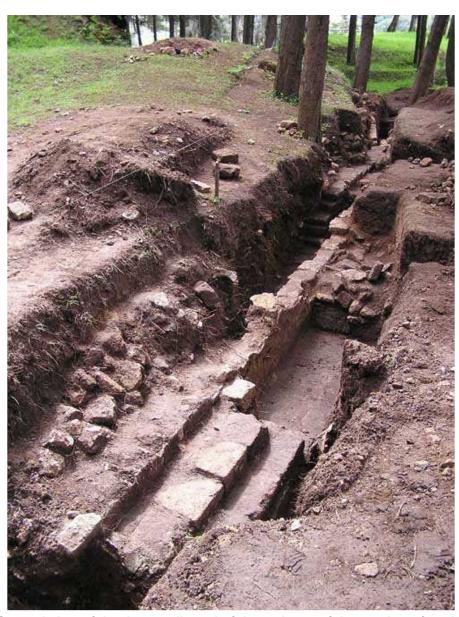
Figure 26. General view of the three walls and of the stairway of the southern façade of Platform RC6a, showing sample of building materials.

The K'iche' of Q'um'arkaj developed complex building techniques which can be seen in the high quality of the joining, in the canals for water disposal, and in the coverings with several layers of stucco. The latter could lead us to a complex genealogy of leaders or show a certain effort to protect buildings from the effects of nature, and at the same time to take care of the center's splendor (Figure 25, above). Although the architectonic monumentality of the structures shows variations between the three sectors, for the most part the same building materials were used, that is selected blocks, soapstone, talpetate, pumice stone, and to a lesser extent river cobbles. Thus, the local geologic resources were exploited (Figure 26 and Figure 27, below).
