Building Four: a Palace in Tula Grande, the Lodging of the Toltec King

Research Year: 2007

Culture: Toltec

Location: Tula de Allende, Hidalgo State, Mexico

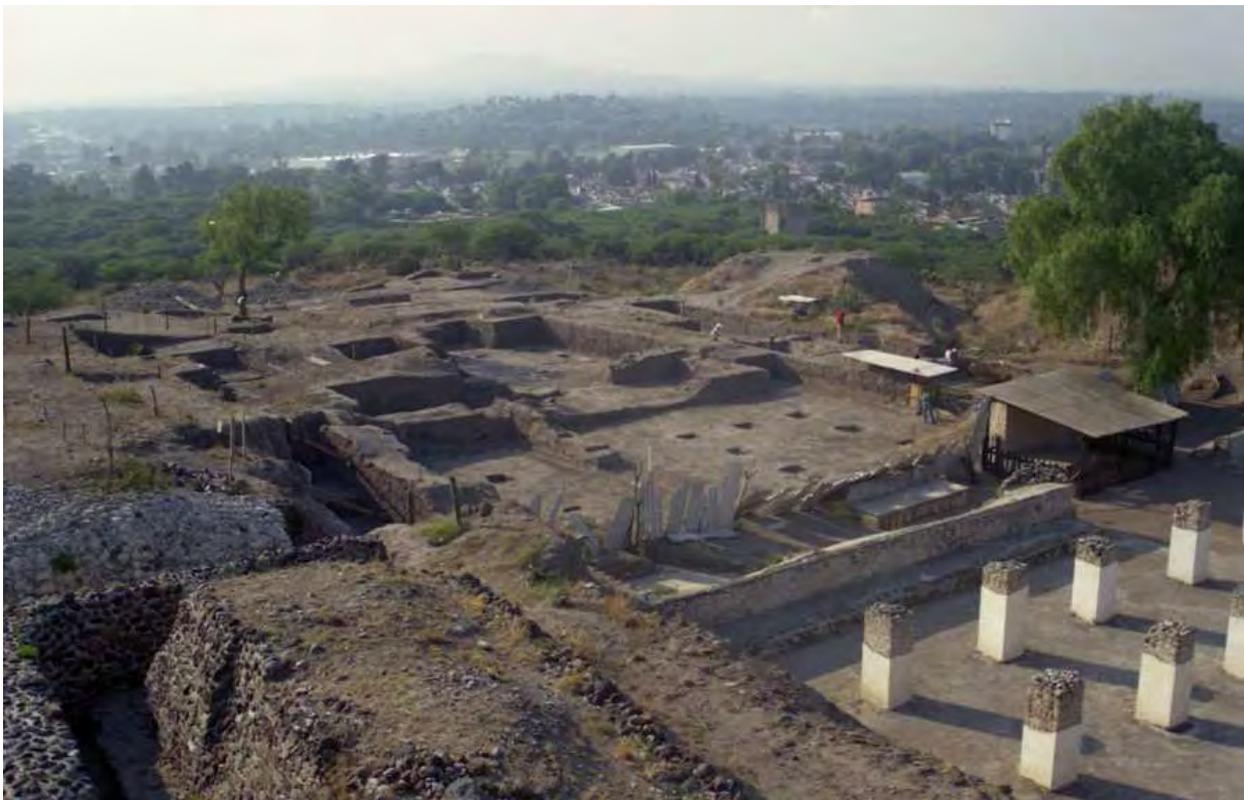
Figure 6. Panoramic view of Building Four and the explored areas, seen from the northwest.

Taking into account the work performed by Acosta (1956, 1960), who uncovered the entrance, the altar-banquette, and three halls of Building Four, plus the area explored during the 2002 - 2004 excavations, we can say that this is a rectangular structure with a length of roughly 64 m in an east-west direction and a width of 42 m in a north-south direction. The building covers an area of almost 2,688 m² from the base of the structure to the wall dividing the building's access from the vestibule ([Figure 6](#) and [Figure 7](#)). Building Four shows a general orientation of 17° east of geographic north in respect with the rest of the structures of the precinct (Acosta 1944: 126).

[Figure 6](#). Panoramic view of Building Four and the explored areas, seen from the northwest.

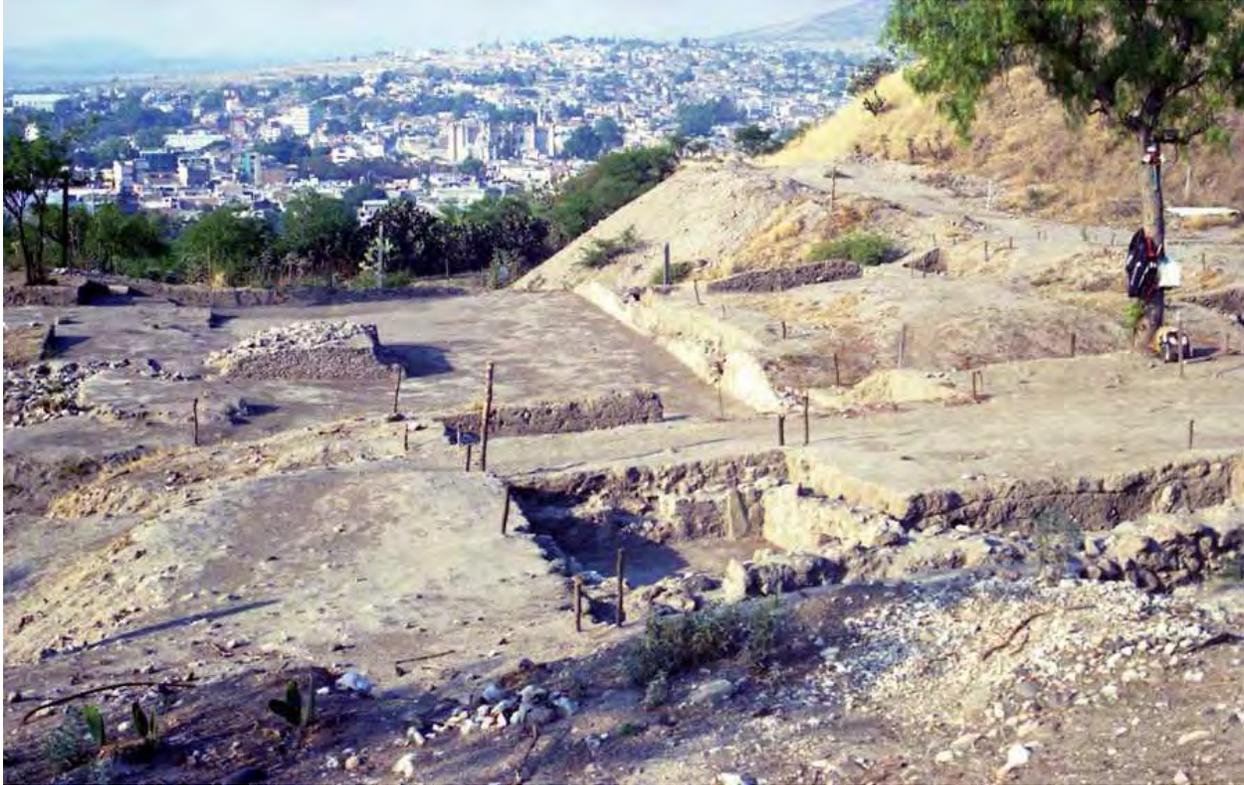
Figure 7. Building Four's east sector.

[Figure 7](#). Building Four's east sector.

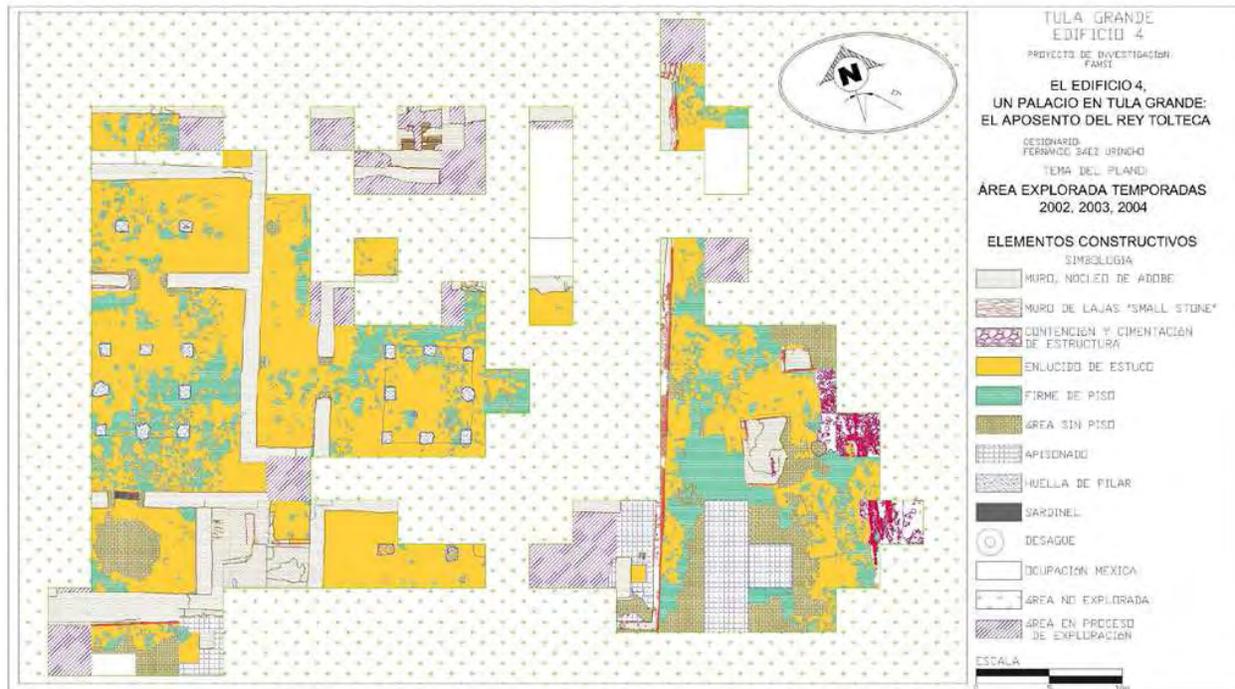
Figure 10. The explored area and the state of conservation of constructive elements in Building Four.

On the north side of the altar-banquette there is a 1.92 m-long entrance communicating with the first hall with portico, it is square with 14 m on its north-south axis, 13 m east-west, covering an area of 182 m². This hall is bounded by adobe walls on its four sides and a series of quadrangular pillars surrounding a central space, three pillars on each side, indicating that it was an open space of 4.90 m in length by 4.60 m wide (the hall), with a roof at the end of the hall (the portico) ([Figure 10](#)).

On the north side of Space 3 there is another room of quadrangular shape, which has been identified as a storage area because of the items found inside. We haven't defined its size with any certainty, but we can say that this is a narrow roofed space, measuring 3.45 m wide on a north-south direction, with a length of at least 12.63 m in an east-west direction, and an area of roughly 43.57 m². The north and south walls enclosing this space are also made of adobe ([Figure 10](#)).

Next to the above, after going up the stairs there is another room, which on the basis of the few evidences we found, suggests a space located on a level of the upper floor. It may have linked with the exterior alley of the palace unit through the south sector. It also allowed direct communication with the northeast part of Pyramid C. We were not able to know the exact dimensions of this room, all we could tell is that it is an area of 6.48 m long by 5.45 m wide ([Figure 10](#)).

On the eastern boundary of the architectonic structure we defined Building Four's greatest area ([Figure 10](#)). This is an open space with an extension (so far as we know) of roughly 39 m long on a north-south direction, by 12 m wide on an east-west direction, covering an area of around 468 m². This open patio is bounded by a long wall made of slabs of *tepetate* (bedrock) covered with stucco, which runs along the whole of this face of the building. On the southwest corner the patio seems to carry on along the exterior alley. In the northwest section we found a series of five stairways going inside Building Four, therefore this indicates the means of access and communication between the open space and the rooms inside the building.

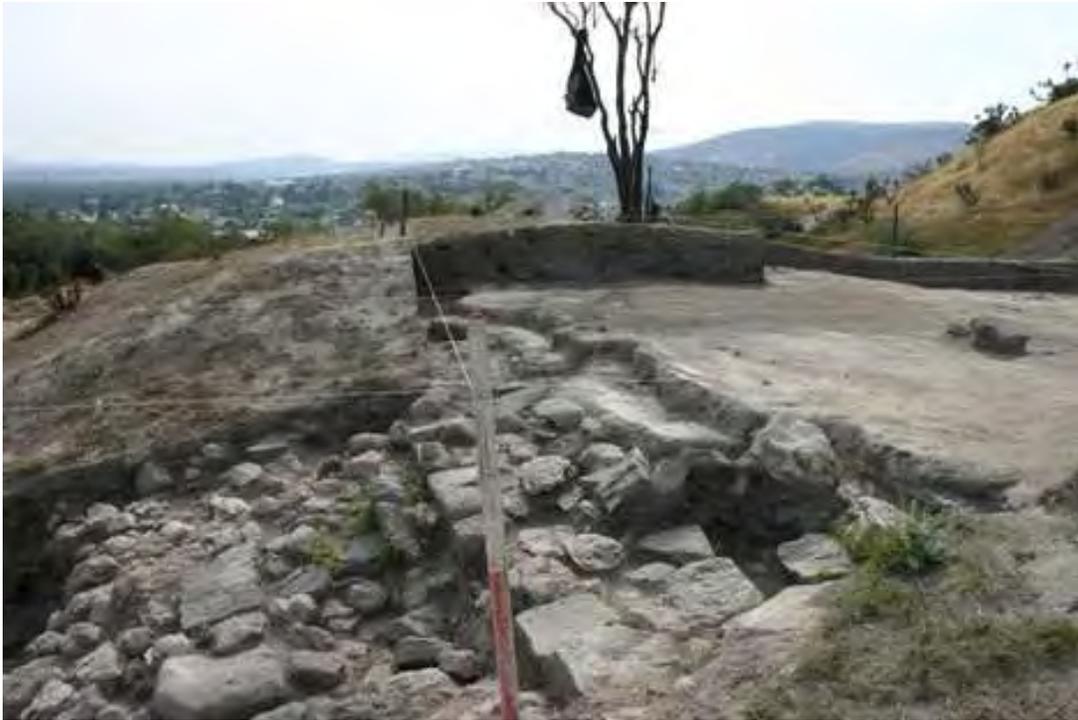
Figure 11. East limits of the structure, where part of the foundations and core can be seen (courtesy of Dan Healan).

Only a small portion on the east limits of the building could be explored, where we excavated the slope of the structure's base. The material used for the base as core for the foundations and for containment is round basalt stone, which is placed in such a way that it allows the stones to link together by means of mortar made of earth with a compacted core. Also present –though in lesser amount– is another type of stone called *tepetate*, or limestone.

These mixtures of stone material are found inside what seem to be containment boxes in order to rise the level of the building. One can see several alignments of worked basalt stones (average width: 60 cm) in a north-south direction ([Figure 11](#)).

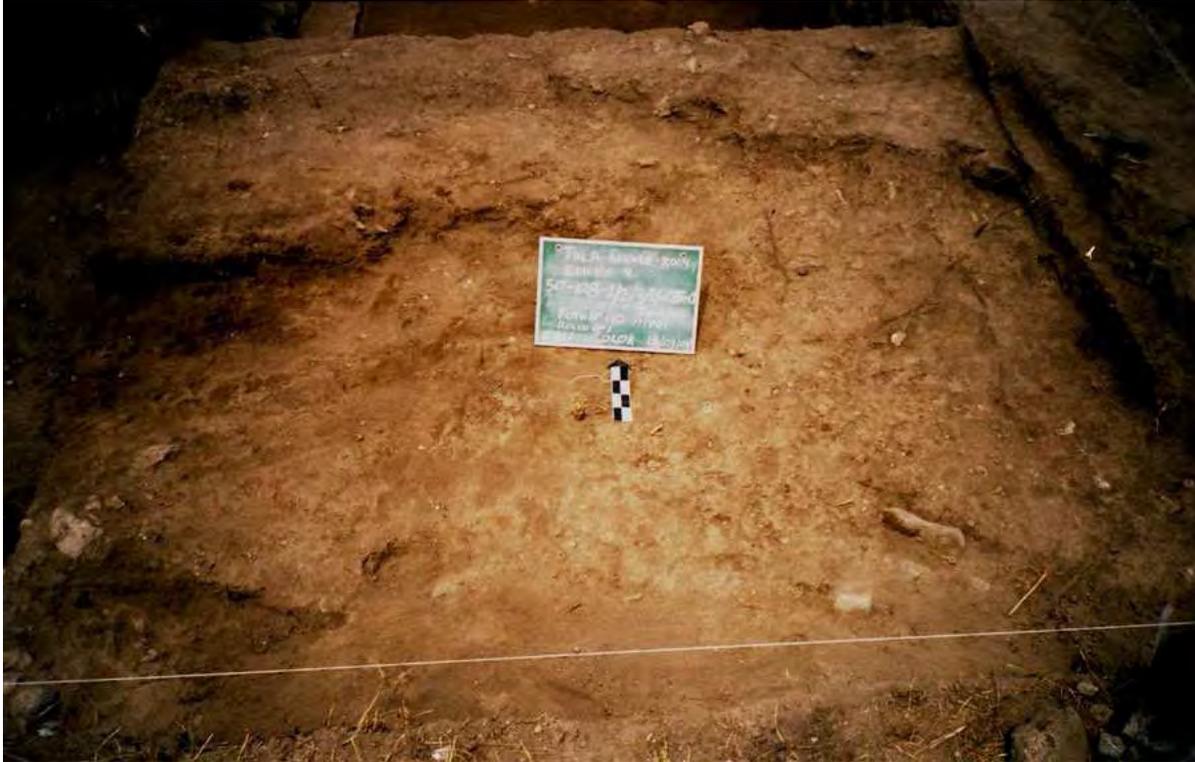
Figure 12. Detail of the adobe core as part of the building's foundations.

Another element used as foundation for this structure was adobe, by means of containment boxes, in order to give greater volume and to raise the level of the floor of some particular area, such as the spaces with stairways in the south room (Space 15) and in the stairways to the north of the open patio, in the altars of the open patio, and in the rowlock at the entrance of the room identified as Space 5 ([Figure 12](#)).

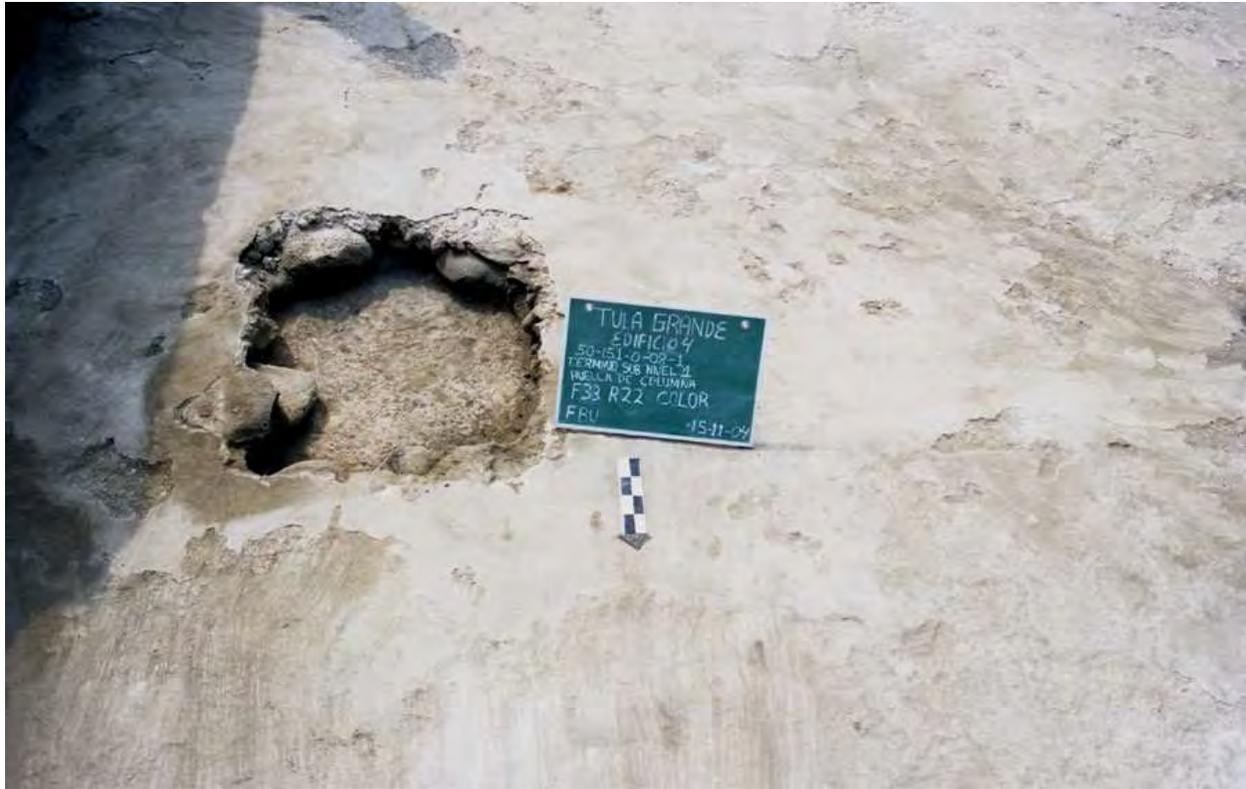
Figure 13. State of conservation of the stucco floor and pillar mold, in which we see the constructive materials of the Toltec floor.

Once the core of the structure was raised in order to give it volume, the walls and floors that give form to the palace unit were erected. The floors were constructed using different materials: first a layer of adobe or compact clayey earth was put in place, mixed with a few *tepetate* pebbles in order to level off the surface, which is 20-26 cm thick over the core of basalt stone. After this the compacted adobe was covered with another layer of limestone (ground, gravel-sized *tepetate*) with a thickness of 2-10 cm, used as bed, and lastly a coat of stucco (measuring 0.3-0.5 cm thick; in some cases we see a 1 cm thick coat) covering the whole surface in order to have a firm and even floor ([Figure 13](#)).

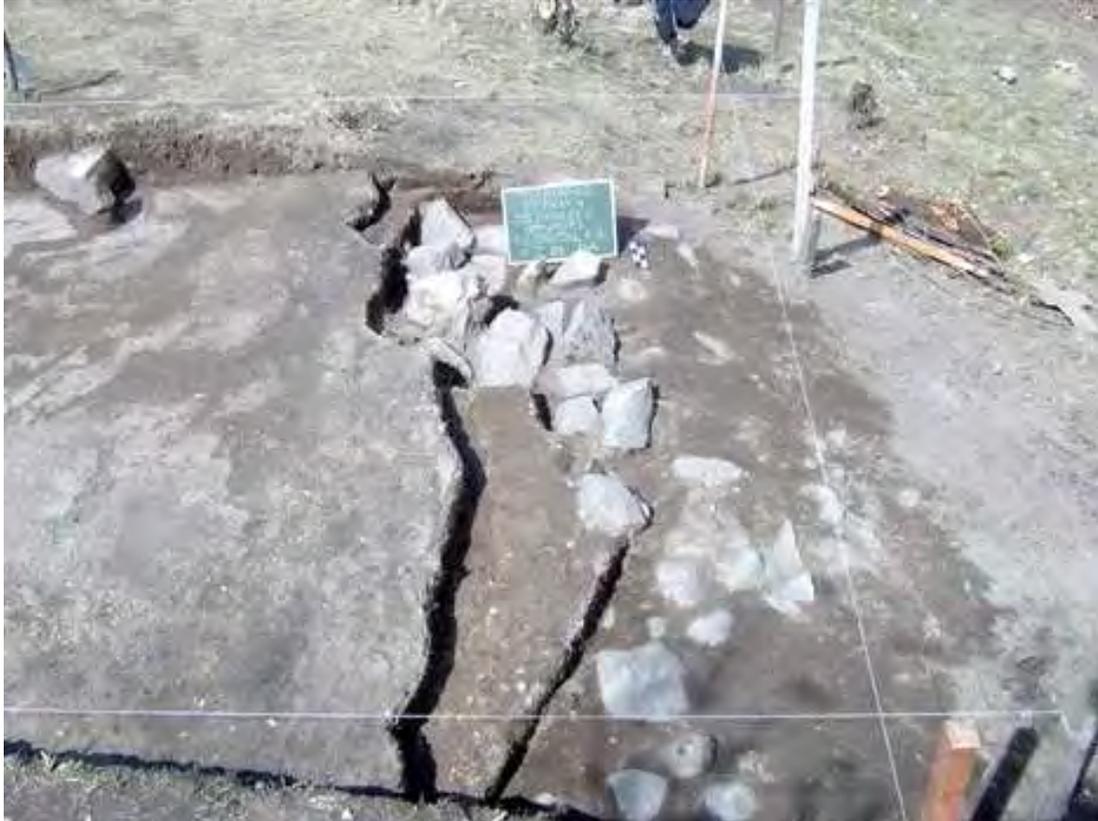
Figure 14. This is the deposition of floors in the east end of the building.

The aforementioned evidences were seen in the eastern boundary of the open patio, where at least six levels of superimposed floors were recorded in a depth of less than 60 cm. Likewise, in the exterior alley to the southwest of the building, we found two floors in less than 15 cm ([Figure 14](#)).

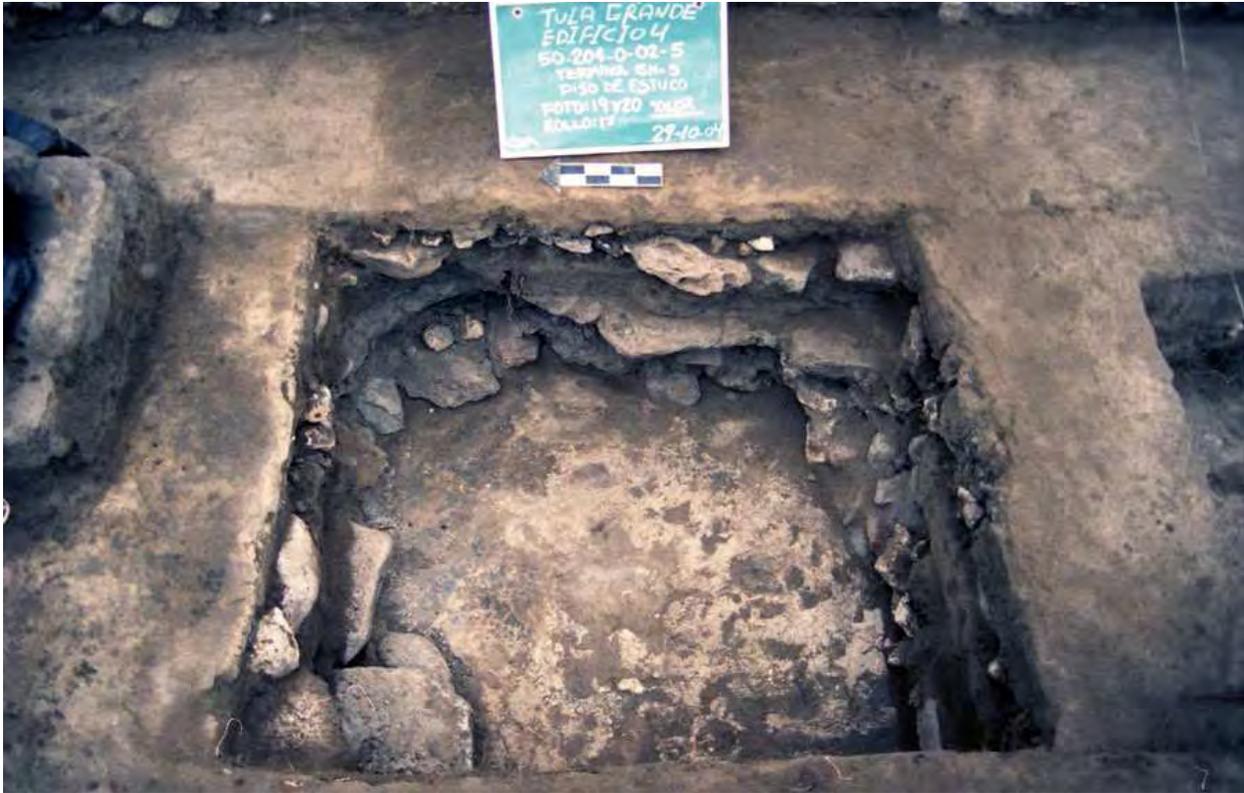
Figure 15. Detail of several remodeling activities endured by Building Four on top of another floor seen at the end, probably that of a substructure.

Under the floor levels identified as part of the maintenance given to the residential unit, in the exterior side of the southwest wall of the same building (Space 16), there is another stucco floor associated with an adobe wall, at 70 cm under the structure's latest occupation level. Likewise, the southeast corner of Space 17 is covered by two layers of tamped earth and basalt cobbling over the same stucco floor, in the same lower level of Space 16. There is also the lower part of an adobe wall, so we regard these evidences as part of a substructure of Building Four ([Figure 15](#)).

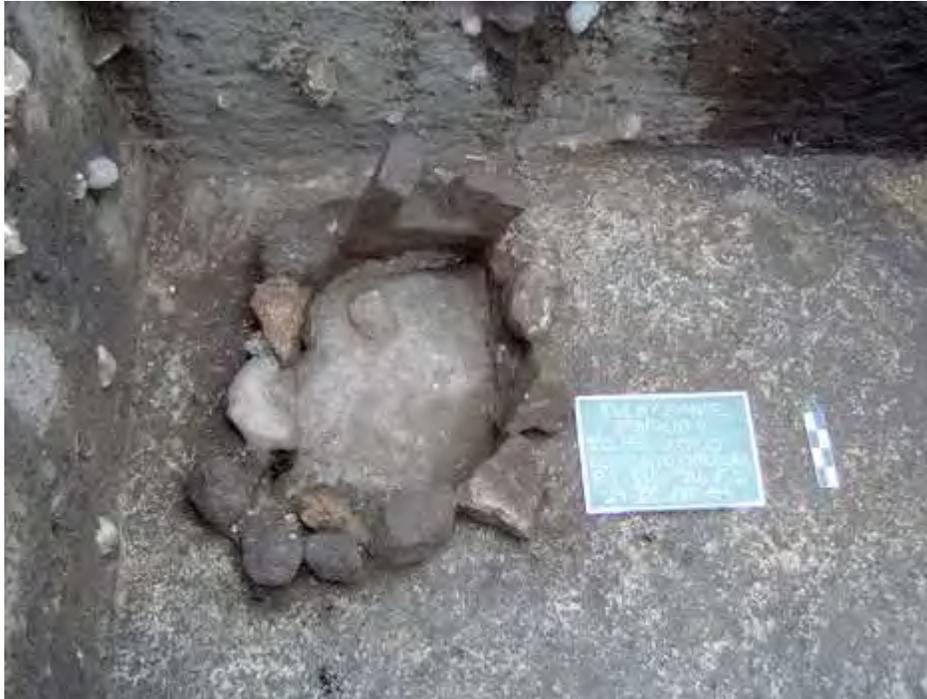
Figure 16. Circular compound of re-used material over a pillar mold, after the abandonment of the East Palace. See the inside of the mold with the remains of the stucco floor of the possible substructure.

It is possible that a floor is part of this substructure. It is laid inside with the traces of the pillars of the second room with portico (Space 13) ([Figure 16](#)).

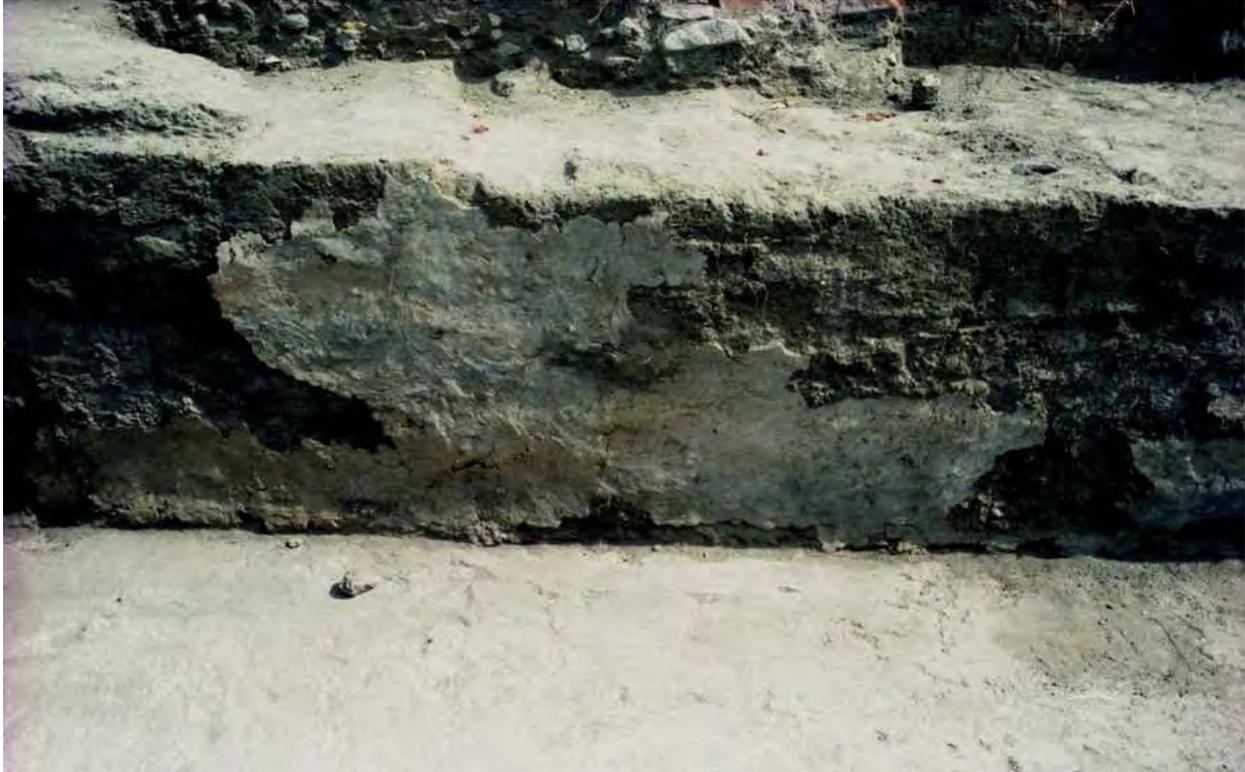
Figure 17. State of conservation of the adobe walls, in which we see the core made of blocks covered with a coat of clay. These rise directly from the floors, with no evidence of banquettes.

One of the characteristic traits of Toltec society is the use of adobe architecture. This pertains to a tradition or style coming from northern regions of Mesoamerica during the Epiclassic period. It is seen in the architecture of Tula Chico (Cobean *et al.* 2004), as well as in other buildings in Tula Grande during the Early Postclassic (Acosta 1958: 76; Cobean *et al.* 1994; Getino 2000). Adobe is a very useful material in the sense that it allows for raising thick and tall walls, as is the case here. Acosta himself pointed out the existence of walls over 4 m high (Acosta 1956: 44). Adobe is highly efficient in terms of temperature control: interior spaces are cool during the hot season and warm in the cold season. However, this material has to be constantly protected and maintained, since it is subject to erosion by inclement weather (Schneider 2001). The ancient builders took this into consideration, which can be seen in the distribution of the walls and the collapsed roof remains associated with the walls. These show that this kind of building material was used to divide spaces inside the building, not for the areas that were exposed to the weather ([Figure 17](#)).

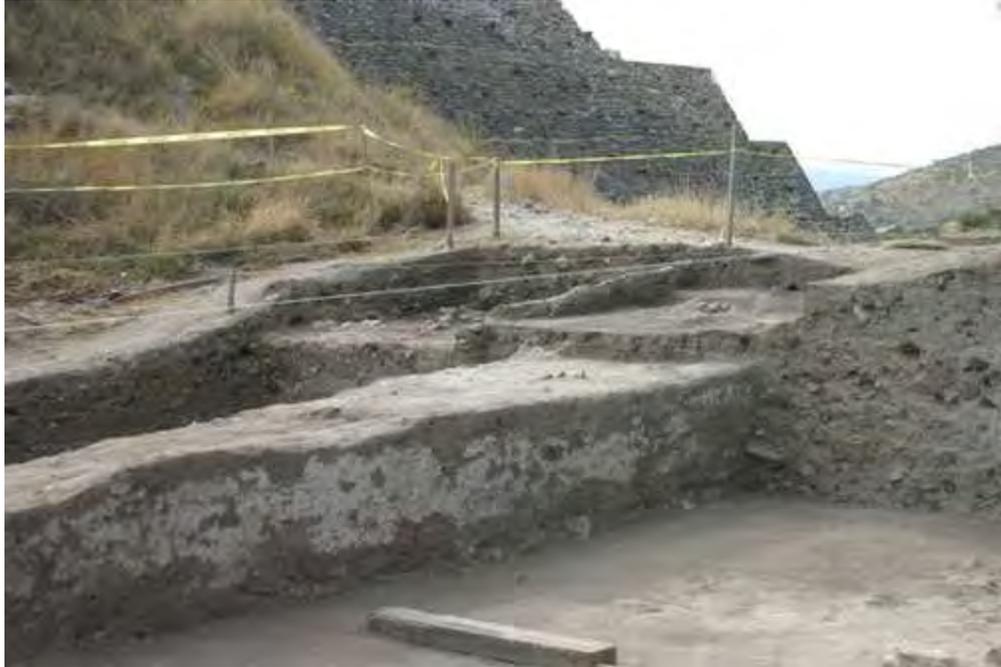
Figure 18. Adobe wall from the building's southwest end, showing a greater width than the rest of the excavated walls. The stucco floor continues under the wall (courtesy of Dan Healan).

These adobe walls rose from the level of the floor before the stucco coat was applied, since in most of the excavated cases in this structure we see the stucco bevel joining the floor with the wall. We know of three cases that suggest remodeling, maintenance, affixing, or perhaps the reutilization of previous stages of Building Four. One of these is the wide south wall located in the room defined as Space 5, since this shows a wall with a greater thickness than the rest of the walls (it is 1.90-2.20 m thick), without considering the thickness of the covering of little *tepetate* slats, which is between 10 and 20 cm. Inside the room one can see the continuation of the stucco floor under the adobe wall, which may indicate an annexed or affixed wall on the previous adobe wall, because of its thickness ([Figure 18](#)).

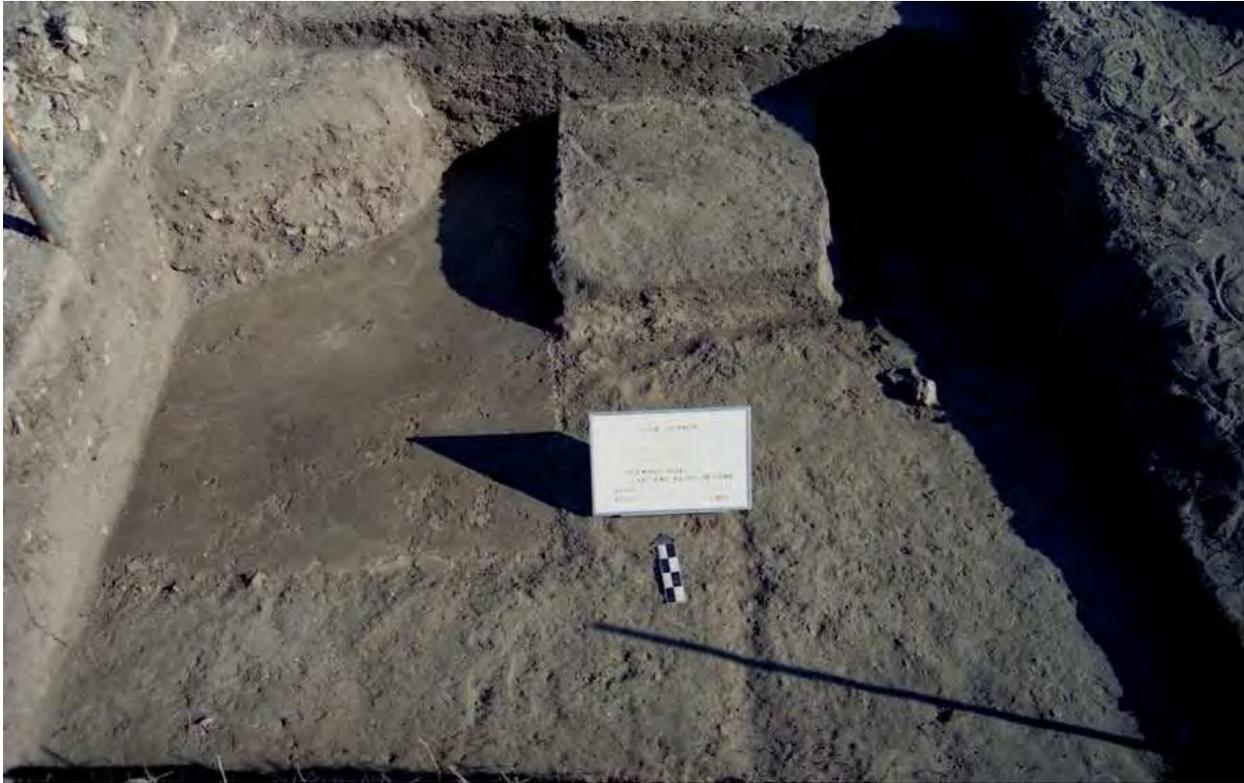
Figure 19. Detail of the stucco floor and adobe wall found beneath the rest of Building Four's constructive elements, pertaining to the last building stage.

The second case is located outside Building Four, under the exterior alley in the southwest sector, where we have a 1 m-thick adobe wall with a north-south orientation associated with a stucco floor. As previously mentioned, this indicates the existence of a substructure which is earlier than the building. Another case is in the room known as Space 17, in the southeast corner inside the building. In this area we have evidence of two adobe walls which do not rise directly from the same floor as the rest of the walls, but go through to the lower floor of the substructure, besides they were part of the containment of the two layers of tamped earth and basalt cobbling that made up the last building stage. This would indicate a maintenance activity or a reuse of elements that are older than the stage currently exposed ([Figure 19](#)).

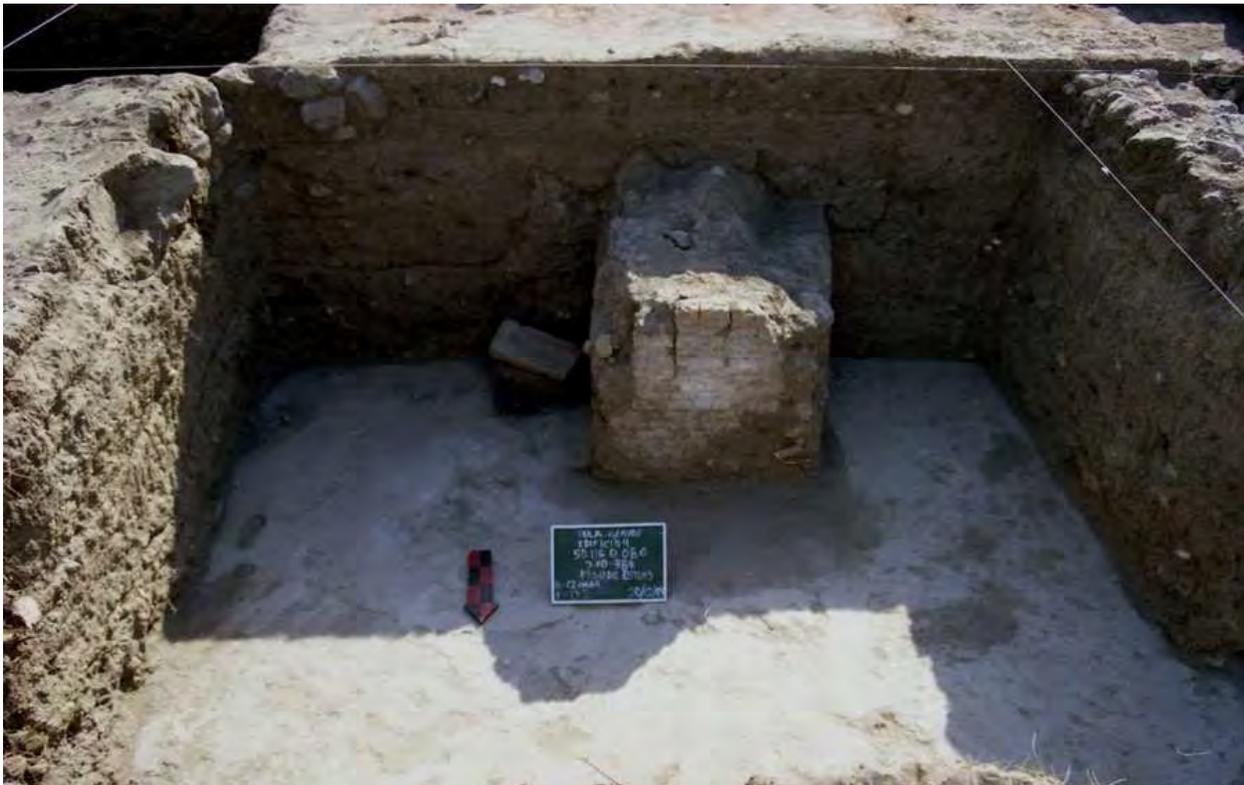
Figure 20. Entrance to the second hall with portico by the alley. See the state of preservation of the wall that was exposed to fire from the wood of the door jambs (wood traces can be seen at floor level).

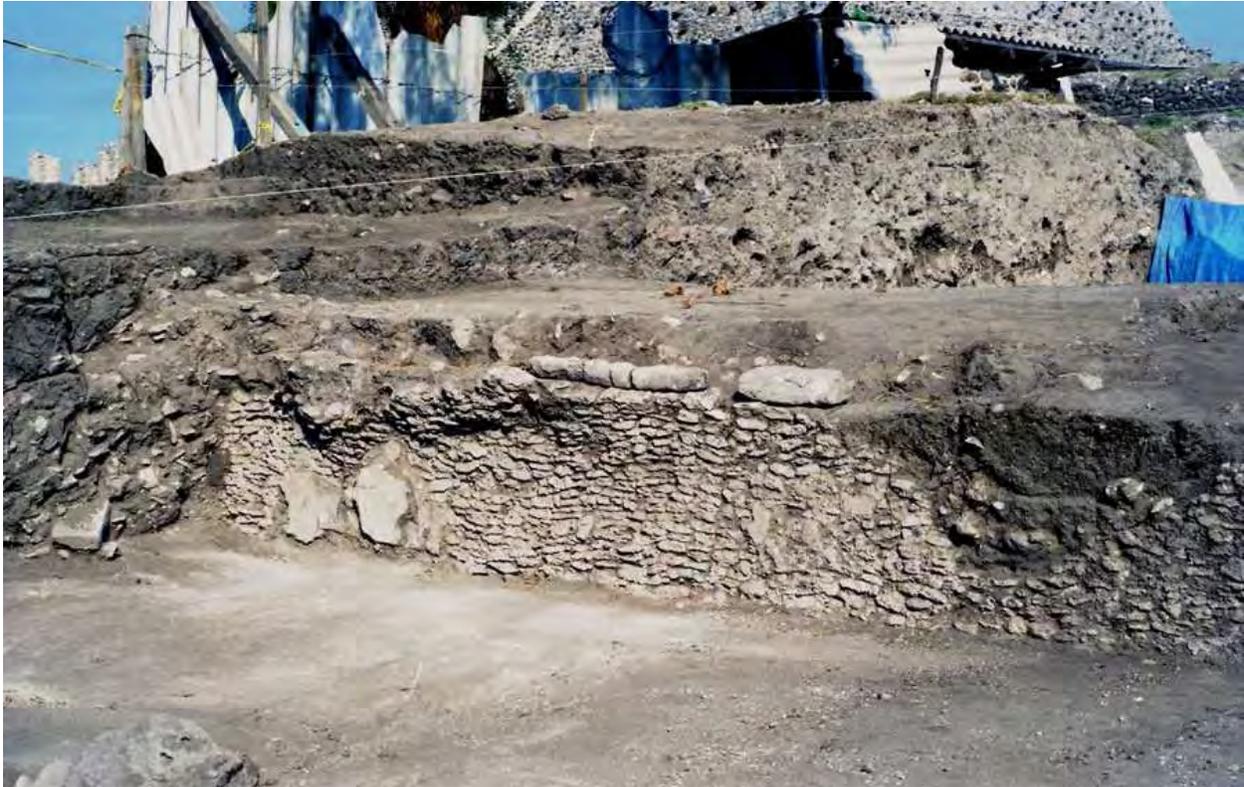
Figure 22. State of conservation of the wall made of slats of "small stone" at the structure's southwest end. See the partial height bordered by quarry stone cornices.

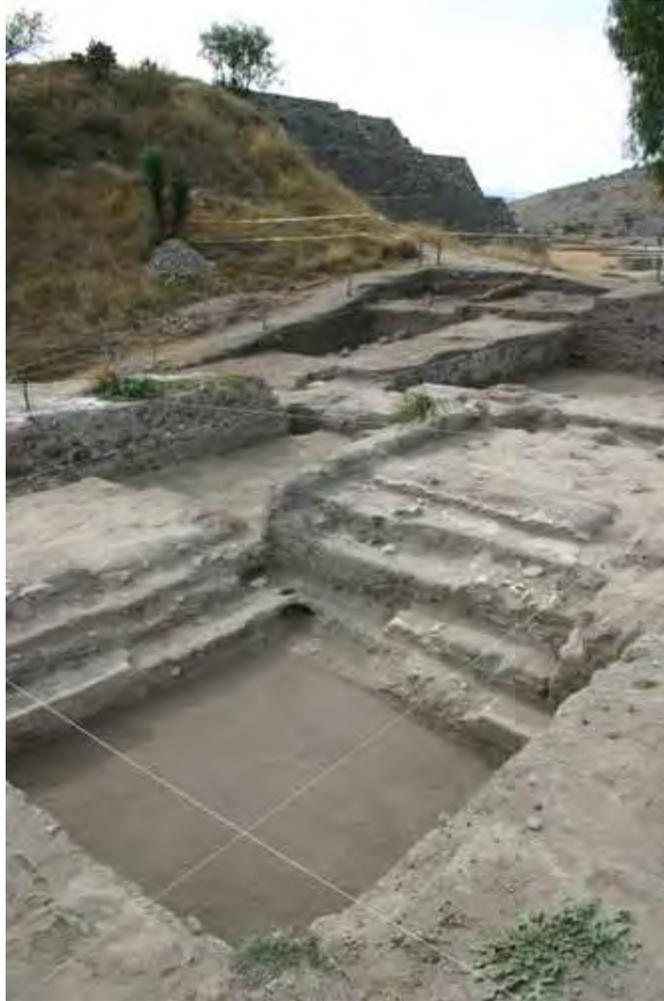
Figure 23. Tepetate slats were also used to build the stairways of the building (courtesy of Dan Healan).

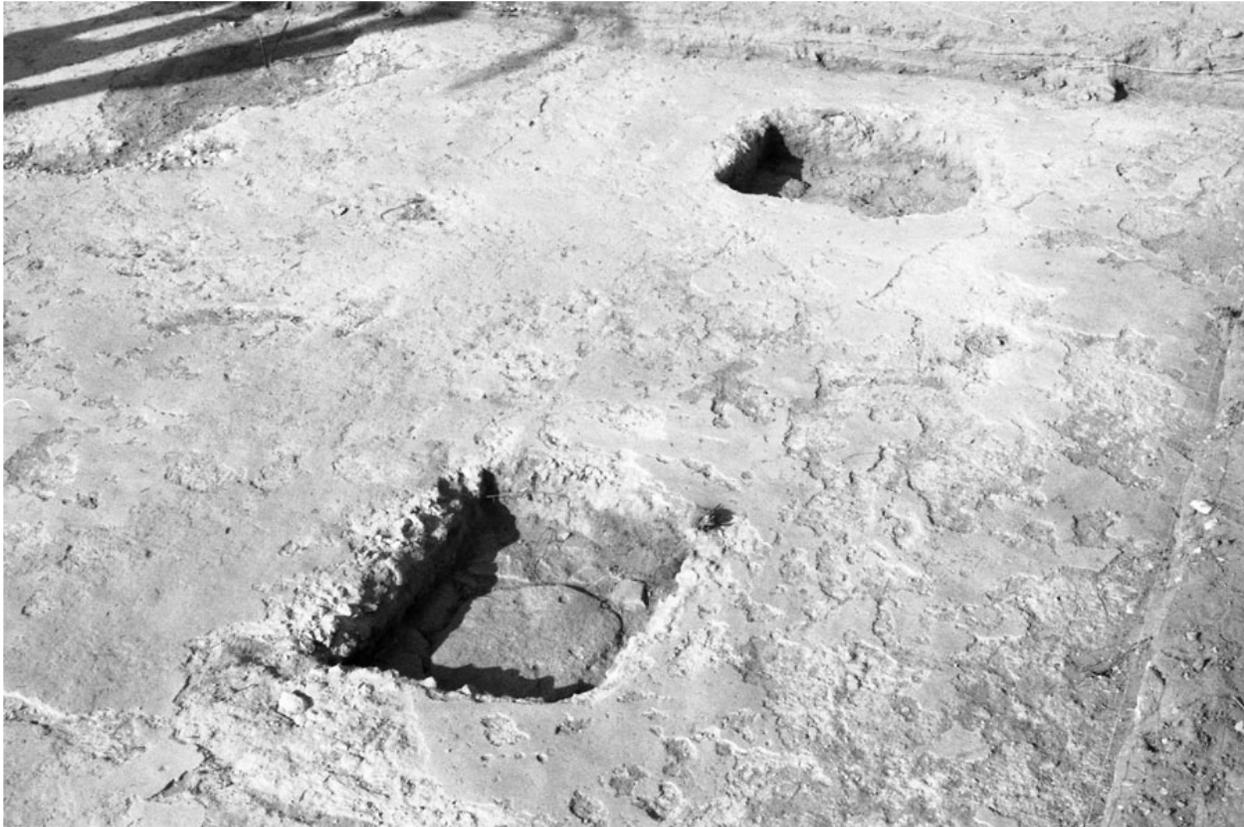
Figure 24. State of conservation of the pillar molds of the first hall with portico, showing the base made of basalt stones.

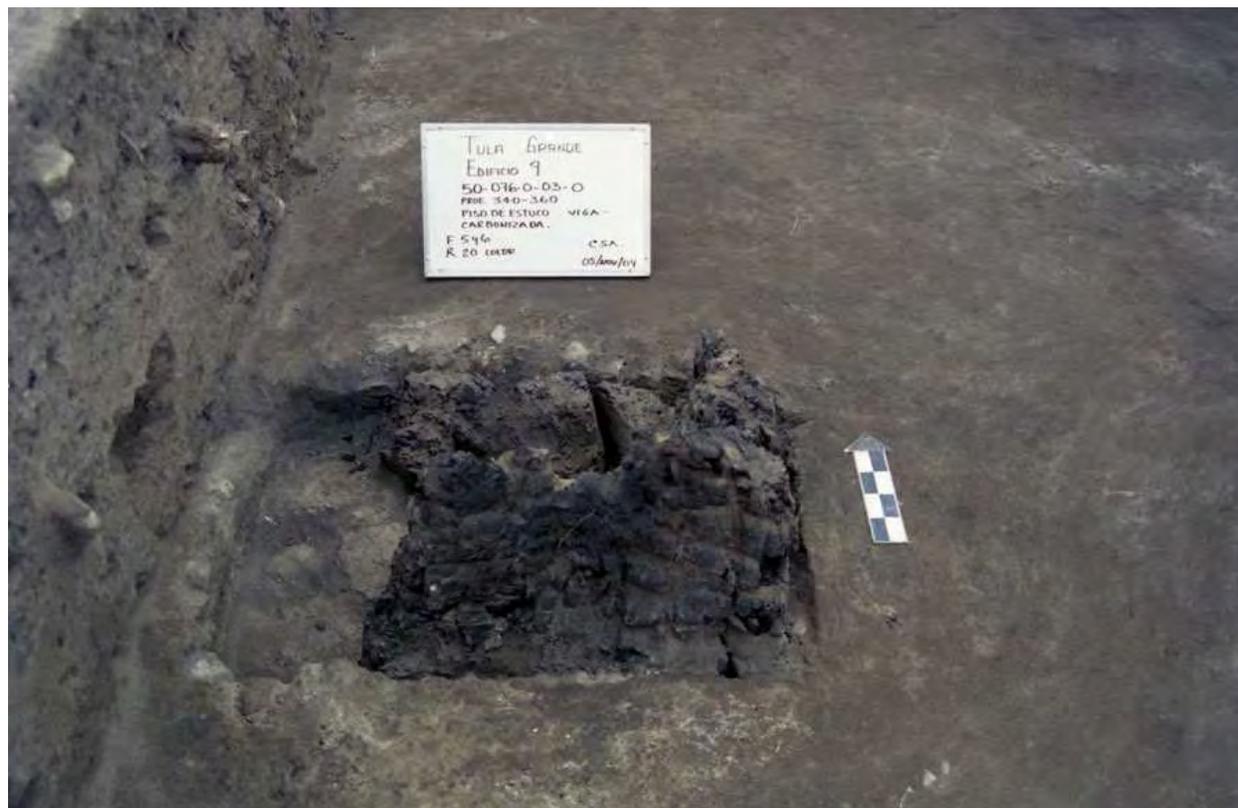
Figure 25. Remains of one of the pillars that were used as support of the building's roof, showing the use of wooden boards to cover the adobe core.

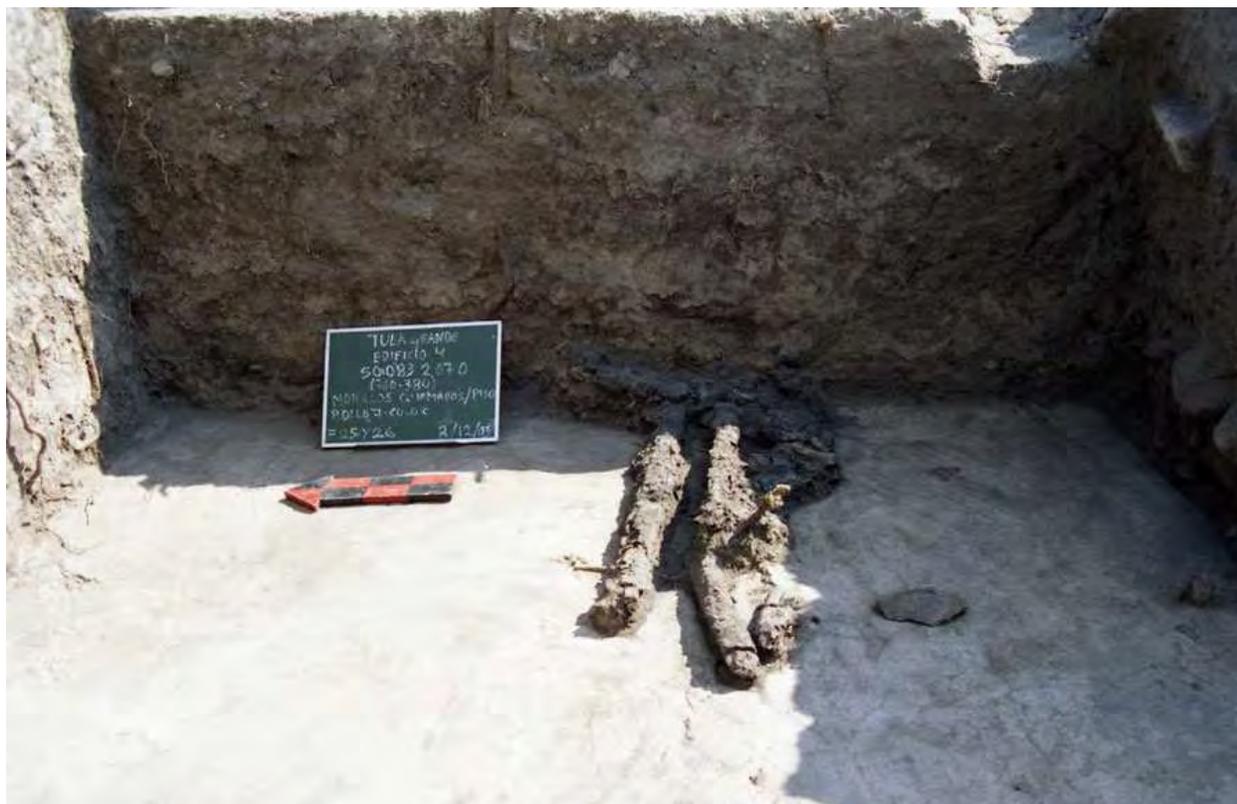
Figure 26. Evidence for the use of poles and beams as part of the construction system used to make the roof of Building Four.

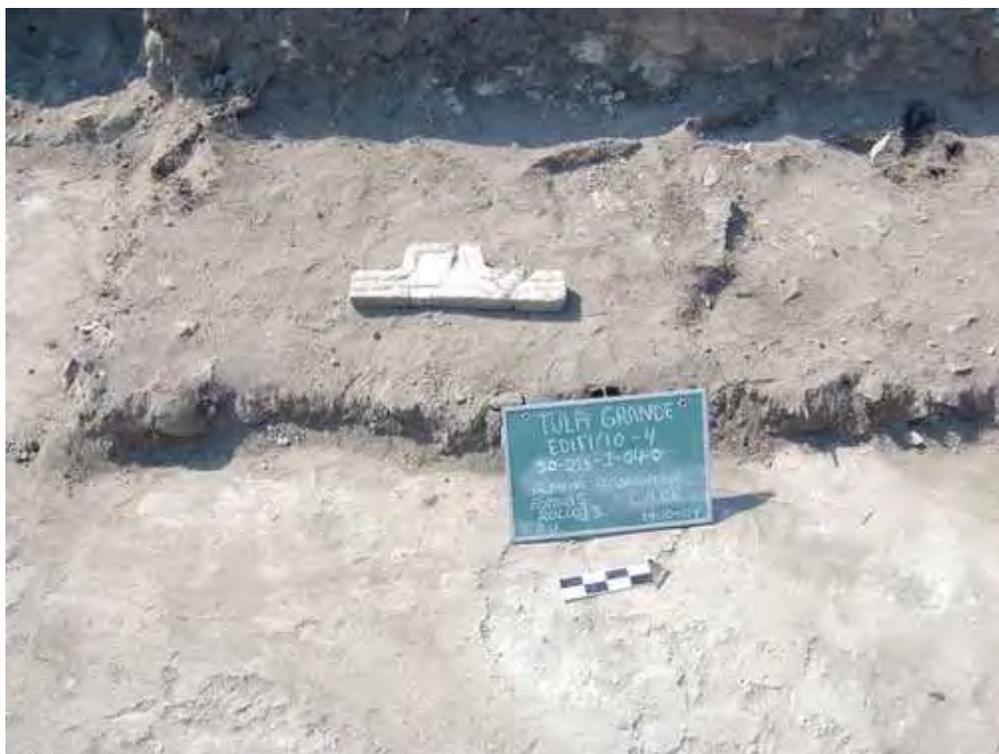
Figure 27. Merlon fragment which was part of the crowning or crest of the roofs, part of the building's decoration.

These materials were found as rubble from the collapsed roof toward the open spaces, such as the open patio (mainly on the west side), therefore they must have been used as decorative elements in the crownings of the roof, in order to improve the view ([Figure 27](#)).

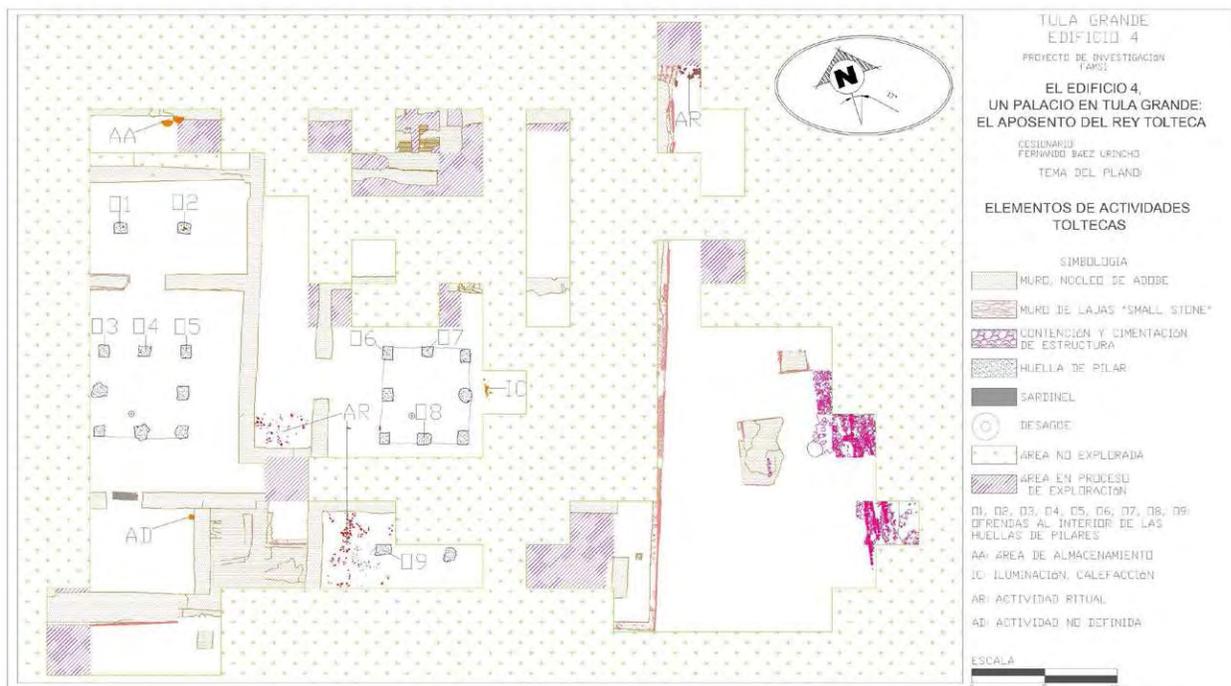
Figure 28. Plan with distribution of spaces in Building Four and portable materials related to activities performed in the palace, before its abandonment and destruction.

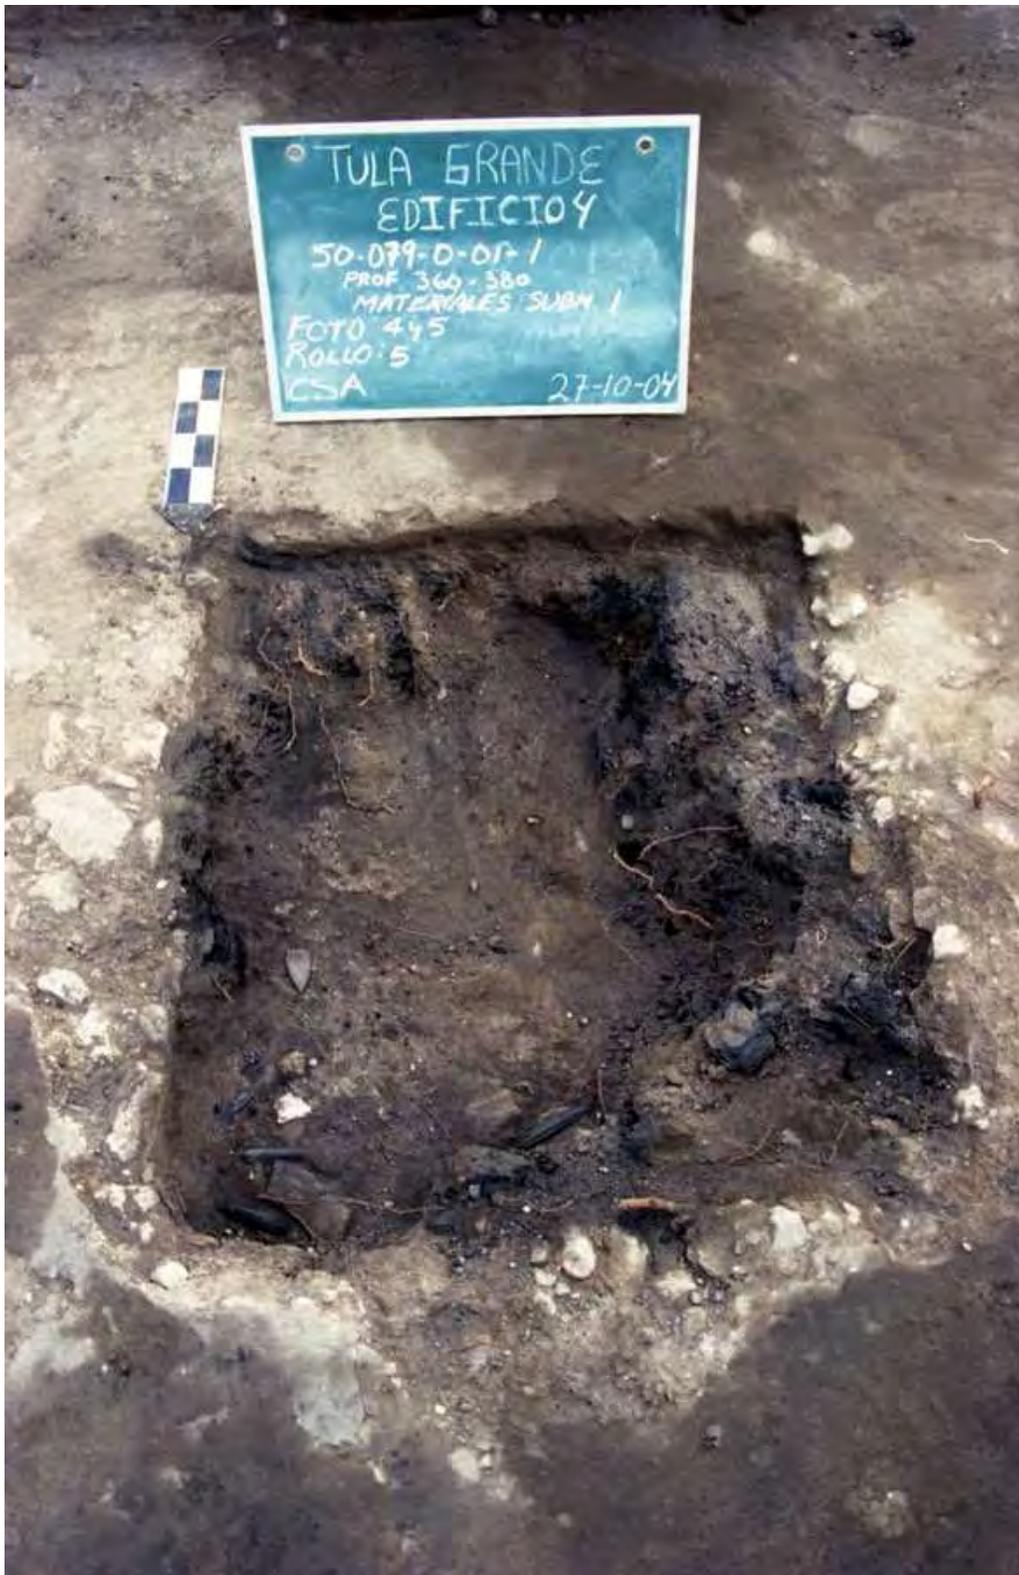
Figure 29. Exploration process inside one of the pillar molds, in which were recorded offerings related to the building of the structure. See the blades and points.
