Building Four: a Palace in Tula Grande, the Lodging of the Toltec King

Research Year: 2007

Culture: Toltec

Location: Tula de Allende, Hidalgo State, Mexico

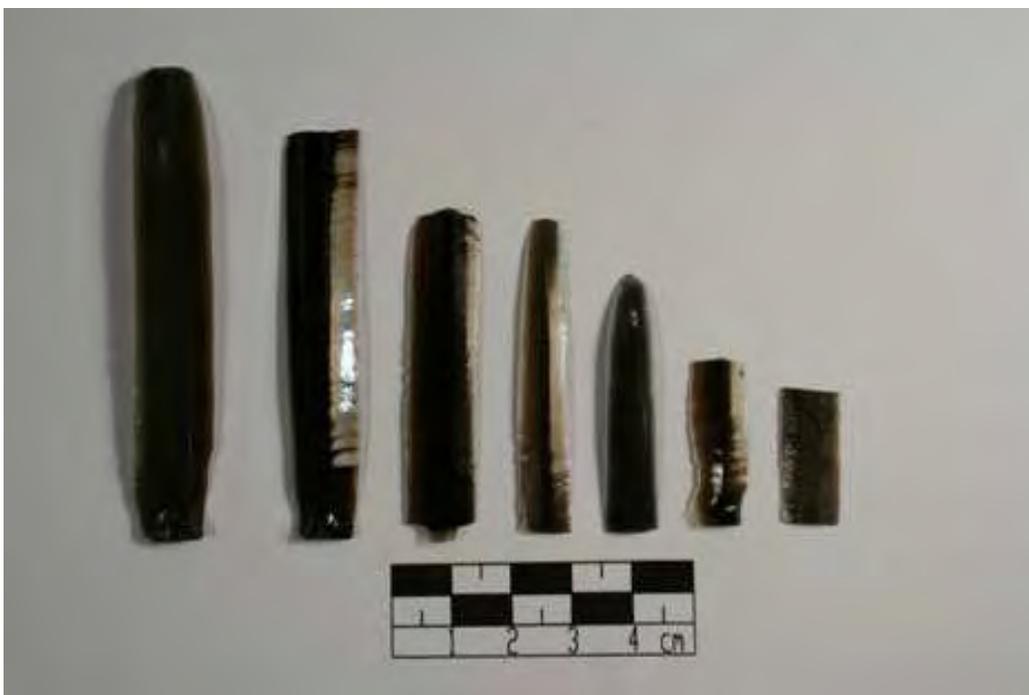
Figure 30. These blades are part of the offerings inside the pillar molds, they are mostly of green obsidian and a few of gray obsidian.

The offering material in the different points we mentioned consists of a series of obsidian prismatic blades. There is no distribution inside of the pillar molds that would indicate a patterning or orientation of the materials, or their state of conservation or the kind of material, since we have fragments of several sizes and whole items of the obsidian prismatic blades, mainly green obsidian and fewer gray ones. We point out the case of Offering 2, with the presence of four small blade fragments of green and gray obsidian. These materials were recorded in association with shell and bone fragments, as well as in offerings 3, 6, 7, 8 and 9 ([Figure 30](#)).

En un caso tenemos siete navajillas prismáticas asociadas con dos puntas completas, In one case we have seven prismatic blades associated with two complete points, one made of flint and one of chalcedony (offering 5). Only one of the blades is complete, it is made of green-golden obsidian with a length of 8.1 cm. The other seven blades are fragments with a length between 2.3 cm and 7 cm. One is made of green-golden obsidian, three are made of green-transparent obsidian, one is dark green and the last one is made of gray obsidian. One point is dark-white or light gray, it is 5 cm long by 2.5 cm of maximum width and 0.5 cm thick, while the other point is clear white or lilac, and is 4 cm tall, 2.3 cm wide, and 0.4 cm thick.

[Figure 30](#). These blades are part of the offerings inside the pillar molds, they are mostly of green obsidian and a few of gray obsidian.

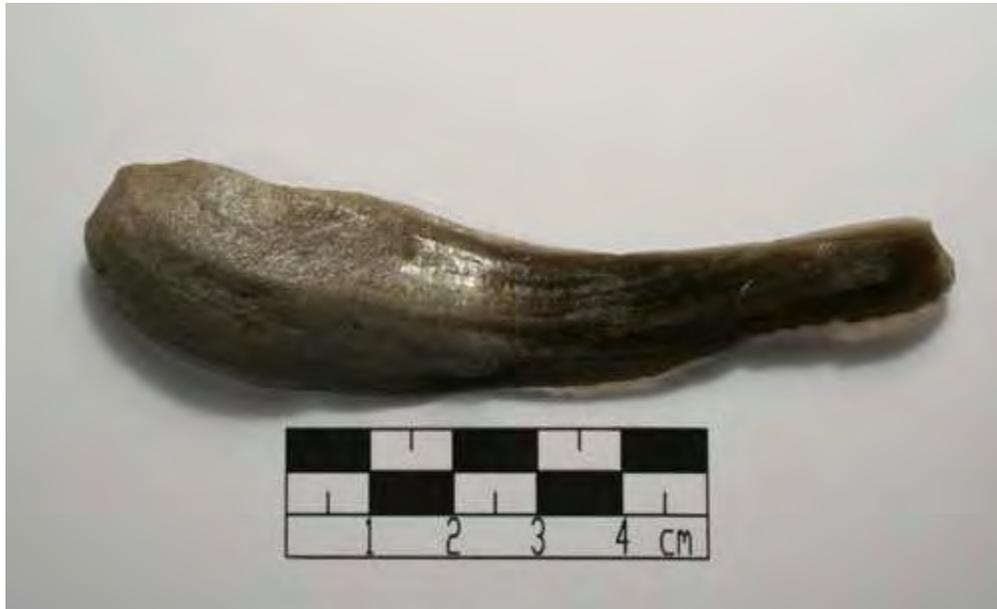
Figure 31. When the building caught fire the heat was so intense that in some cases it caused morphological changes in some of the materials deposited as offerings.

In this case we have offering 1, which is a complete prismatic blade made of green-golden obsidian. It is 10.2 cm long by 2.5 cm of maximum width. In offerings 2 and 4 we have five blades, two melted ones of green obsidian: one is complete, measuring 9.6 cm long by 1.95 cm wide, and the other one is fragmented, it is 8.13 cm long by 1.77 cm wide. Another green obsidian fragment with no fire alteration is 8.76 cm long by 1,78 cm wide, apparently this was exposed to fire. A last blade has pigment remains ([Figure 31](#)).

These items were observed through a stereoscopic microscope; we could see that some of them have no wear marks, while others have wear marks in the form of micro-flaking. The distribution of wear marks usually is zonal, not continuous.

[Figure 31](#). When the building caught fire the heat was so intense that in some cases it caused morphological changes in some of the materials deposited as offerings.

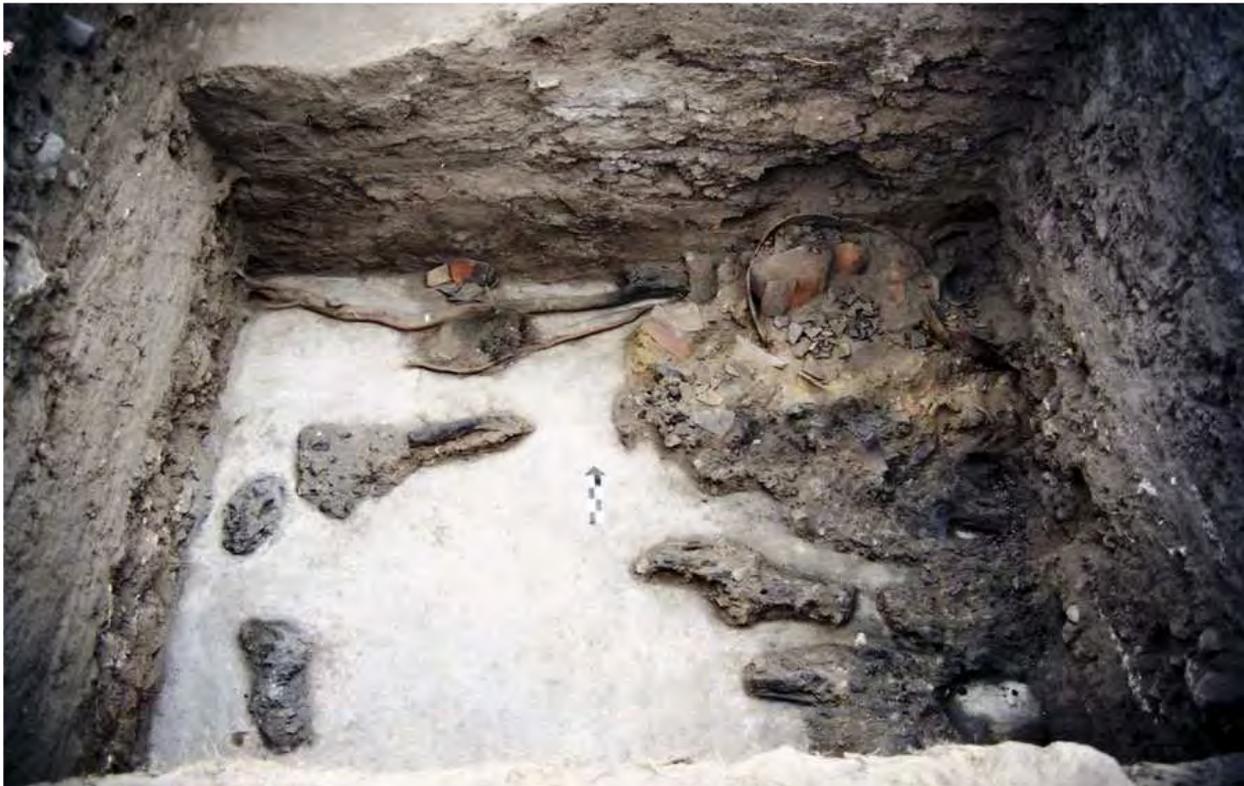
Figure 32. The storage area is located in the northwest sector of the building. It was defined by the presence of at least two great jars deposited on the stucco floor, which suffered the effects of fire when the roof came down.

Coming back to the activities focused on the room of the building, in this section we have so far identified three kinds of activities, such as storage of food products, as well those associated with illumination, heating, food warming, and/or ritual use of the building, and activities of a ritual kind. In the first case, we located a storage area in Space 4, called storage area AA ([Figure 32](#)), which was defined as such on the basis of the presence of at least two big storage jars, which were identified as pertaining to the *Soltura Rojo Alisado* type, which is characteristic of the Tollan complex (Cobean 1990: 430-437) of the Early Postclassic (AD 900-1150) (Mastache *et al.* 2002: 41-50). These jars have a globular shape with a rounded base, with a height of 80 cm-1 m, by 20-40 cm of rim diameter, a maximum width of 69 cm, and a paste thickness of 1-2 cm. The rim is curved-divergent with a rounded edge ([Figure 33](#)). The jars were found on the north side of Space 4, near the adobe wall on the stucco floor, aligned on an east-west axis in vertical position. They were fragmented and crushed on the upper part because the roof collapsed and fell over them. The jars showed signs of having been exposed to fire on several areas, because of direct contact with wood from the roof when this collapsed during the fire.

[Figure 32](#). The storage area is located in the northwest sector of the building. It was defined by the presence of at least two great jars deposited on the stucco floor, which suffered the effects of fire when the roof came down.

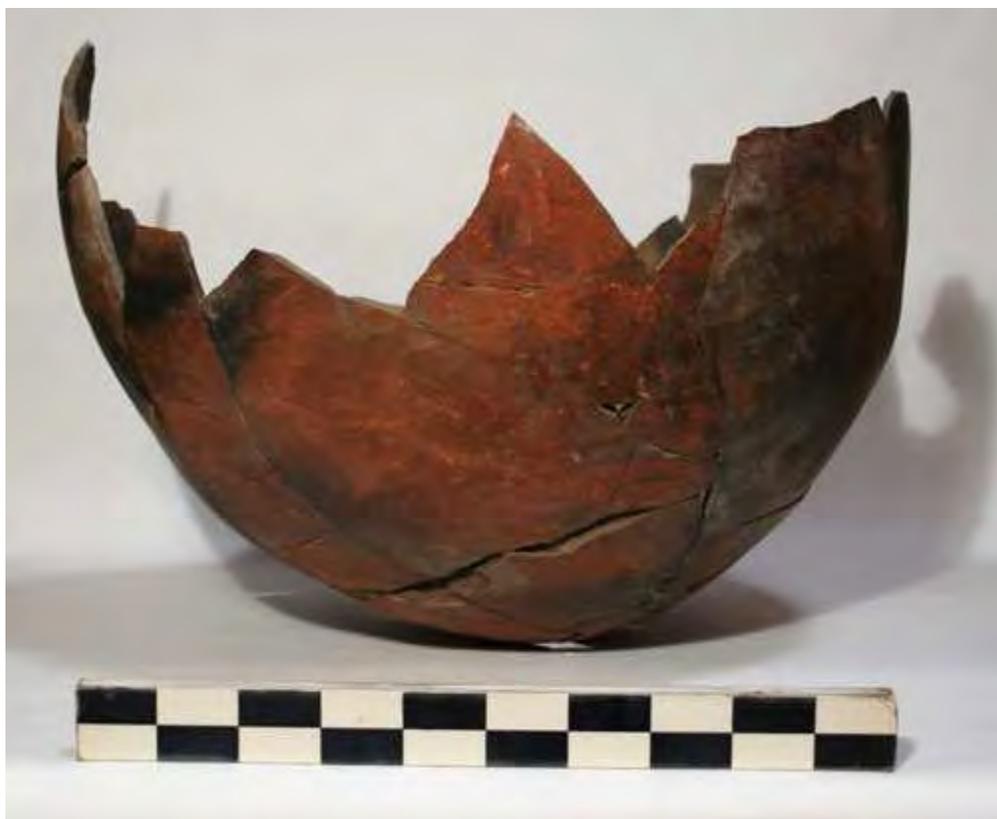
Figure 33. Partial consolidation of one of the storage jars, of the type known as Soltura Rojo Alisado, which is characteristic of the Tollan phase, at the moment of greatest peak of Toltec culture.

Associated with the storage jars were found a textile fragment (26 cm-long by 17 cm-wide) and a rope fragment with knots, which may have been used to cover the mouth of the vessels. We also recovered corn cob remains, which had been carbonized by the fire. This evidence shows that this product was used in the area.

[Figure 33](#). Partial consolidation of one of the storage jars, of the type known as *Soltura Rojo Alisado*, which is characteristic of the Tollan phase, at the moment of greatest peak of Toltec culture.

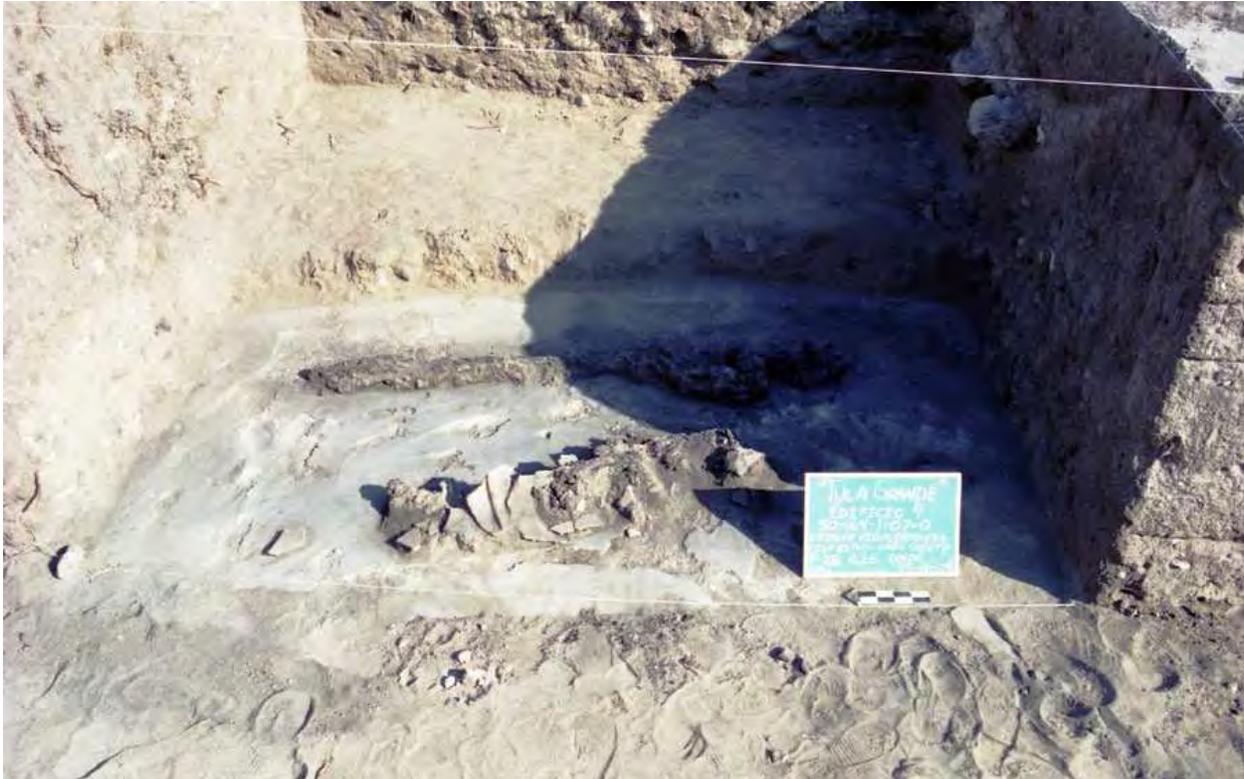
Figure 34. Evidences of a brazier that may have been used for internal illumination and heating inside the East Palace.

because of the location and spatial association of the brazier inside the building, we can propose that the presence of the brazier is due to the need to illuminate and heat the east part of the second hall with portico.

These remains were found on the stucco floor, completely fragmented under the remains of the roof of the building ([Figure 34](#)). During this period of work within the project it was not possible to consolidate the vessel. We intend to do this in the future in order to salvage all of the vessel and to know its shape ([Figure 35](#)).

[Figure 34](#). Evidences of a brazier that may have been used for internal illumination and heating inside the East Palace.

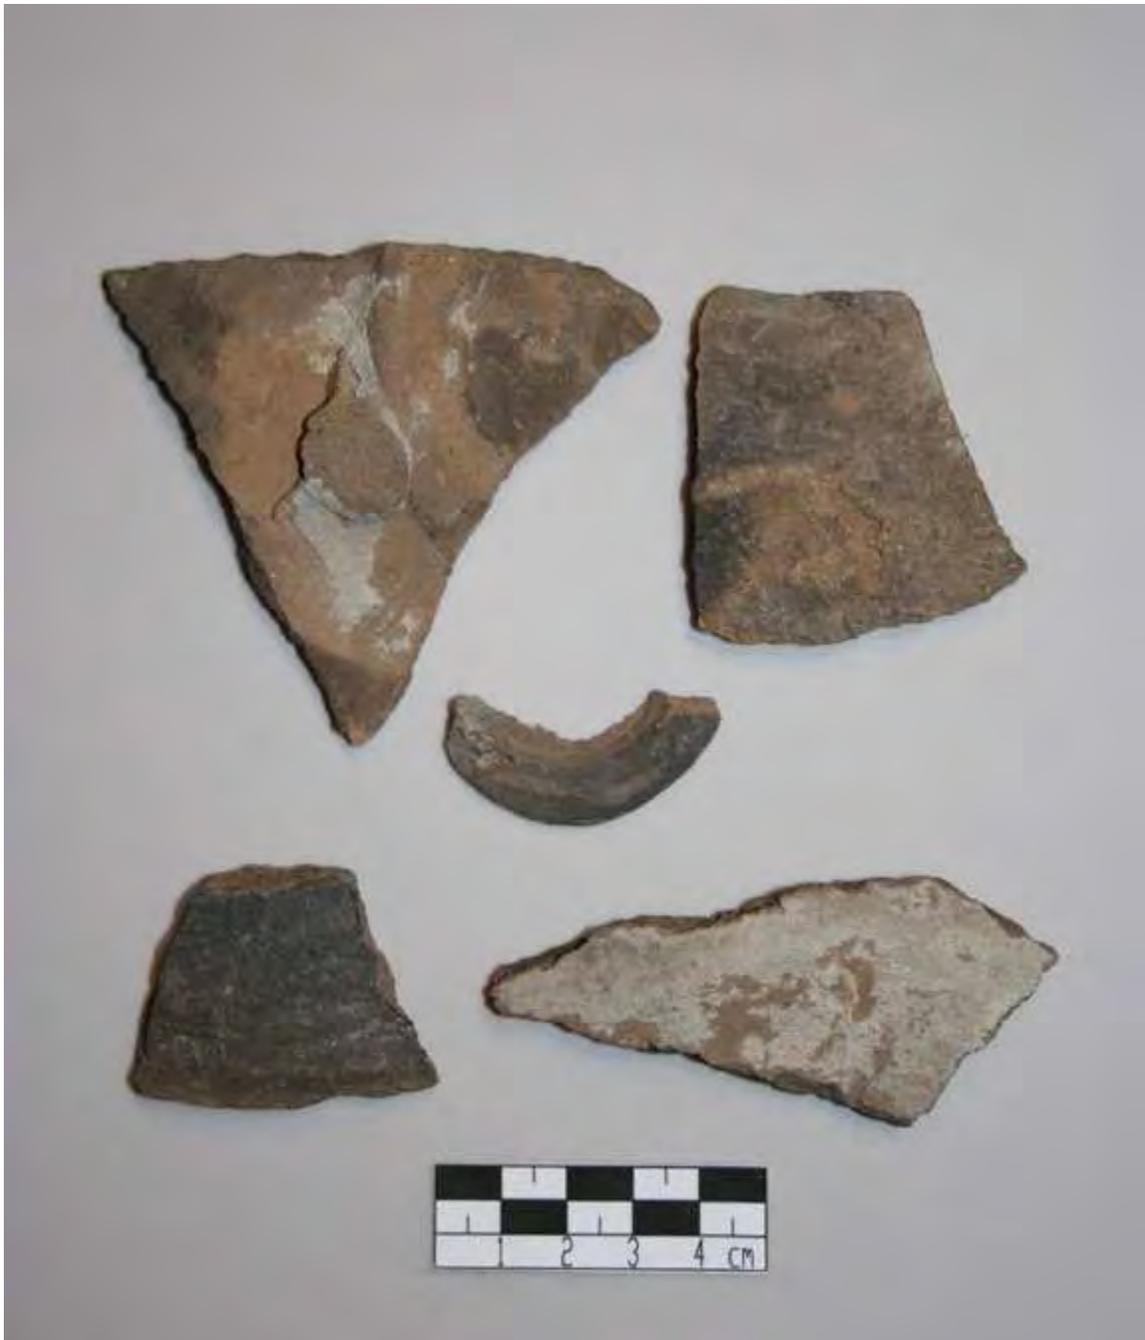
Figure 35. Brazier fragments pertaining to the Abra Café Burdo type, which is characteristic of Tula's Tollan phase.

[Figure 35](#). Brazier fragments pertaining to the *Abra Café Burdo* type, which is characteristic of Tula's Tollan phase.

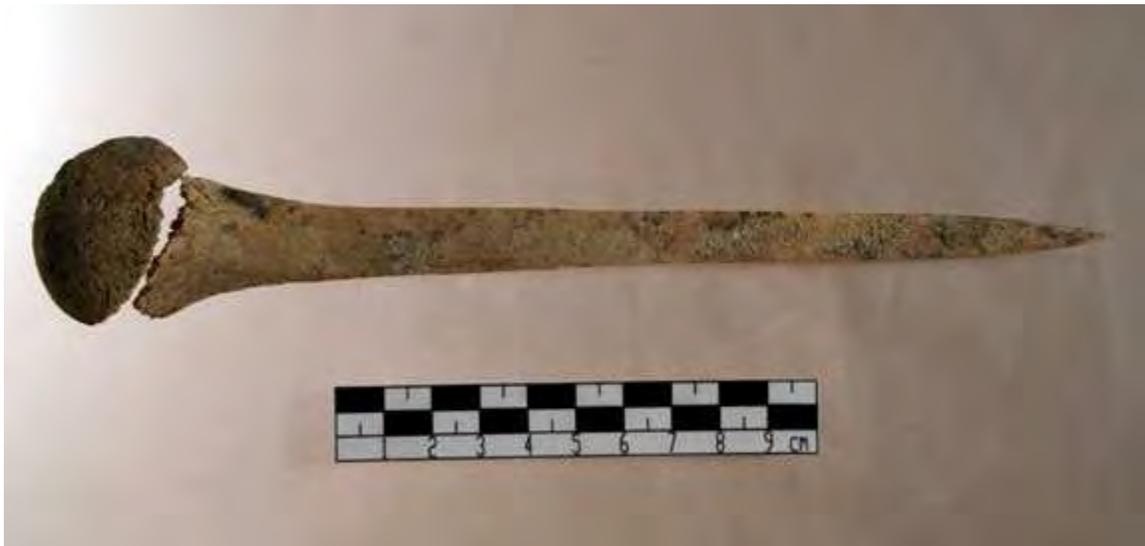
Figure 36. One of the bone awls found on the stucco floor with red pigment stains, inside the second room with portico.

Associated with the areas with pigment, in the second room with pillars we only have two bone awls in contact with the stucco floor, showing remains of red pigment on their surface in the distal section of the item ([Figure 36](#)).

[Figure 36](#). One of the bone awls found on the stucco floor with red pigment stains, inside the second room with portico.

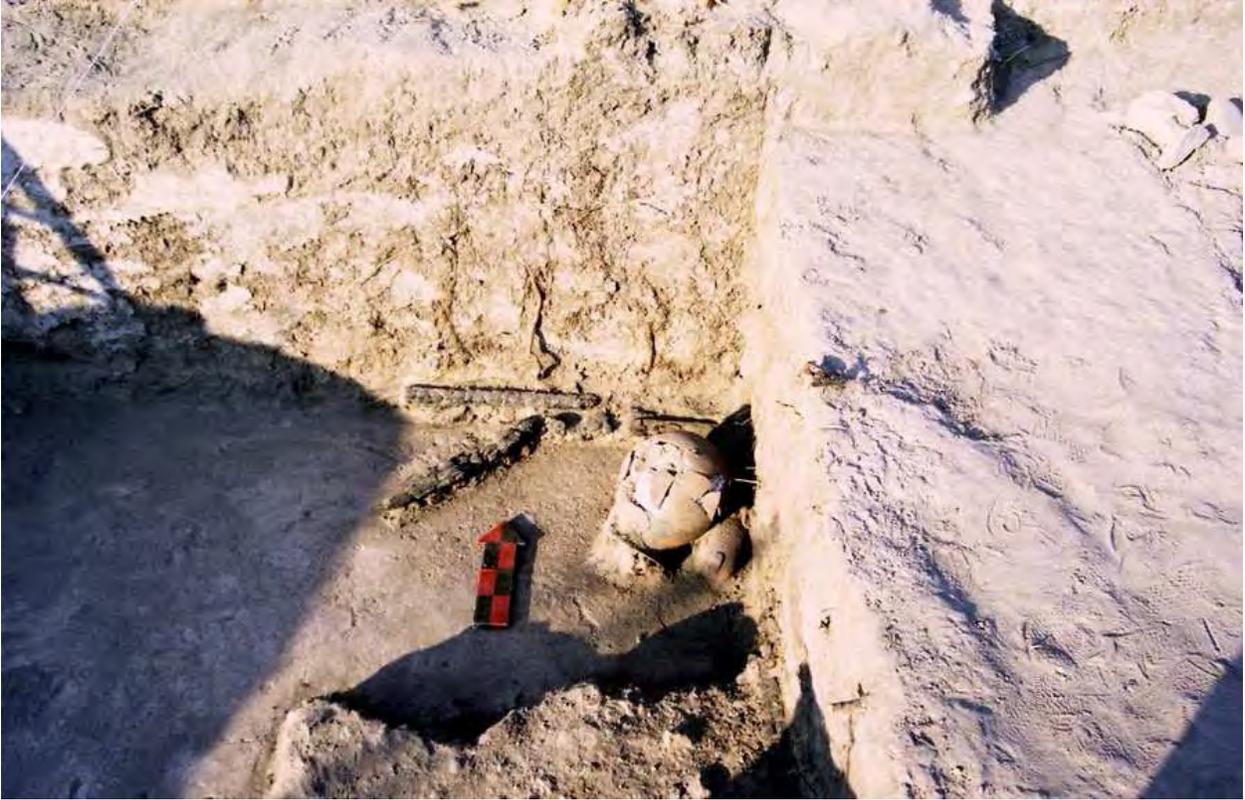
Figure 37. Vessel and rabbit sculpture found in situ, in the northeast corner of the room defined as Space 5. They were found covered by the remains of the burned roof.

Pertaining to undefined activities –AD- in the northeast corner of the room at the south of the first hall with portico (Space 5) we have two elements, a jar associated with a basalt sculpture ([Figure 37](#)), which shows the characteristics in miniature of the *Soltura Rojo Alisado* type of the Tollan complex (Cobean 1990: 430-437). The jar is of globular shape with a hemispherical base. It is 37.4 cm high by 30 cm of maximum width, with 19 cm in rim diameter and 15 cm of neck diameter, with a curved-divergent rim of round finish, and the paste is 0.7 cm thick. The manufacturing technique is by modeling, since on the whole it doesn't have a geometric shape. The interior surface finish is rough smoothing, and the exterior is roughly polished, showing irregular polishing traces.

[Figure 37](#). Vessel and rabbit sculpture found *in situ*, in the northeast corner of the room defined as Space 5. They were found covered by the remains of the burned roof.

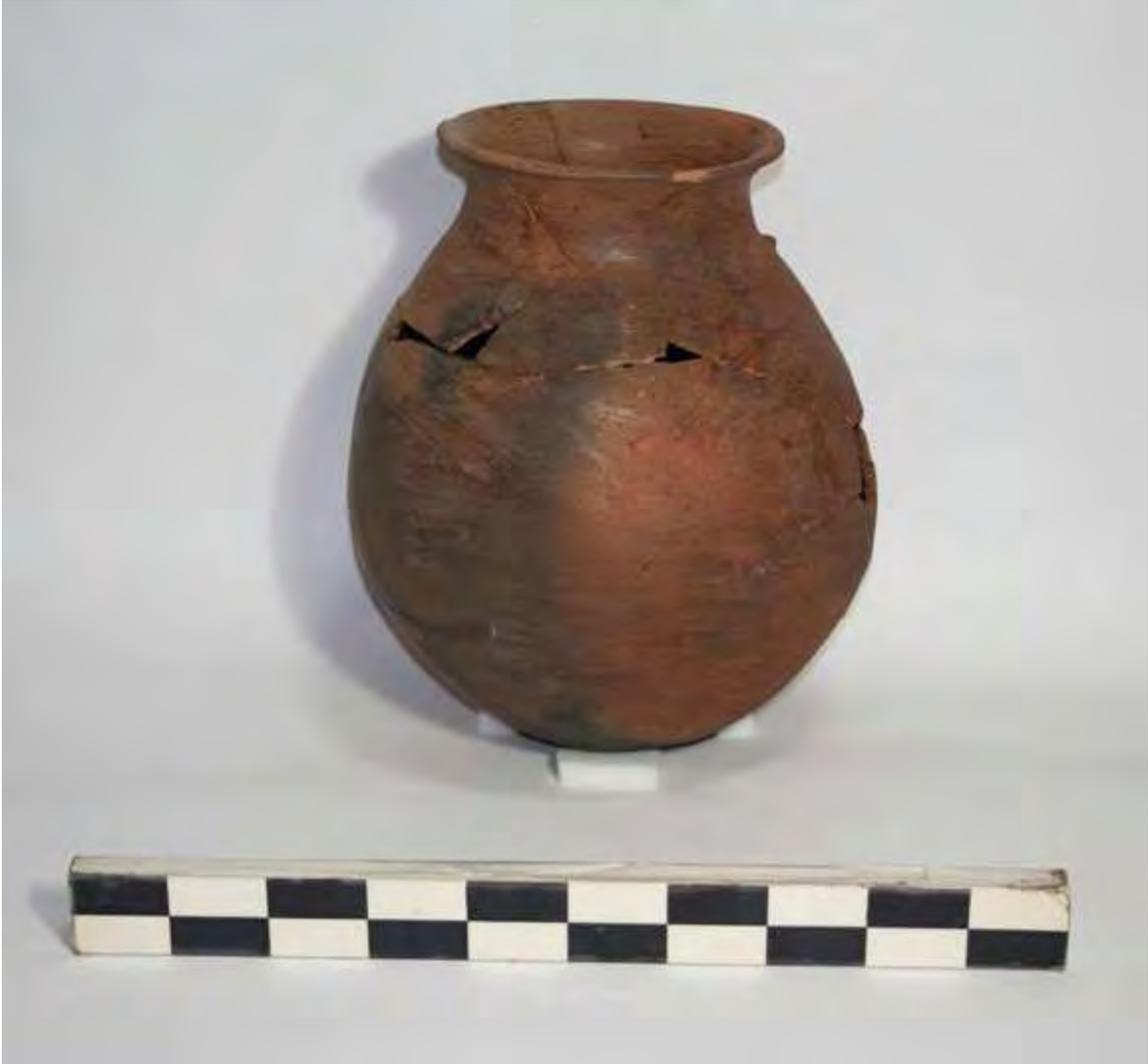
Figure 38. Vessel after restoration work.

This vessel is peculiar in that it has three small bumps on the body's upper part, near the neck. These are small buttons added around the vessel. The vessel shows no handles for holding or transportation, nor any firing stains, but it has black and orange areas in the interior and exterior, which were caused by the fire from the roof of the building ([Figure 38](#)).

We performed a micro-excavation of this vessel, but found no traces of the materials that would indicate its original contents. We analyzed the sediments inside the vessel, but found no remains of organic matter or any other material deposited inside it. This may be due to the fact that it may have been empty when it was placed in this spot, or else the contents were liquid and left no traces whatsoever.

[Figure 38](#). Vessel after restoration work.

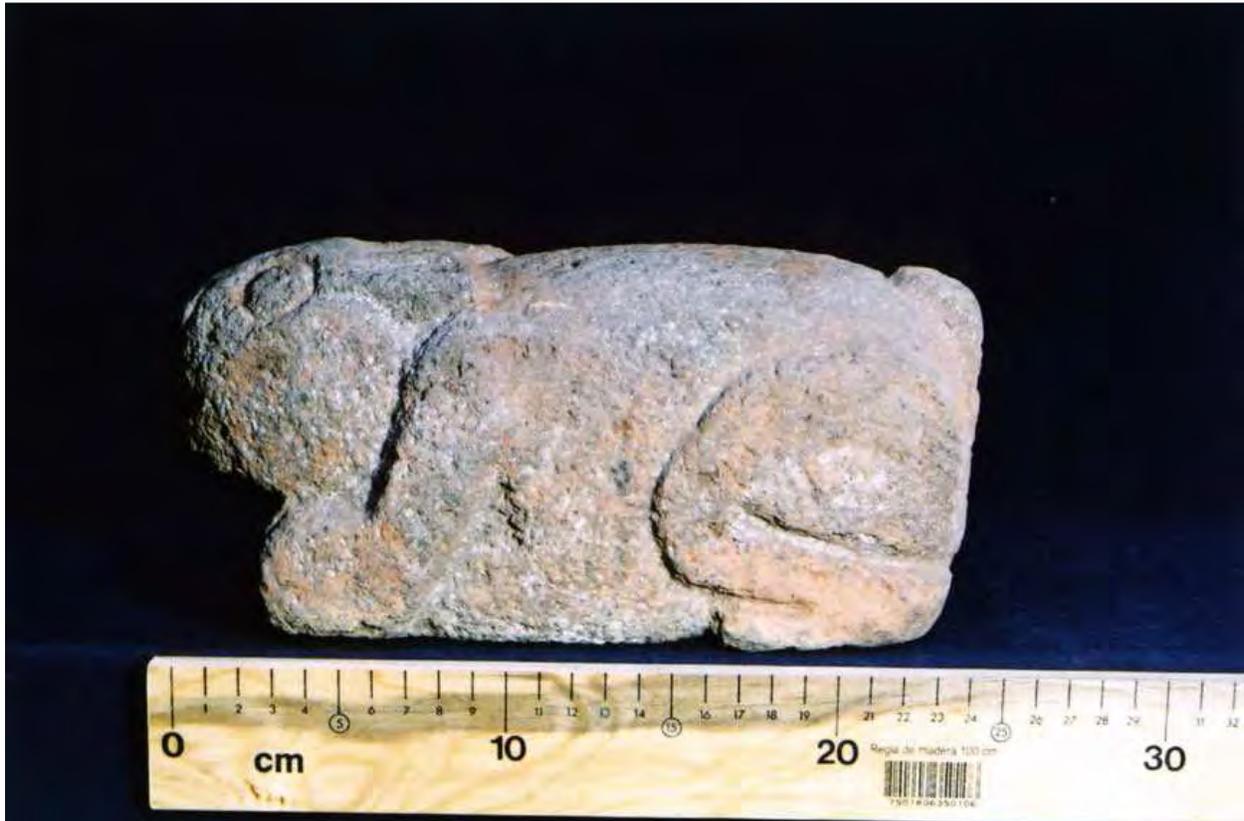
Figure 39. Rabbit sculpture on which pigment remains can still be seen (courtesy of Elizabeth Jiménez).

The basalt sculpture represents a rabbit, it is 22 cm long on its base and 26 cm of maximum length, by 11 cm wide and 12 cm high. It shows well-defined features and has remains of red and yellow pigment ([Figure 39](#)). The sculpture together with the jar are the two pieces that were deposited on the stucco floor. The vessel was found in a horizontal position and the sculpture was placed standing up between the jar and the adobe wall. Both items show evidence of contact with fire, although not intense fire, on

[Figure 39](#). Rabbit sculpture on which pigment remains can still be seen (courtesy of Elizabeth Jiménez)

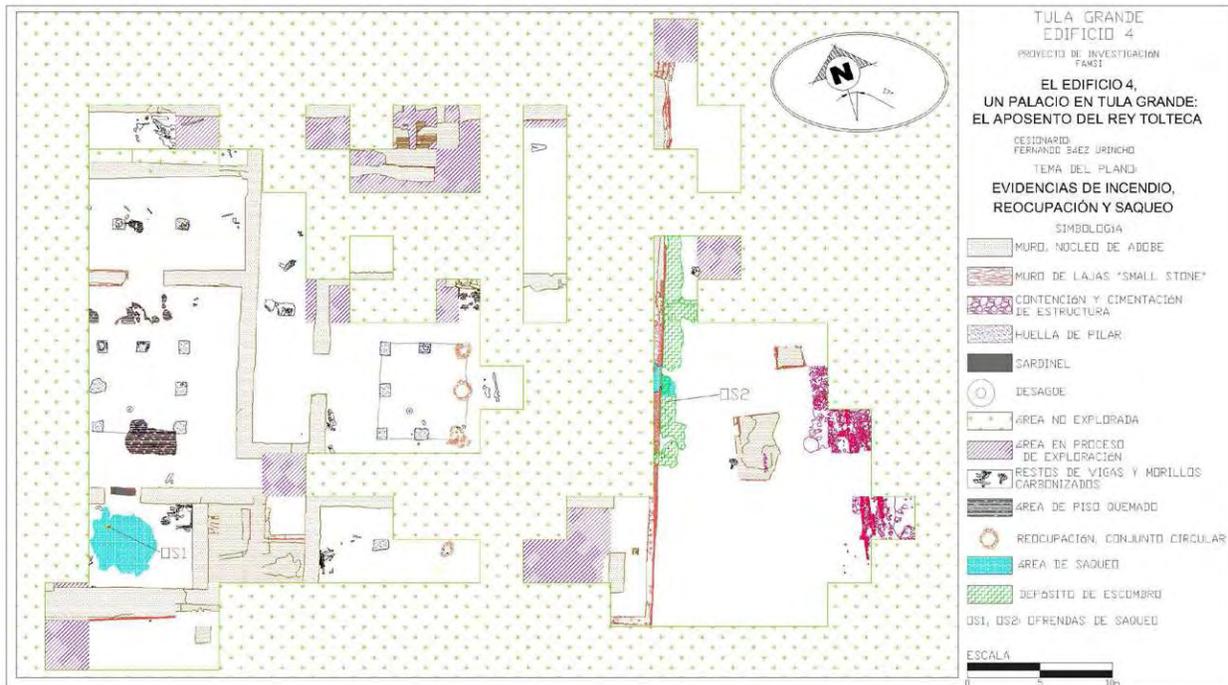
Figure 40. Distribution plan and characteristics of the different events that happened after the abandonment of Building Four.

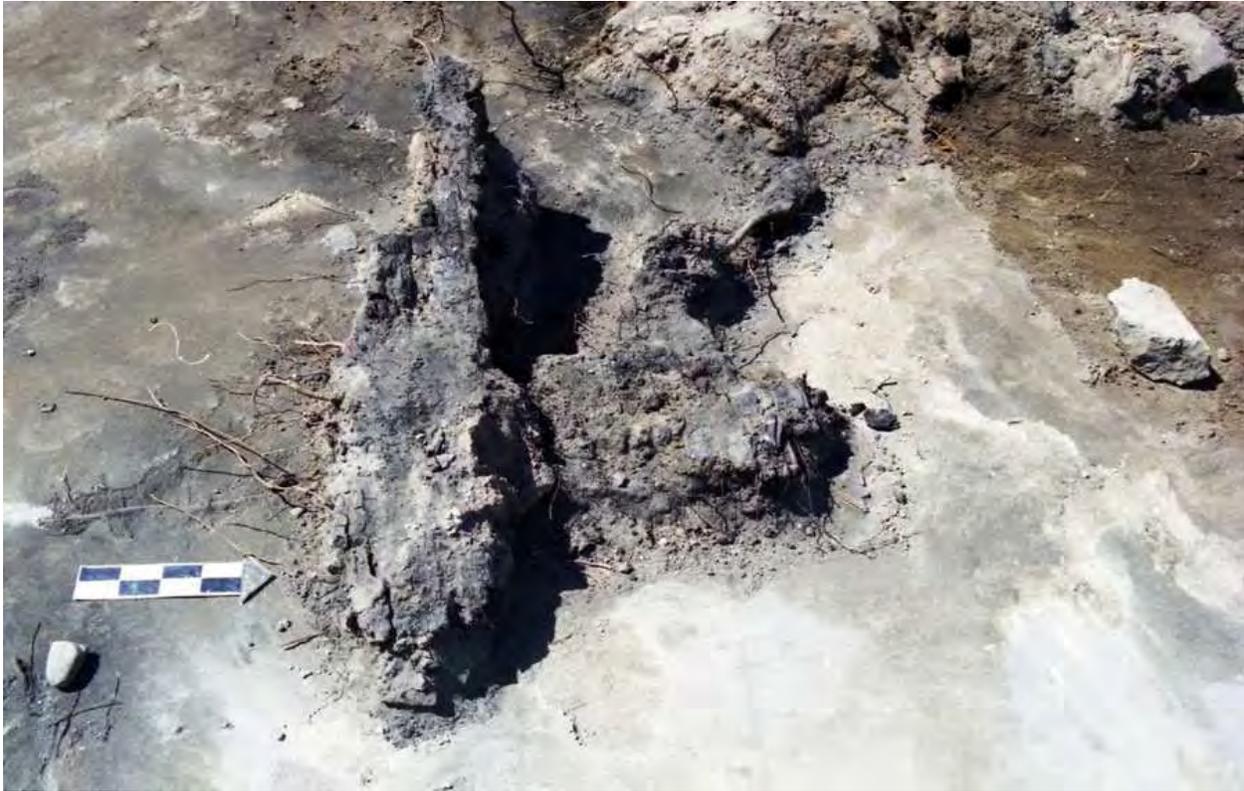
Figure 41. Carbonized wood remains on the stucco floor, part of the burned roof that collapsed inside the different spaces of the building.

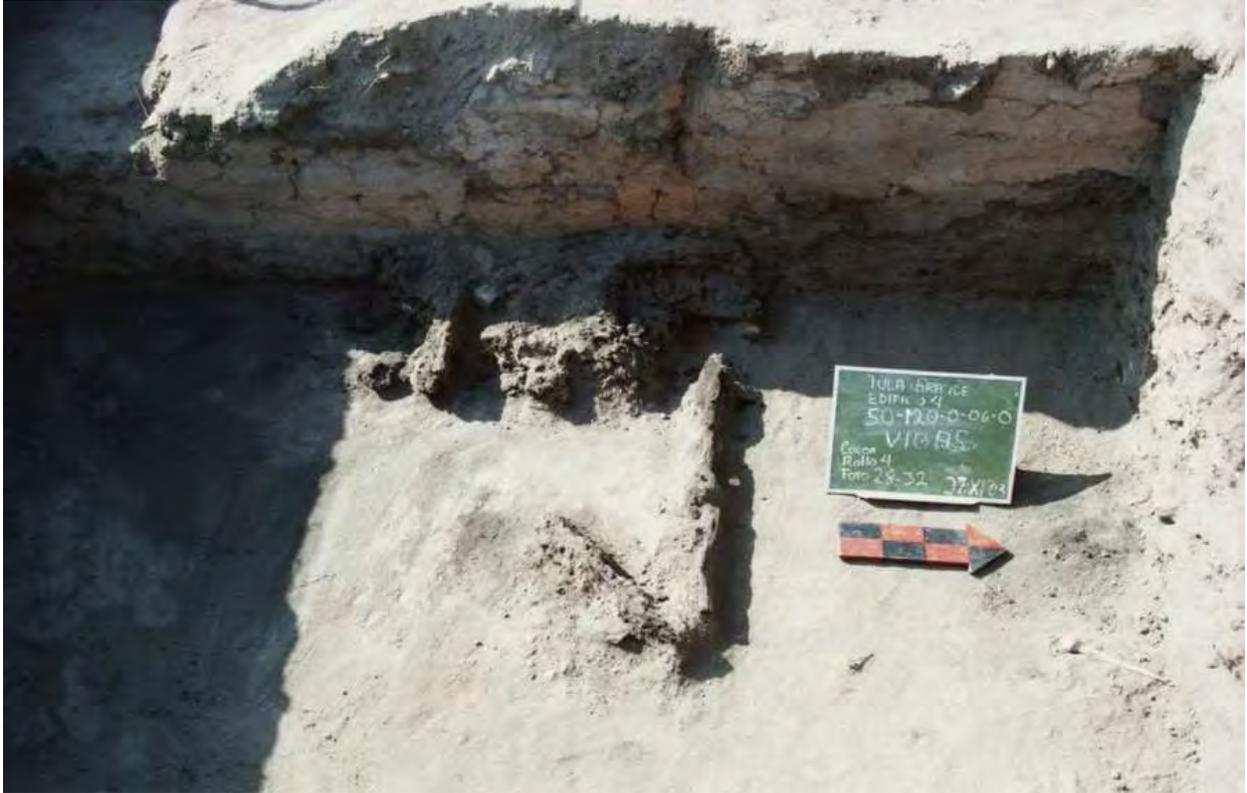
Figure 42. When the roof collapsed it was on fire, which caused fire damage on the adobe walls.

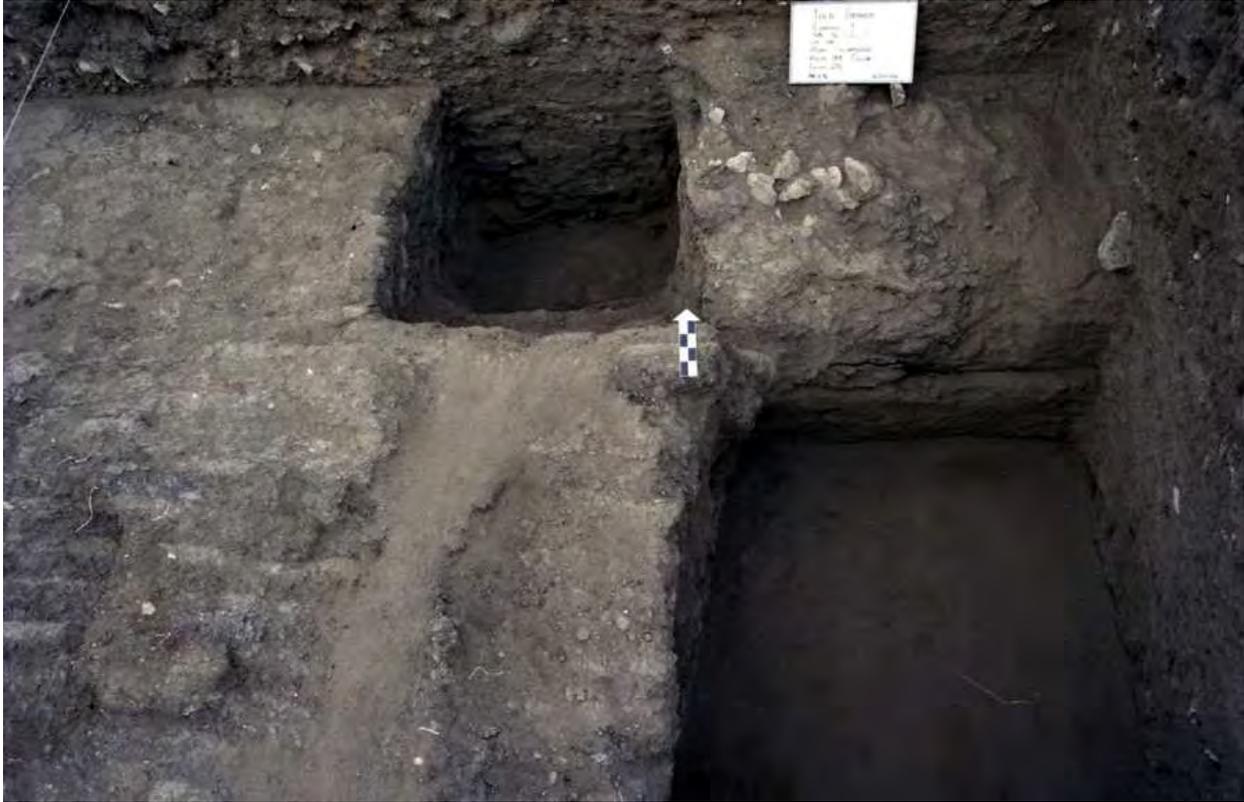
Figure 43. Among the damages caused by the abandonment and fire was the collapse of the walls, as seen in the structure's north sector.

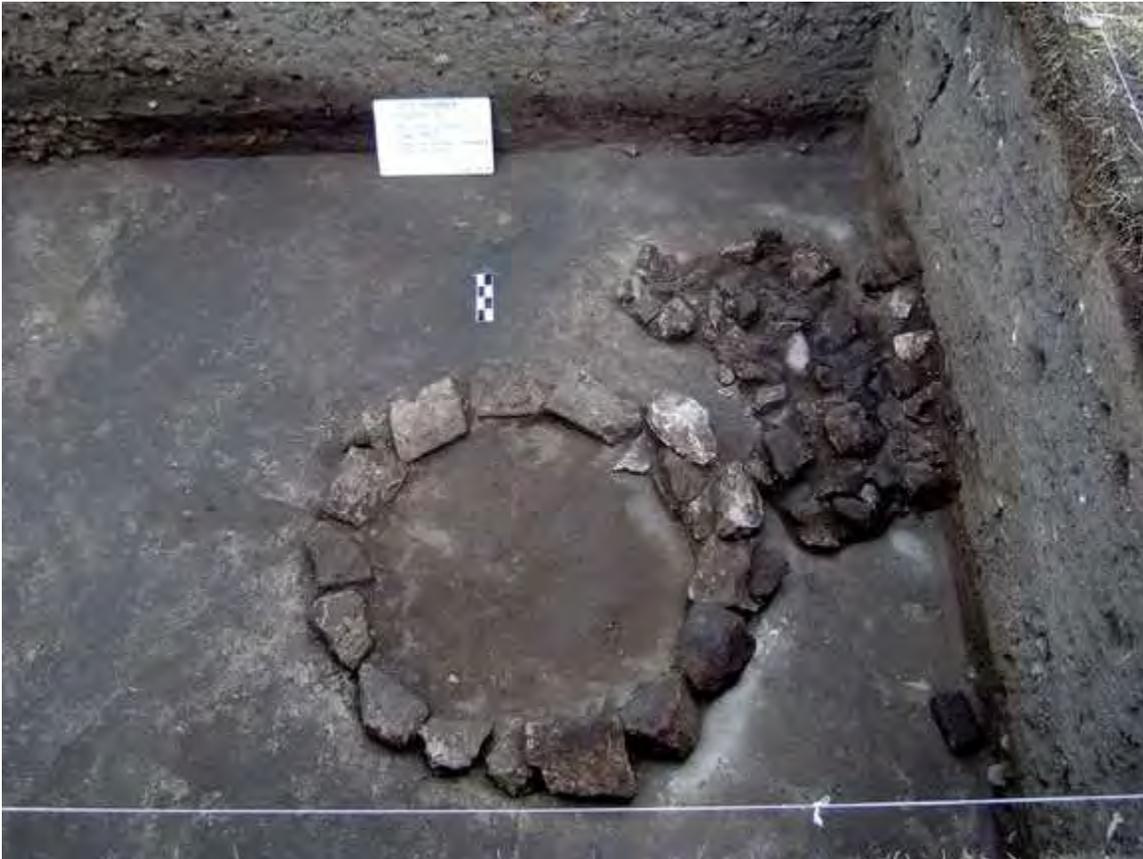
Figure 44. A typical feature of the reutilization of space and building materials after the abandonment of Building Four is the presence of a series of circular compounds located over the aligned pillar molds.

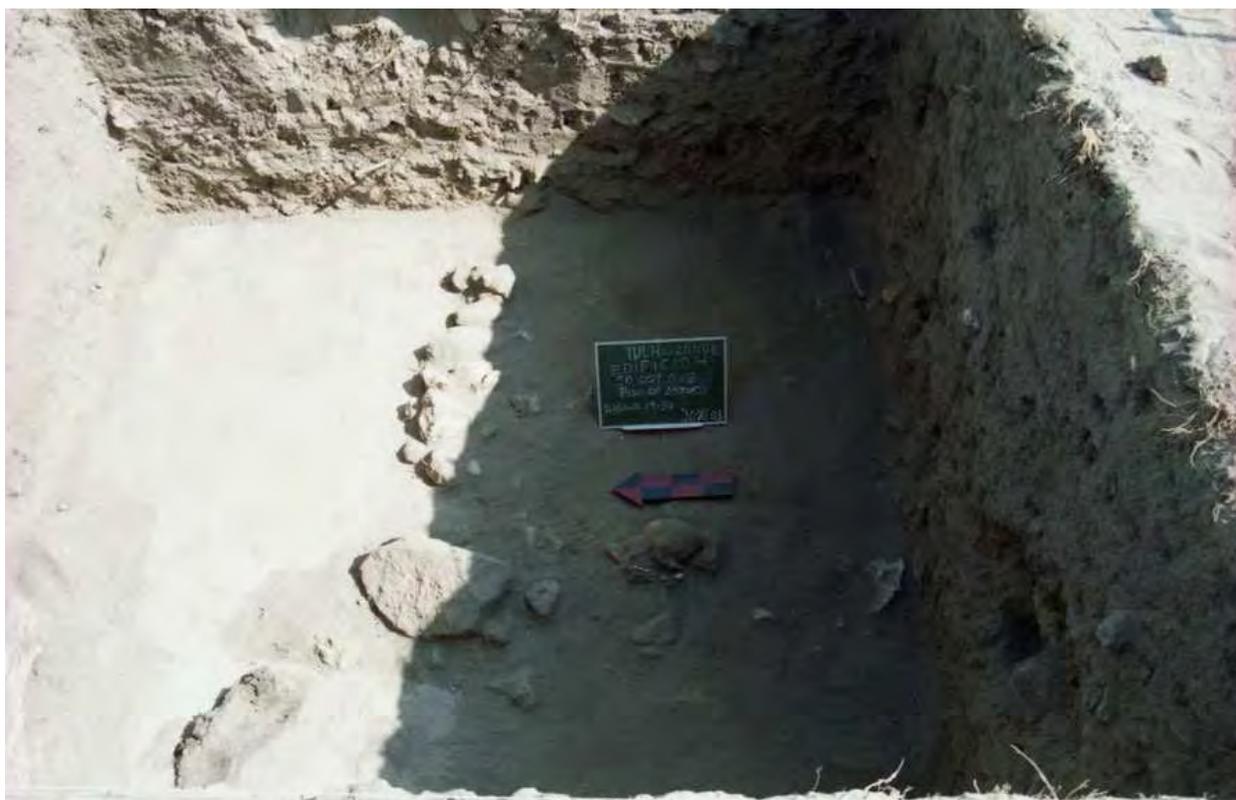
Figure 45. Another feature indicating the later reoccupation of the building is the destruction and looting of the building.

The first area deals with a huge looting found in the center of the room at the south of the first hall with portico (Space 5). In the stucco floor we see a broken surface of 4 m in diameter, with earth of very loose consistency. However, we were unable to explore the pit. In the center of the pit, on the floor level we recorded an offering with a whole vessel –OS1– which was subjected to a micro-excavation and was found to hold bird bones ([Figure 45](#)). This vessel pertains to Aztec orange monochrome ware, it is a pumpkin-shaped bowl with slightly spherical walls with straight rim, rounded edge, and convex base. The thickness of the paste is 0.4-0.6 cm, the vessel is 8.5 cm high and 18.1 cm in maximum width. The rim has a diameter of 17.5 cm and the base a diameter of 9.5 cm. The vessel shows wear marks inside and out ([Figure 46](#)).

[Figure 45](#). Another feature indicating the later reoccupation of the building is the destruction and looting of the building.

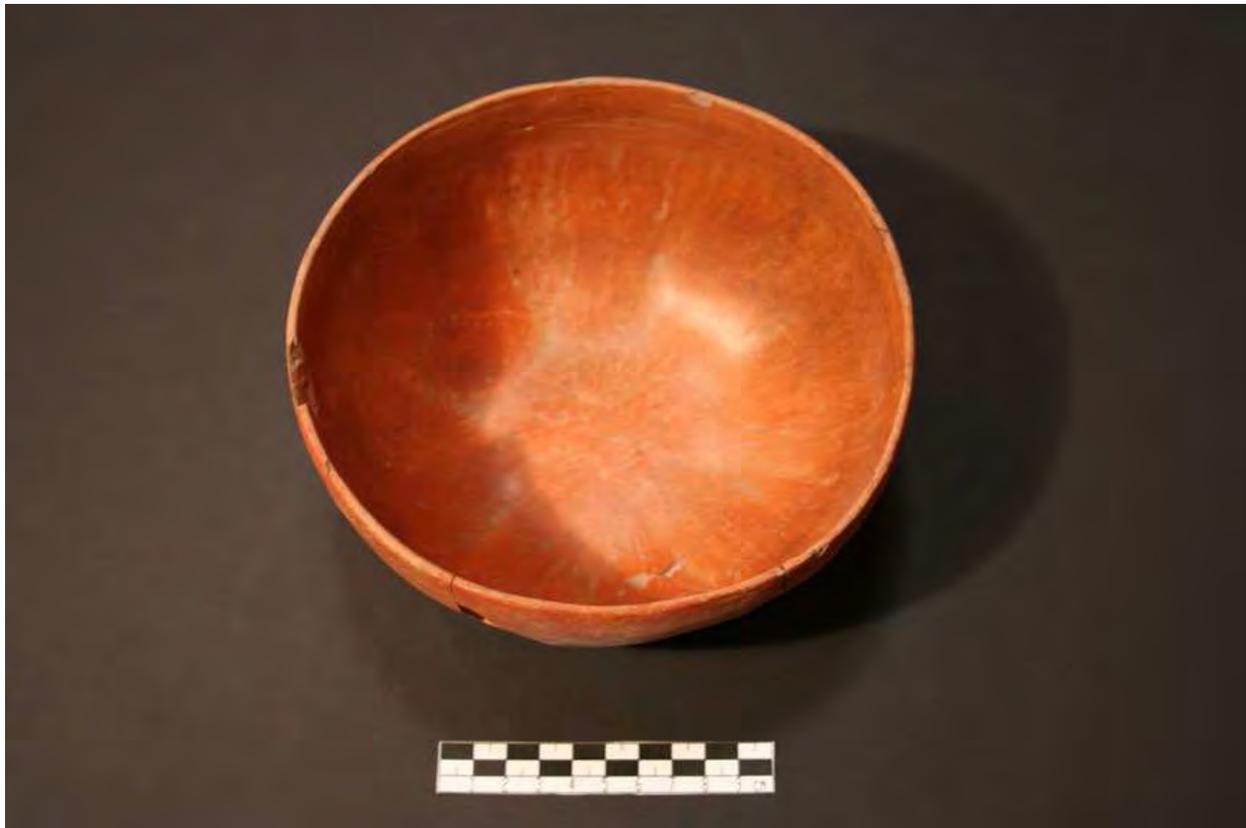
Figure 46. Activities performed after the abandonment of the building were carried out by groups with Mexica affiliations from the Late Postclassic, as seen by this vessel in a looted offering.

[Figure 46](#). Activities performed after the abandonment of the building were carried out by groups with Mexica affiliations from the Late Postclassic, as seen by this vessel in a looted offering.

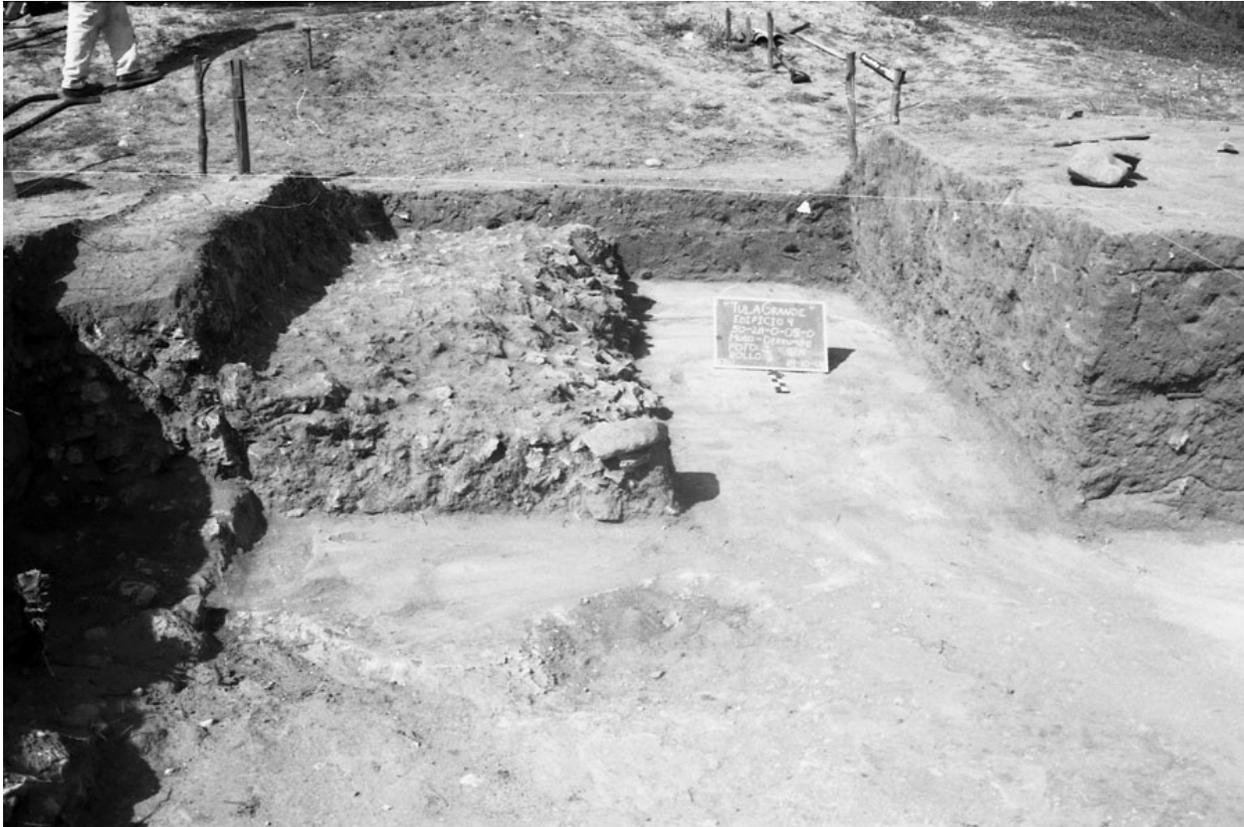
Figure 47. The dismantling of the building elements can be seen in the deposition of material coming from the slab walls concentrated in the north sector of the open patio.

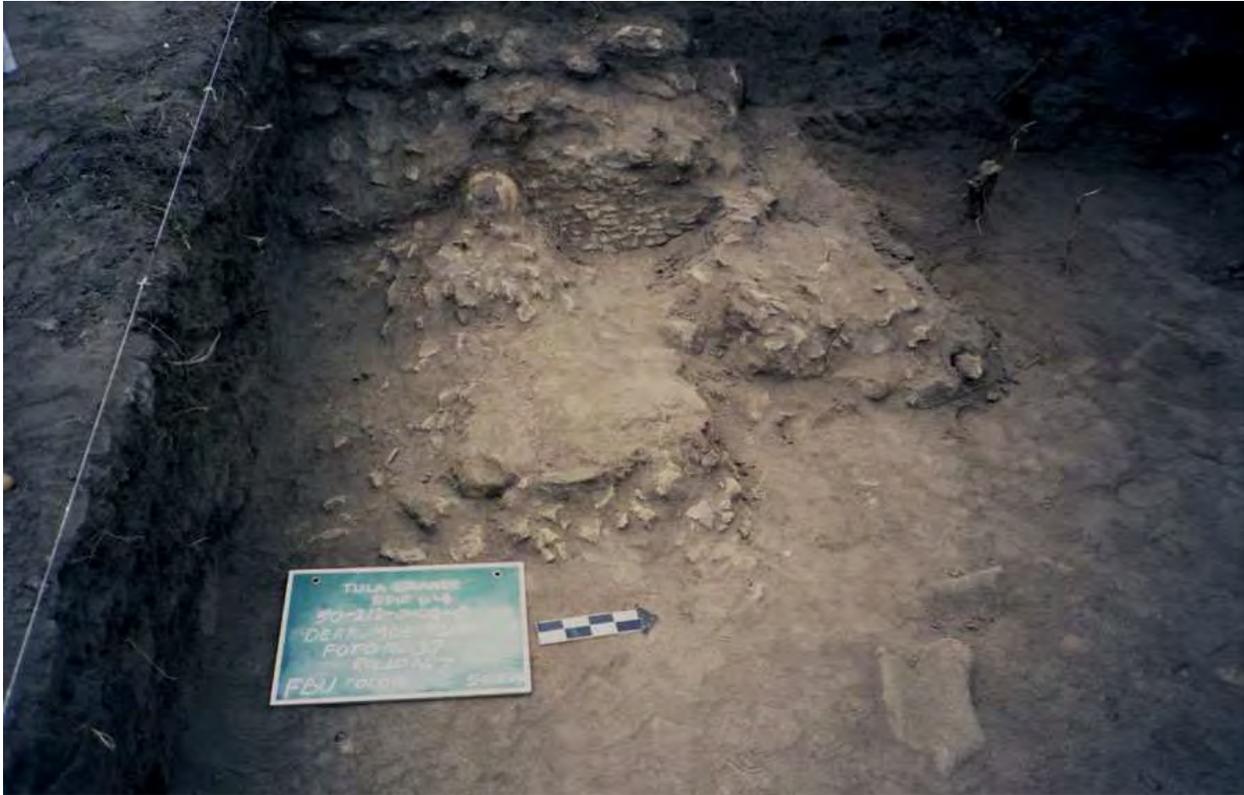
Figure 48. A human skull was deposited on the rubble material, indicating the presence of later groups, and the different activities they performed on the structure.

On this cluster of *tepetate* slabs near the looted area we recorded a human skull –OS2–, which may be that of an adult female. This skull was the only element deposited here, and we found no other bone remains associated to it. The paleobotanical analysis identified seeds in the soil samples taken inside and around the skull. We don't have the results indicating the kind of seed yet, but in principle they indicate that the skull was used as an offering ([Figure 48](#)).

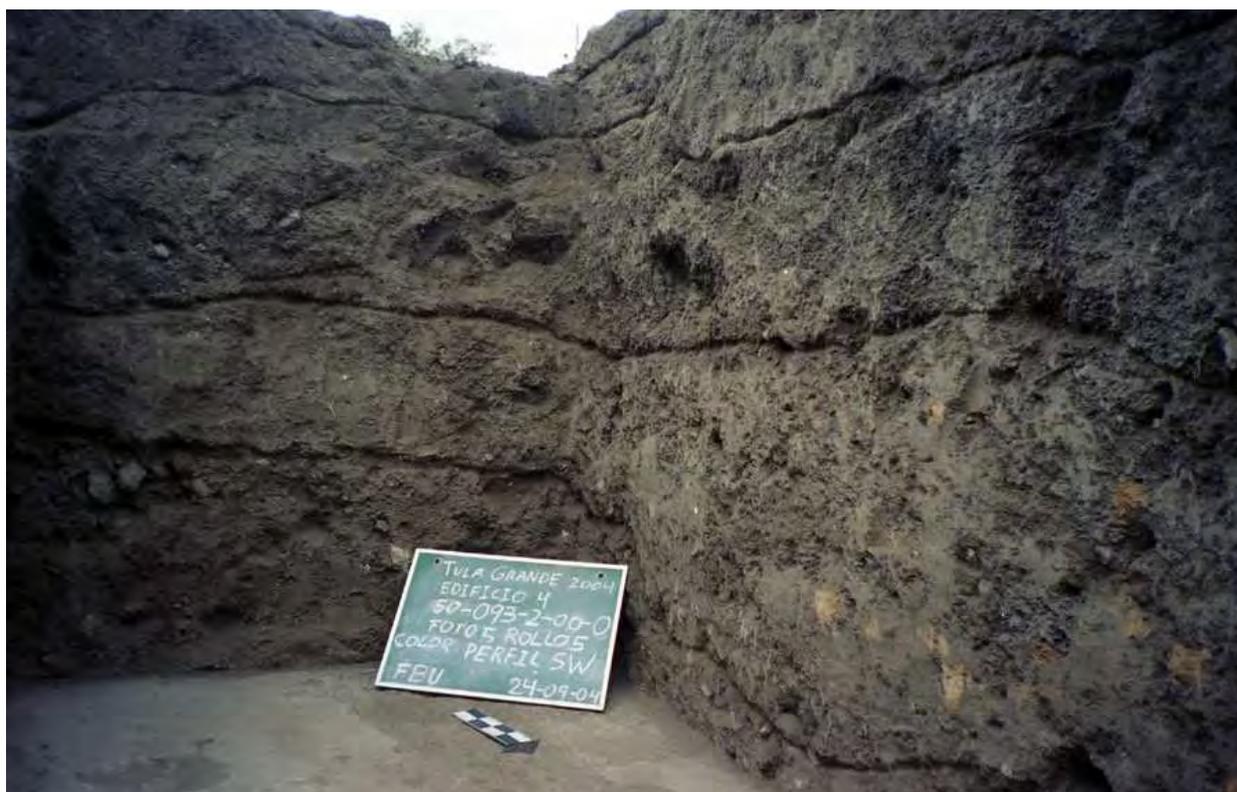
Figure 49. The filling-up of the surface of this area for leveling purposes was an extensive activity. A good part of the structure was covered with filling materials until a height of over two meters was reached on top of the Toltec floor.
