Building Four: a Palace in Tula Grande, the Lodging of the Toltec King

Research Year: 2007

Culture: Toltec

Location: Tula de Allende, Hidalgo State, Mexico

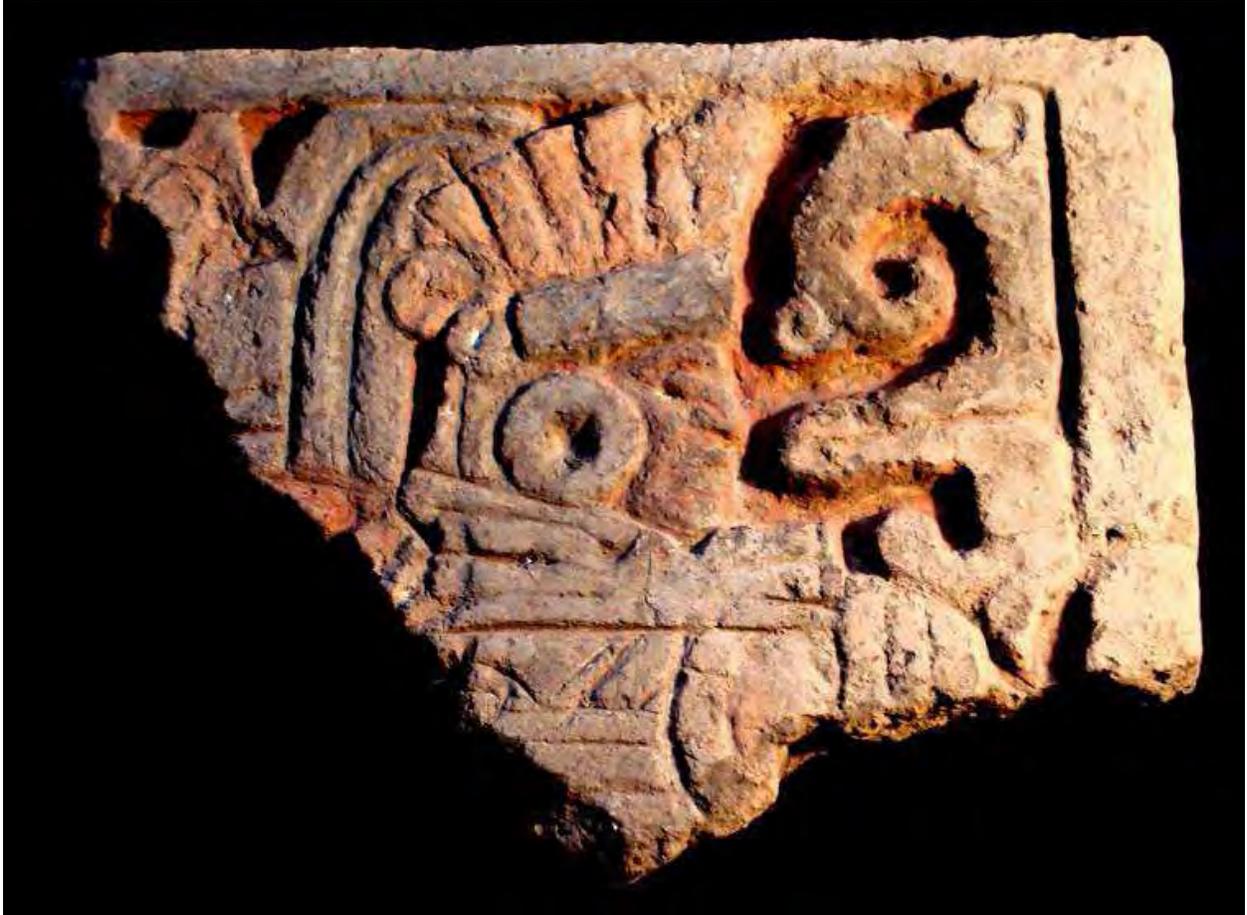
Figure 50. Among the recovered fill materials are a series of engraved slabs, showing designs that suggest this was a very important space during its peak (courtesy of Elizabeth Jiménez).

Among these are a series of fragmented slabs showing figures of richly attired personages. The latter were found as part of the leveling fill. One slab was located in the southeast sector of the alley (Space 7), and another one in the north sector, while in the southeast corner of the first hall with portico (Space 2) two slabs were found. In the northeast sector of the first room with pillars (Space 3) was found one slab, another slab fragment in Space 10, and other small fragments were scattered around many zones inside the building ([Figure 50](#) and [Figure 51](#)).

We believe that these items probably come from exterior spaces, in particular the exterior walls of the open patio and the alley to the south of the building, since during the excavation process we recovered along the wall of the open patio smaller fragments located on the stucco floor. These were associated with the decorative elements of the crowning of the roofs on the outside, such as merlons, cut conch-shells, architectonic tenons showing *chalchihuites*, and miniature tenon blocks. Over these were found concentrations of *tepetate* slabs from the small stone wall. These small fragments pertain to slabs in which we can see elements belonging to the slabs discussed above. Unfortunately, since these items were not found in primary context, they received no priority for a detailed iconographic analysis. However, after studying the distribution of all materials and the different occupation and decay processes in the building, we became aware of the probable provenience of the materials, therefore they will be studied as part of this project.

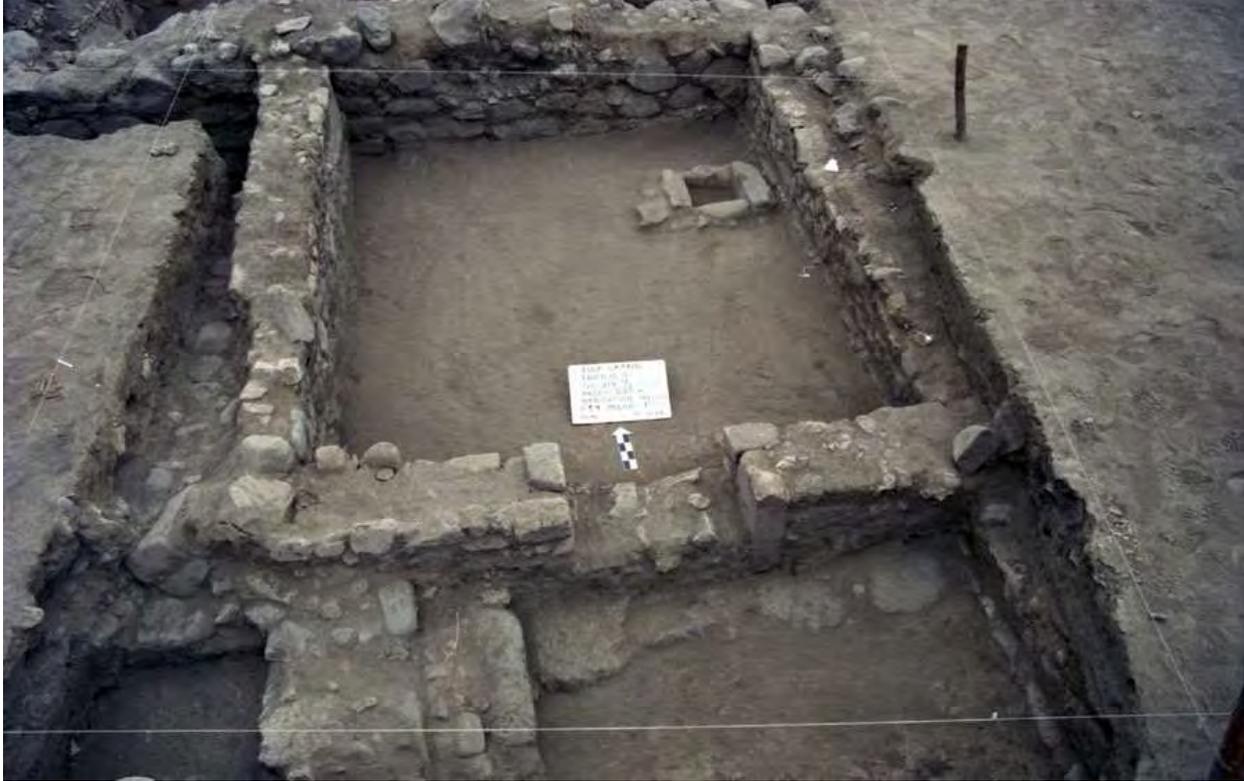
Figure 57. These construction features are typical of Mexica architecture in the region.
