FAMSI © 2005: Carlos Rudy Larios Villalta

Architectural Restoration Criteria in the Maya Area

Site: Maya Area

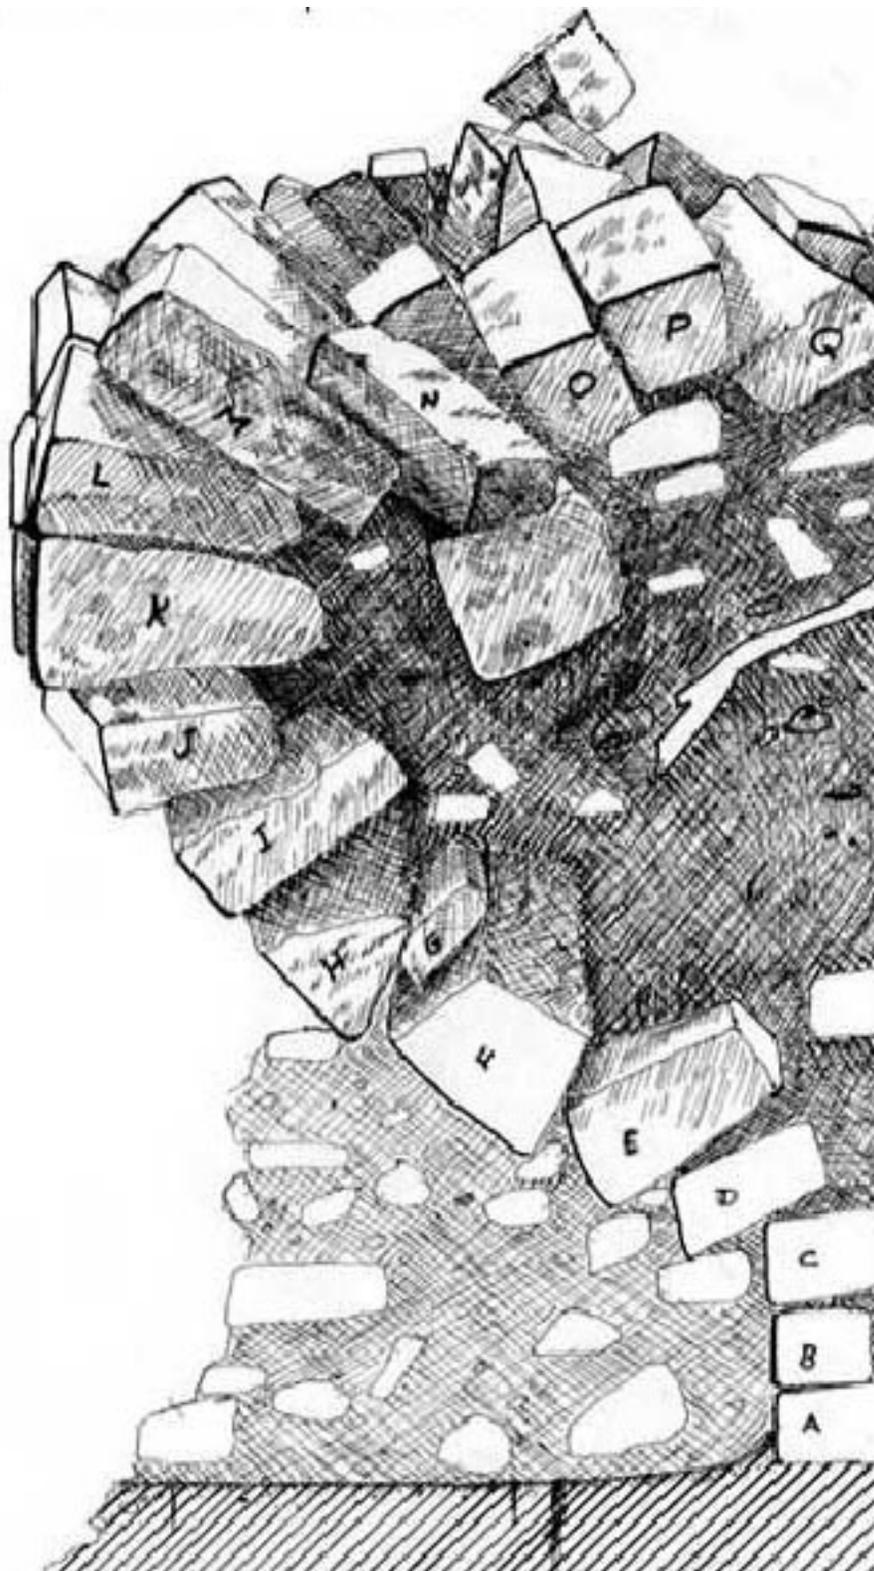
Figure 1. Cross section: Element No. 9, Structure 10L-22, Copán.

To facilitate this task, it is convenient to establish a reticule formed by squares measuring two per two meters, named after their topographic position. This means that each localized element will have its distance from the point of origin, both in latitude, longitude, and height above sea level. This is useful not only for recording archaeological data but also to facilitate the task of architectural surveys, with absolute accuracy.

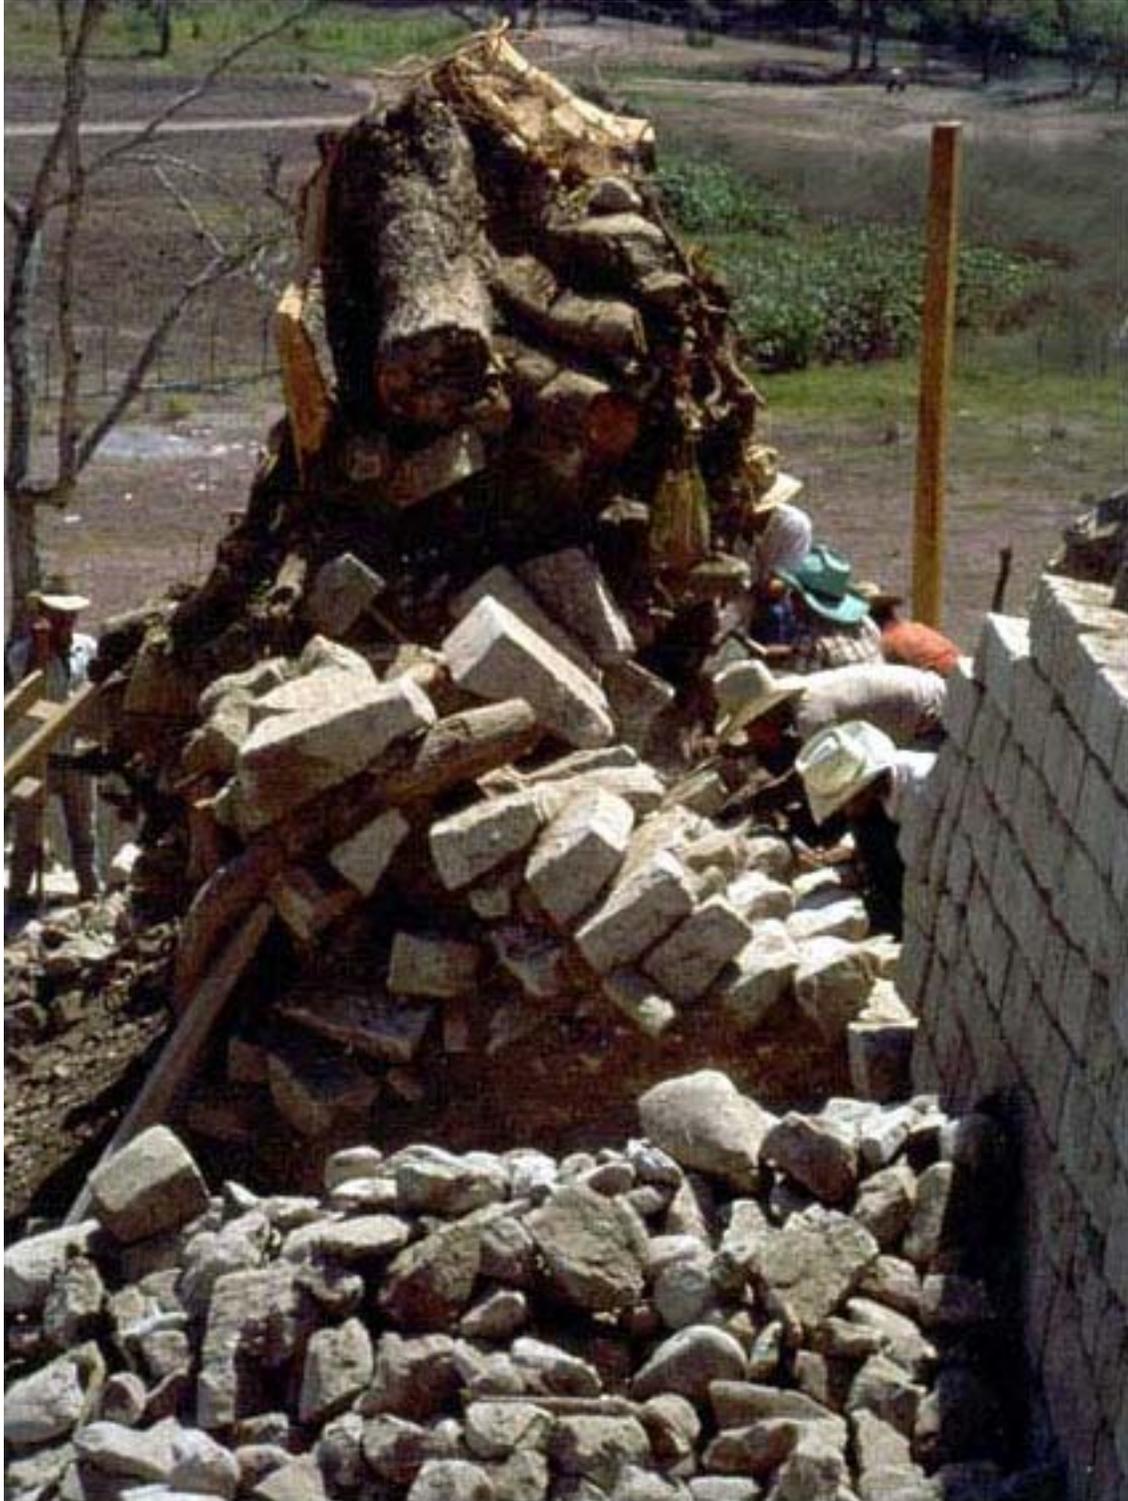
Photo 51. Copán, Structure 10L-21, north section, restoration process through anastylosis, March, 1991.

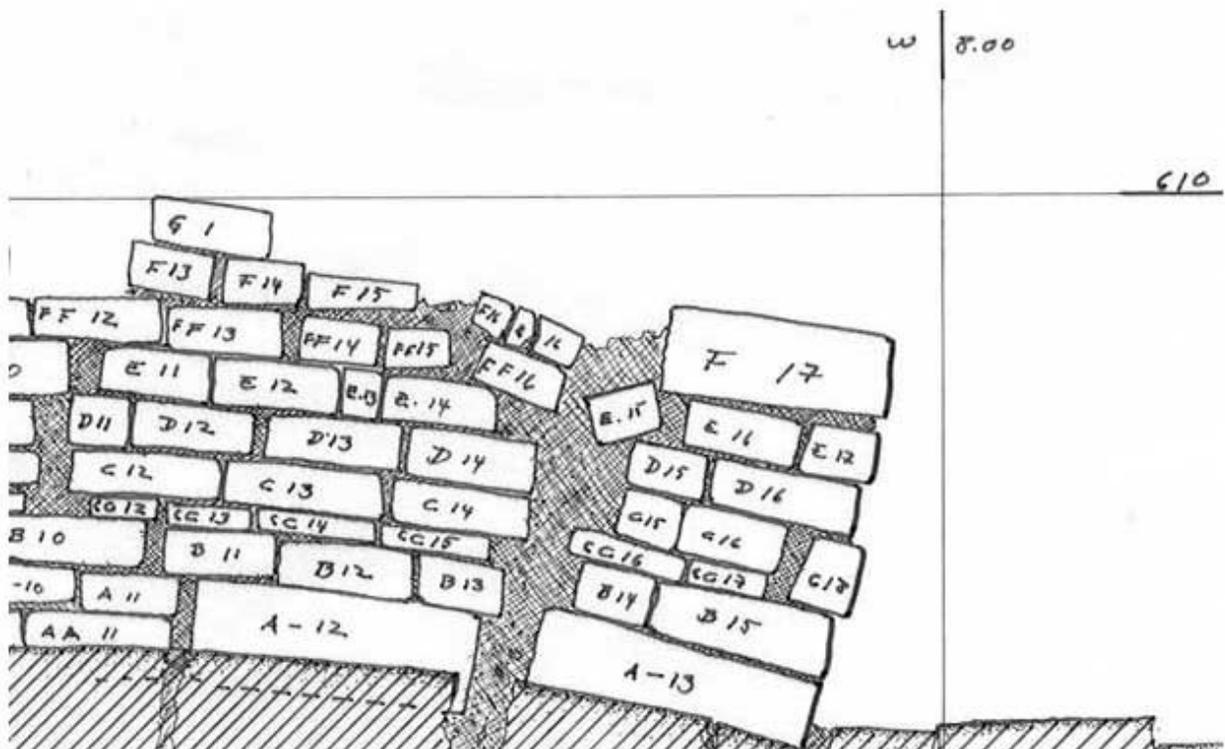
Figure 2. Example of adequate way to mark stones in preparation for anastylosis. Marks on the main face of stones are to be avoided.

In most parts where buildings from the Maya area in Guatemala, Belize and the Southern Yucatán Peninsula are found, construction stones are extremely feable limes, so whenever they collapse and portions of the construction fall down, they are usually destroyed to such a degree that it is not possible to carry out any reintegration work; however, we have seen this rule broken in the past. At El Pilar, for instance, a site from the El Cayo district in Belize, we were able to find several sculpted stones that were a part of the frieze of a collapsed structure.

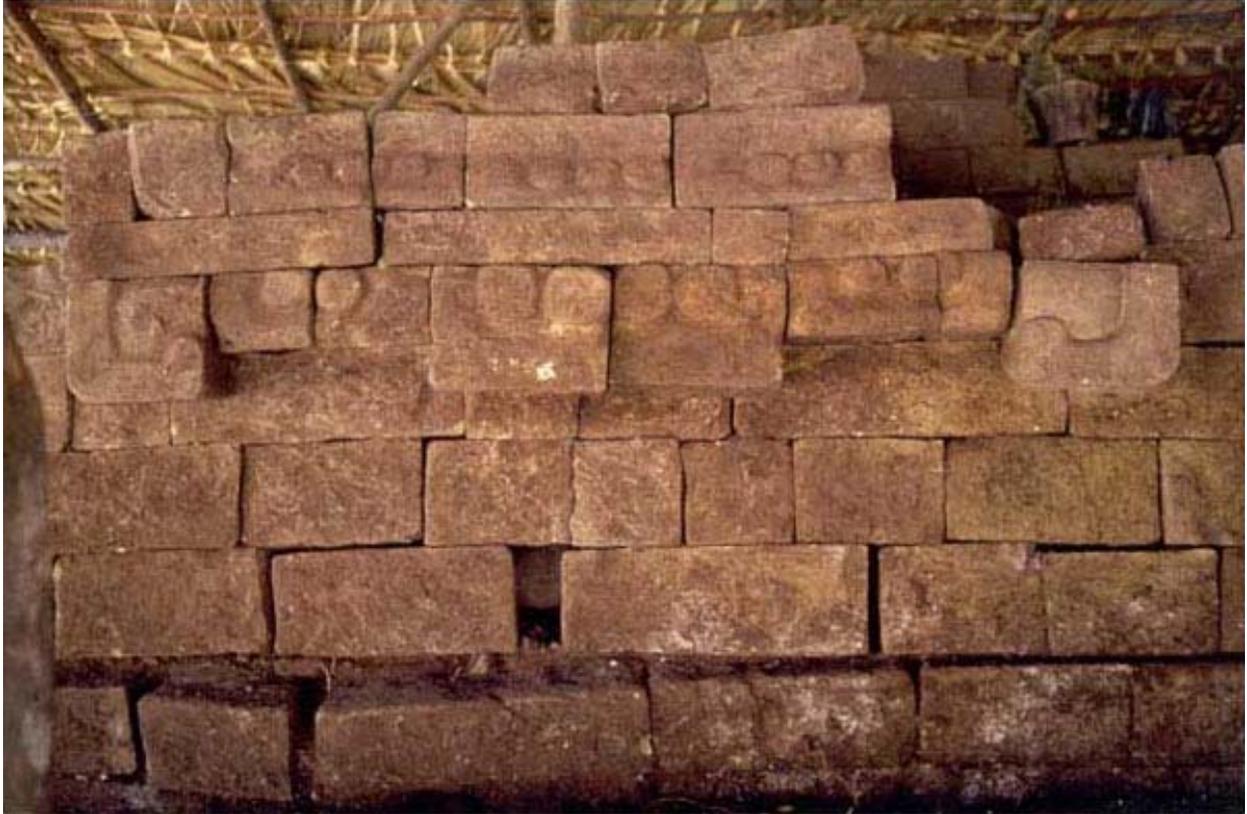
Photo 1. Copán, Structure 9N-82, preliminary reintegration of stone blocks, east side, 1981.

After careful study and several lab trials, the stones were transported to the site for a structural test. Fortunately, the main stones fitted in just like when we slide a drawer into its original place, evidencing as well that before the collapse took place, the building had been burnt with a very intense fire which indelibly marked the stones. The pink stains produced by burning also fitted with great precision, providing additional proof of its correct placement ([Photo 2](#) and [Photo 3](#), shown below).

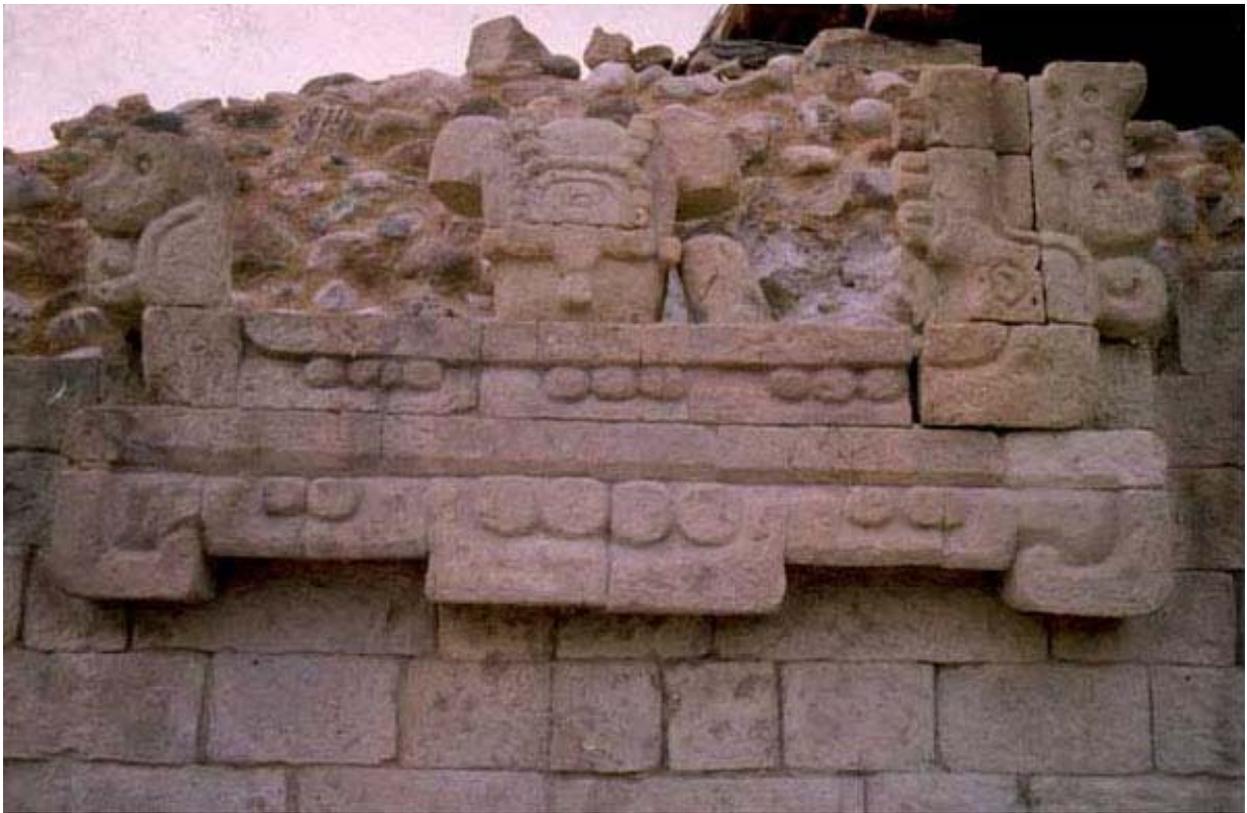
Photo 2. Copán, Structure 9N-82, reintegrated sculpture, 1983.

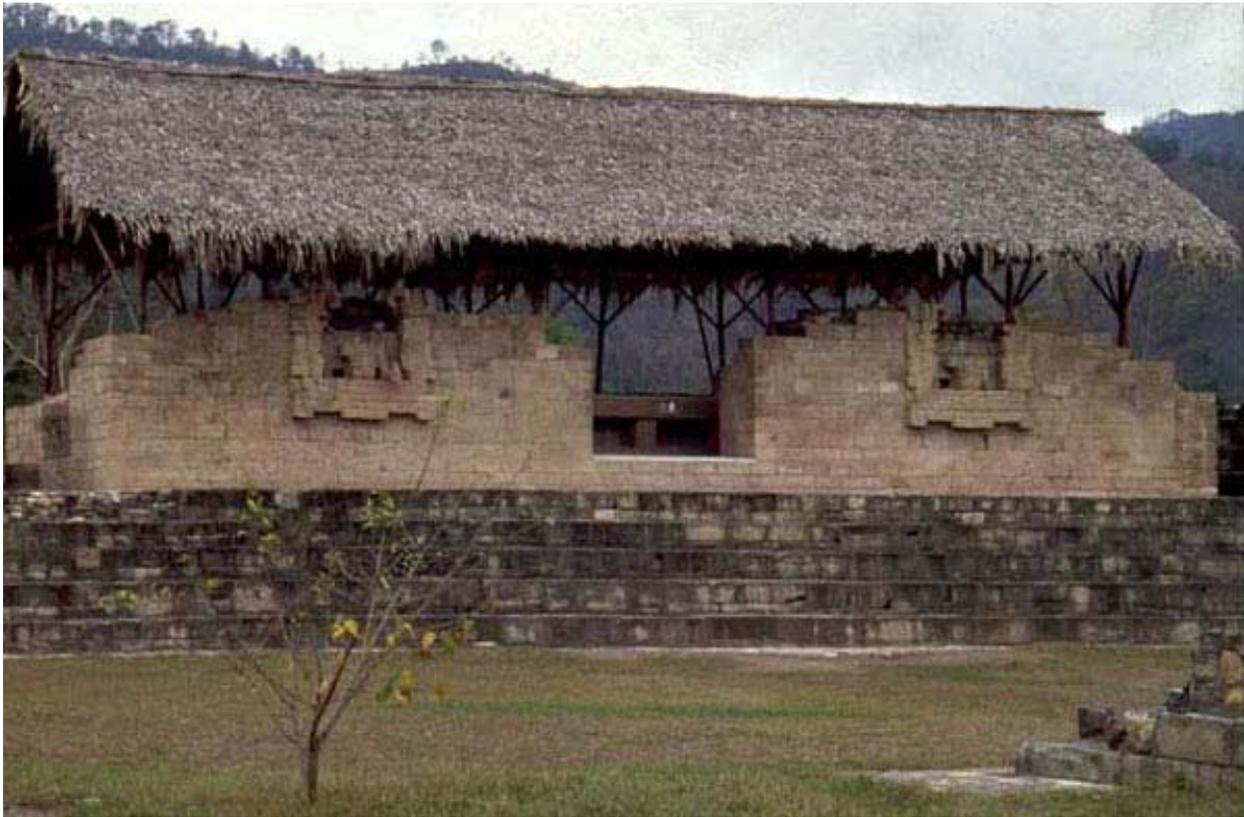
Photo 3. Copán, Structure 9N-82, main façade restored and protected with a palm roof, 1986.

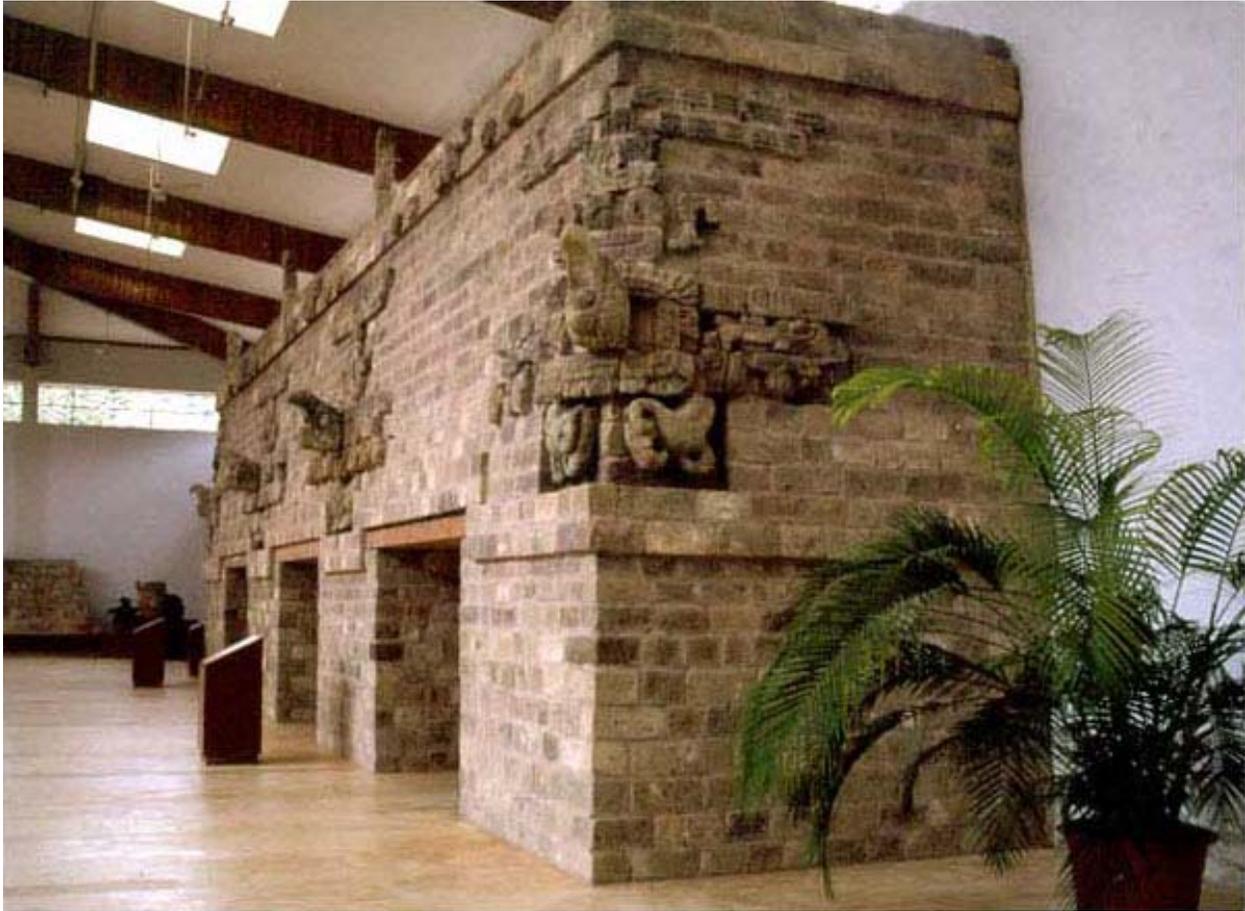
Photo 53. Copán, replica of Structure 10L-10; the ballcourt is inside the Sculpture Museum, 1997.

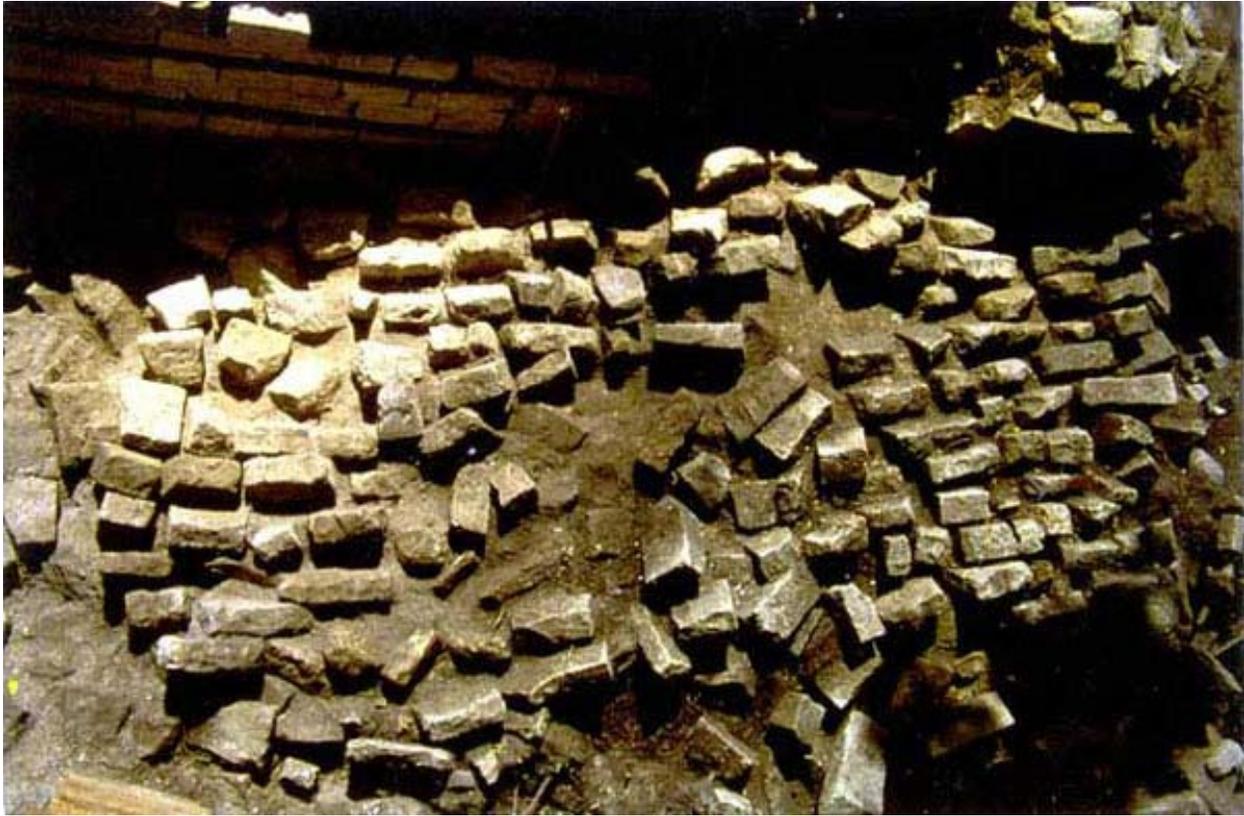
Photo 4. Copán, west wall, fallen, Structure 10L-22A, 1988.

A portion of the bearing wall of the west façade in Structure 10L-22A was almost completely collapsed ([Photo 4](#)). After careful excavation, we found within the rubble on a section that showed the organization of several courses of ashlar stones, including a row of perfectly organized corner stones. With the documentation method already described, each stone was marked and then, with the help of photography and joint work, we were able to reintegrate the ashlar stones providing the building with a greater significance ([Photo 5](#), below).

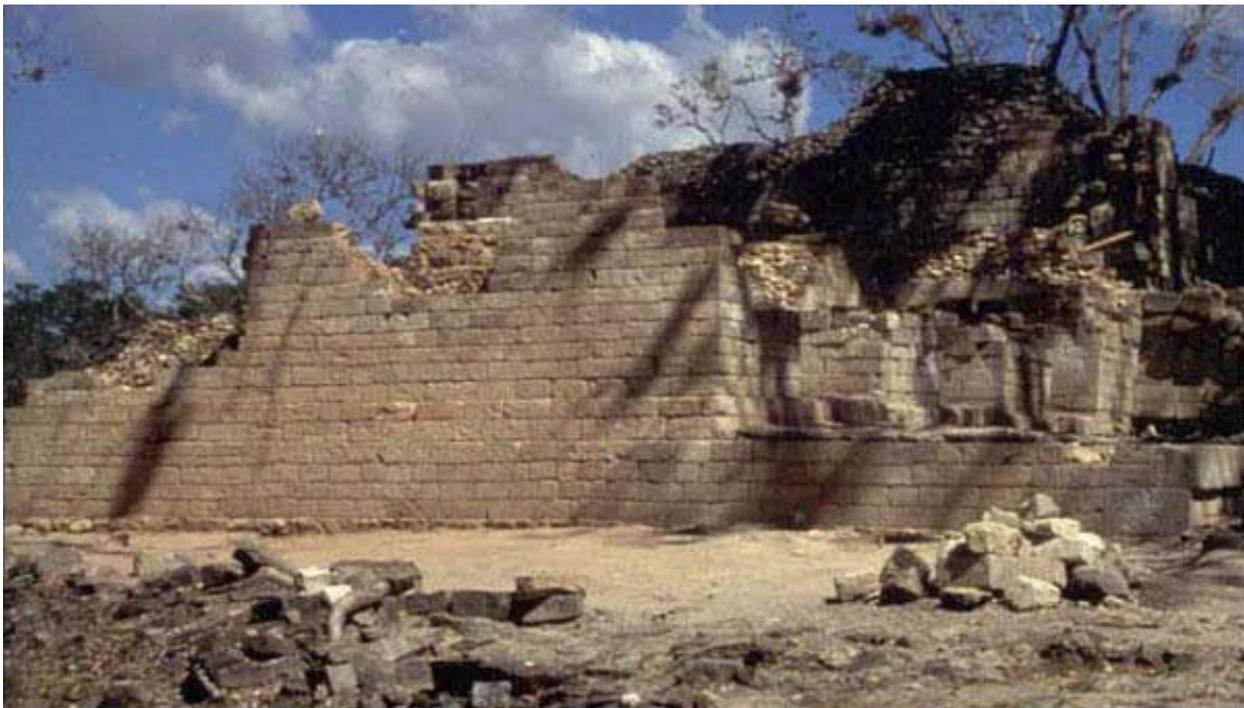
Photo 5. Copán, restored west wall, Structure 10L-22A, 1989.

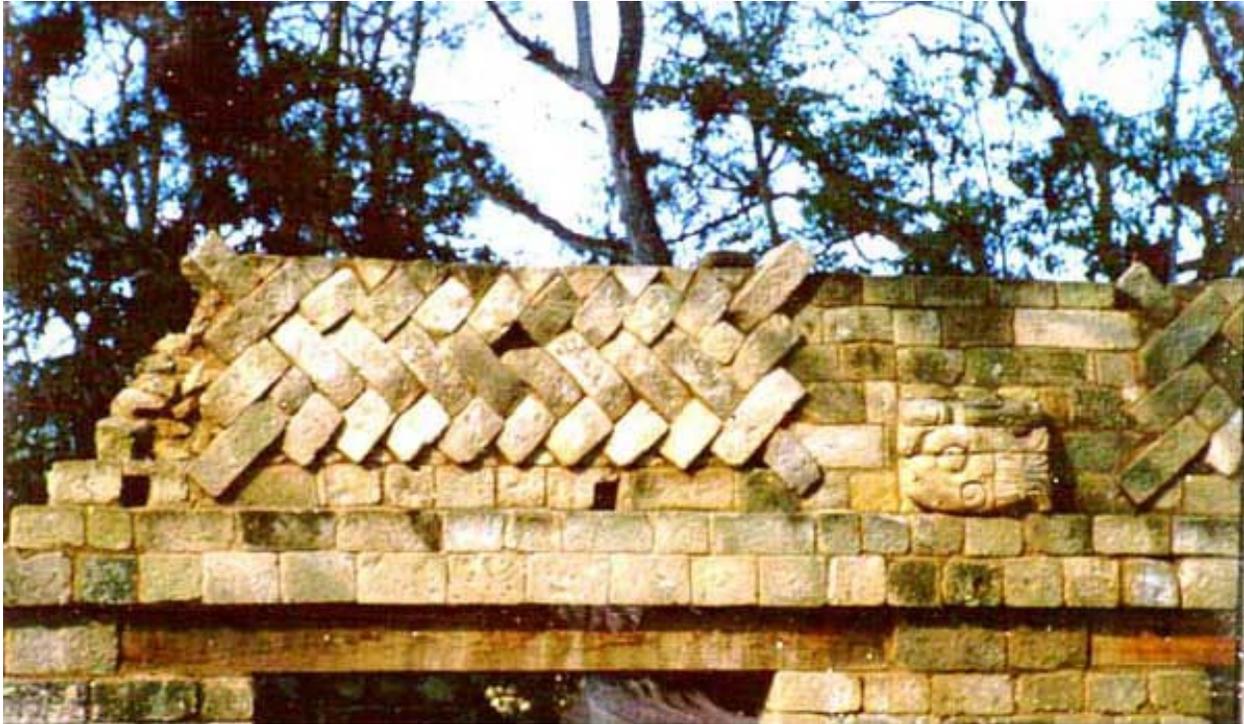
Photo 7. Copán, Structure 10L-22A, detail of sculpture, upper portion, 1991.

In the same way, one portion of the main façade, south side, containing mosaic sculpture, had also fallen in a relatively organized fashion, and we were able to reintegrate it with the certainty of doing the right thing ([Photo 6](#), shown above, and [Photo 7](#), below). Besides, in the eastern edge where the structure abutted with its neighboring one, Temple 22, we still had a portion of the upper zone decoration which helped to understand the fallen elements with clarity.

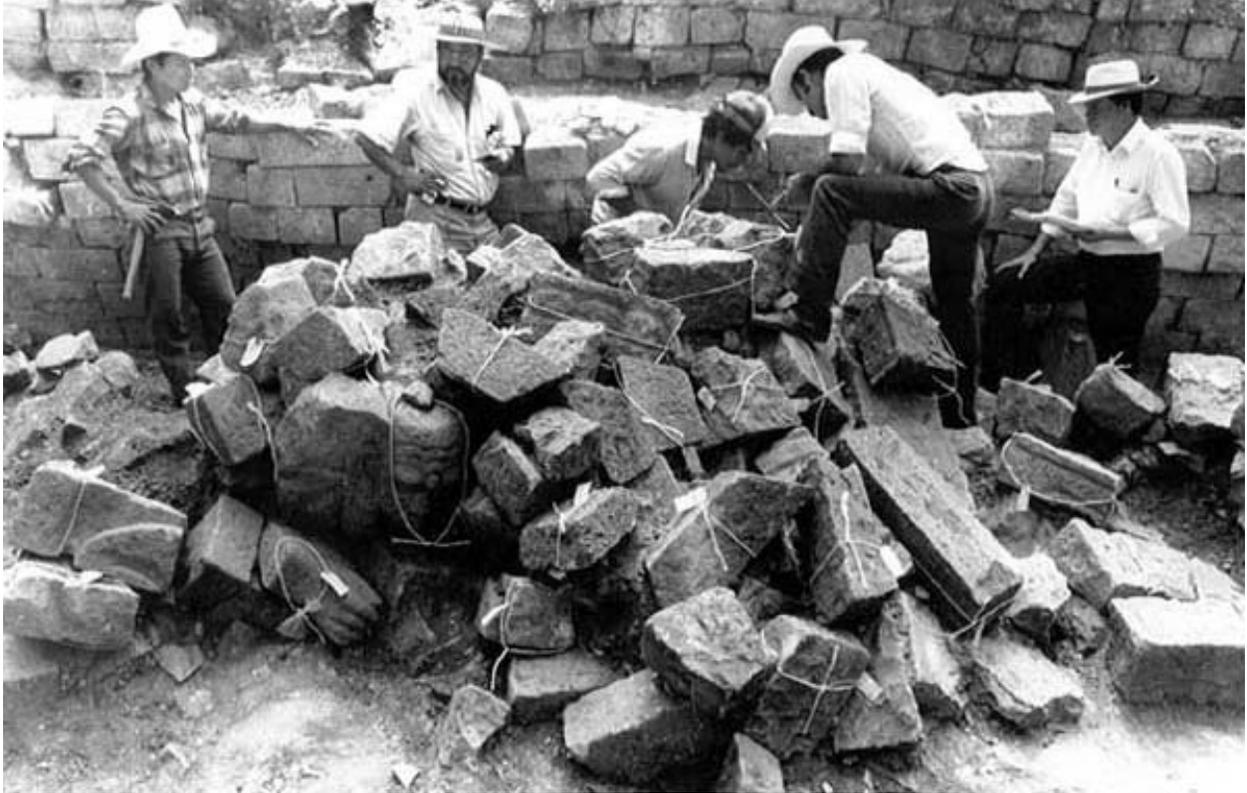
Photo 8. Copán, Structure 10L-29, 1991. West wall rubble.

Our greatest success took place when the team of archaeologists under the supervision of Wyllys Andrews as co-director of PAAC (Tulane University), worked in the liberation of Structure 10L-29, located north of the Acrópolis. The collapsed western façade, which apparently was a huge labyrinth of fallen stones ([Photo 8](#)) was actually a frieze of mosaic sculpture, which appeared before us in a surprising order and with a remarkable feasibility for reintegration.

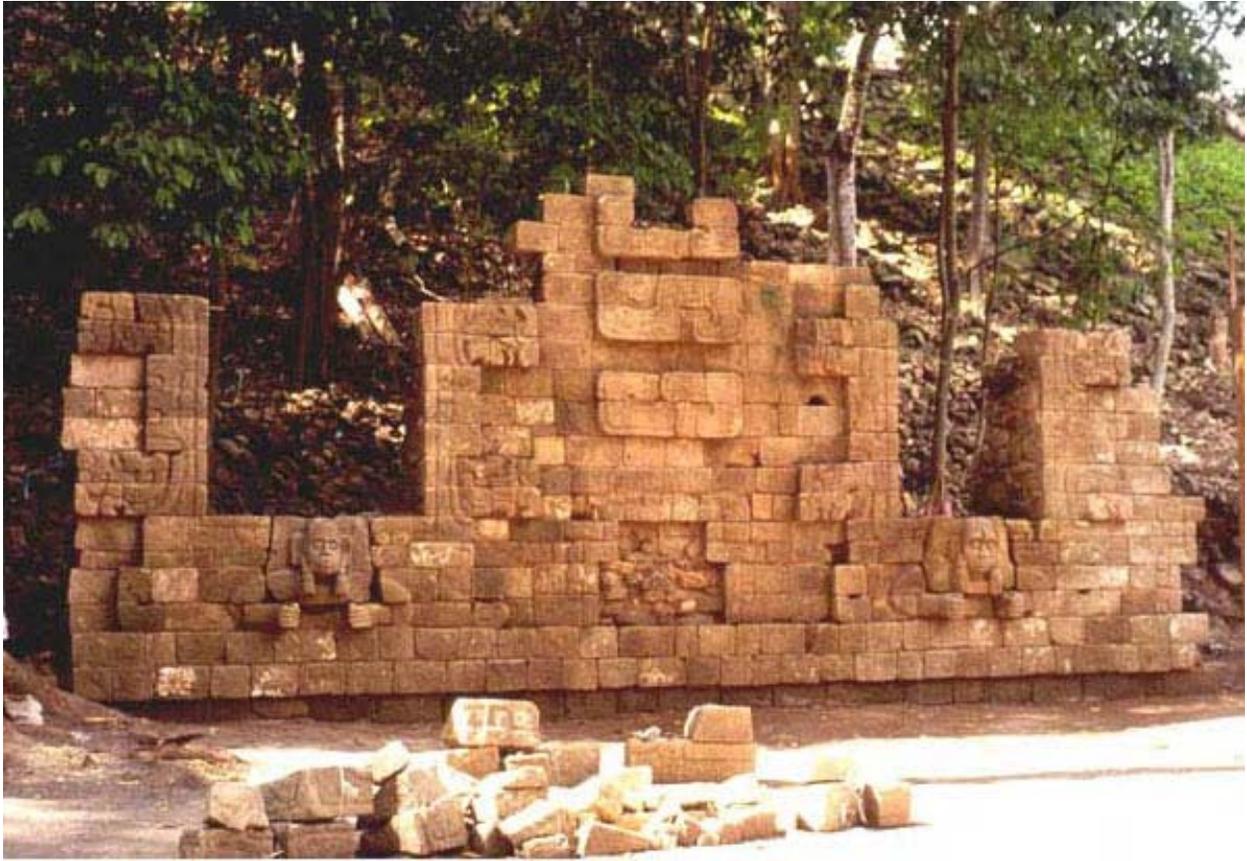
Photo 10. Copán, Structure 10L-29, mosaic sculpture reintegrated in adjacent area, 1991.

The process was repeated with the subsequent layers of stone; the method functioned perfectly well, and its immediate results may be seen in [Photo 10](#), shown above, where the portion of the frieze recovered and recomposed in an adjacent part of the collapsed building may be observed. Today, the southern façade may be observed at the Sculpture Museum ([Photo 54](#), below).

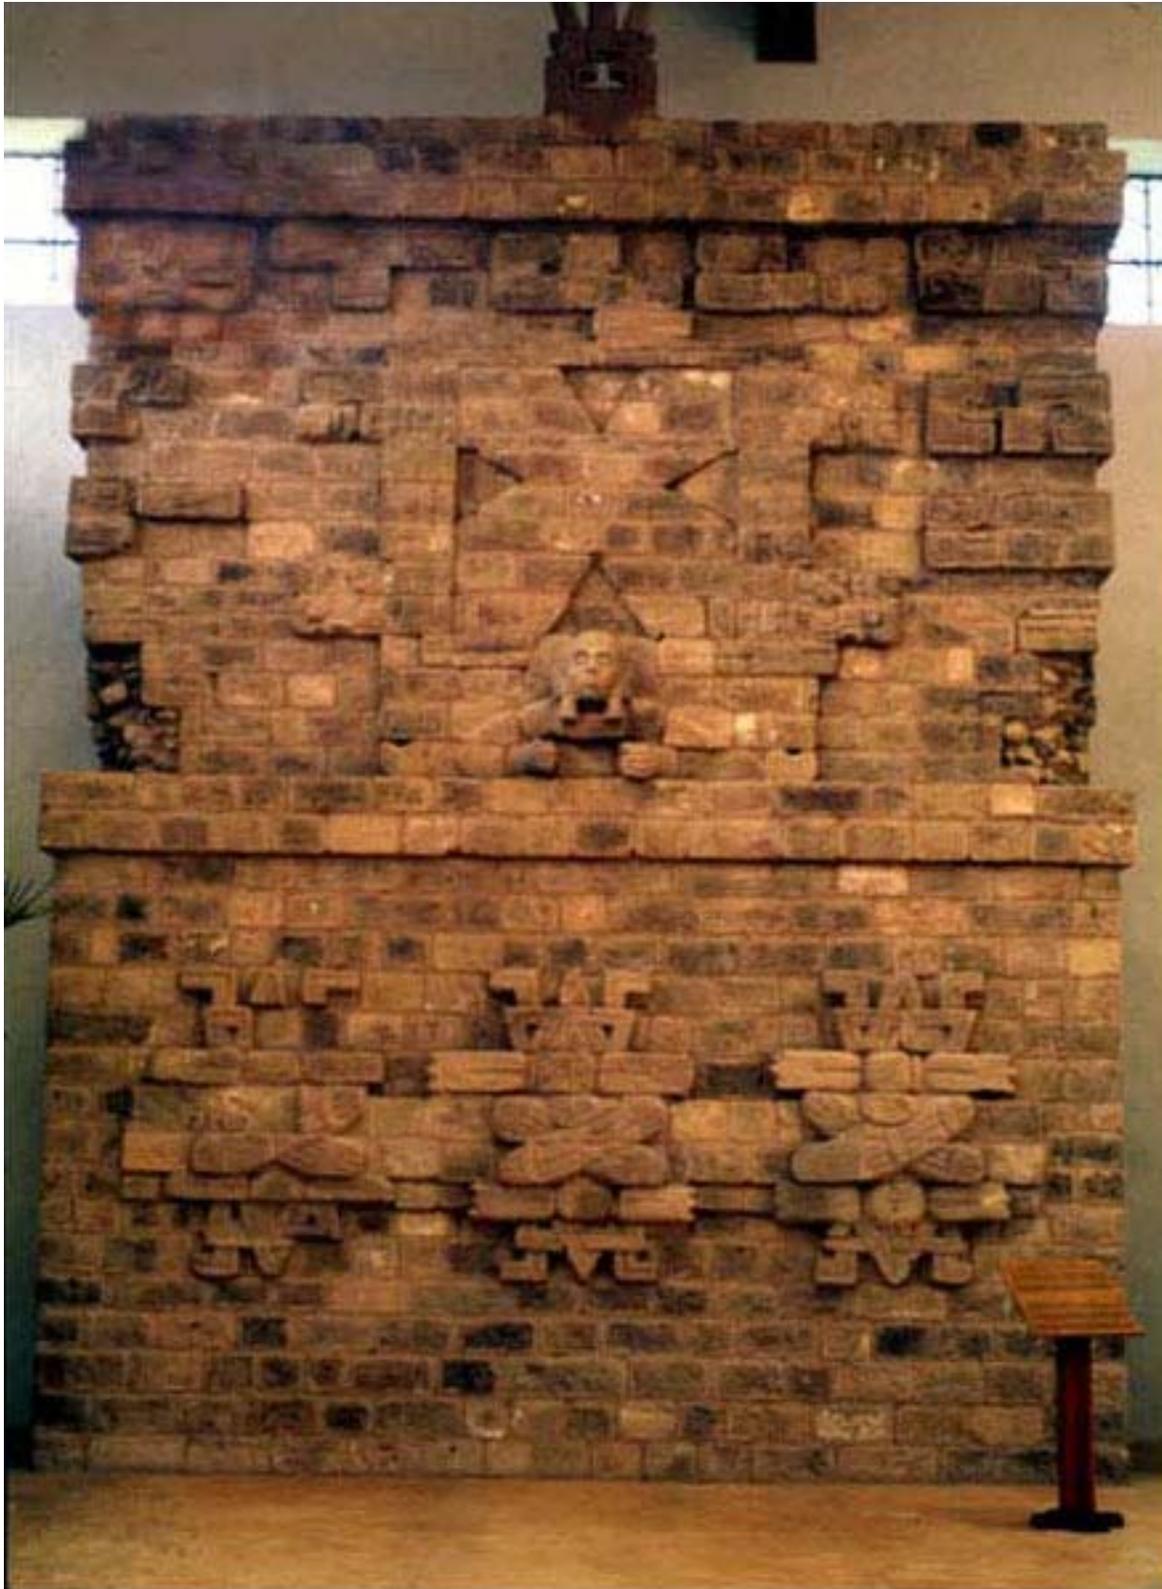
Photo 54. Copán, Structure 10L-29, south façade, inside the Sculpture Museum.

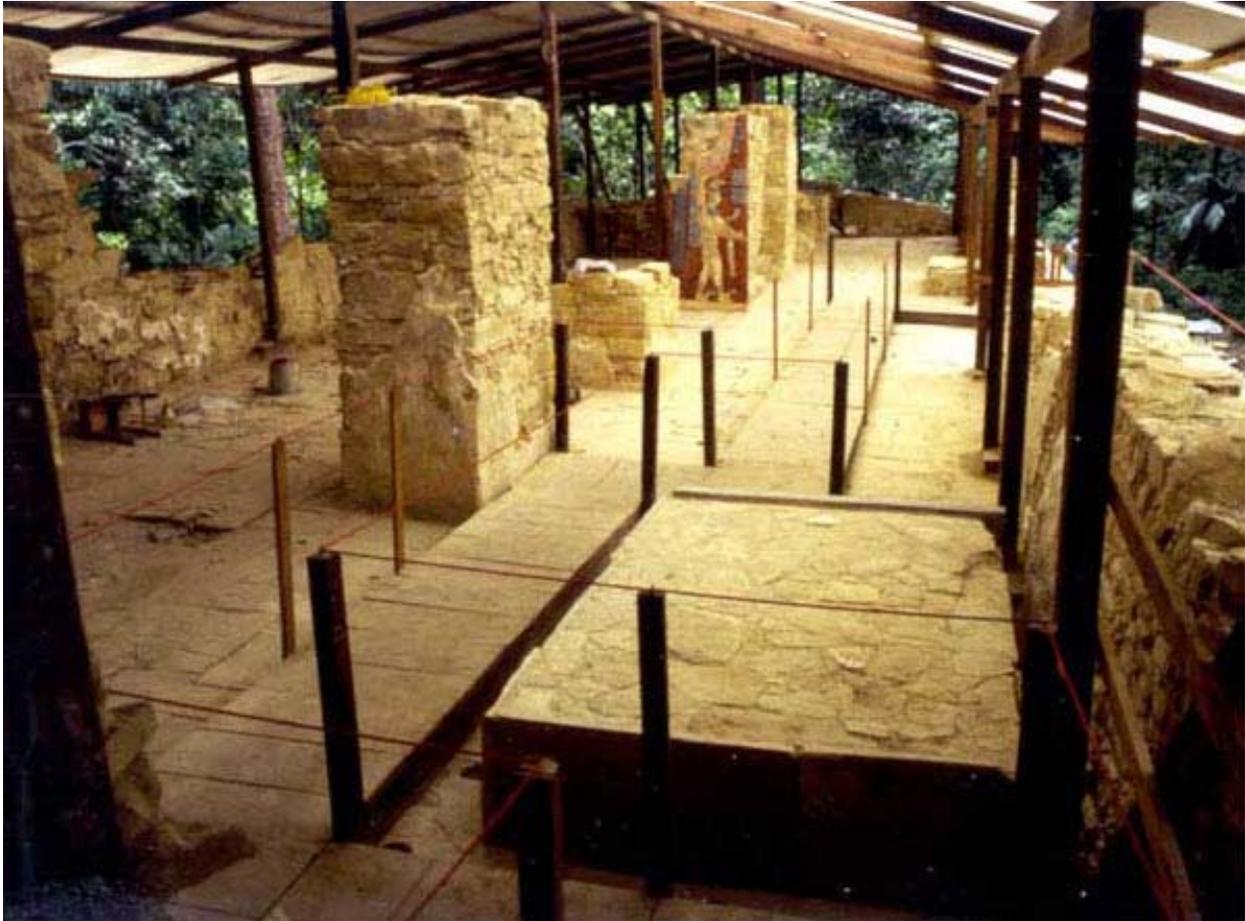
Photo 57. Palenque, Structure XIX after restoration was completed. There is a footpath for tourists and a protective roof. There are no side walls and therefore ventilation is constant, while the shade of trees helps to stabilize the interior temperature, July, 2000.

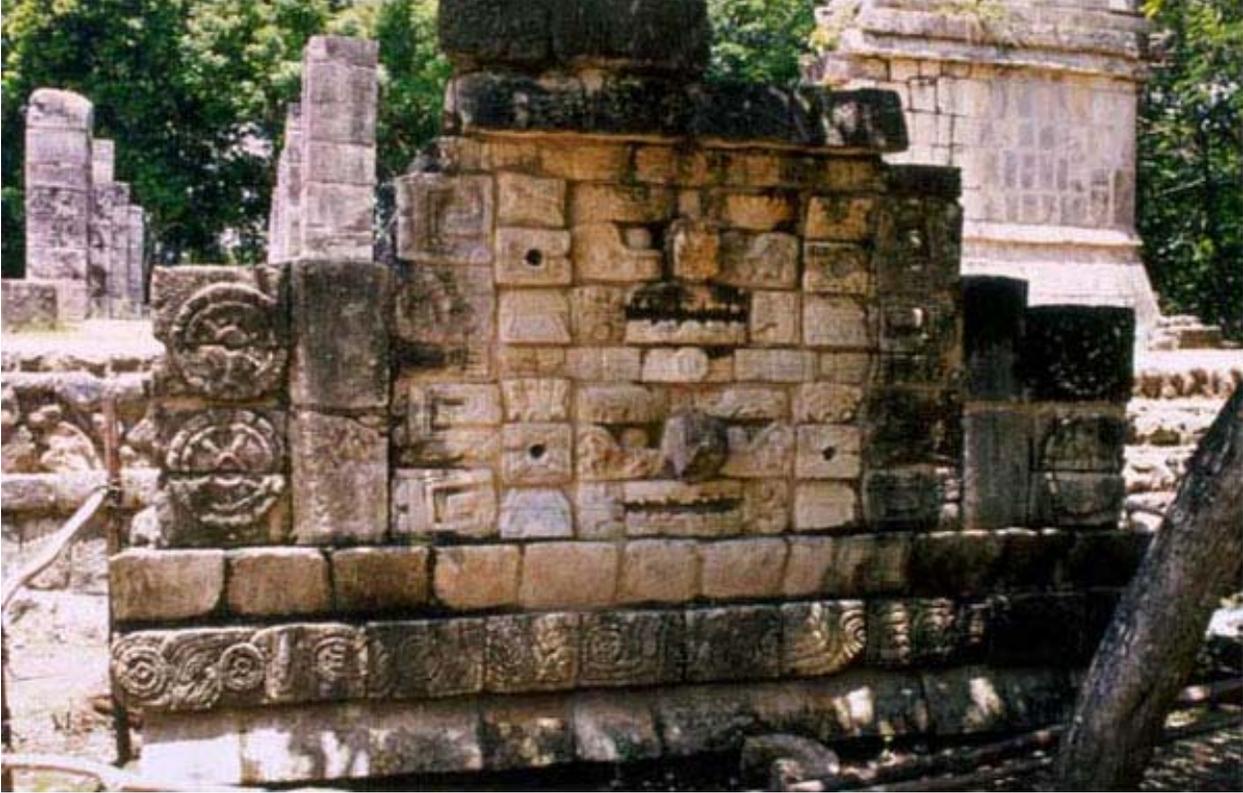
Photo 12. Chichén Itzá, NE colonnade. Repairs using anastylosis in adjacent space, July 31, 2000.

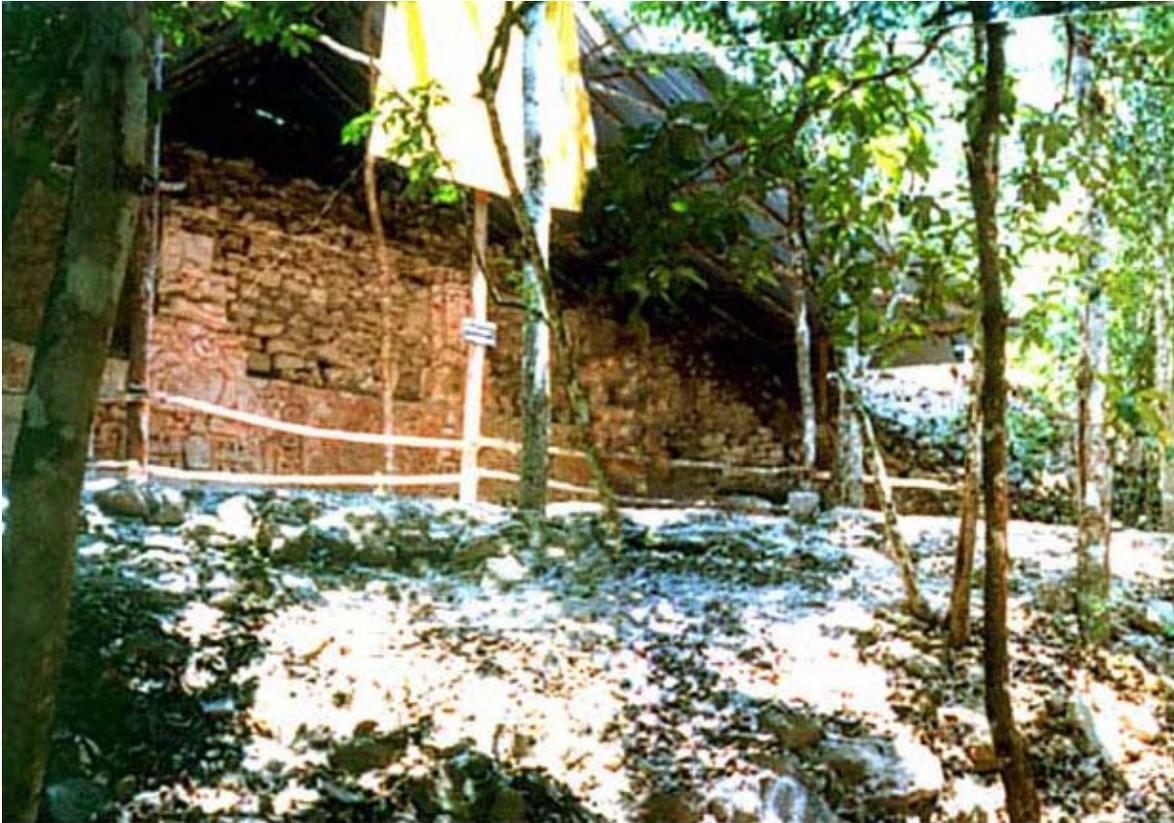
Photo 49. Balamkú, House of the Three Kings. March, 1993 (photograph courtesy of Graziela Sartori).

In this sense, we shall refer to the very interesting case of Balam Ku in the structure denominated Of the Four Kings (see [Photo 49](#) and [Photo 50](#)), because evidently, the intention to secure protection and conservation to the wonderful stucco frieze may be qualified as witty and effective. It serves its purpose by providing stuccoes with a quite stable climate and by protecting them from the wind, heat, cold, humidity, rain, etc. The photographs referred to, however, clearly show that much of that visible structure did not exist prior to 1993, as the stucco frieze was exposed for all to see, with a plated roof as a protecting means. I do not have an in-depth knowledge of the details of this work and I don't feel like judging or criticizing, though the presence of some degree of imagination is evident. I insist, however, that it represents an adequate and excellent solution as far as a conservationist objective is concerned, because it stabilizes the microenvironment of the object to be preserved.

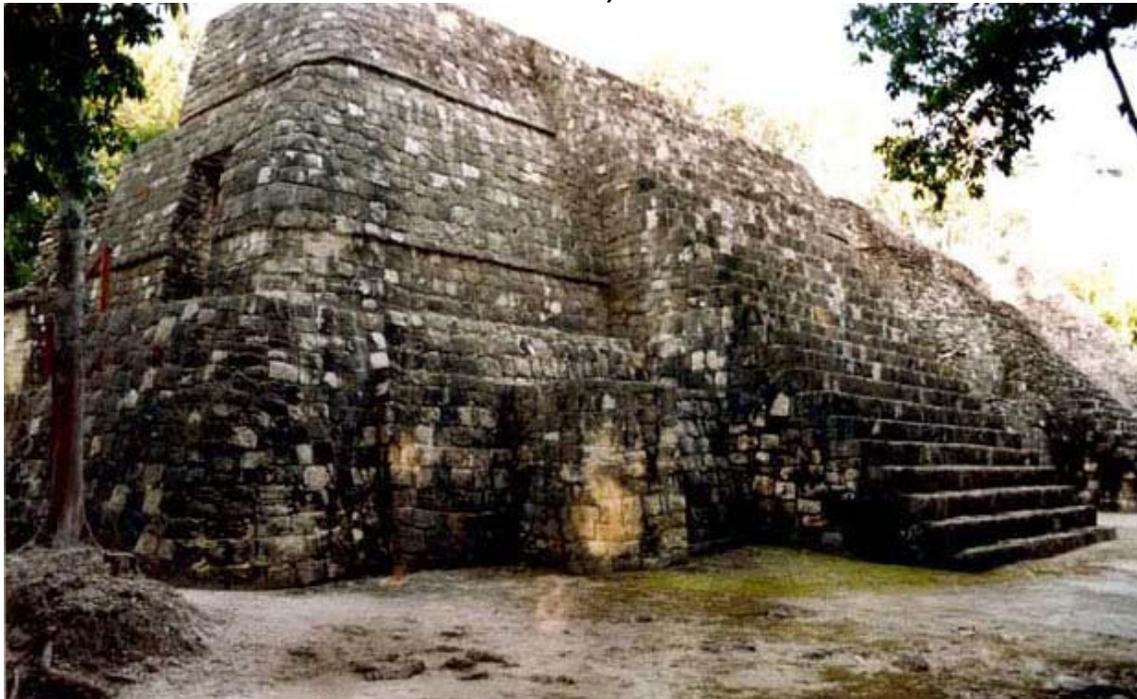
Photo 50. Balamkú, House of the Three Kings, following the protective reconstruction, February 18, 2000.

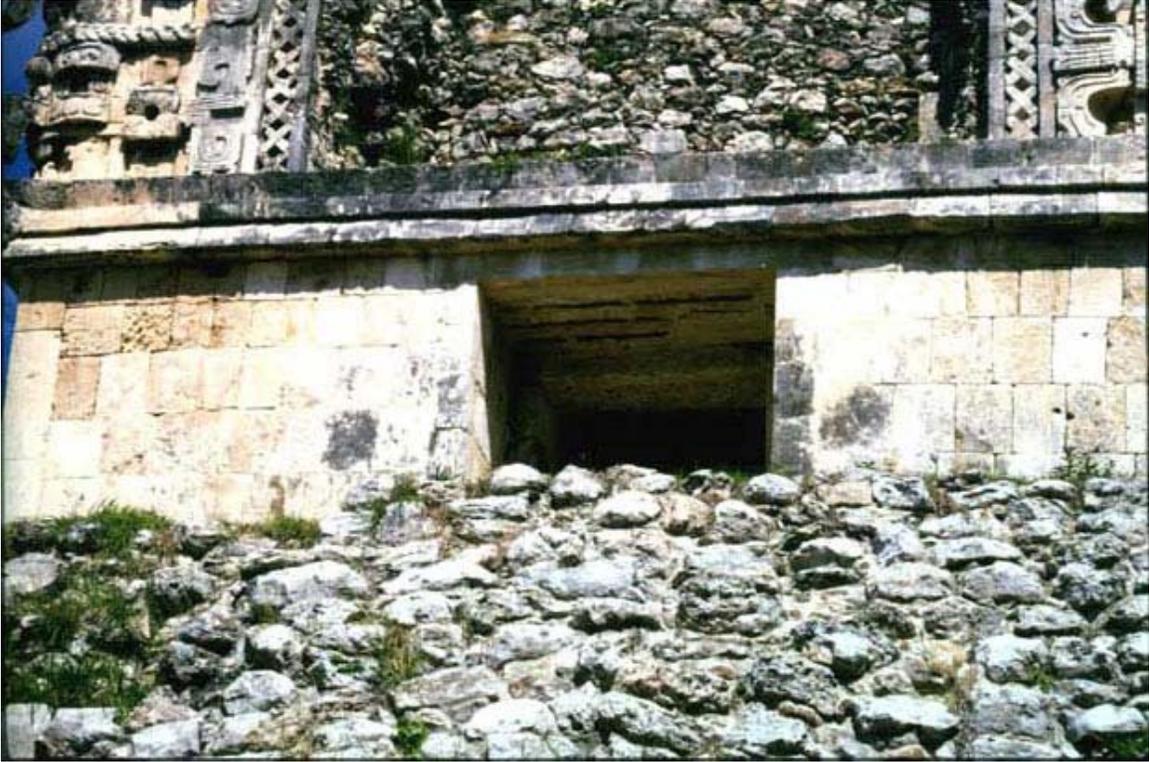
Photo 13. Uxmal, Quadrangle of Nuns. Deteriorated concrete lintel, July 28, 2000.

We should simply take a look at [Photo 13](#), [Photo 14](#), and [Photo 15](#). The first corresponds to Uxmal, with its rusted iron and concrete fault. The second corresponds to the main entrance to Tikal's Temple IV, with the concrete lintel that was placed during the National Tikal Project, one that now, less than 20 years later, has also failed. The third picture, taken personally by this author in Cahal Pech, Belize, 1992, shows the use of abundant iron bars in reconstruction works. Presently, the concrete and the iron are being removed from Uxmal to be replaced by wooden lintels similar to the original ones. I consider this an indispensable and appropriate initiative.

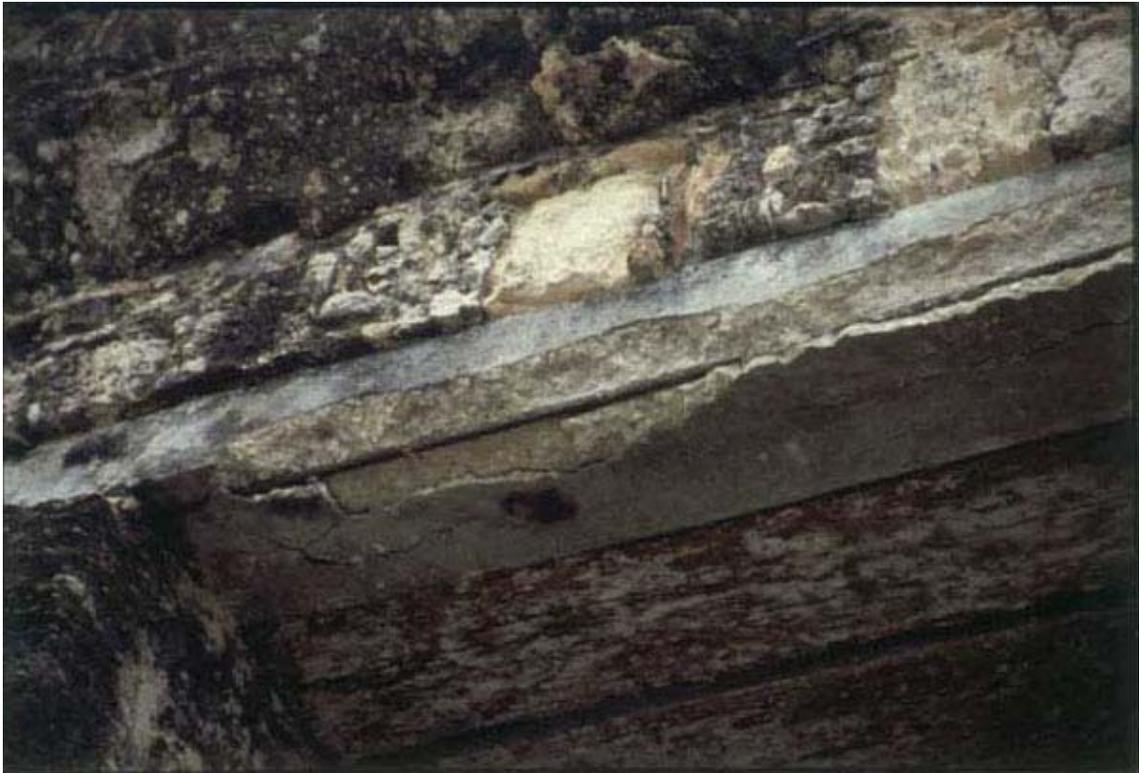
Photo 14. Tikal, Temple IV. Lintel with deteriorated concrete. May 22, 1991.
