FAMSI © 2005: Carlos Rudy Larios Villalta

Architectural Restoration Criteria in the Maya Area

Site: Maya Area

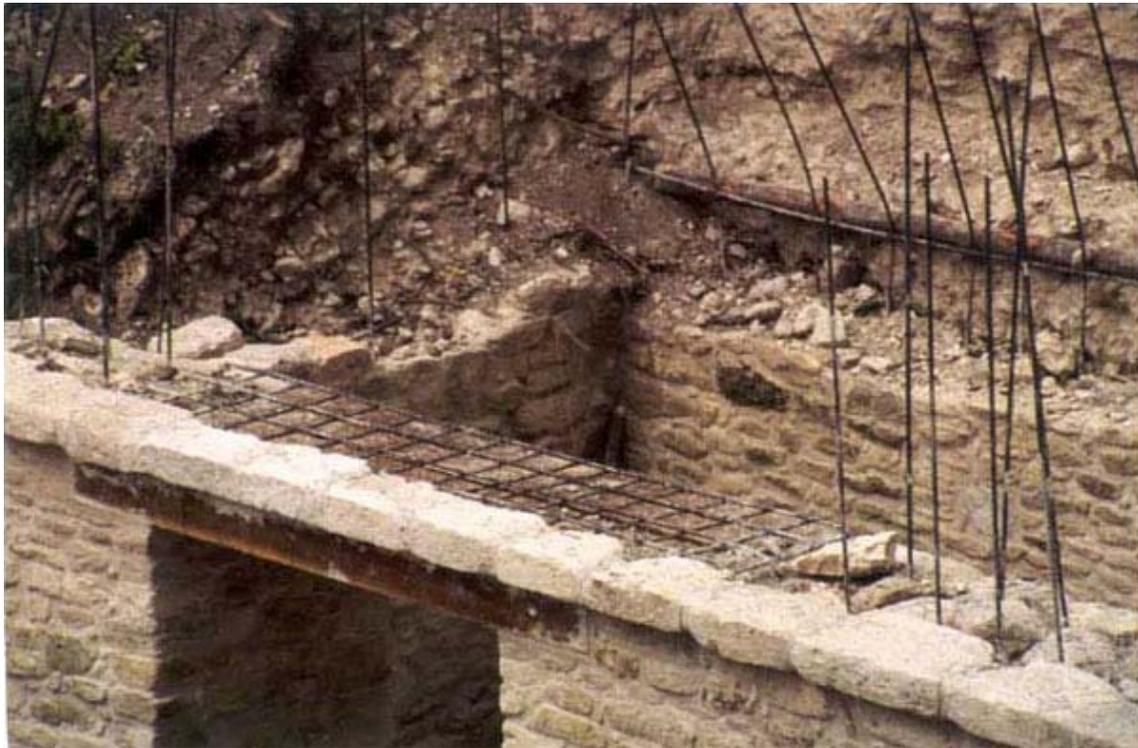
Photo 15. Cahal Pech, Structure 19 during reconstruction, using numerous iron bars, June 12, 1992.

We should simply take a look at [Photo 13](#), [Photo 14](#), and [Photo 15](#). The first corresponds to Uxmal, with its rusted iron and concrete fault. The second corresponds to the main entrance to Tikal's Temple IV, with the concrete lintel that was placed during the National Tikal Project, one that now, less than 20 years later, has also failed. The third picture, taken personally by this author in Cahal Pech, Belize, 1992, shows the use of abundant iron bars in reconstruction works. Presently, the concrete and the iron are being removed from Uxmal to be replaced by wooden lintels similar to the original ones. I consider this an indispensable and appropriate initiative.

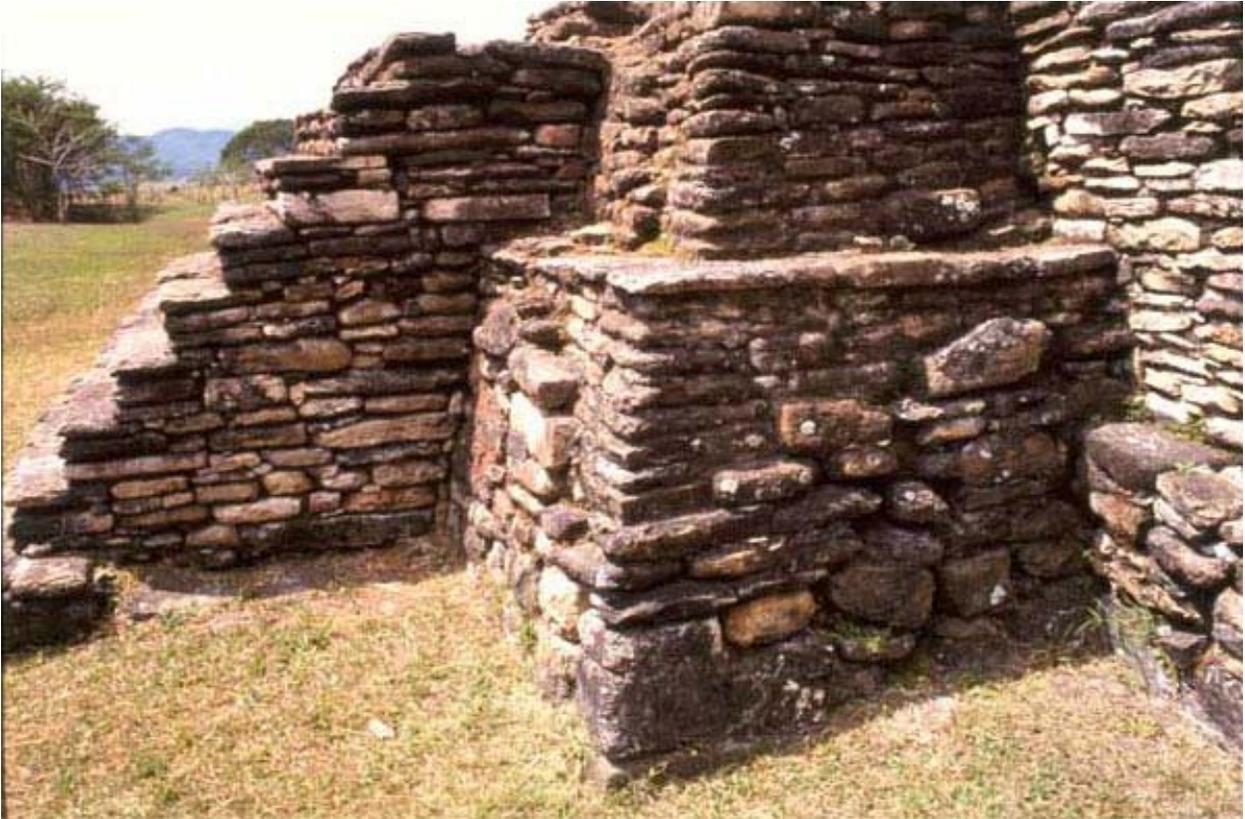
Photo 16. Toniná, small restored pyramid with insets as a mark of our time, March 4, 2000.

The system of inset faces consists in reconstructing as much as possible using the same original materials found during the excavations, but changing the position of the wall's surface, by making a slight inset within the original, as may be observed in the pictures from Toniná, Palenque, and Ek Balam: ([Photo 16](#), [Photo 17](#), [Photo 18](#), [Photo 19](#) and [Photo 20](#)). Occasionally, the surface of ashlar stones is also changed. If they were rectangular in shape and thin, they are made irregular and coarse; if they were coarse, the new ones are thin and rectangular.

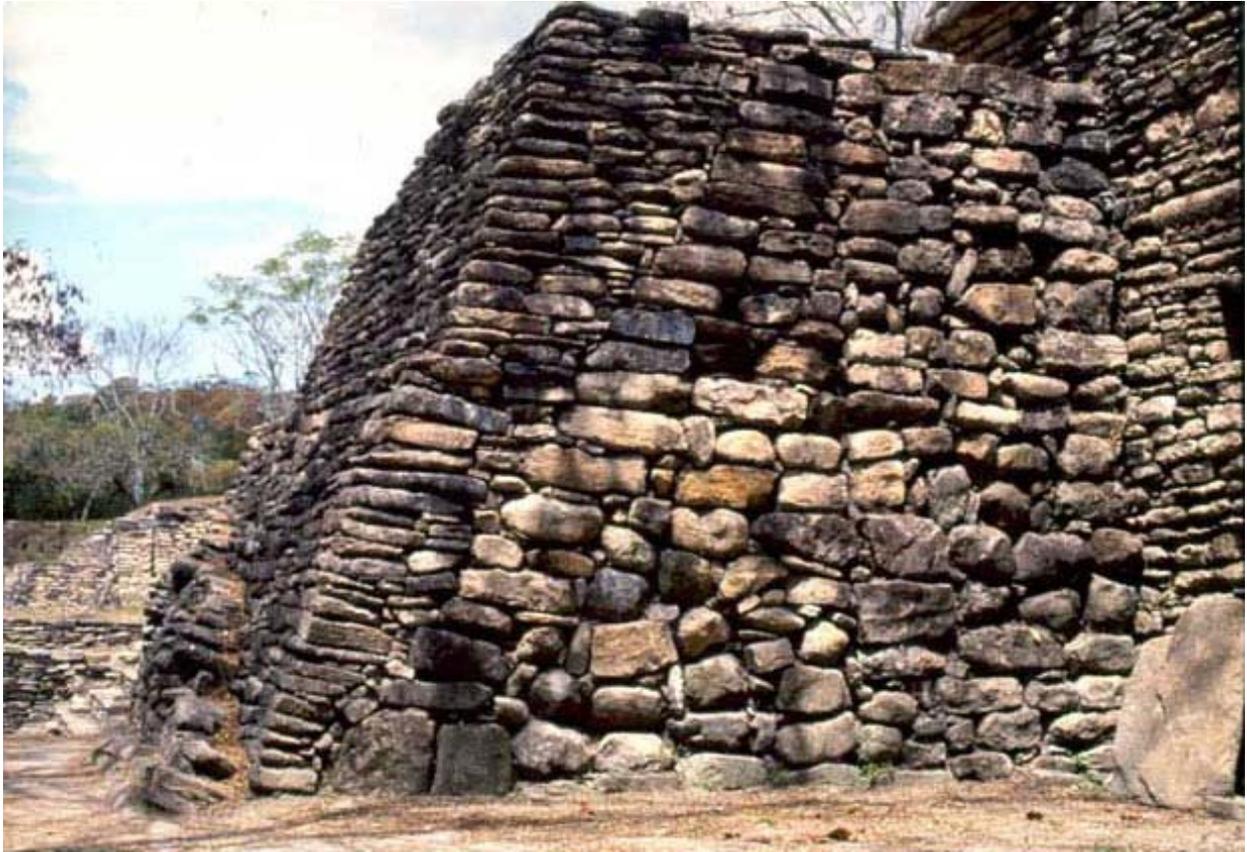
Photo 17. Toniná, an additional example of insets as a mark of our time, March 4, 2000.

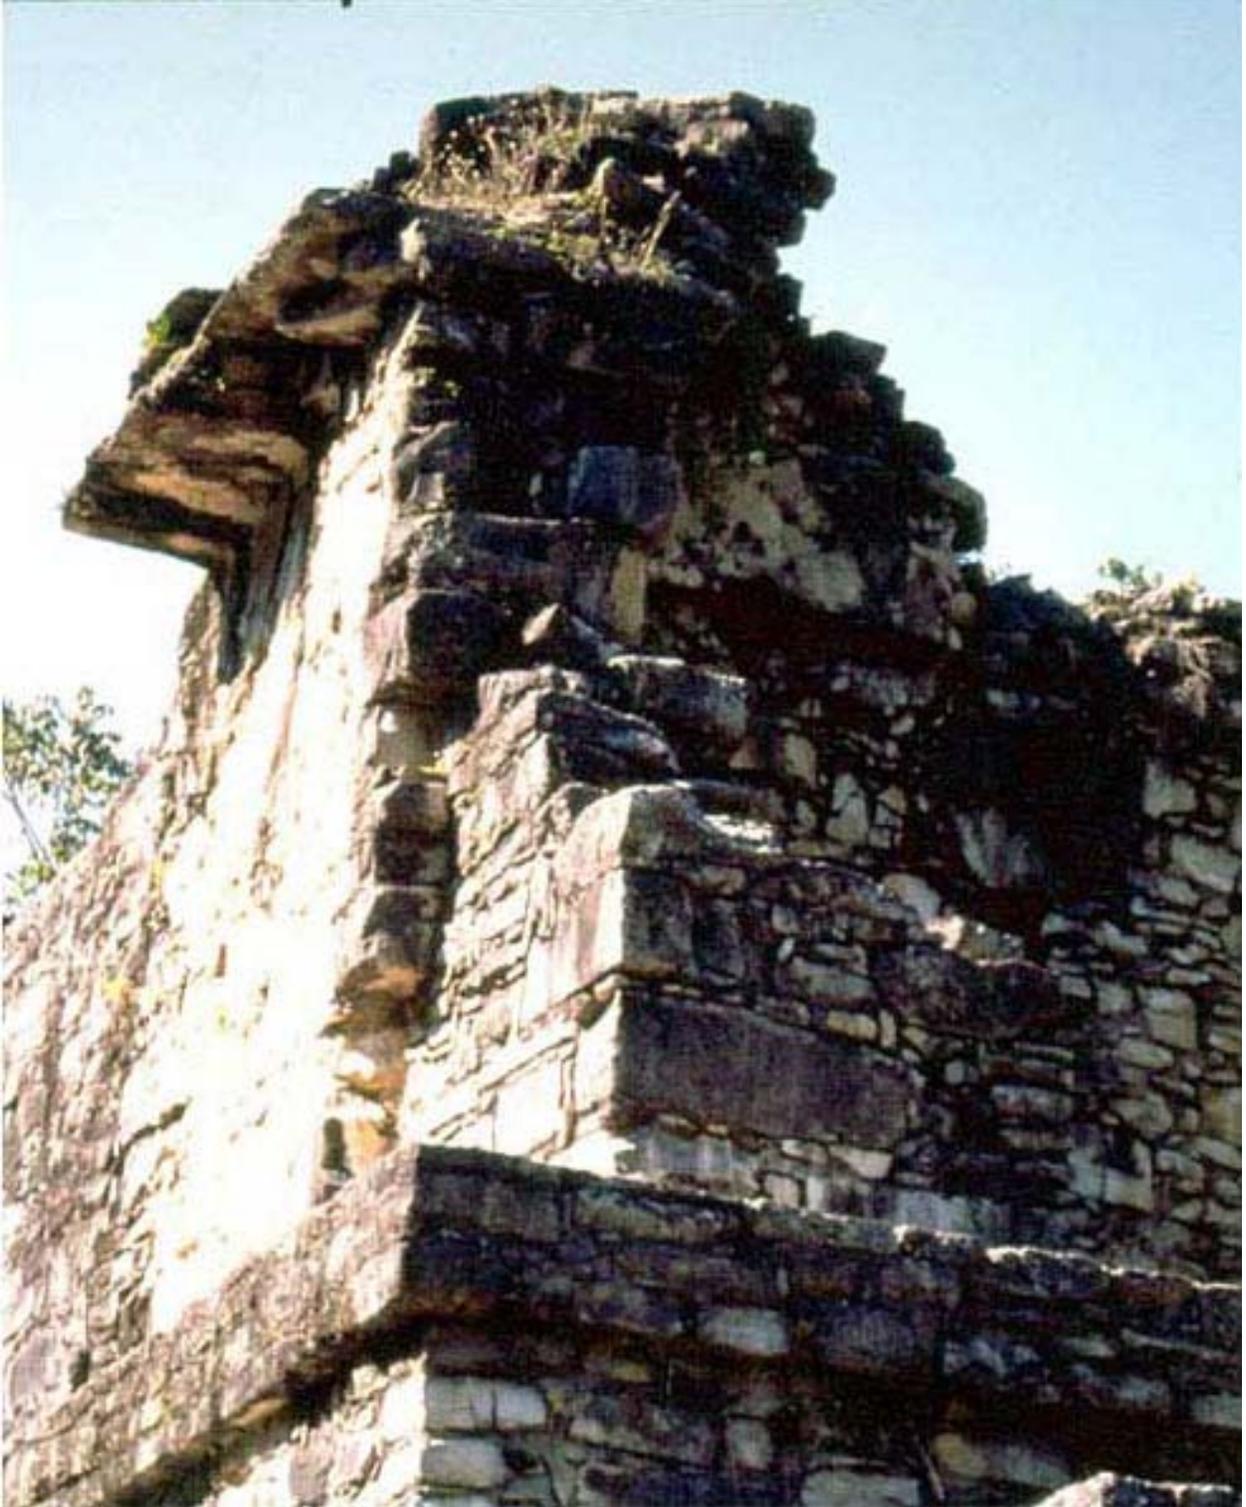
Photo 19. Palenque, Group of the Cross. Corner with insets, February 2, 2000.

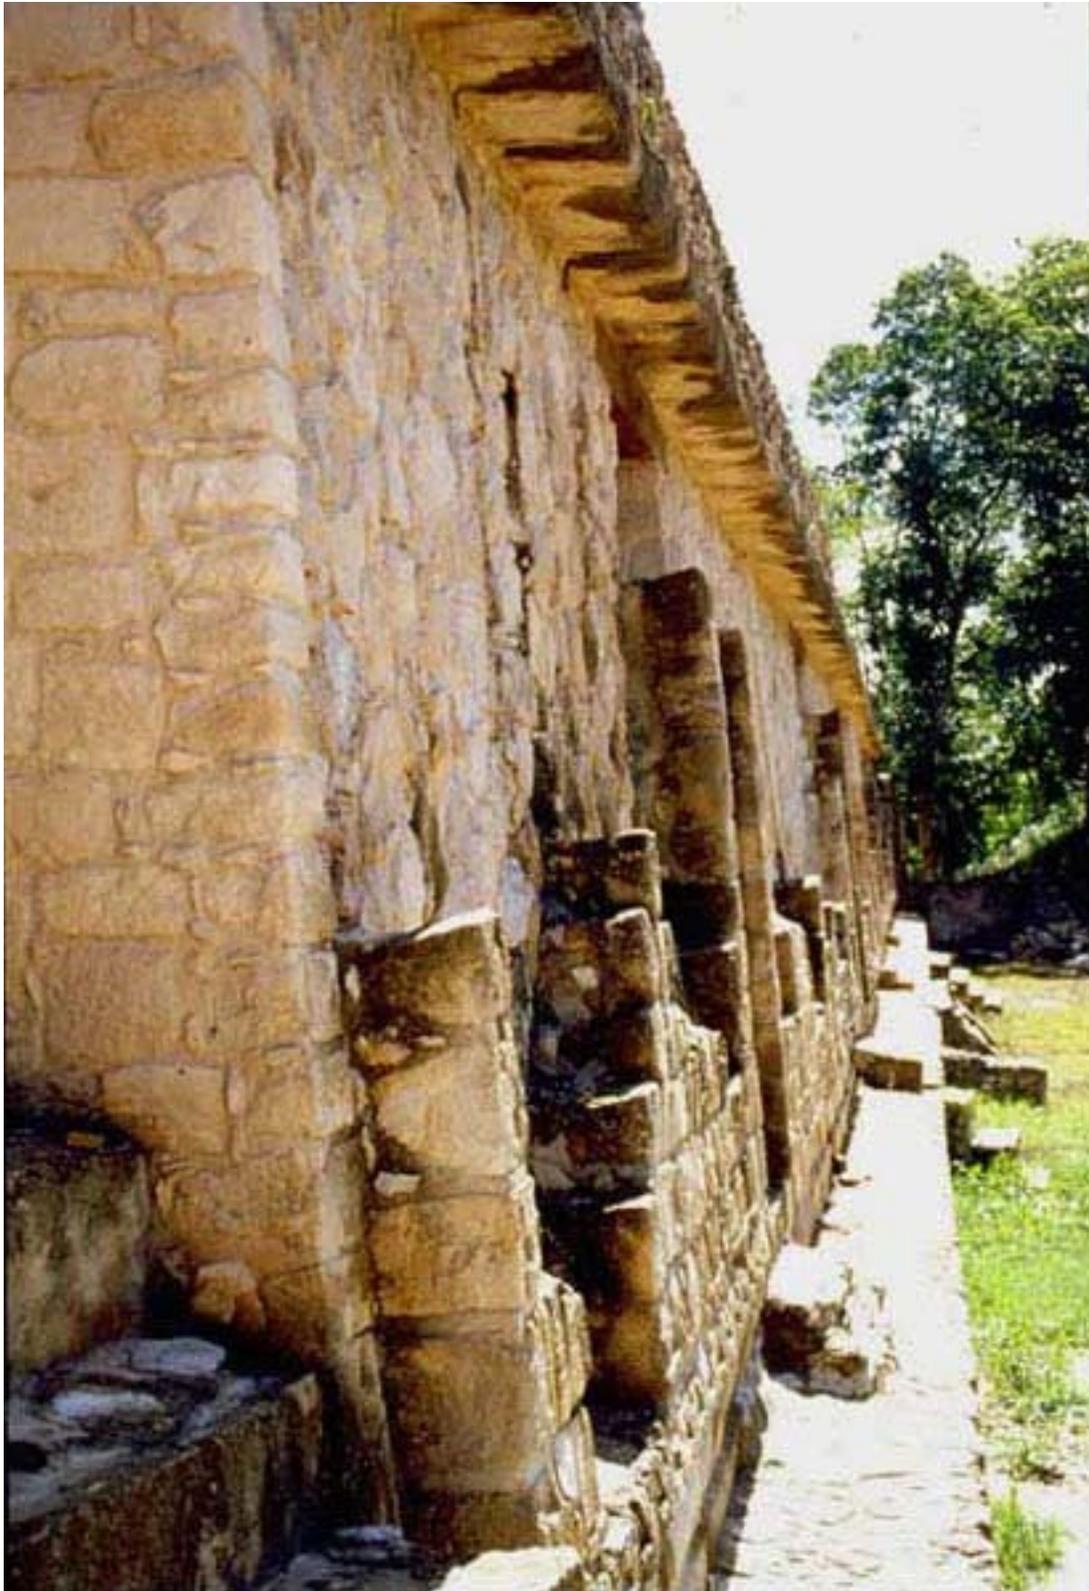
Photo 20. Ek Balam, Temple 1, detail of recessed reconstruction. August 8, 2000.

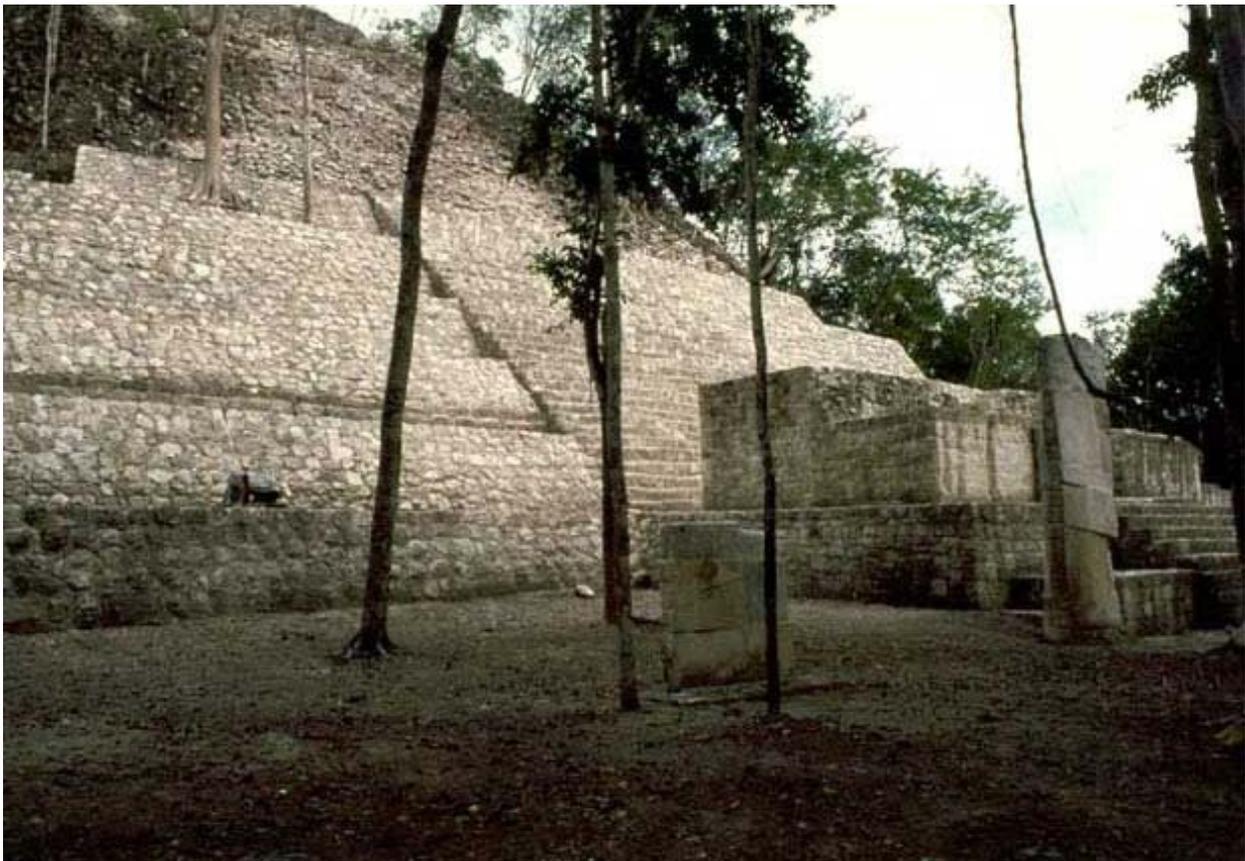
Photo 21. Calakmul, Structure 1, restitution of volumes as a part of the restoration process, July 25, 2000.

The main idea is to return or rebuild the lost volumes. This has been accomplished by reconstructing the missing parts with a changed texture and materials, to suggest the original shape, evident or by analogy. Occasionally, even the incline of the originals is modified, etc. A few examples may be observed in Calakmul, Campeche, México ([Photo 21](#) and [Photo 22](#)), and particularly in Yaxhá, Petén, Guatemala.

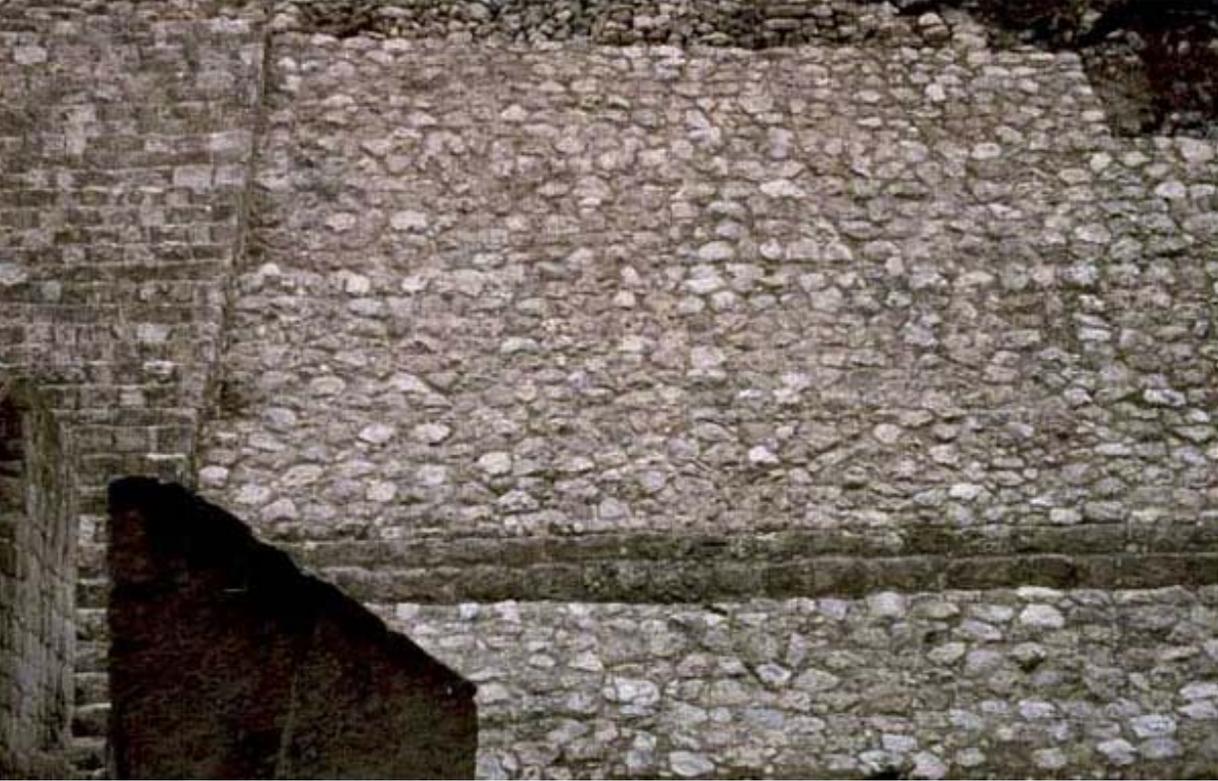
Photo 22. Calakmul, Structure 1, restitution of volumes and change of texture, detail, July 25, 2000.

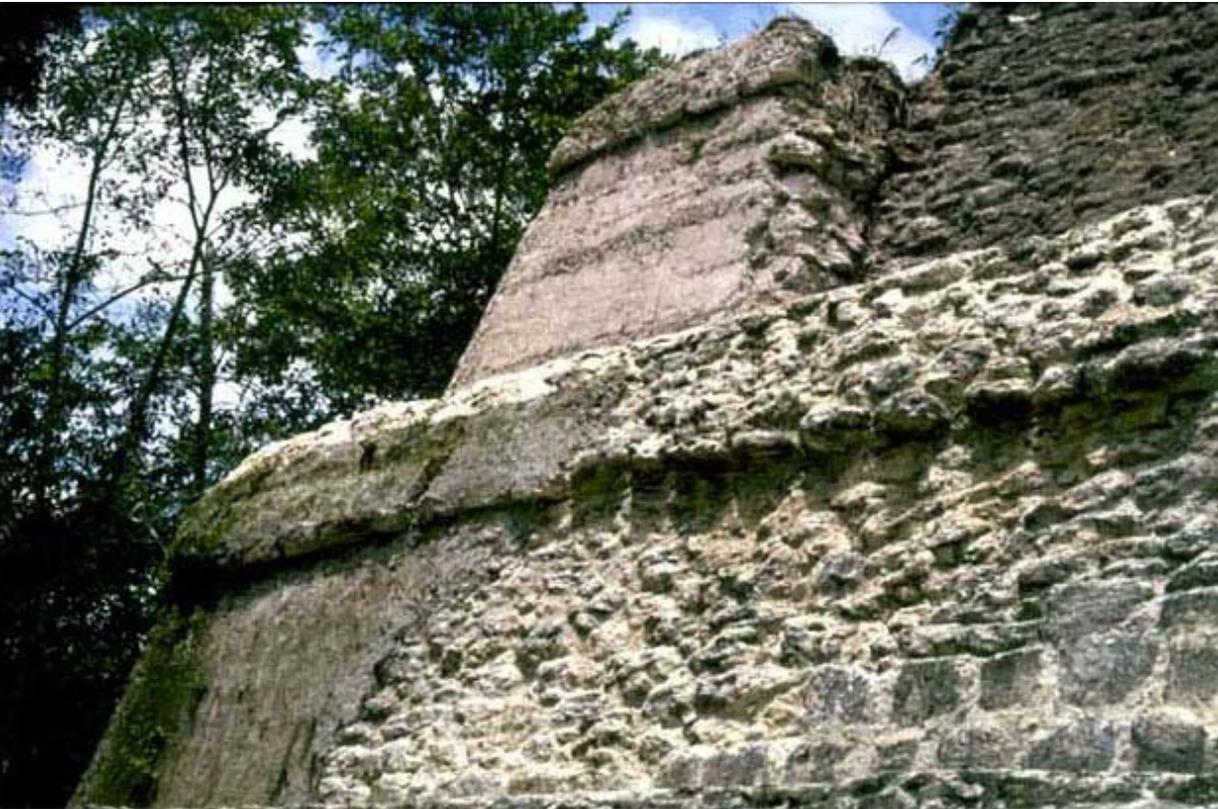
Photo 23. Yaxhá, Structure 216, restitution of volumes, change of materials. May 27, 2000.

The case of Yaxhá deserves our special attention: there, reconstruction was undertaken by using the earth of the ruin turned into mud with the addition of rustic stones. This material is placed to line damaged cores or refills by means of a small form, or board mould ([Photo 23](#), [Photo 24](#), and [Photo 25](#)), as if it were a melting. According to the statements by Oscar Quintana, Project Director (personal communication, December 2000), it is some sort of experimental sacrificial layer, which in spite of changing the color, the texture and the materials, and rebuilding the missing portions with a degree of imagination, may later be eliminated or changed at will.

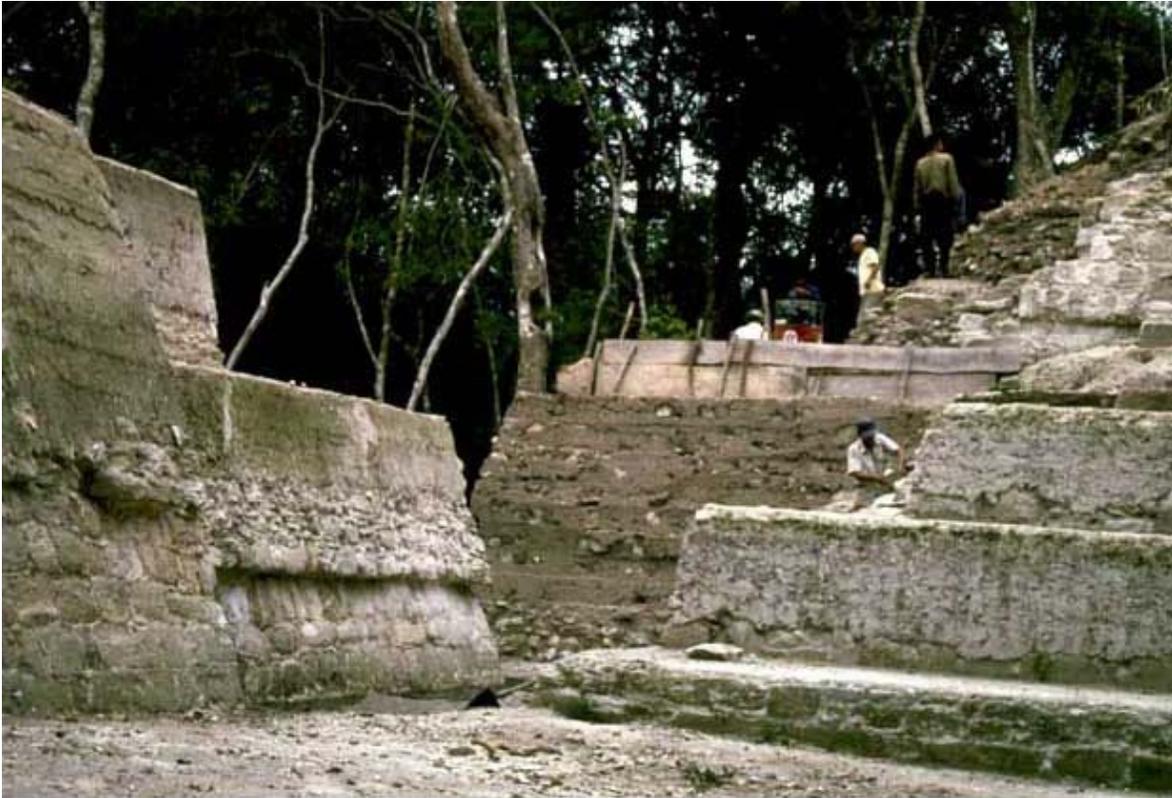
Photo 24. Yaxhá, northern area. Experimental restitution of volumes with mud and stones, May 27, 2000.

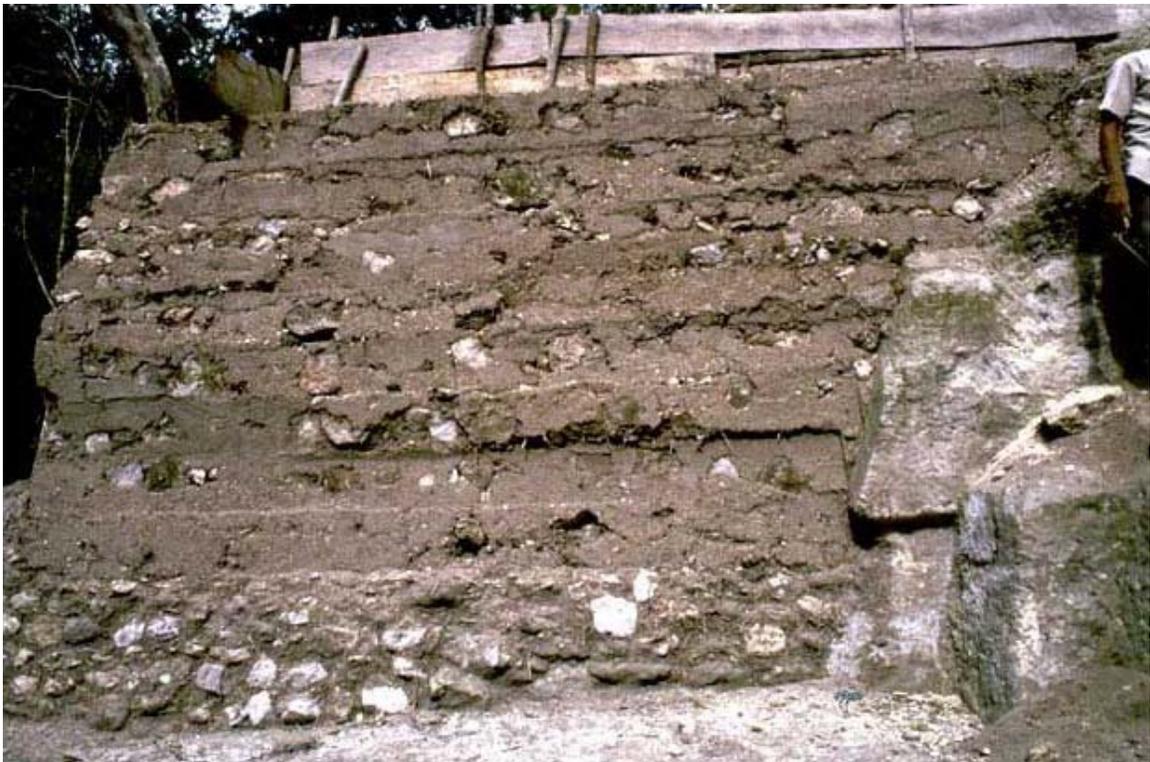
Photo 25. Yaxhá, detail of experimental restitution of volumes with mud and stones, May 27, 2000.

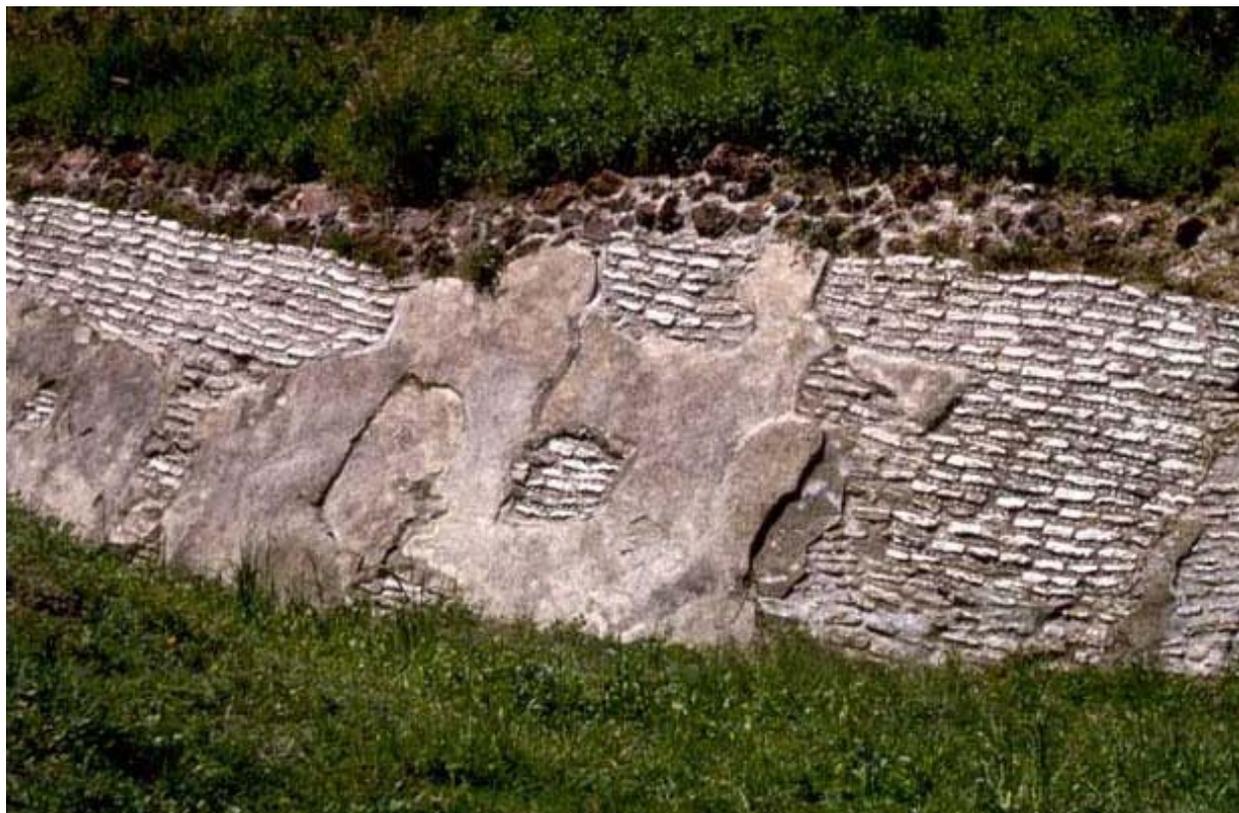
Photo 26. Cholula, restoration with the use of small stones in the joints to show the reintegrated portions, July 16, 2000.

The small stones embedded in the ashlar stone joints of the restored walls, have been used in different ways. At some sites of the Mexican plateau, the mark has been common in the entire integrated part, and therefore, it makes it easy to distinguish the new work. In [Photo 26](#), from Cholula, Puebla, México, it is possible to observe something of what we have said.

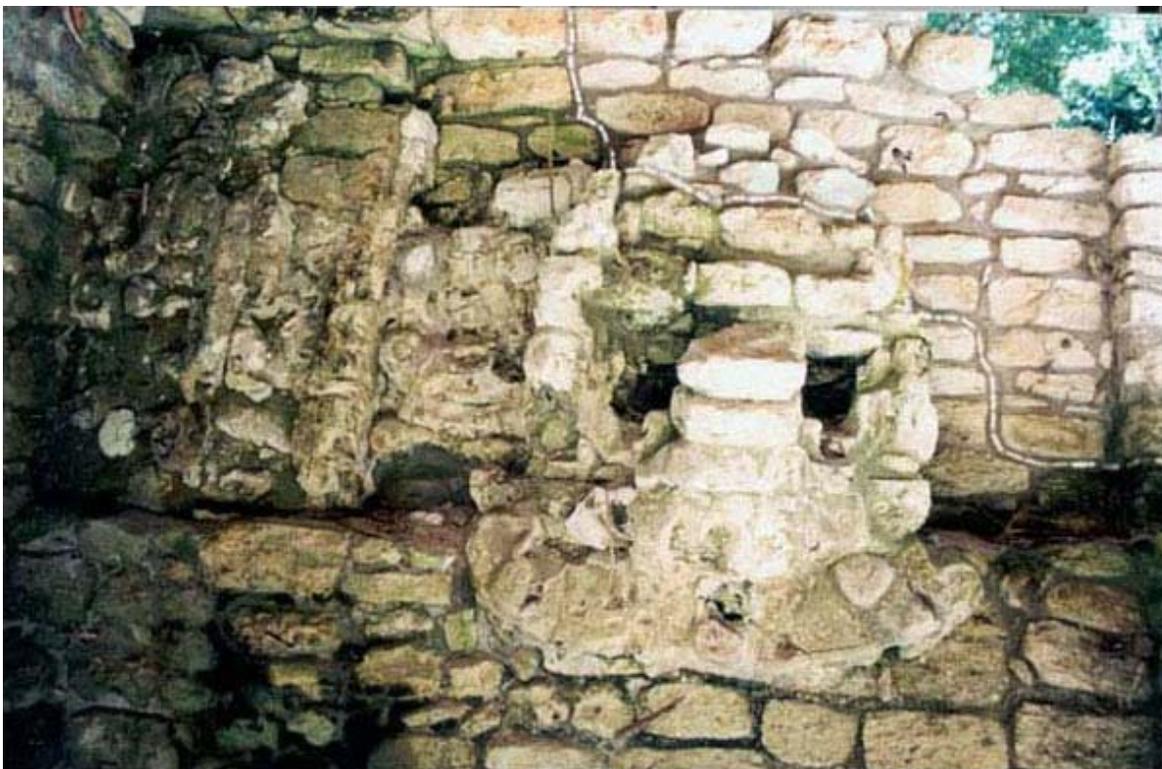
Photo 27. Tzibanché, mask, thin flagstones in a continued line showing complementation, February 19, 2000.

Elsewhere, in places like Balamkú and Kohunlich, thin flagstones have been used, a work consisting in putting in place small cracked and relatively polished stones, which as a thin serpent, draw the limit between what was found *in situ* and the integrated parts ([Photo 27](#) and [Photo 28](#)). In ashlar stones with rectangular cuts and a carefully laid lining, the examples observed in Ek Balam are of interest. There, two different techniques were used to define the integrated parts: insets in the grand façade of the main palace with a full reconstruction, to which we have already referred to ([Photo 18](#)), and something very special: a line defined by means of partially empty joints that draw, without a doubt, the limit within the original and the integration ([Photo 29](#)). This final technique has also been used at Kohunlich.

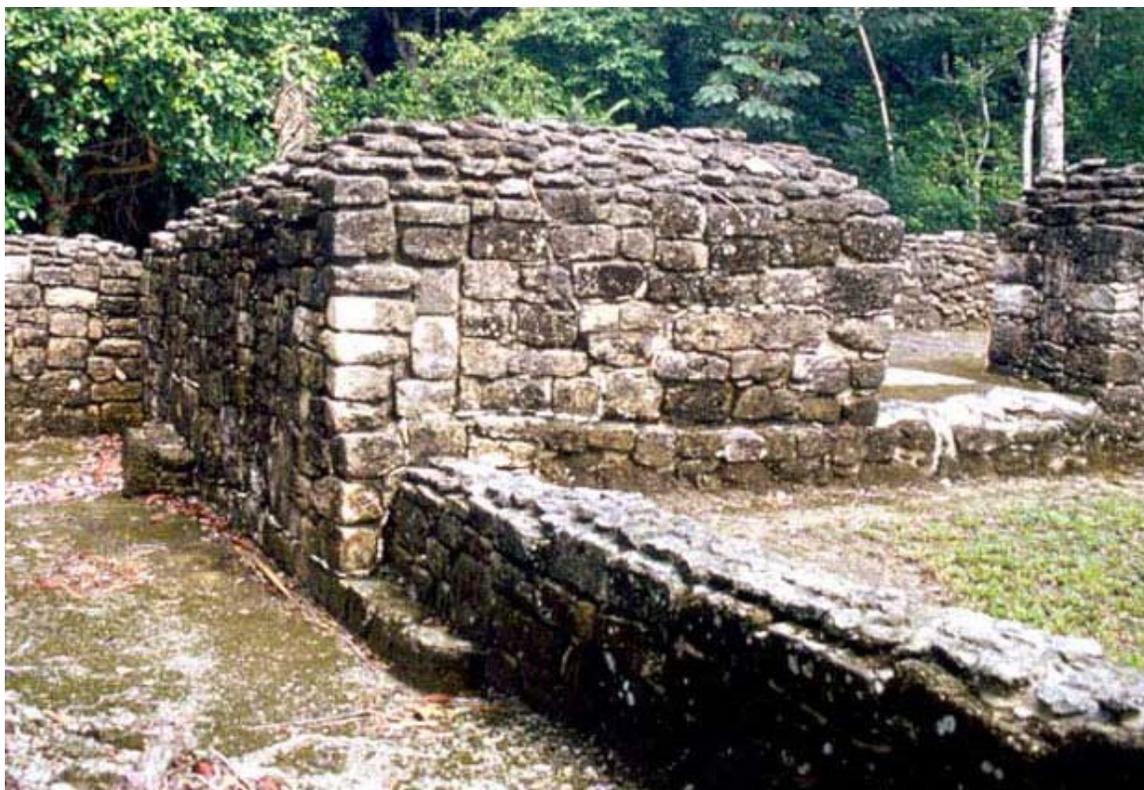
Photo 28. Kohulich, thin flagstones in a continued line showing complementation, August 4, 2000.

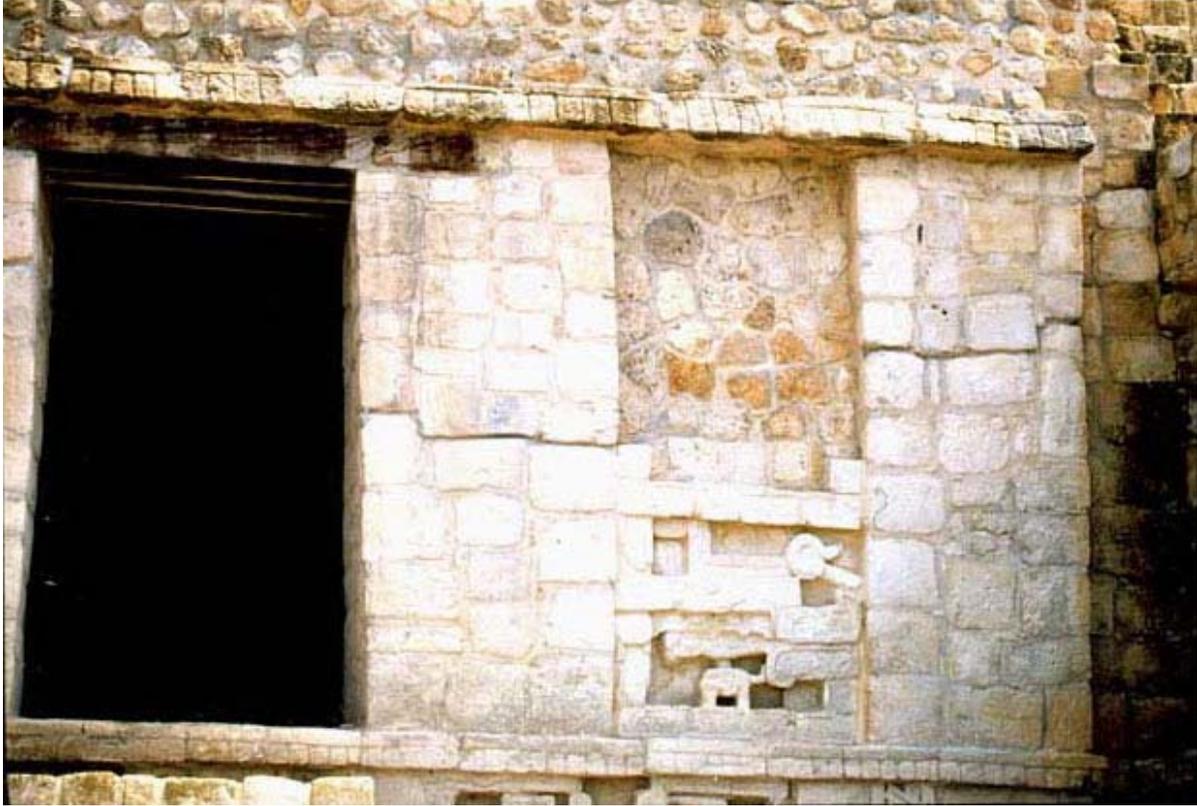
Photo 29. Ek Balam, Temple 1, detail of partially empty joints to divide the integrated parts from the original ones, August 1, 2000.

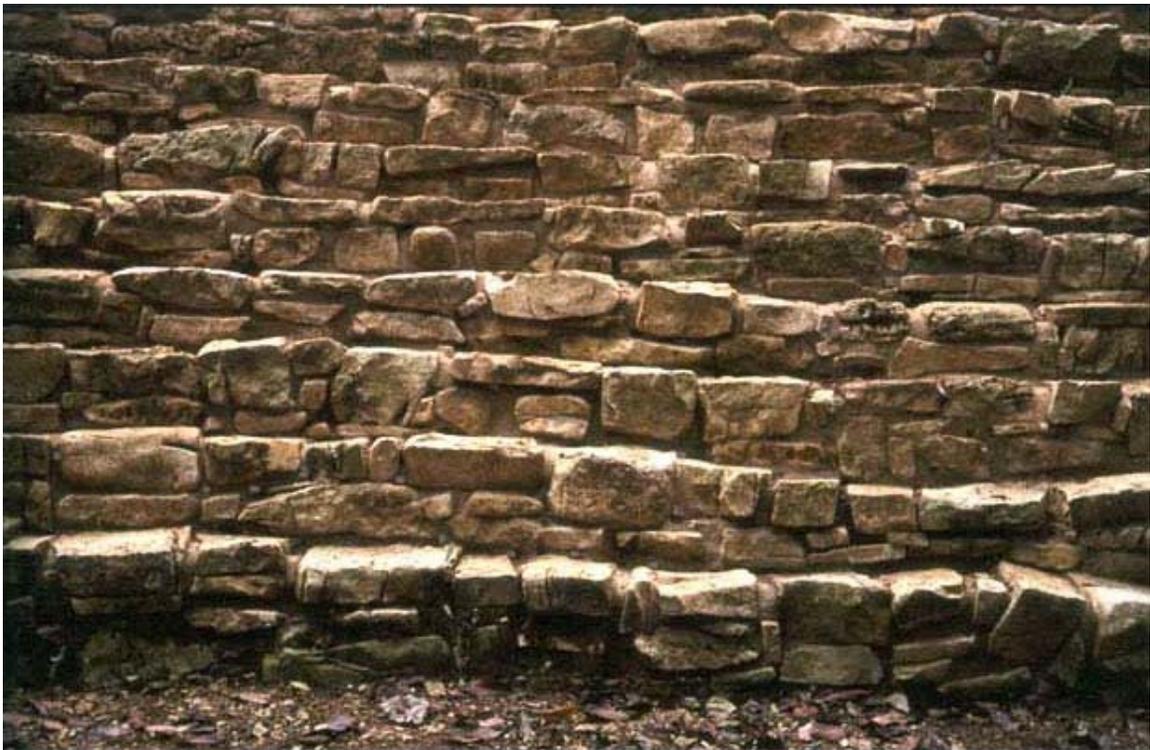
Photo 30. Palenque, Structure XIX, a portion of the restored main stairs, signalled with rectangular stones, March 20, 2000.

At Palenque, México, where I have been acting as an advisor for the restoration of Structure XIX (1999-2000), the idea of modifying the nails system or unrustable clamps and thin flagstones emerged, for considering that metals, notwithstanding they are a clear modern evidence, tend to contrast remarkably on close examination. For that reason, with a special machine, we cut rectangular fractions of a very dark-gray stone, with a cross section of approximately 1 cm x 2.5 cm and a length of 6-8 cm. In the same way than at Copán or El Pilar, these rectangular stones separate the integrated parts by forming a dotted line with a separation of 10 cm to 15 cm ([Photo 30](#) and [Photo 31](#)).

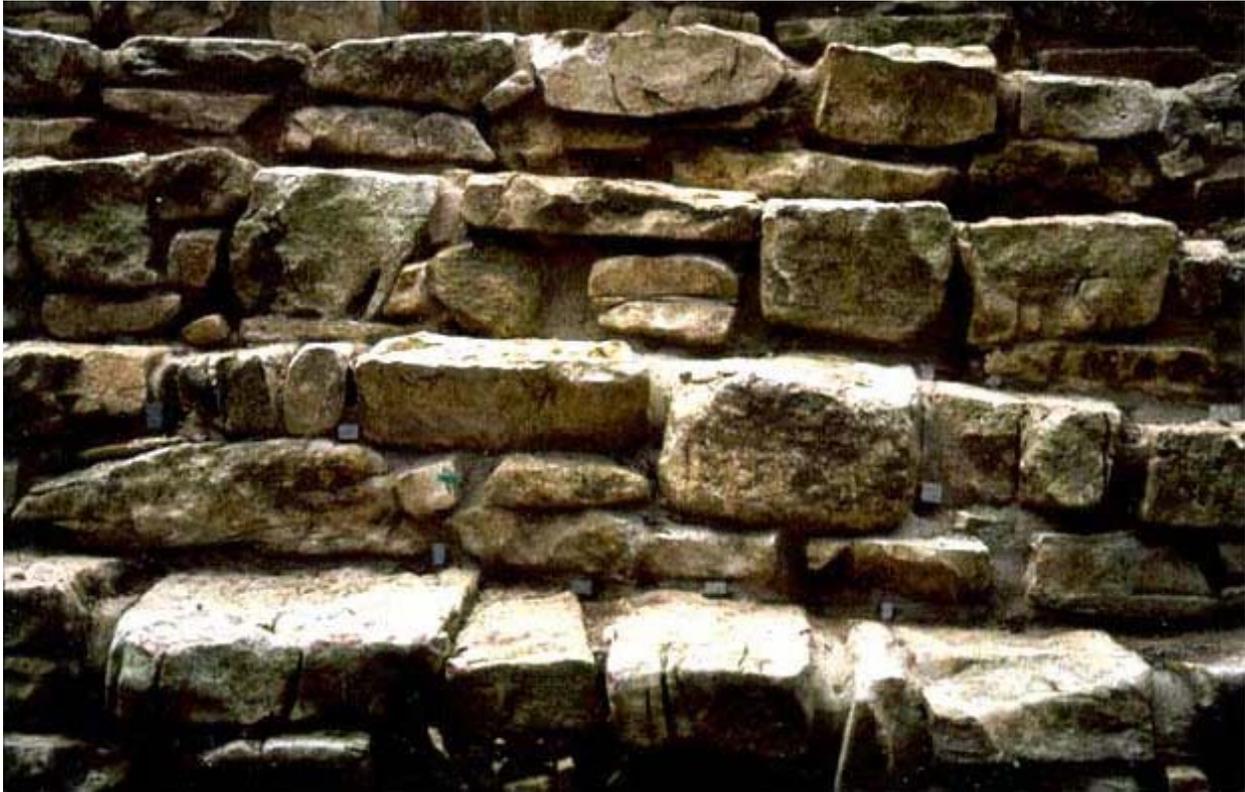
Photo 31. Palenque, Structure XIX, detail of integrated steps marked with rectangular stones in a dotted line, March 20, 2000.

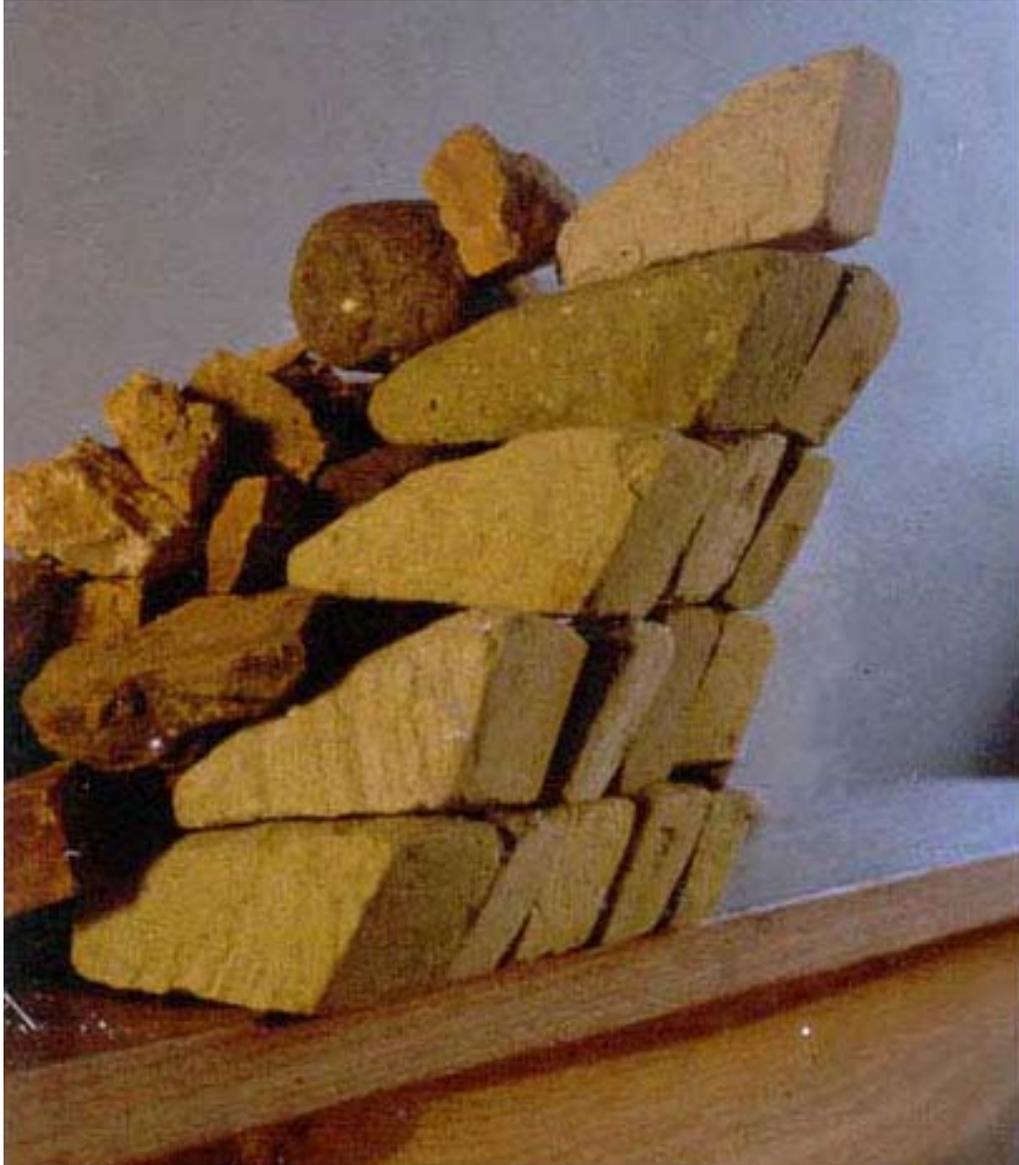
Photo 52. Copán, experiment: scale construction of dry laid vault, October, 1986.

As an extreme example, let me show you [Photo 52](#), above, an experimental arrangement of scale-cut stones, on which no agglutinant or mortar has been used. Stones were organized merely with small wedges until the desired balance was achieved, and there are five courses one on top of the other breaking the vertical position, imitating a portion of the Maya vault (Copán, October 1986).

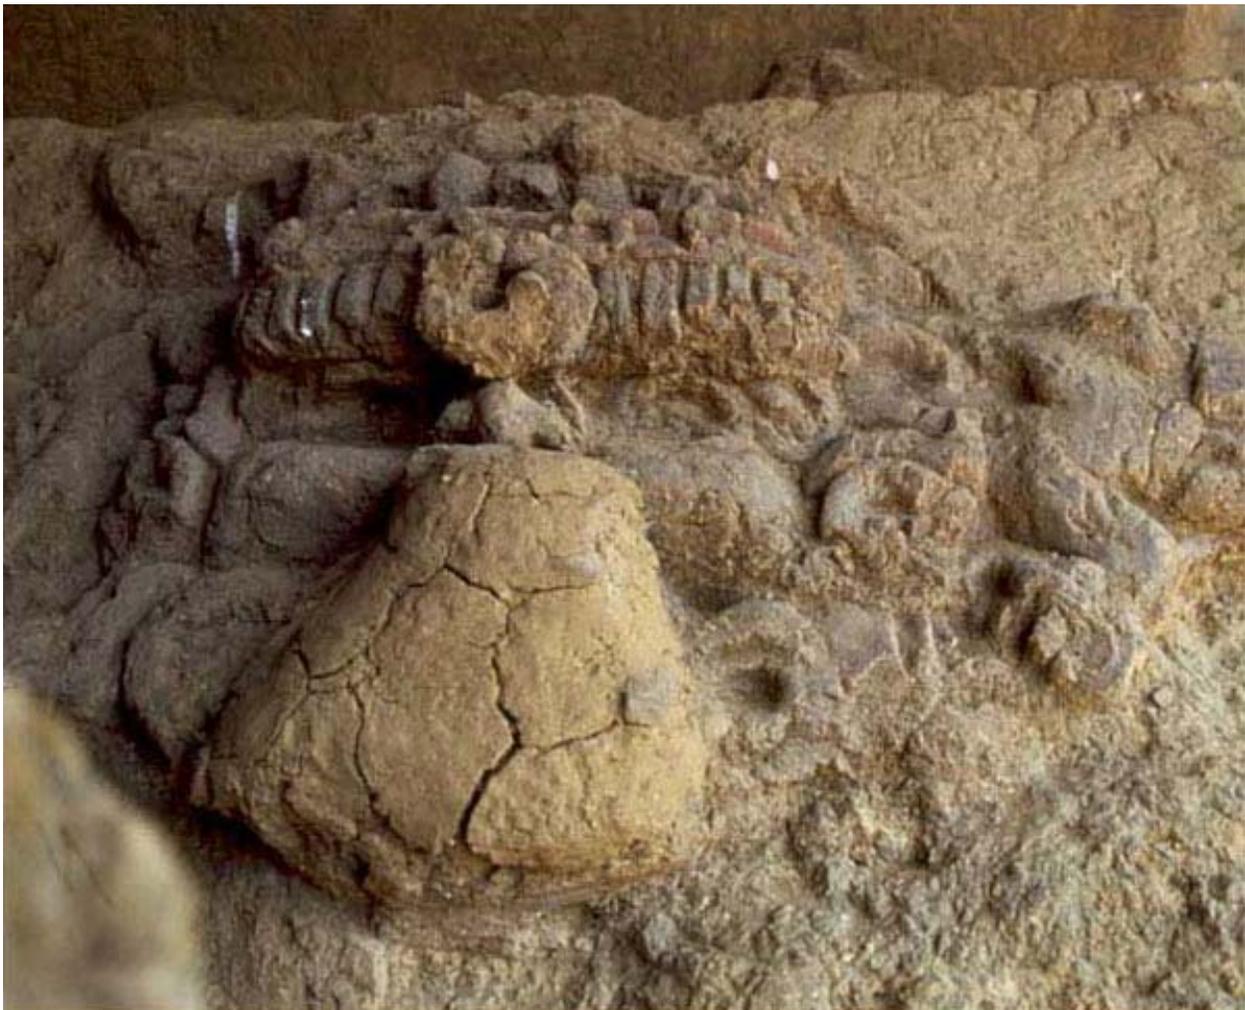
Photo 35. Kaminaljuyú, Structure DIII-1, the same clay mask shown in Photo 32, when repair was attempted, November 14, 2000.

The problem I detected during my last visit, which took place in November 2000, was not related to the quality of the roof, which had performed effectively, even though it was in a deplorable condition. The masks modelled as a part of architecture have deteriorated for human causes and the complete absence of expert assistance. In [Photo 35](#), below, we can observe the attempts made to repair one of them, which, according to the vigilant, was damaged during the 1976 earthquake. It is also evident that whoever did this did not have a clue on how to do it right, and lacked any artistic ability. Compare with [Photo 32](#), 1963.

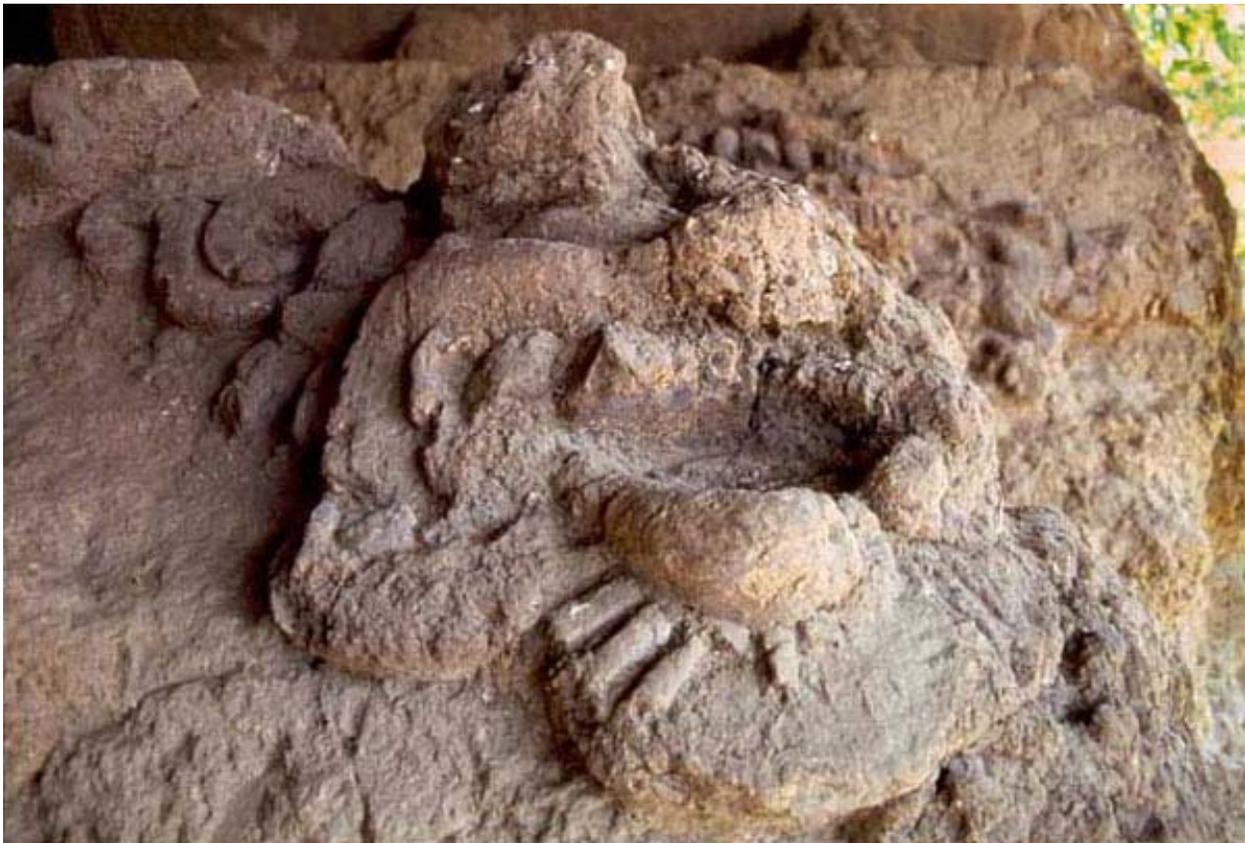
Photo 36. Kaminaljuyú, Structure DIII-1, remains of a clay and talpetate modelled mask, not easily accessible to visitors, November 14, 2000.

The characters seen in [Photo 33](#) and [Photo 34](#), as also other modelled elements, of which I have no illustrations at hand, are completely gone due to human factors we shall not discuss at this time. However, it is evident that the mask fraction which is not so easily reachable by people ([Photo 36](#)) still shows a good state of preservation ([Photo 37](#), and [Photo 38](#)). In this case, the roof proved effective and has accomplished its protecting mission.
