FAMSI © 2005: Carlos Rudy Larios Villalta

Architectural Restoration Criteria in the Maya Area

Site: Maya Area

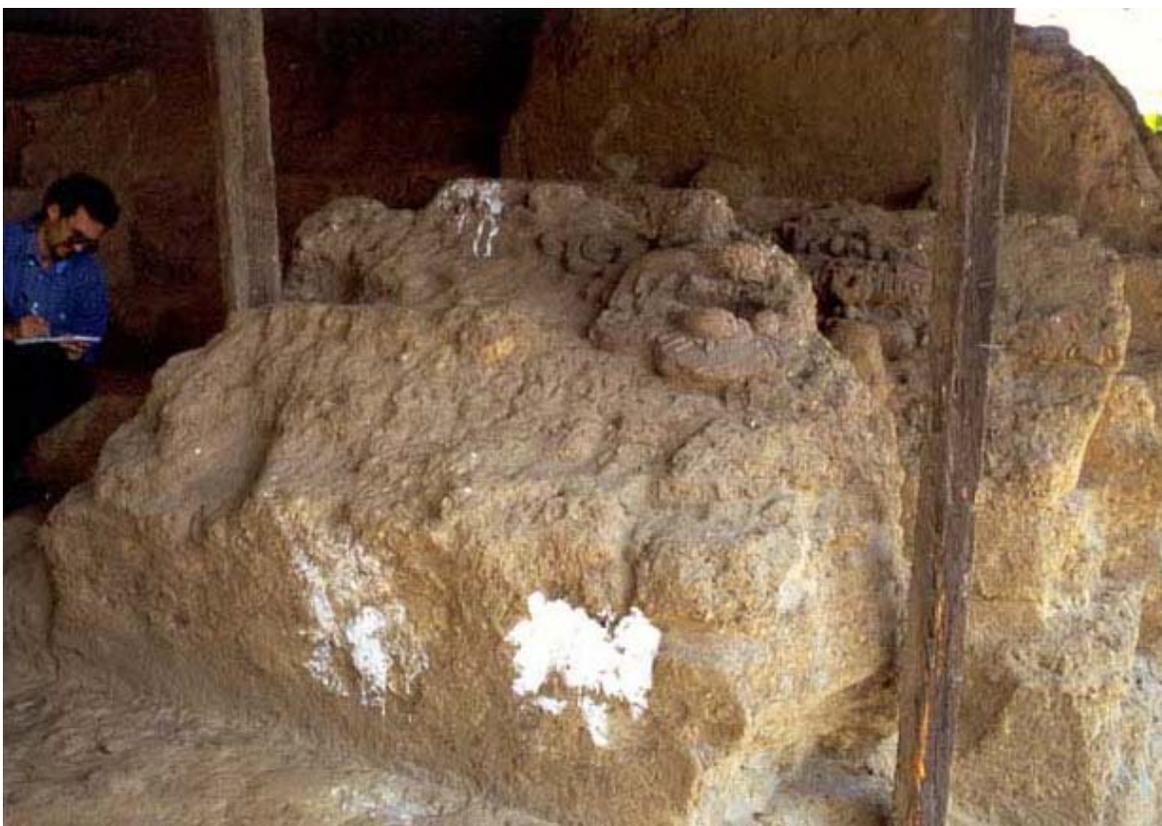
Photo 37. Kaminaljuyú, Structure DIII-1, portion of mask and overview of the building, November 14, 2000.

The characters seen in [Photo 33](#) and [Photo 34](#), as also other modelled elements, of which I have no illustrations at hand, are completely gone due to human factors we shall not discuss at this time. However, it is evident that the mask fraction which is not so easily reachable by people ([Photo 36](#)) still shows a good state of preservation ([Photo 37](#), and [Photo 38](#)). In this case, the roof proved effective and has accomplished its protecting mission.

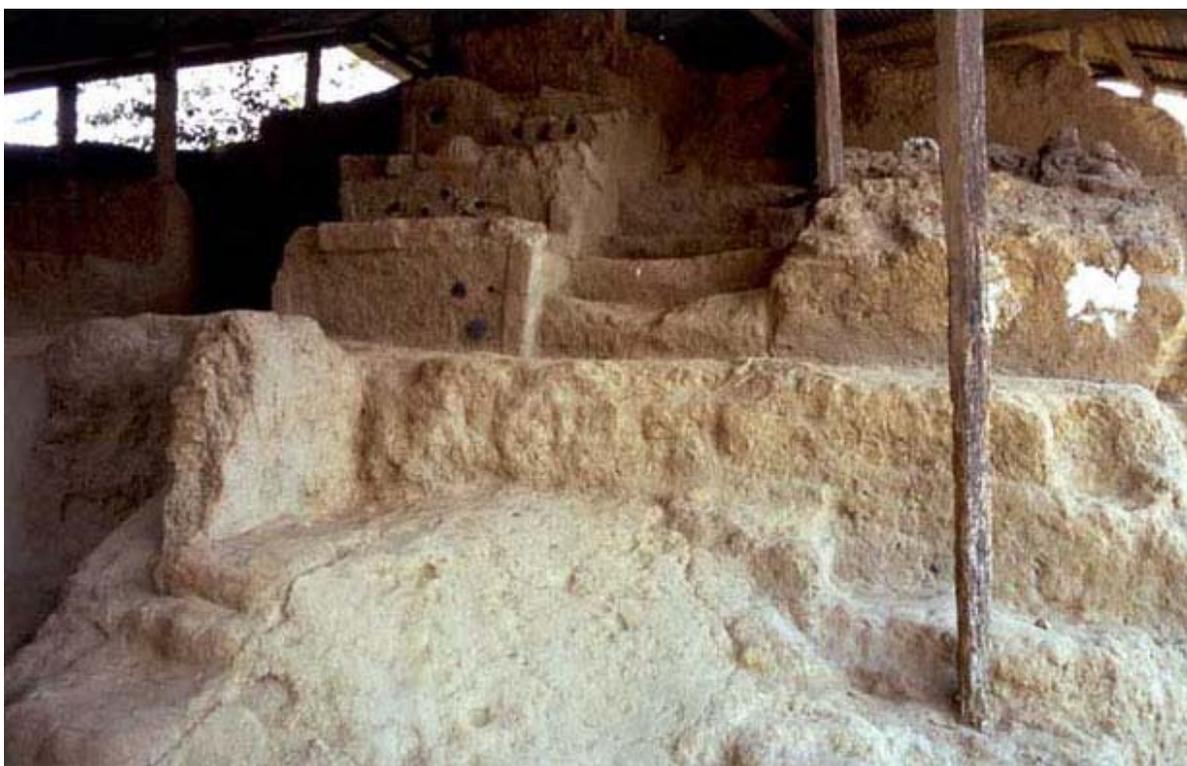
Photo 38. Kaminaljuyú, Structure DIII-1, general view of the masks area, November 14, 2000.

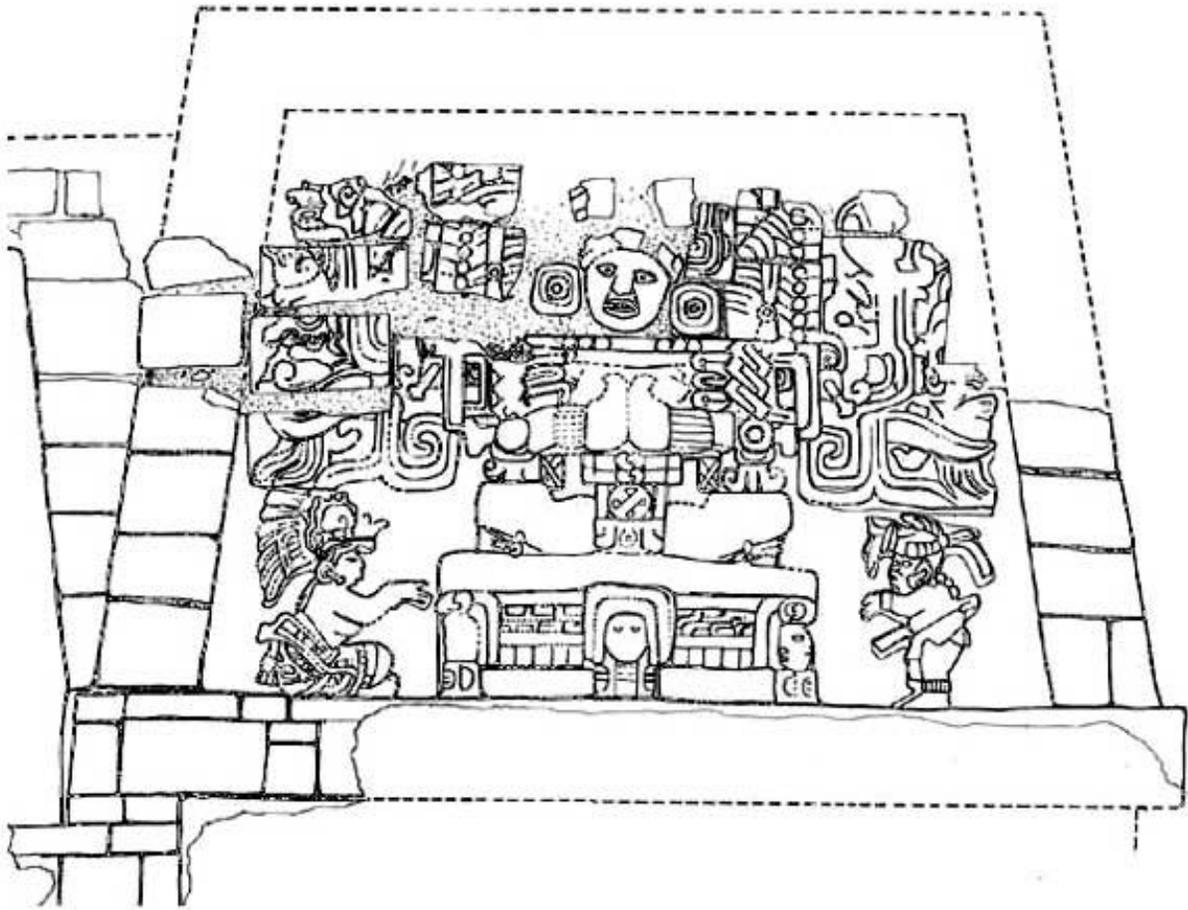
Figure 3. Drawing of frieze in Structure 5D-44, Tikal. This is a stuccoed sculpture which has been covered for conservation purposes.

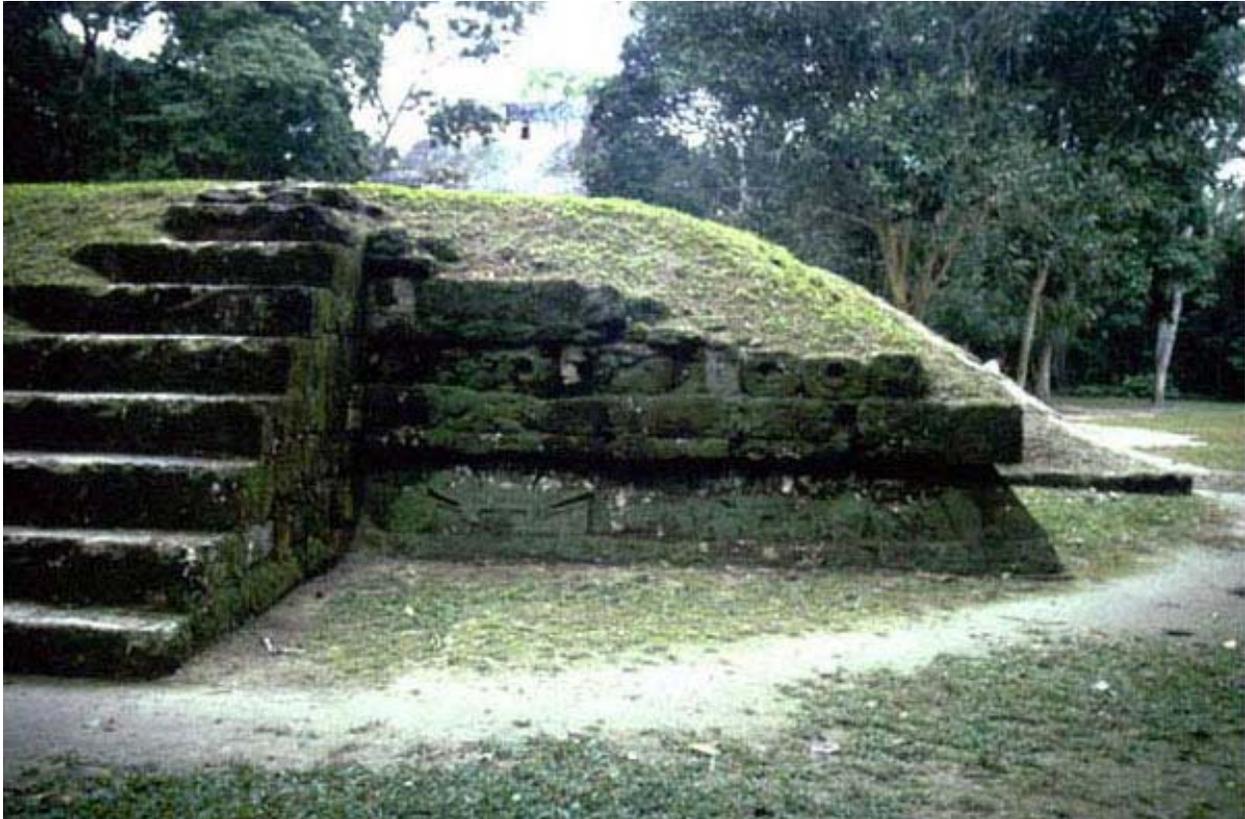
Photo 41. Tikal, Structure 5C-53, portion of south façade, very damp. December 12, 2000.

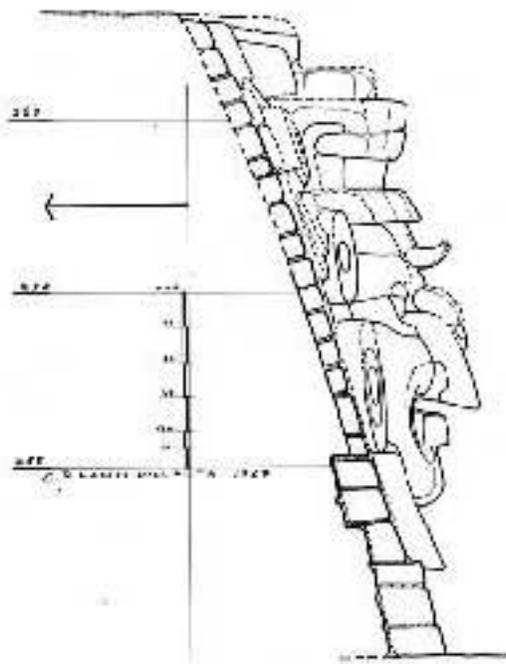
Figure 4. Structure 5D-33-2nd, Tikal. Drawing in profile of mask located at the west side of the stairs, 1967. Note the volume and the well defined lines immediately after its liberation. Drawing by Rudy Larios.

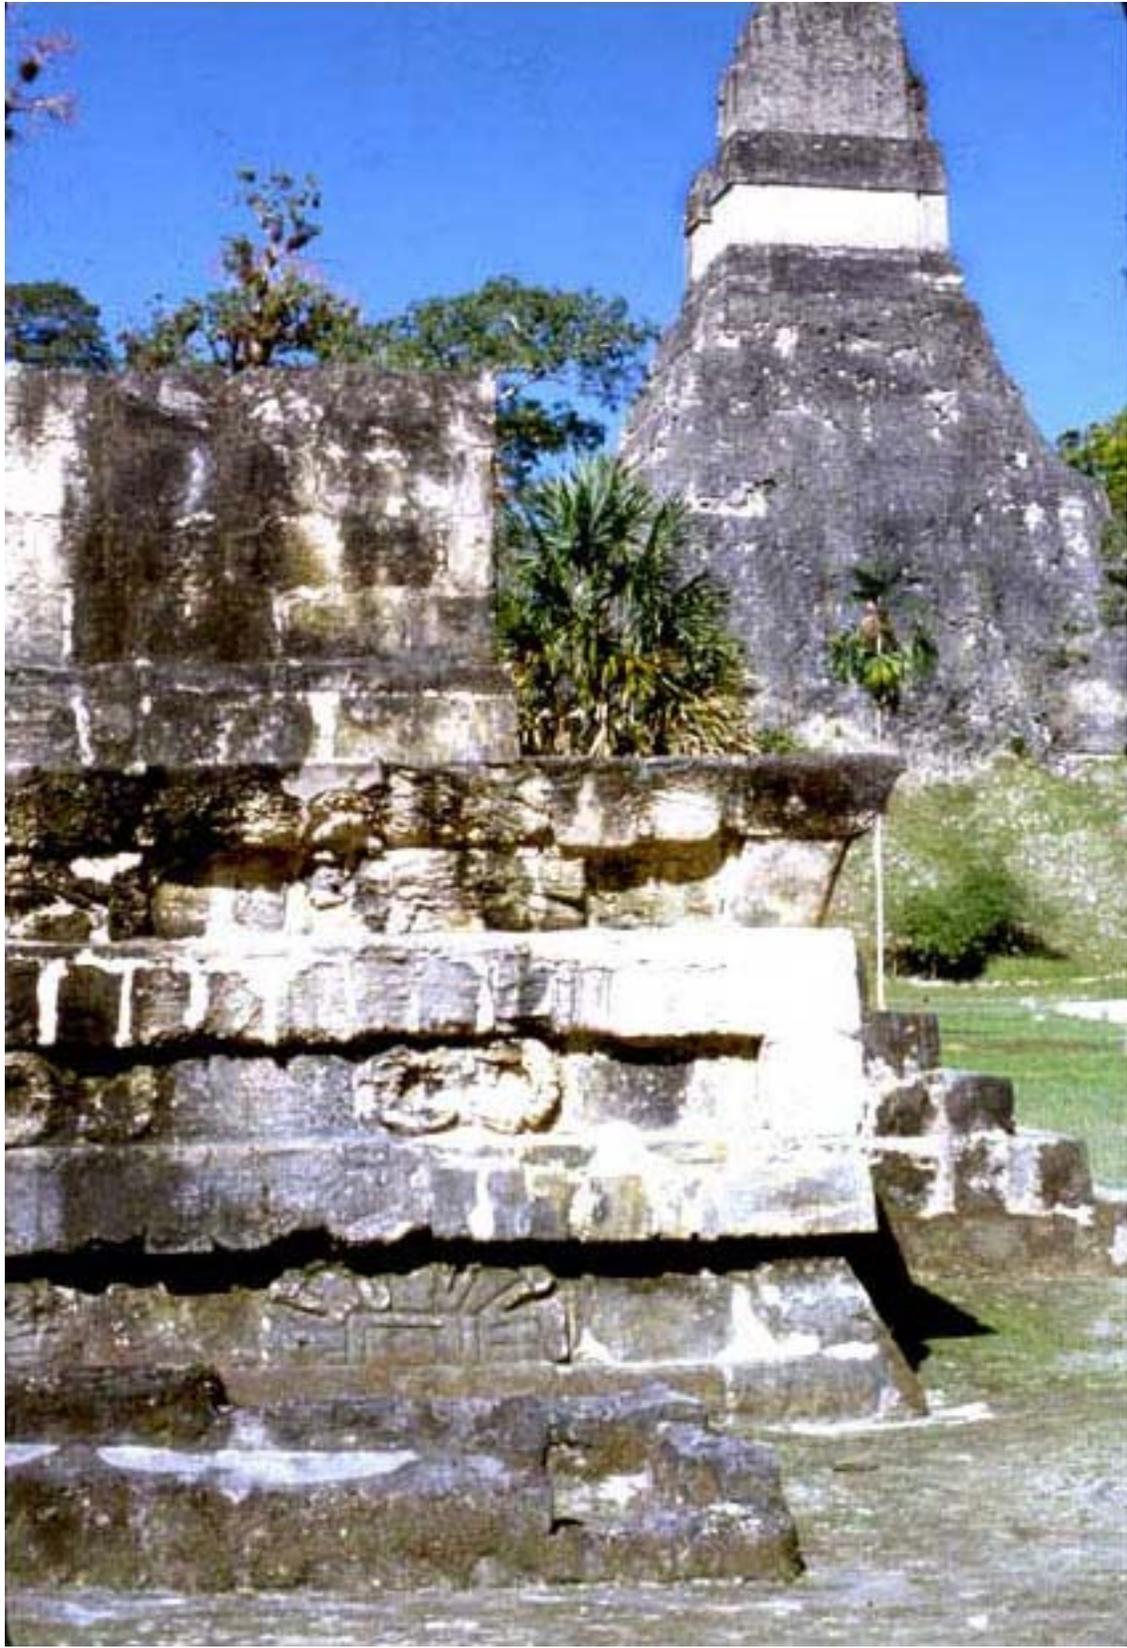
Photo 42. Tikal, Structure 5D-43 with Temple 1 at a distance, and an advanced deterioration of the stone, February, 1980.

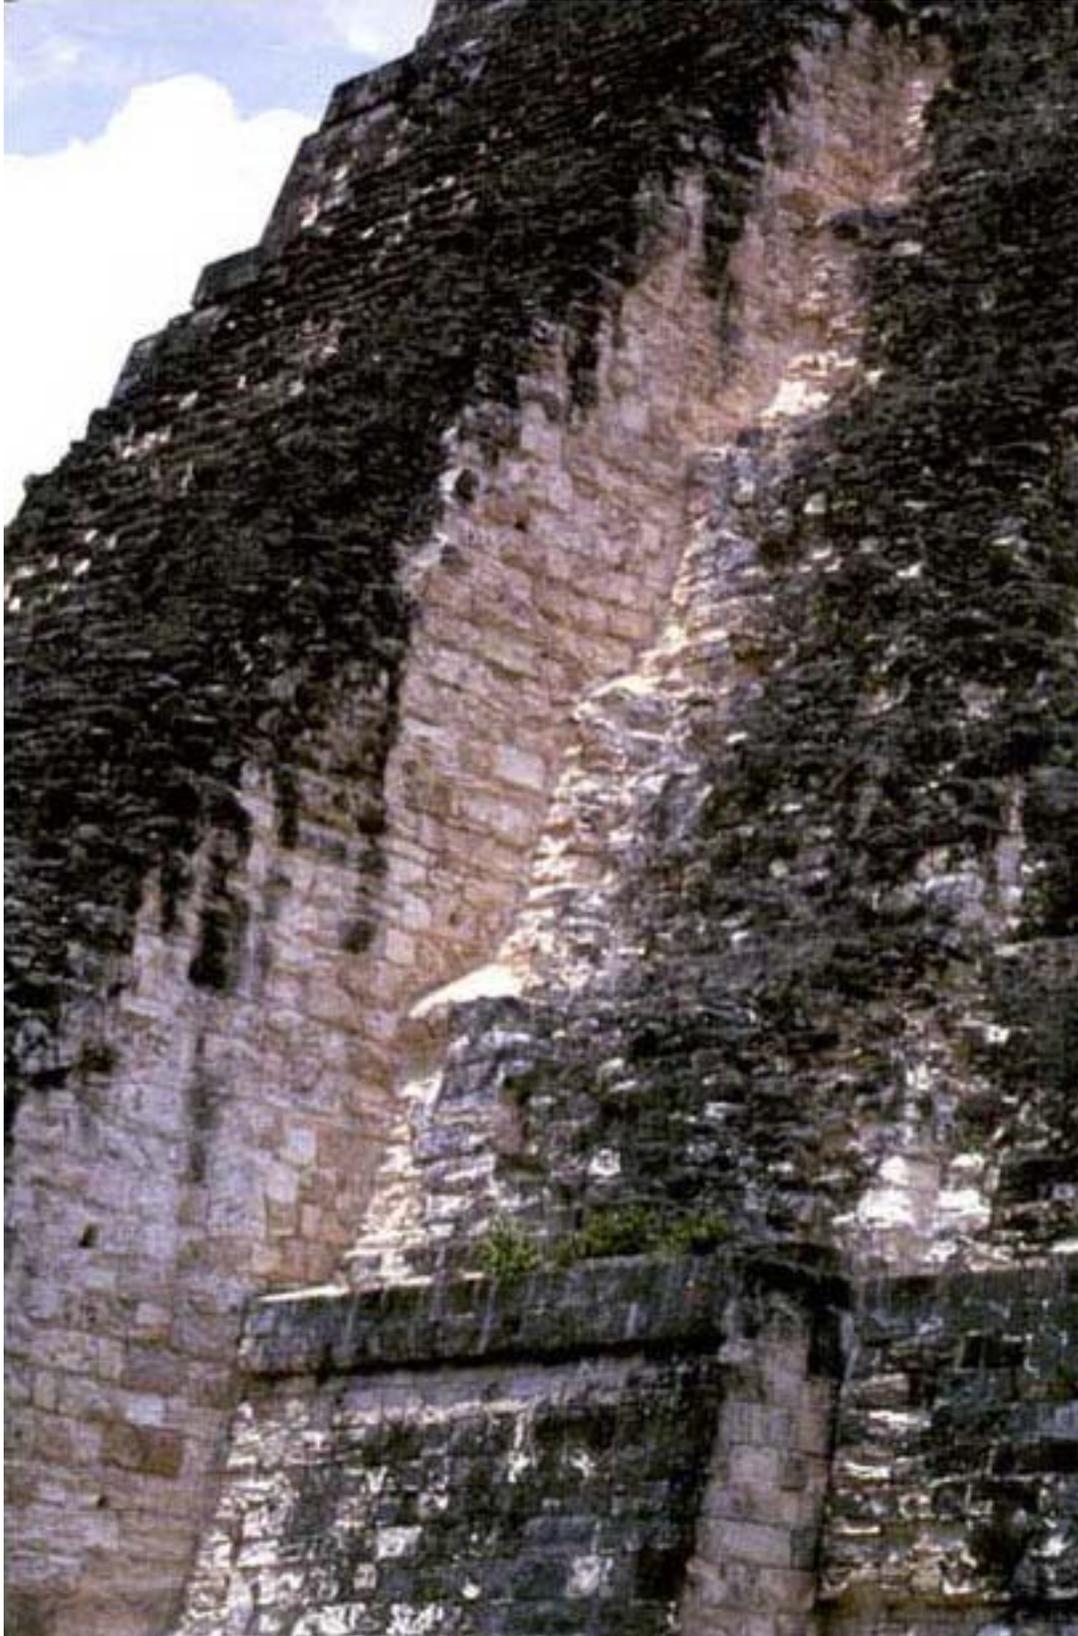
Photo 43. Tikal, Temple 1, south side of the stairs, heavily deteriorated; note the white dust on the joints with the terraces, May 14, 2000.

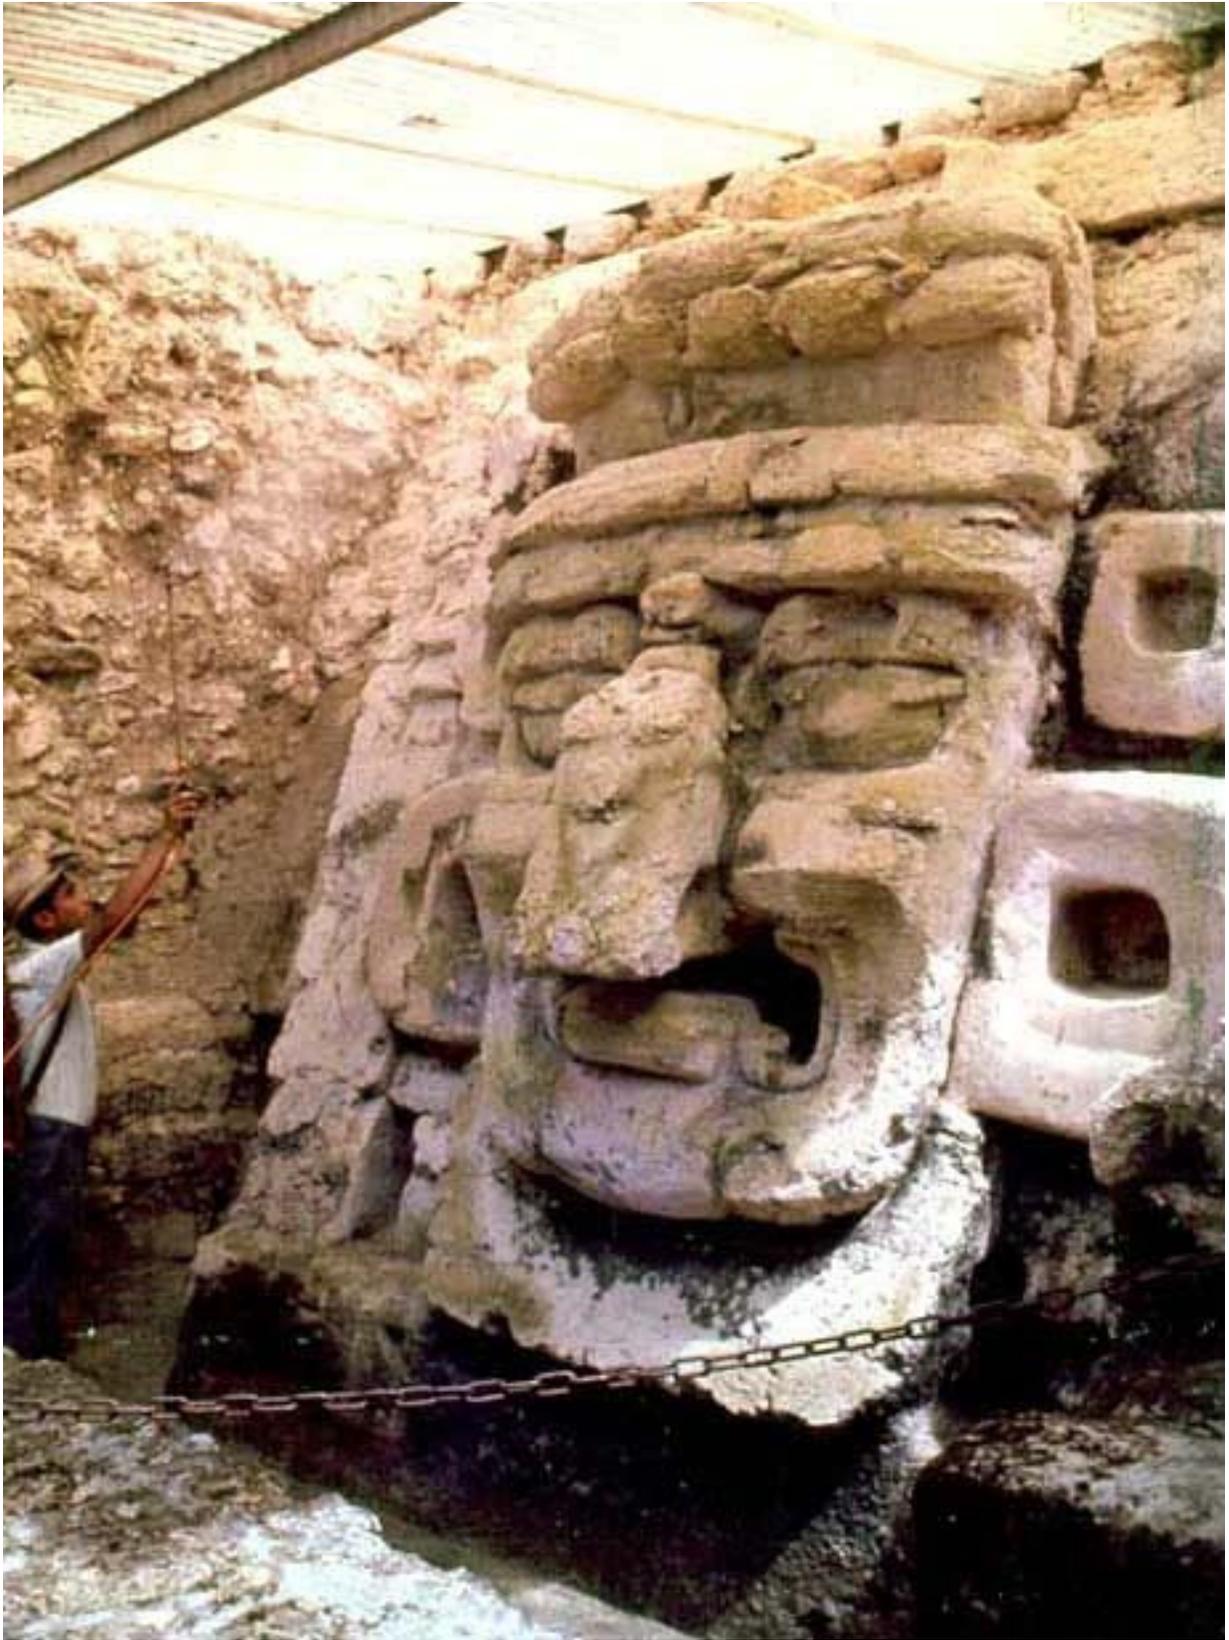
Photo 44. Tikal, Structure 5D-33-2nd, stone and stucco mask, west side, August, 1972

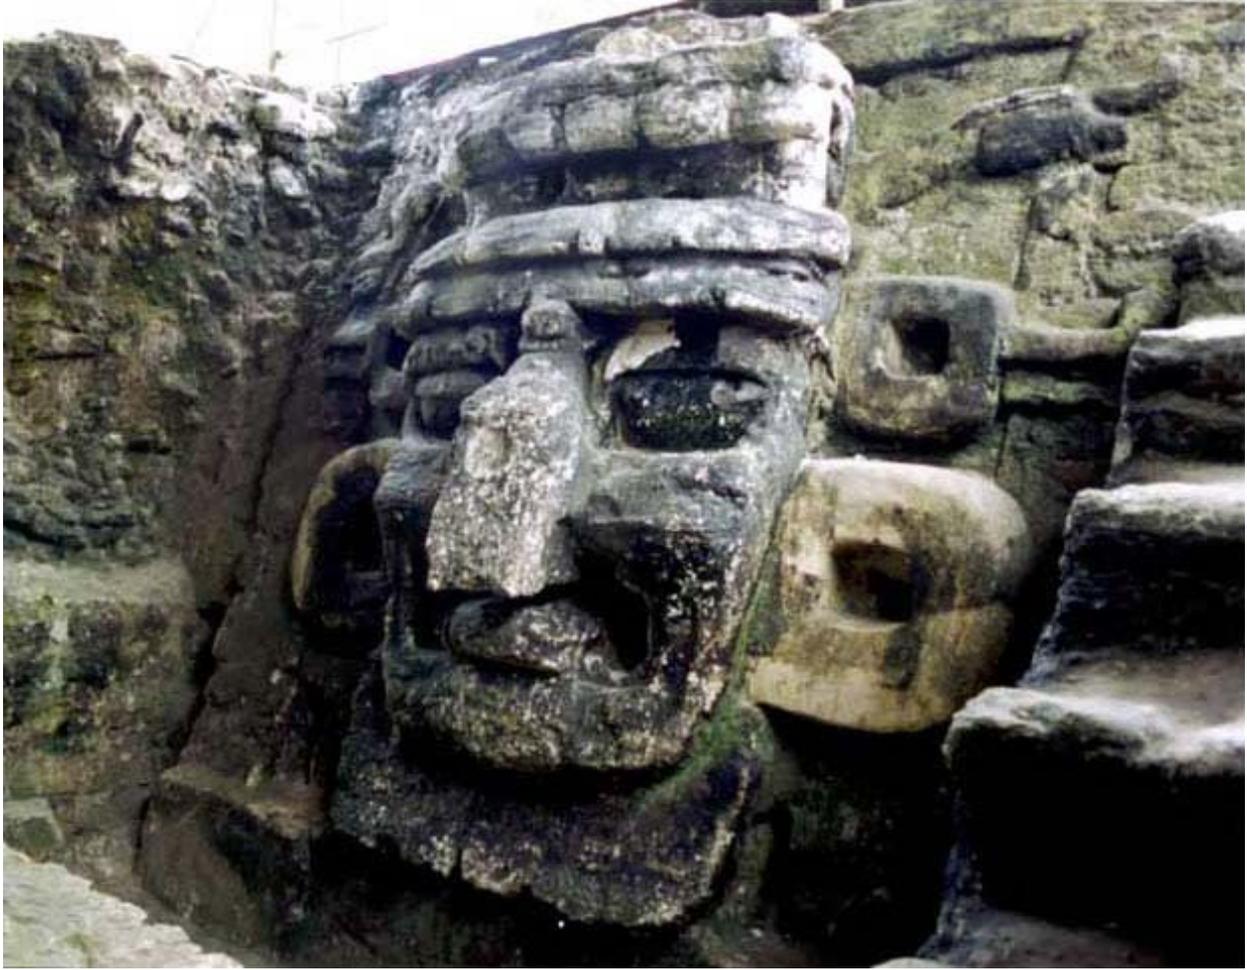
Photo 45. Tikal, Structure 5D-33-2nd, mask, west side. December 12, 2000.

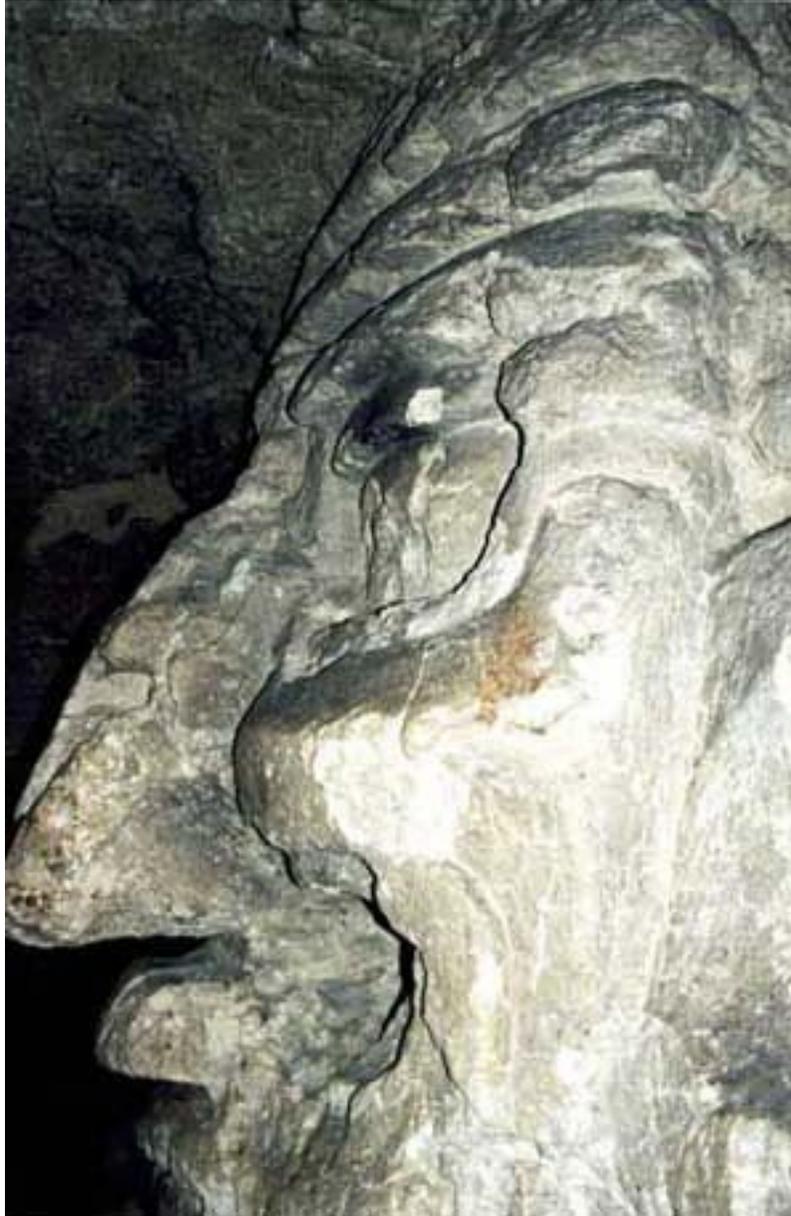
Photo 46. Tikal, Structure 5D-33-2nd, west side mask, inside the tunnel, in a very good state of conservation, December 13, 2000.

On the east side of Structure 5D-33-2nd, another mask is found, identical to the one previously described. Its state of conservation is amazingly good, I could even say it looks the same than when I first saw it thirty four years ago ([Photo 46](#)). The main difference lies in the fact that it was left inside a tunnel; it was not exposed to climatic change, neither was it roofed with transparent sheets so that visitors could take pictures; on the contrary, it was left inside the tunnel with a high degree of humidity, but constant, and free of winds, effects of sunlight and with little or none touristic visitors.

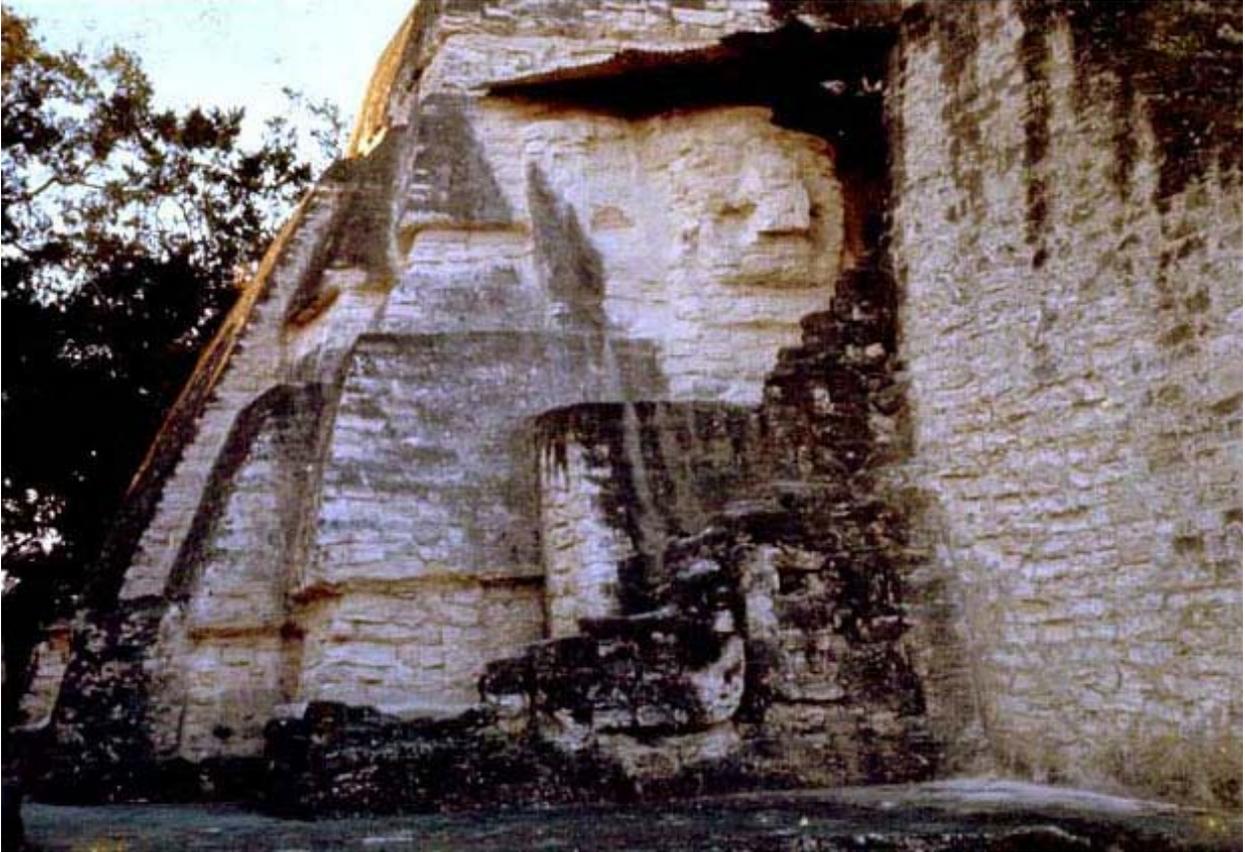
Photo 47. Tikal, Structure 5D-22, west mask. The light parts represent deterioration. The parts darkened by microflora are better preserved, February, 1978.

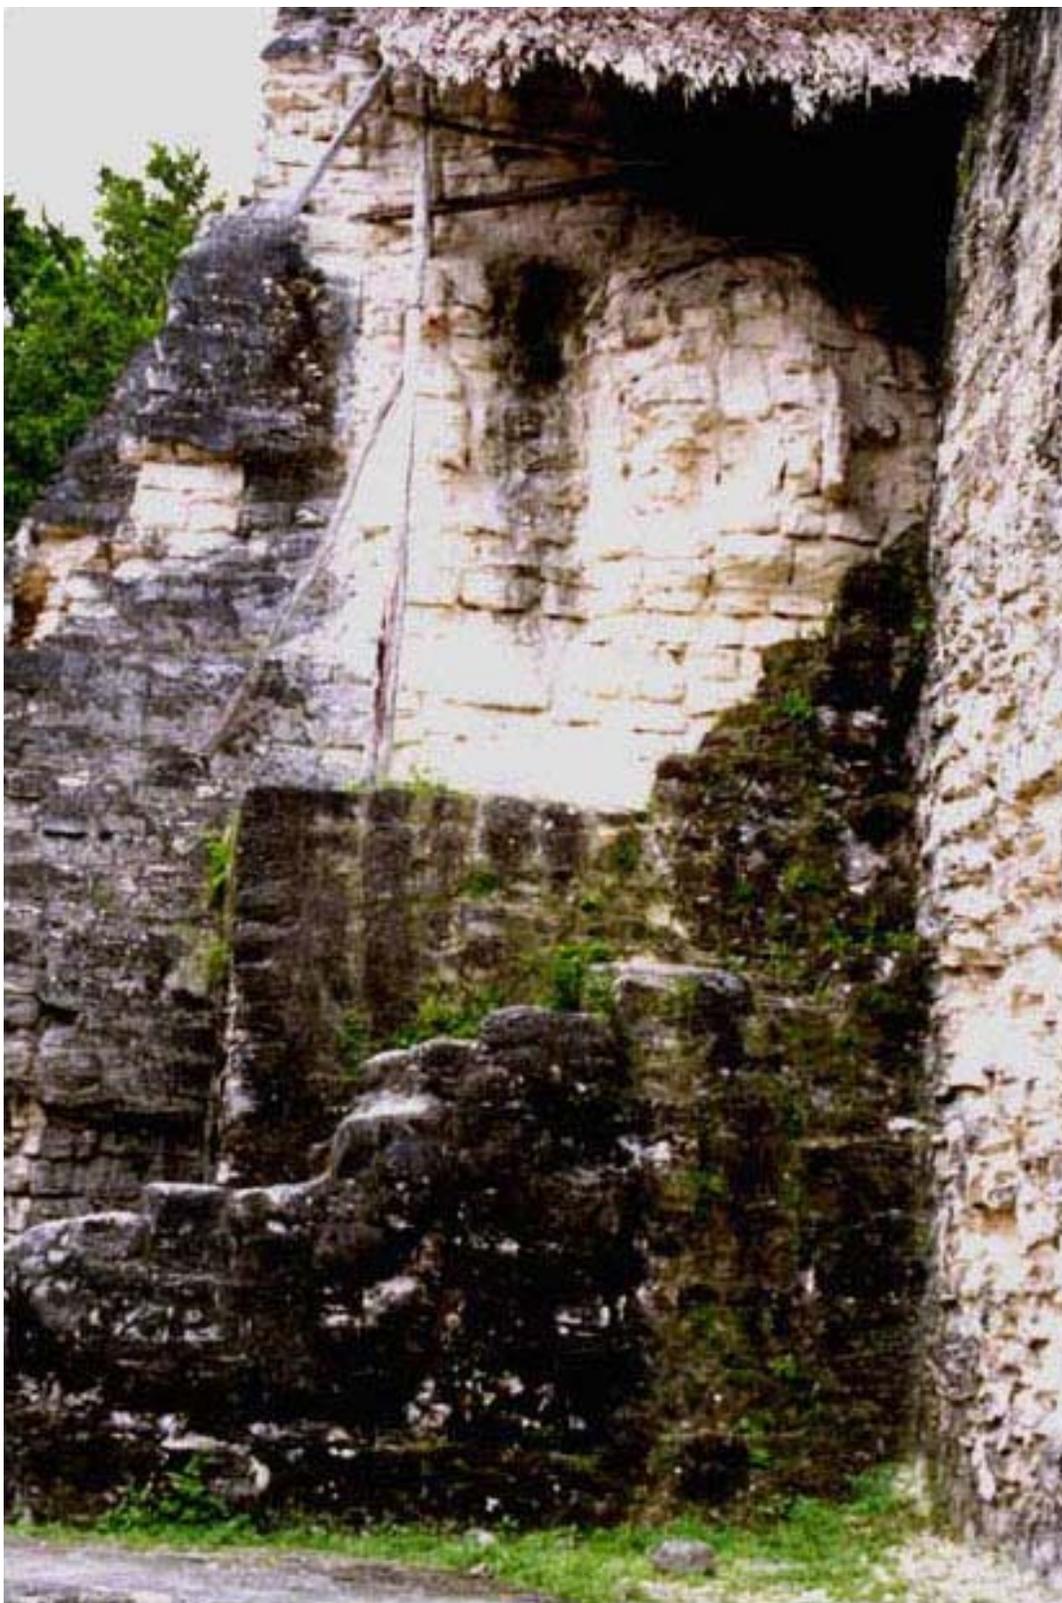
Photo 48. Tikal, Structure 5D-22, idem photo 47, though this one was taken on December 13, 2000; note that the mask has almost disappeared. The damp parts with a heavy dark color show a much better state of preservation than the roofed portion.

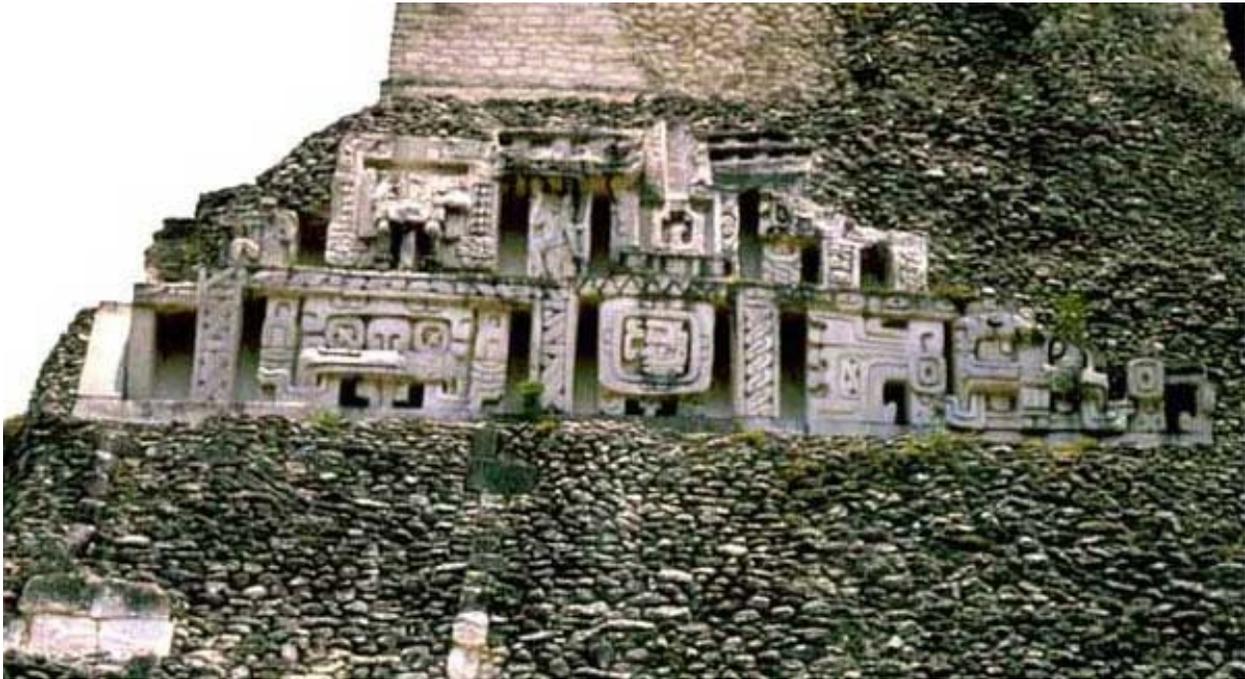
Photo 39. Xunantunich, El Castillo, west side, replica of frieze. May 24, 2000.

In Xunantunich, like in many other restored sites, tourism is important, so we did not think it would be right to bury the frieze once more, as it was done with Tikal's, though undoubtedly it would have been the best option. After careful consideration, we came to the conclusion that the best thing to do was to make an exact natural size replica ([Photo 39](#), below) to be placed later in front of the original.

The system consisted of elaborating a faithful copy of the frieze by modeling it in clay in an area adjacent to the building, first on the basis of the original piece and then based on existing drawings and abundant additional details and sections prepared to that purpose. Later, we molded the figure with rubber and fiberglass, to finally elaborate the copy in a polyester resin, fiberglass, and limestone powder with the color of the stuccoes.

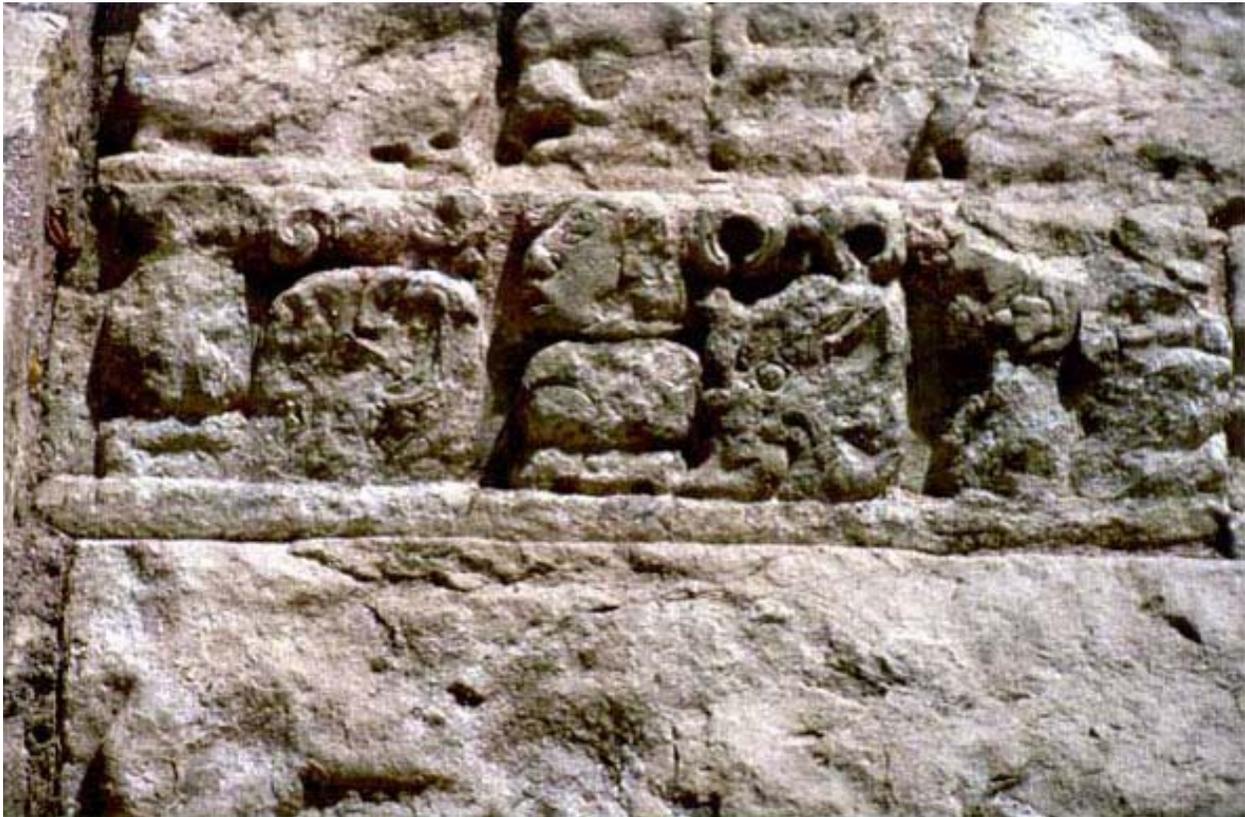
Photo 67. Copán, the Hieroglyphic Stairway, detail of deteriorated steps at the base of the stairway.

The tuff stone, which is of volcanic origin, is hard, stable, and easy to carve. Nonetheless, the deterioration usually present in exfoliations ([Photo 67](#), below) is increasingly worrying. At this site, with different component materials, once more the buildings that remained in the shadow were in a much better state of preservation than those which received more sunlight throughout the year.

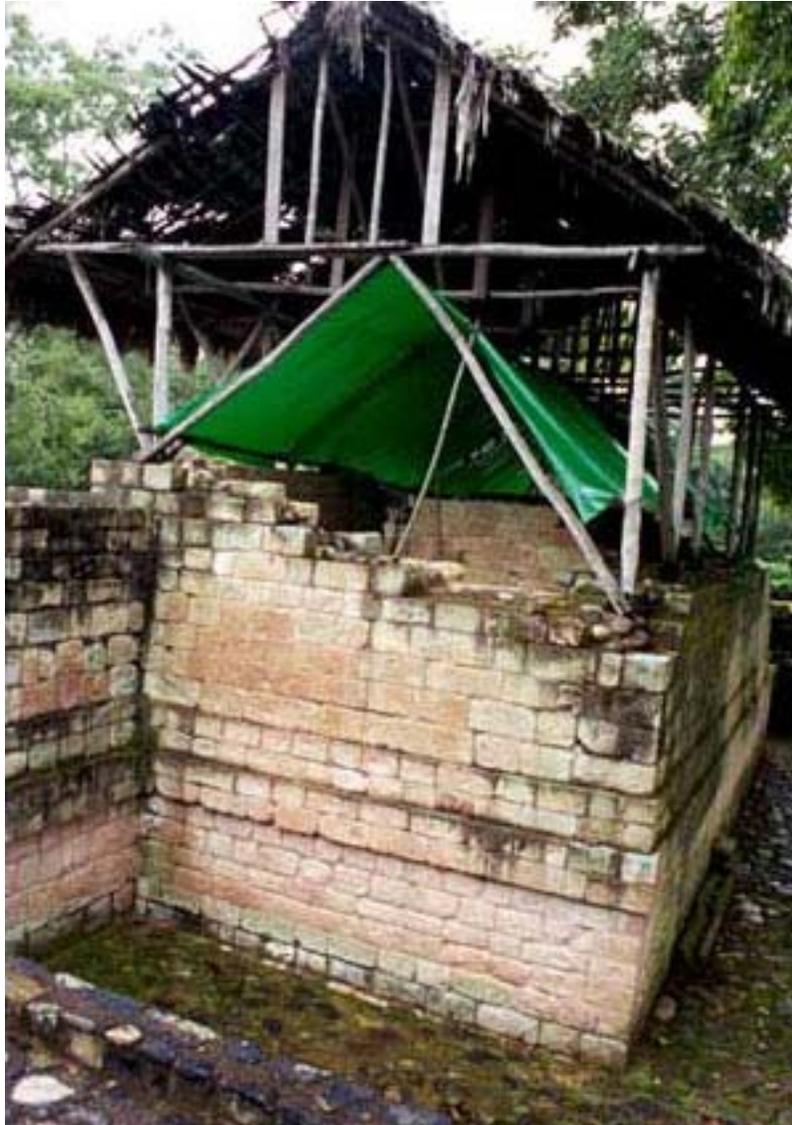
Photo 55. Copán, Structure 9N-67, the protective roof is in very poor condition, November 22, 2000.

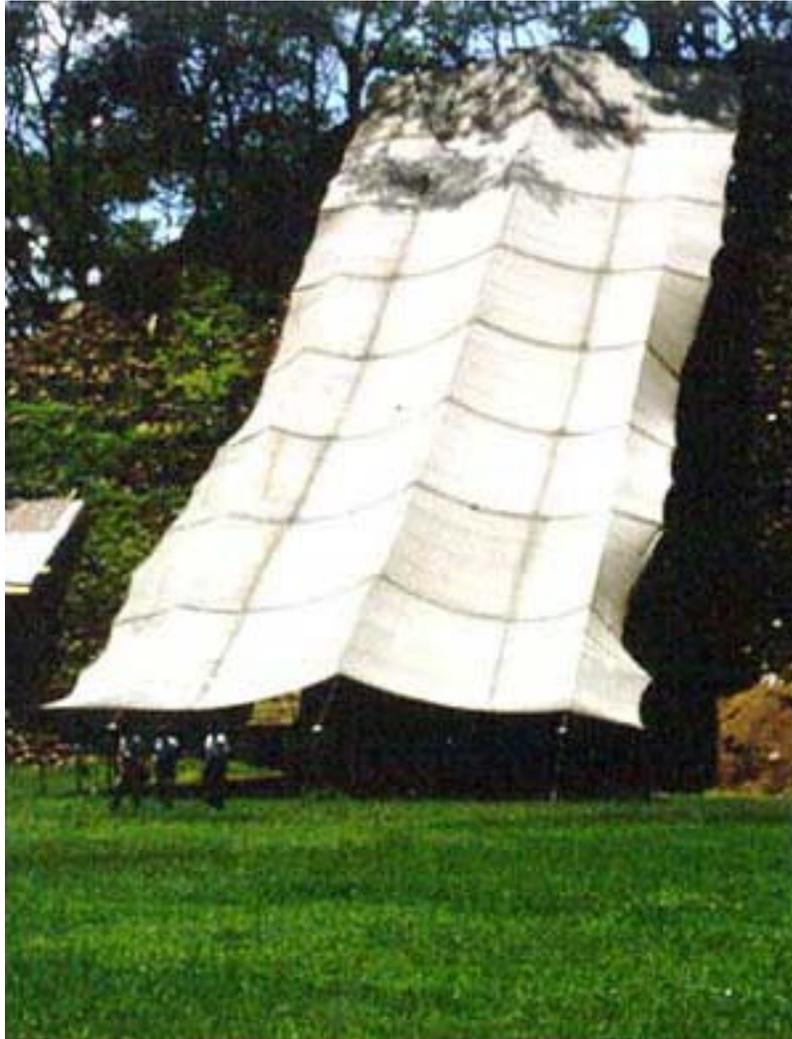
Photo 69. Copán, Hieroglyphic Stairway with protective canopy put in place in 1985, picture taken in 1988.

Obviously, delicate materials require a special protection, and the museum represented a wonderful tool. Yet, very important monuments with stuccoes or original sculpture required roofing, like 9N-82 and 9N-67. Unfortunately, we must say that maintenance of these roofs has failed ([Photo 55](#), shown above). In the particular case of the Hieroglyphic Stairway ([Photo 68](#), below) in Copán's center, it was as well necessary to display a tilt to cover the entire stairway, the stela, and the altar in front of it ([Photo 69](#), below).

It might be of interest to narrate that when I first arrived to Copán (1975) we were caught in a big storm; the scene was discouraging, because rain water run on the sculpted stairs as a huge cascade, sweeping away thousands of chips of the decomposing stone. My great wish was to do something to stop this, and several years later I was given the opportunity to design a tilt, which was put in place in 1985, and which is still there, protecting the monument.

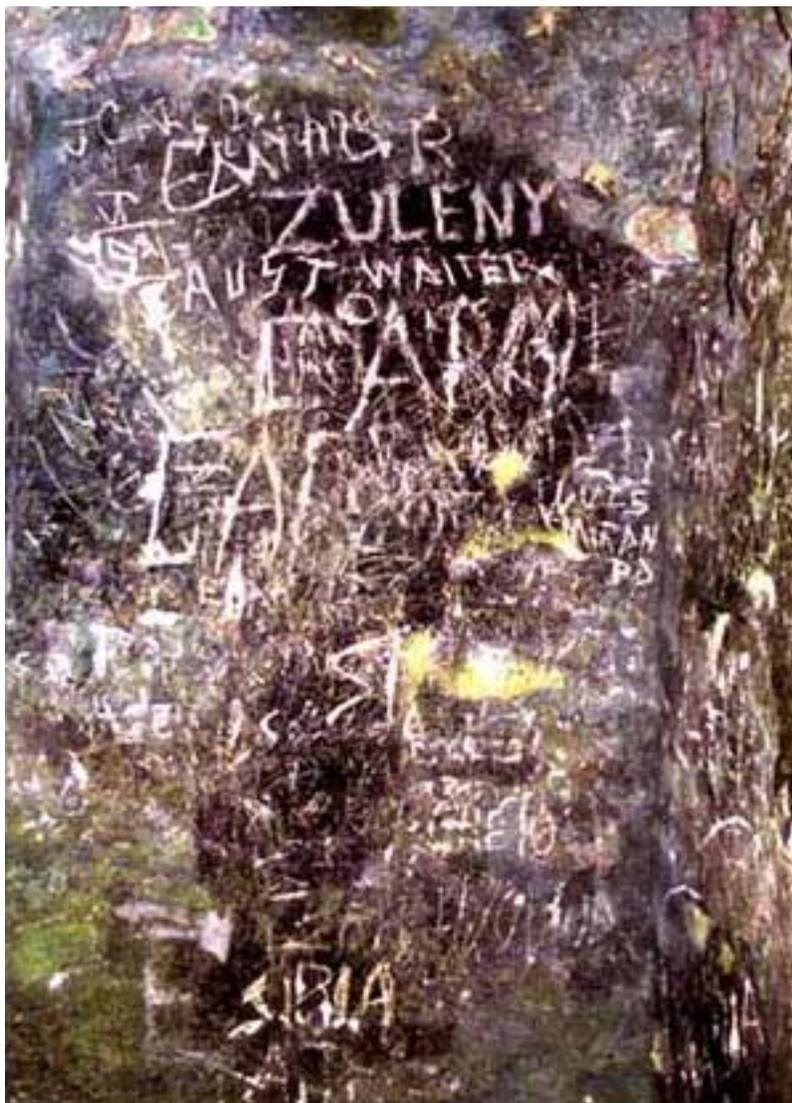
Photo 56. Tikal, Structure 5D-33-2nd, interior of chamber with modern graffiti on the original stucco. Deterioration here was caused by man and not by humidity.

Finally, I must say that the most dangerous aspect of conservation is the poor attention given to the sites already restored. This is a widespread problem; there's no personnel trained in conservation, and even maintenance has been relegated to sweep the floors now and then, and to use the machete, which occasionally risks to become a destructive agent. In several archaeological sites, and I won't be giving any names, one can see how the machete of the cleaning crews have added to the destruction of the most important stones of the restored structures.

[Photo 56](#). Tikal, Structure 5D-33-2nd, interior of chamber with modern graffiti on the original stucco. Deterioration here was caused by man and not by humidity.

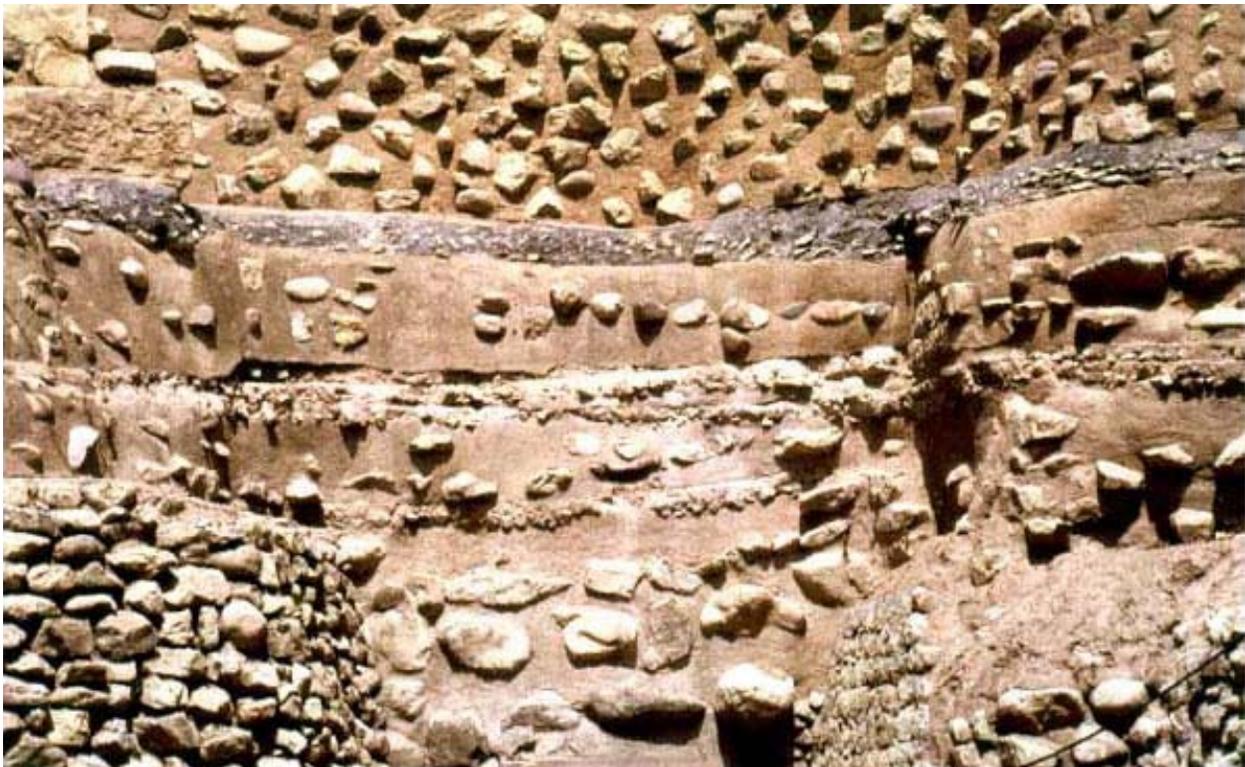
Photo 60. Copán, showing in detail how the cut was stabilized and cultural strata restored, 1991.
