FAMSI © 2005: Carlos Rudy Larios Villalta

Architectural Restoration Criteria in the Maya Area

Site: Maya Area

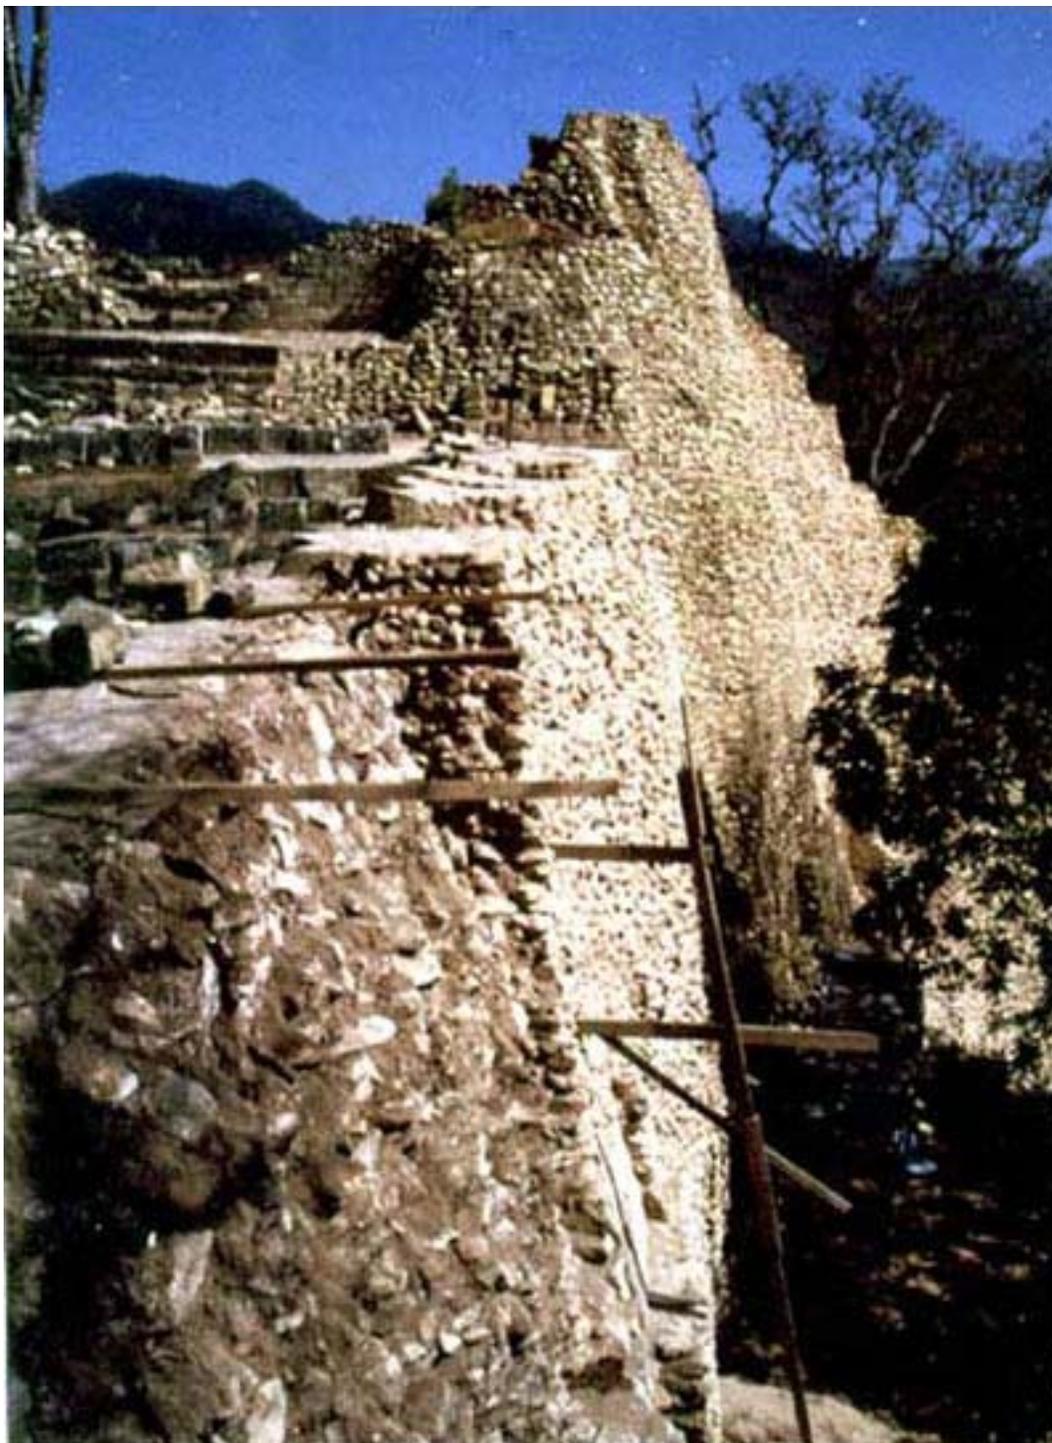
Photo 61. Copán, the cut during the stabilization works. Detail of arrangement, 1992.

In this case, it is important to explain that the project foundations rested on the fact that if we were able to restore formal architecture, we could also be able to restore or stabilize the cut. Basically, we would attempt to preserve all existing architectural features, by stabilizing them and defining the different building strata ([Photo 60](#)). In broken parts with no architecture, work would consist in returning a portion of the lost or weakened volume, with liners similar to retaining walls, to rebuild the cut ([Photo 61](#)). In addition, and in the clear understanding of the potential danger of water filtrations, our project included the stabilization of the eastern patio and the stairs found at the edge of the cut ([Photo 62](#), below).

[Photo 61](#). Copán, the cut during the stabilization works. Detail of arrangement, 1992.

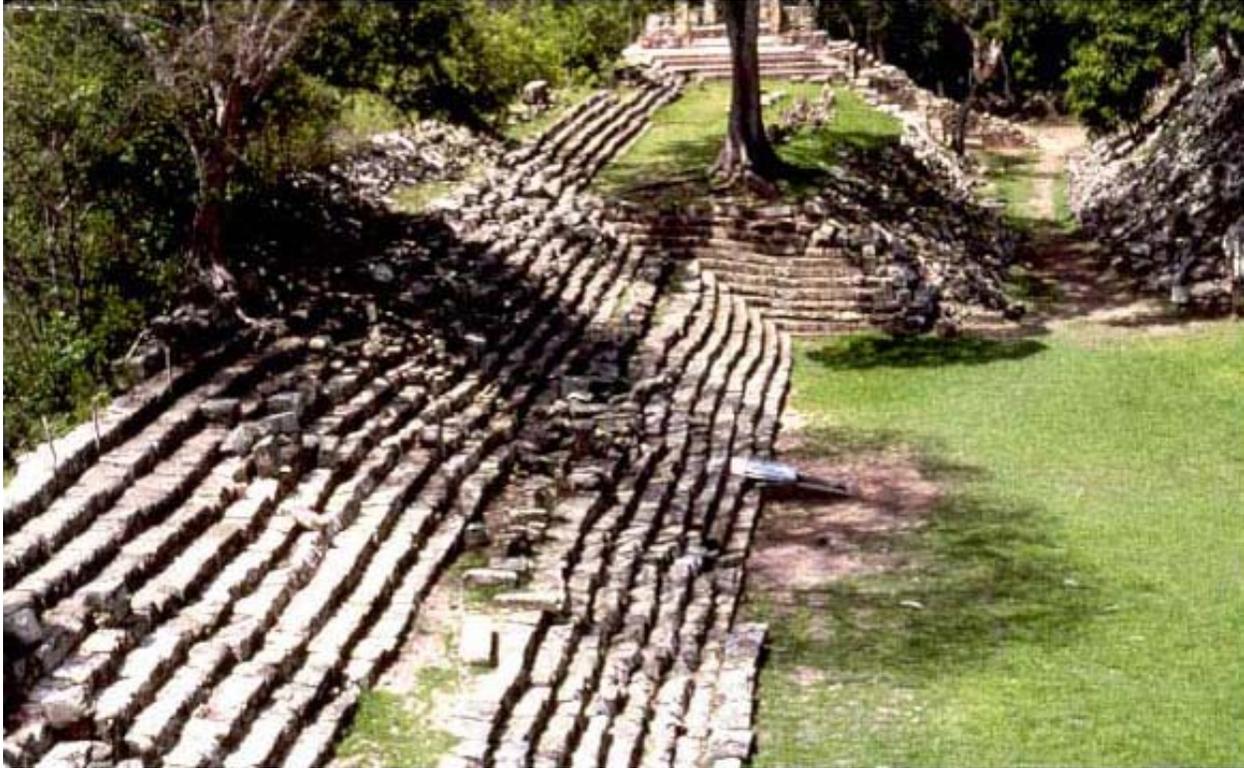
Photo 62. Copán, east court, general view of stairs at cut's edge, before restoration. From Temple 22, looking south, 1987.

[Photo 62](#). Copán, east court, general view of stairs at cut's edge, before restoration. From Temple 22, looking south, 1987.

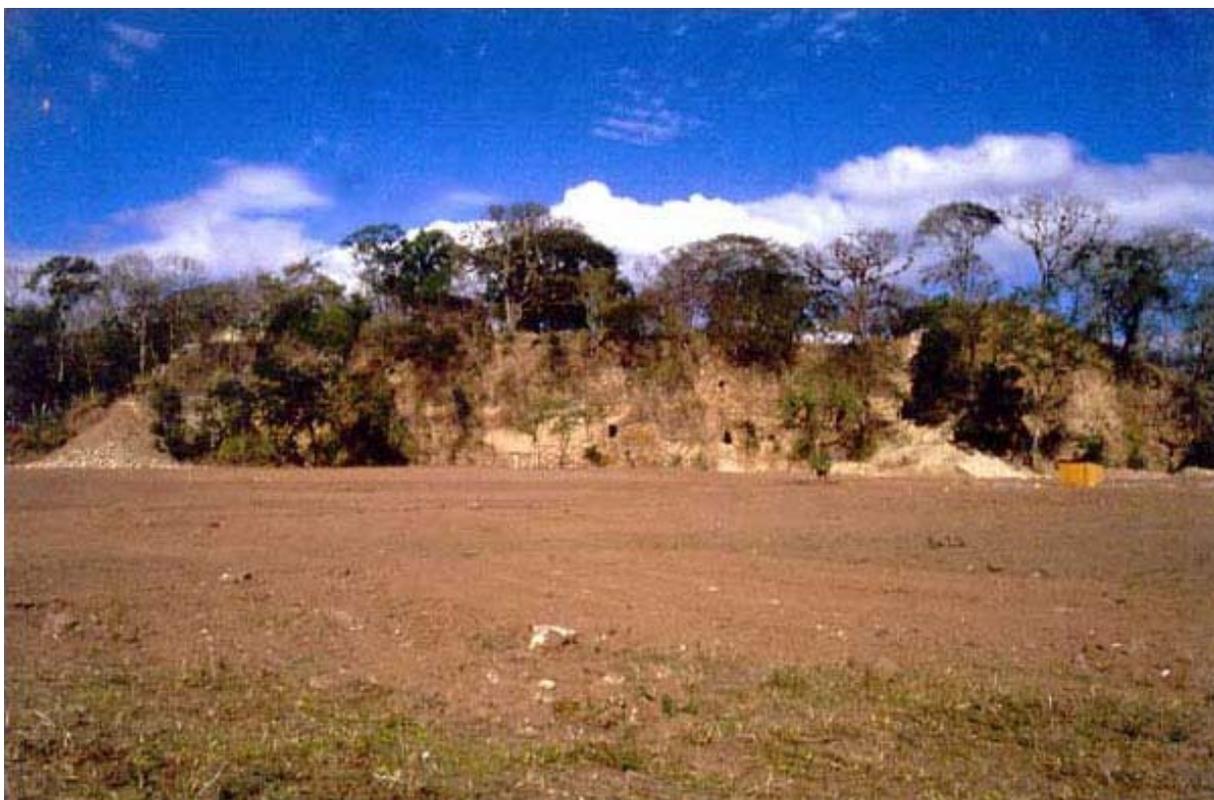
Photo 63. Copán, archaeological cut, in the process of completing the bracing in its base, 1990.

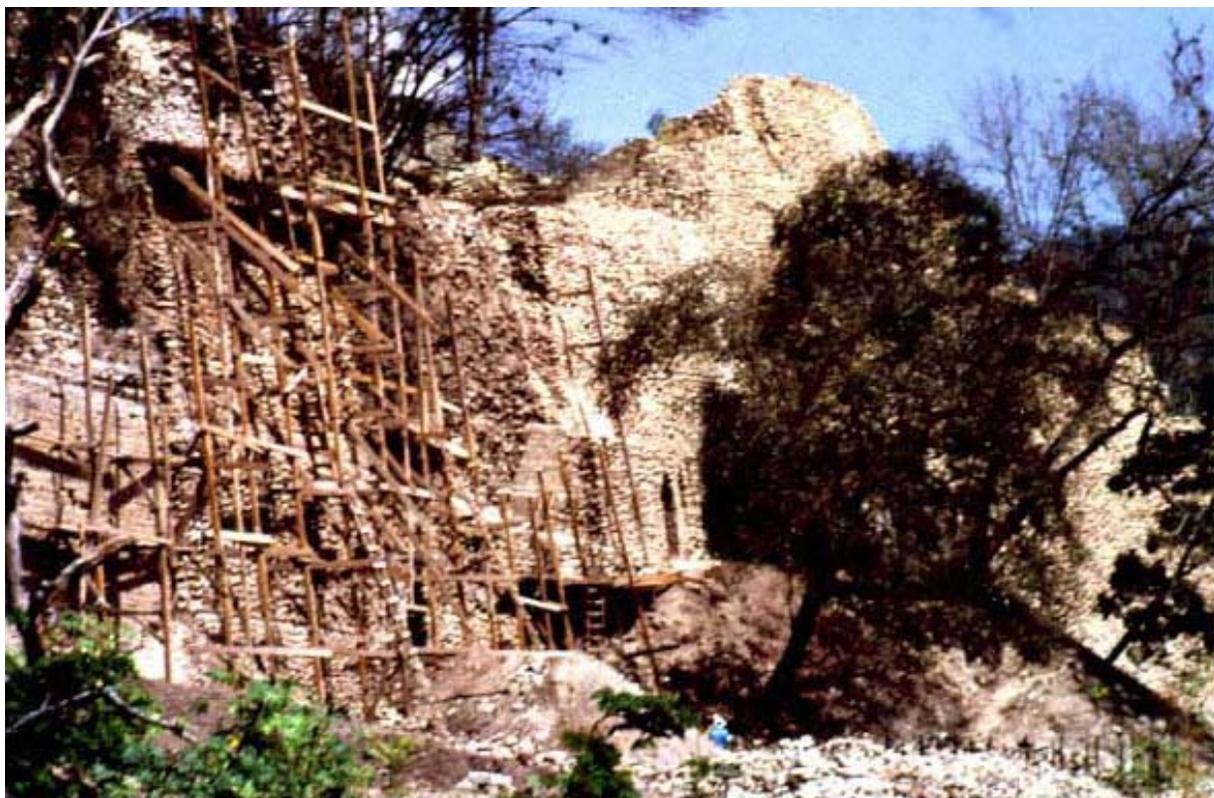
Photo 64. Copán, archaeological cut, in the process of stabilization. Wooden scaffolds were used throughout the entire work, 1992.

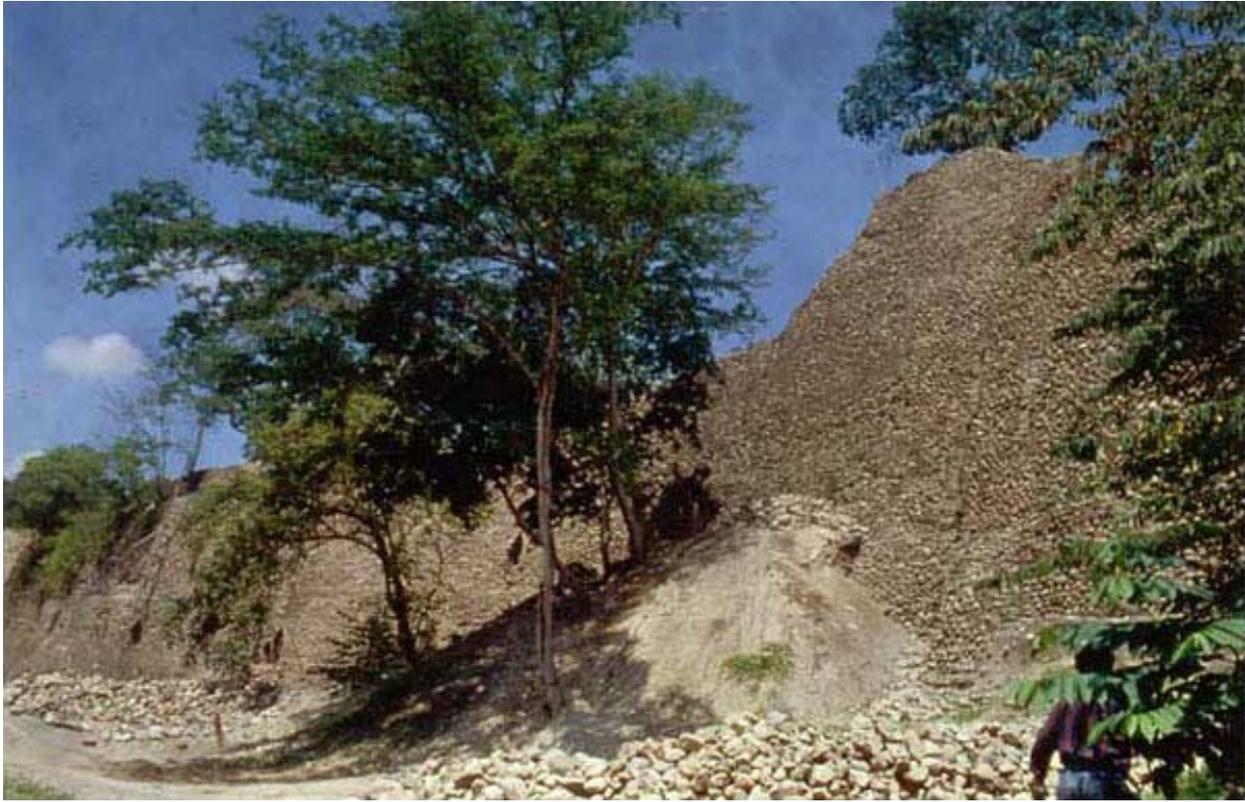
Photo 65. Copán, archaeological cut, general view, during stabilization works, 1993.

The final result was good, and we succeeded in stabilizing an extension almost two hundred meters long, with a height that varied from twenty to twenty five meters, plus the stairs of the east border of the eastern patio, at the edge of the cut. Photos ([Photo 64](#) and [Figure 65](#), and [Photo 66](#)) show this process and a portion of the completed works. Needless to say, those works were but the first step in the conservation process; a permanent maintenance is required, to keep the surface of the restored portion in such condition that rain waters are quickly evacuated before they have the chance to filtrate. Otherwise, the destruction process will start all over again.

[Photo 65](#). Copán, archaeological cut, general view, during stabilization works, 1993.
