6. The Settlement and Its Architecture

MARY PRINDIVILLE and DAVID C. GROVE

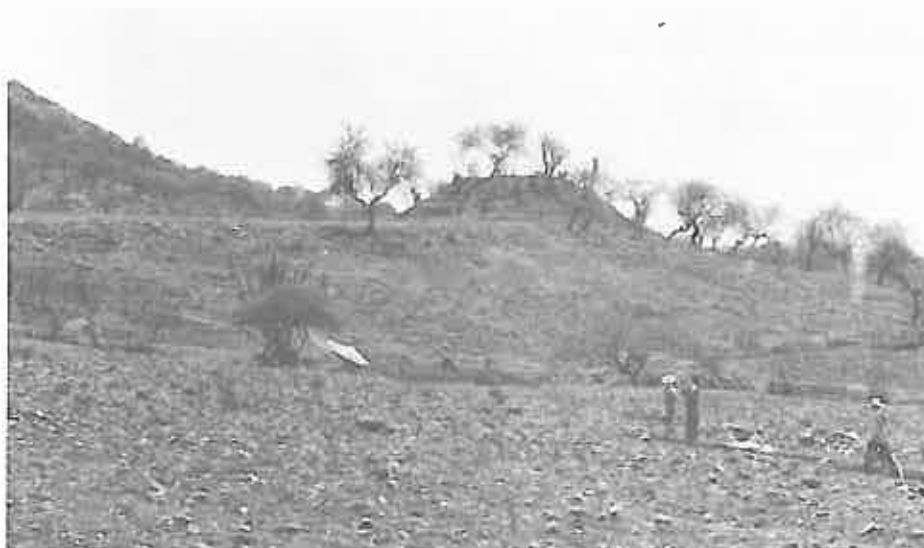
Figure 6.1. PC Structure 4 mound, with T-3 Structure 1 pyramid.

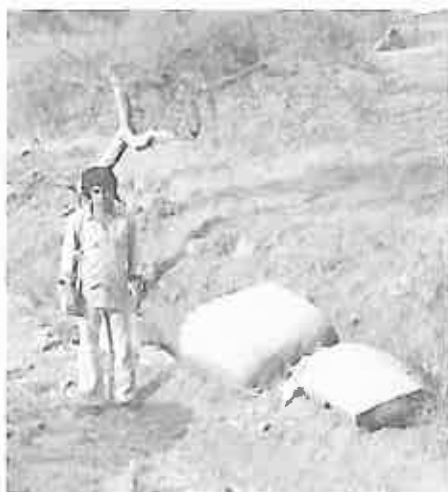
Figure 6.3. Large worked stones at the eastern end of PC Structure 4.

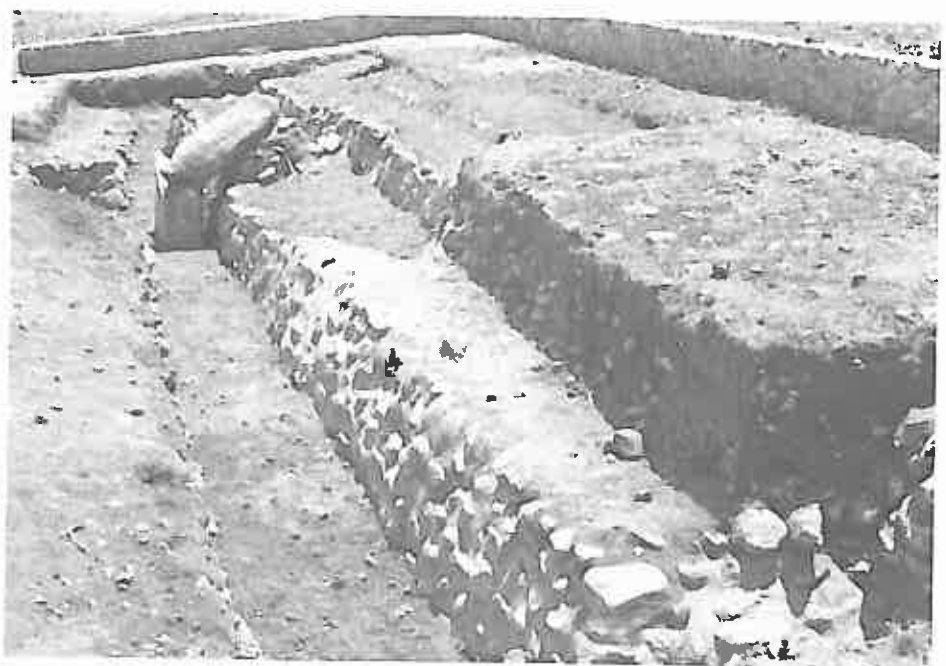
Figure 6.4. T-6 Structure 1 with broken stela (Mon. 27) in situ (wall in background built by project to protect the structure and stela).

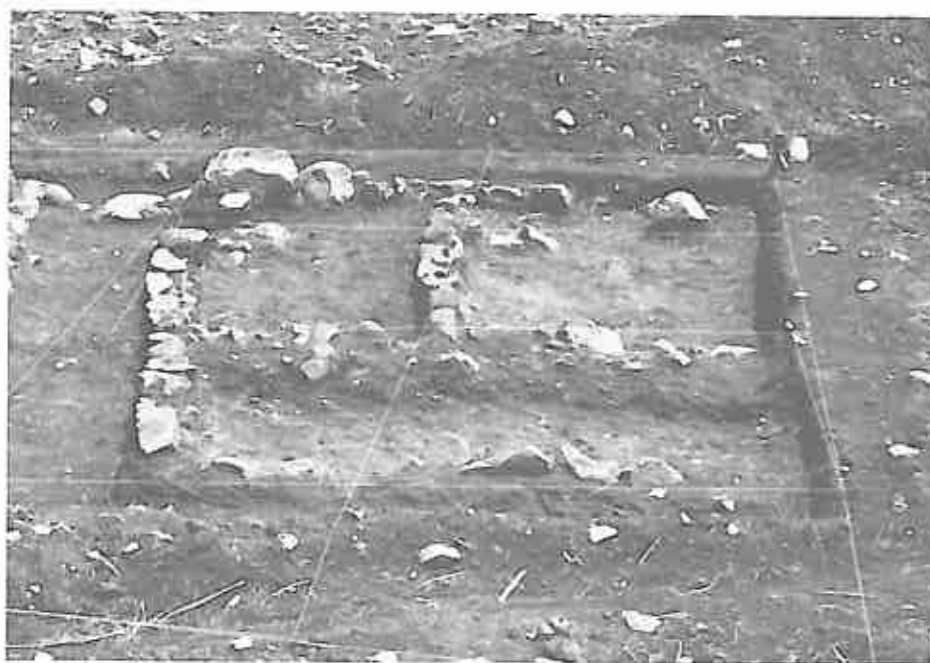
Figure 6.5. Wall line composed of a single row of stones, PC Structure 2.

One type of foundation wall is characterized by an alignment of small cobbles (ca. 20–40 cm diameter). Although these walls can be up to three rows in width, a single row is the common practice (Fig. 6.5). These foundation lines appear to correlate with wattle and daub wall construction. Norman Thomas (1974:7, Fig. 5), using ethnographic examples, shows that such stone lines are usually placed at the base of wattle and daub walls to retard erosion. Our excavations did not find any postmolds or wall trenches adja-

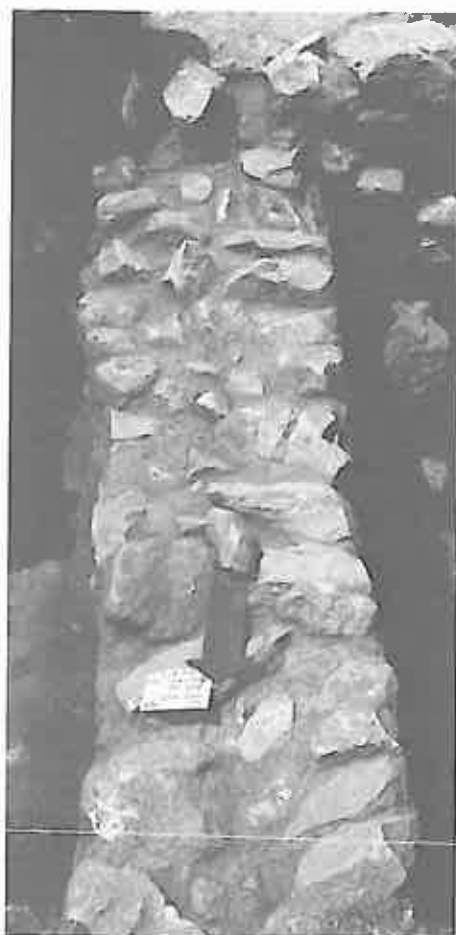
Figure 6.6. Wide foundation wall line, PC Structure 3.

The second and more common foundation wall type is constructed of large (50–80 cm) stones laid to present a relatively flat upper surface (Fig. 6.6). This larger and heavier foundation seems to have served as the base for adobe brick walls. There are three variations to this wall type: (1) one row of large stones edged on both sides by smaller cobbles; (2) one row of cobbles edging a row of large stones; and (3) a double row of large stones. This last variation is often two courses high.

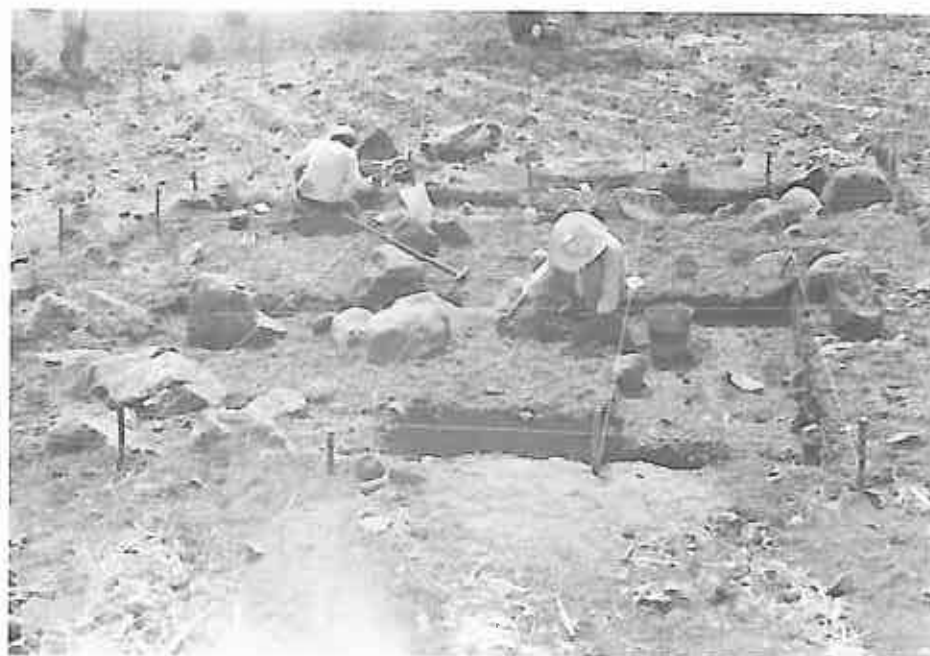
Figure 6.7. T-9B house excavations showing wall line boulders protruding into plow zone.

The Barranca phase structures found on N-2 and T-9B likewise show different foundation construction techniques. The T-9B house is outlined by a wall composed of large stones set side by side but not laid out to create a flat upper surface. The impression given is simply of stones set side by side (Fig. 6.7). The wall is single in some areas and double in others (Fig. 4.20). Within the structure apparent room areas are also delimited by rows of the irregular large stones. On the other hand, the few segments of walls remaining of the N-2 structure were single rows of small cobble-size stones (Fig. 4.37). Both the T-9B and N-2 structures were probably of wattle and daub, since daub fragments were found in the excavations of both areas and no regular stone foundations occur.

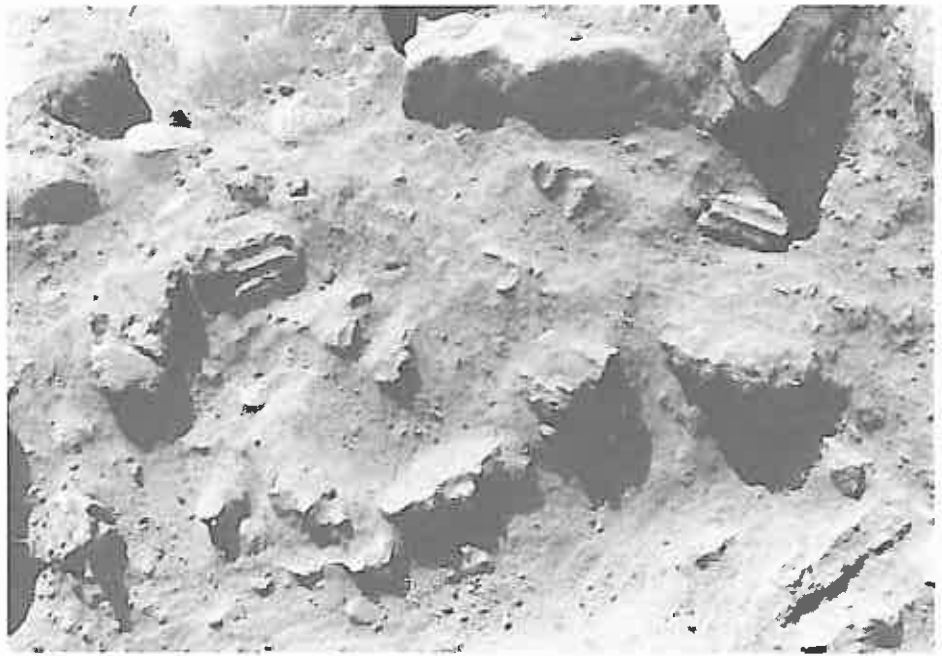
Figure 6.8. Daub fragments in situ, T-23 Structure 1.

The mud plaster or daub placed over the cane sides of the houses is easily identified when found in archaeological contexts because of the cane impressions left in the mud fragments (Fig. 6.8). At Chalcatzingo the impressions serve to identify the cane as *Tithonia tubaeformis* of the Compositae family. These plants are abundant along field borders and the hillslopes of Chalcatzingo. Today, as in the past, their tall stems are often as thick as a human thumb.

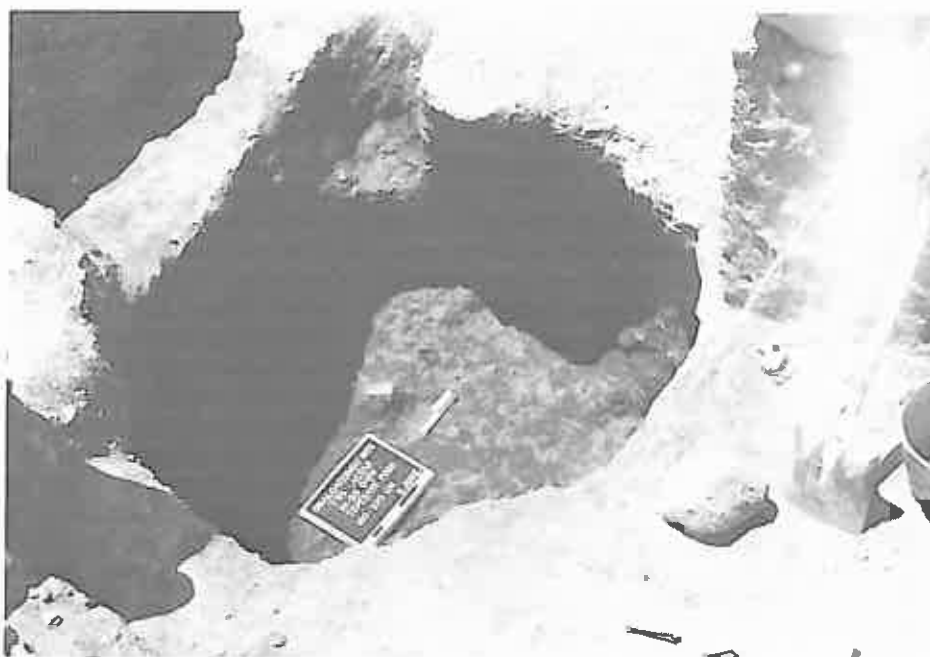
Figure 6.12. Subterranean storage pit, T-25.

6.12), where it had been associated with a Barranca phase house. It may have originally functioned as a storage pit, but when excavated it contained trash and a human burial (no. 103). While such pits were commonly used for trash disposal at other Formative period sites, few were found at Chalcatzingo.
