## UNCLASSIFIED BUILDINGS AND SUBSTRUCTURES

1. STRUCTURE F-3, *Linton Satterthwaite*

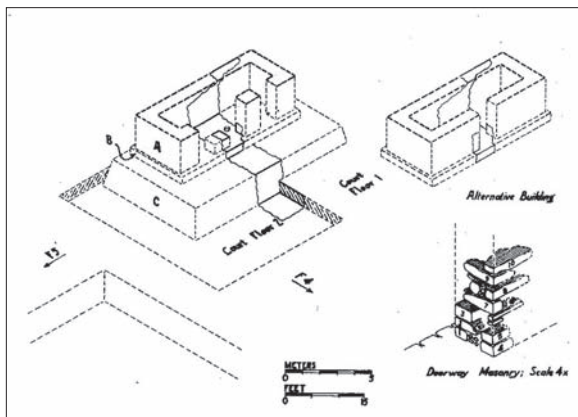
Figure 10.1 Isometric perspective reconstruction of Structure F-3, with part of Court Floor 2 cut through to show original platform height. At right, alternative reconstruction of building; also sketch of corner stones at four times the given scale.

Before our superficial excavations in this mound a considerable expanse of outer rear wall surface showed at the building's left end. Here it stood to full or nearly full wall-height, but no part of the vaulted roof had survived. The mound appeared much higher from the front and from the right end than from the rear or from the left end, due undoubtedly to erosion from the hill rising sharply in those directions. Excavation, by Satterthwaite in 1934, was confined to a center trench and pits, the objective being identification of the roof-type and cross-section dimensions. A little clearing was done at the left rear corner to locate it as a basis for reconstructing the plan without digging it out. Digging was with only intermittent supervision. No points were surveyed or triangulated, so the plan (Fig. 10.1) must be shown as rectified. We neglected to take levels on the structural units, so the sections are based on straight measurements, except mound surface lines, which reflect careful work with the leveling instrument. The chief interest in Structure F-3 lies in the fact that it was a vaulted building of medium vault-span index in a peripheral location. Also interesting are the presence of a portable altar on the floor, its narrow center door, and the possibility that there may have been only one door (Fig. 10.1).

After erection of Unit C the court floor was raised 60 cm (Figs. 10.1 and 10.2). This upper floor (Court Floor 1) slopes noticeably down toward the plaza (south), while the lower one apparently slopes down somewhat from east to west toward the center of the court. Both slopes may apply to both floors, and would be useful for drainage.

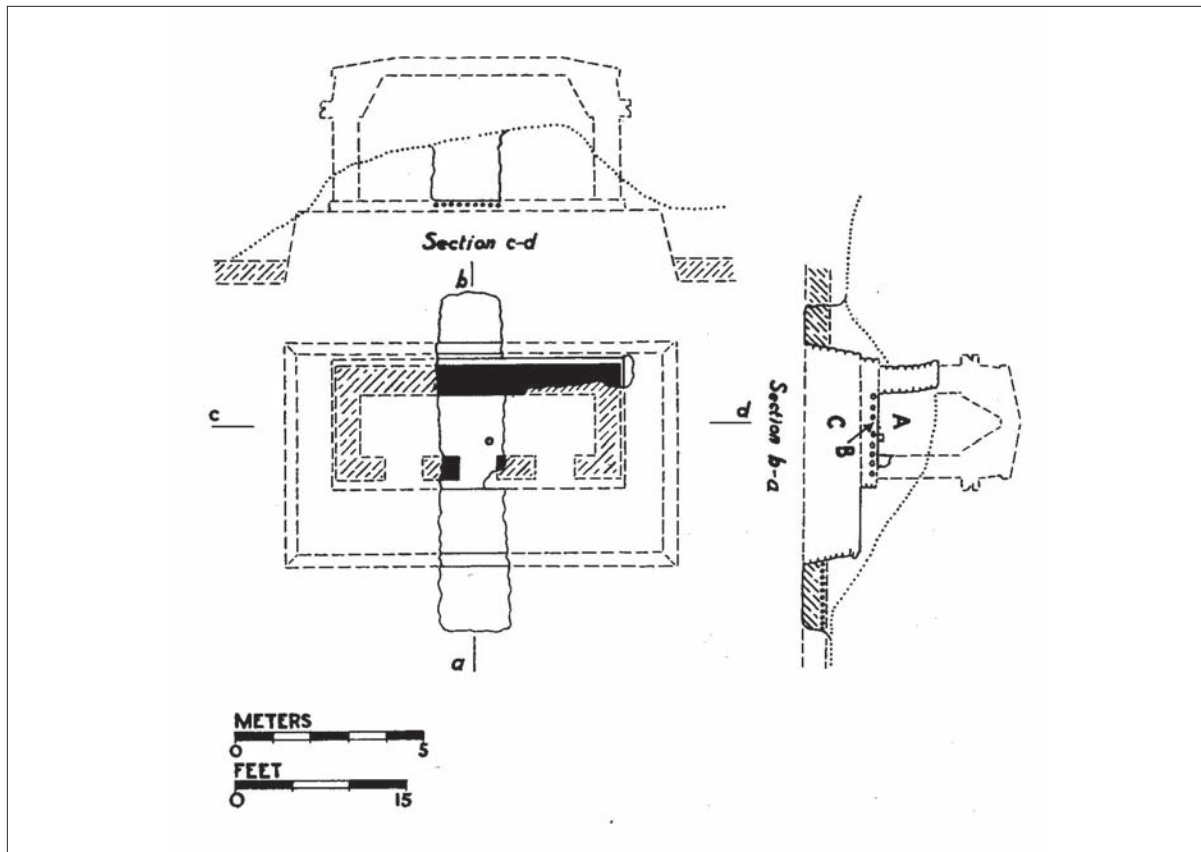
Figure 10.2 Plan and Sections of Structure F-3. Note that center doorway only is certain.

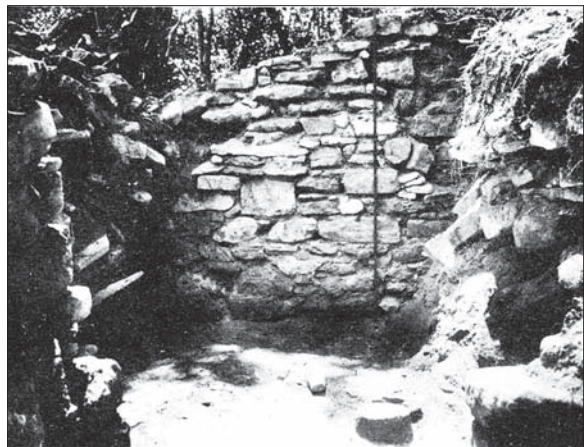
Figure 10.3 Inner building-wall masonry. Rule stands on floor and against rear wall. Portable altar in situ.

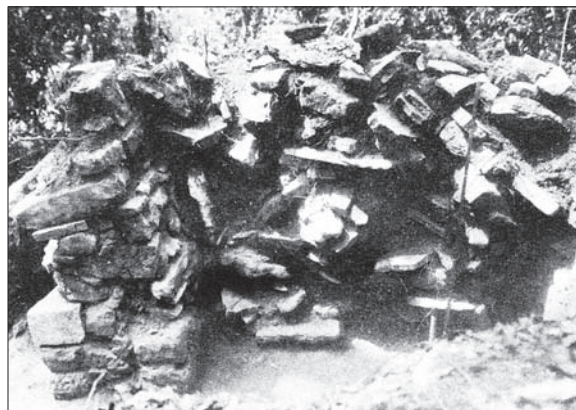
Figure 10.4 Cut section through debris in room of Structure F-3. Rule extended to 1.4 m, stands on floor. Jamb of centered doorway at observer's left.

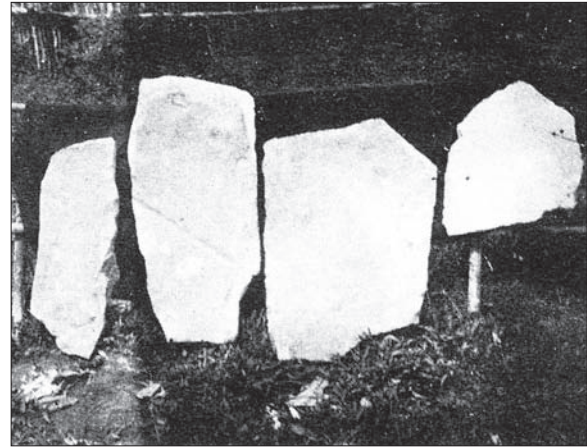
Figure 10.5 Capstones from debris of Structure F-3; part of one on right missing; holes in it probably not artificial.

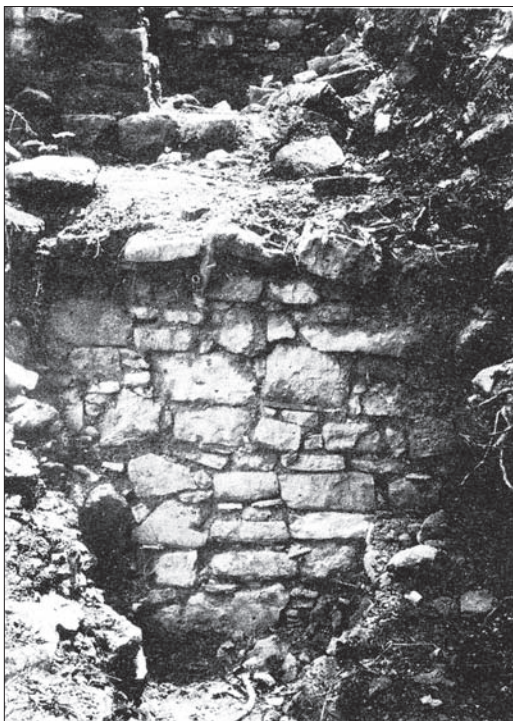
Figure 10.6 Masonry of Unit C, front center. At top, stones of unit B and, at upper left, of Unit A, the building. Rear wall of building shows through doorway (Str. F-3).

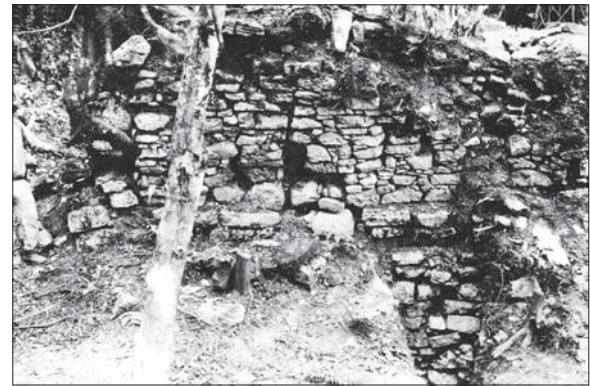
Figure 10.7 Masonry of all units, at rear. Face of Unit C shows only in pit. Man's foot is near left rear corner of Unit B (Str. F-3).

Piers and doorways of collapsed vaulted buildings are often invisible before excavation, and there was no visible sign of the central doorway here until after excavation. We dug only at center. Hence we have provided alternative restorations with and without piers and extra doorways (Fig. 10.1). The simpler plan was used on the map of the site. The restored wall-height is slightly more than a required 2 m minimum. Stones surviving above this, in semi-position, may or may not pertain to a medial molding (Fig. 10.7).

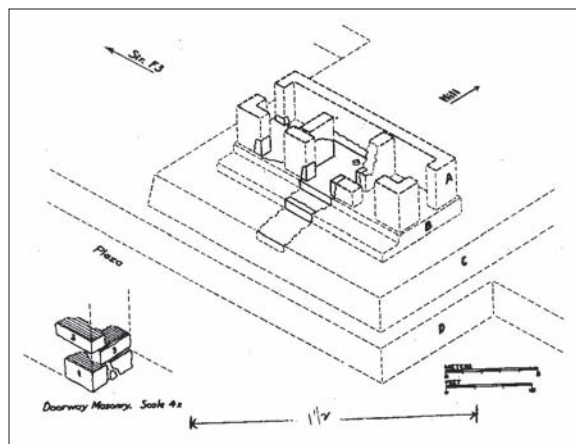
Figure 10.8 Isometric perspective reconstruction of Structure F-4; at lower left, sketch of corner stones in doorway at four times the given scale.

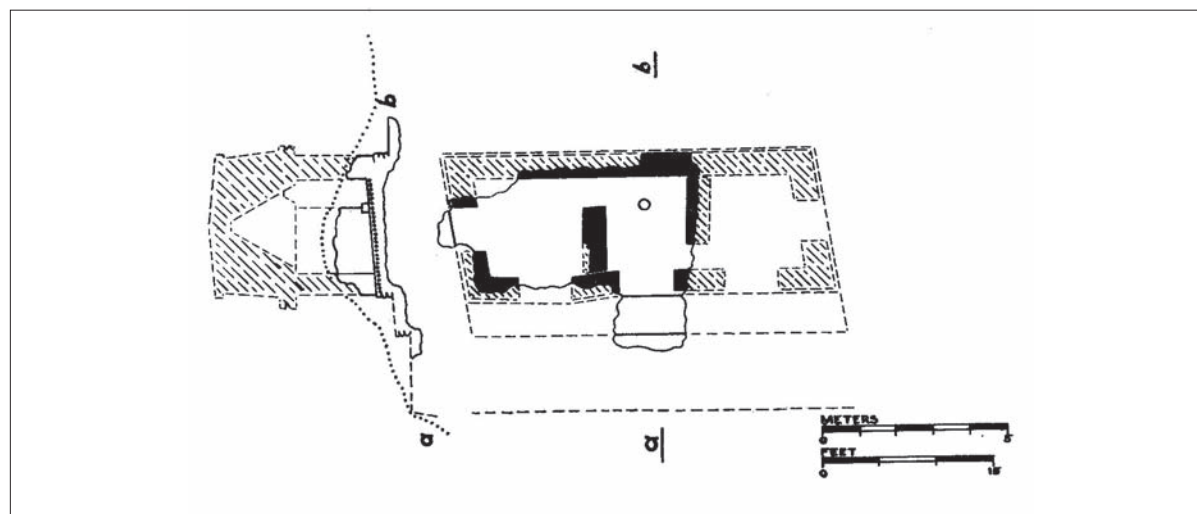
Figure 10.9 Plan and Section of Structure F-4.

Figure 10.9 shows, that the reconstructed plan is quite, reliable, the contour of the mound calling for a left room of about the size of the right one. The partitions between rooms are structurally secondary to the main walls and piers, which they abut. We did not have the wit at this time to determine whether base levels and plaster might prove them a non-contemporary modification, nor

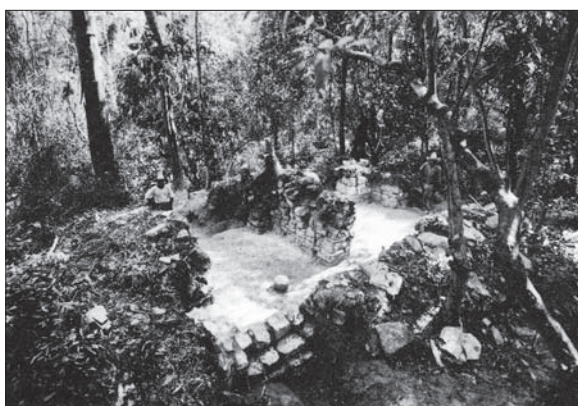
Figure 10.10 General view of Structure F-4 excavation, looking down and from rear. Portable altar in situ. Men stand before central and end doorways. Part of rear wall stump and plinth in foreground.

Tabular stone, in very bad condition. At door jambs large well-squared tabular blocks showing bonding. Three of these at right end (southerly) door measured (in cm) 38 x 26 x 21, 47 x 23 x 17 and 55 x 20 x 14. The long dimensions alternated in the face of the wall, jamb, wall. Heights are given last. In the opposite jamb two comparable blocks measured 38 x 20 x 25 and 33 x 26 x 18 cm, respectively. The larger scale drawing of Figure 10.8 is of the first jamb, made to scale from a rough sketch. The inside corner, between the large stones 1 and 3, was formed of several small stones and mortar. No data on chinking. Stump at center of rear wall indicated absence of rubble-masonry wall-heating (Fig. 10.10).

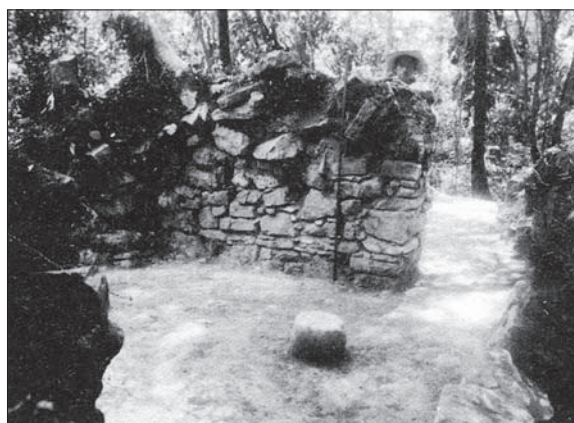
Figure 10.11 Masonry of partition; rule extended to 1.42 m, rests on floor and leans against it. Portable altar in situ in middle room, man in right room (Str. F-4).

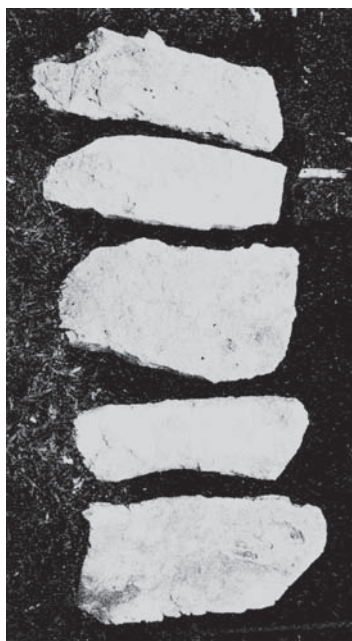
Figure 10.12 Capstones from debris (Str. F-4).

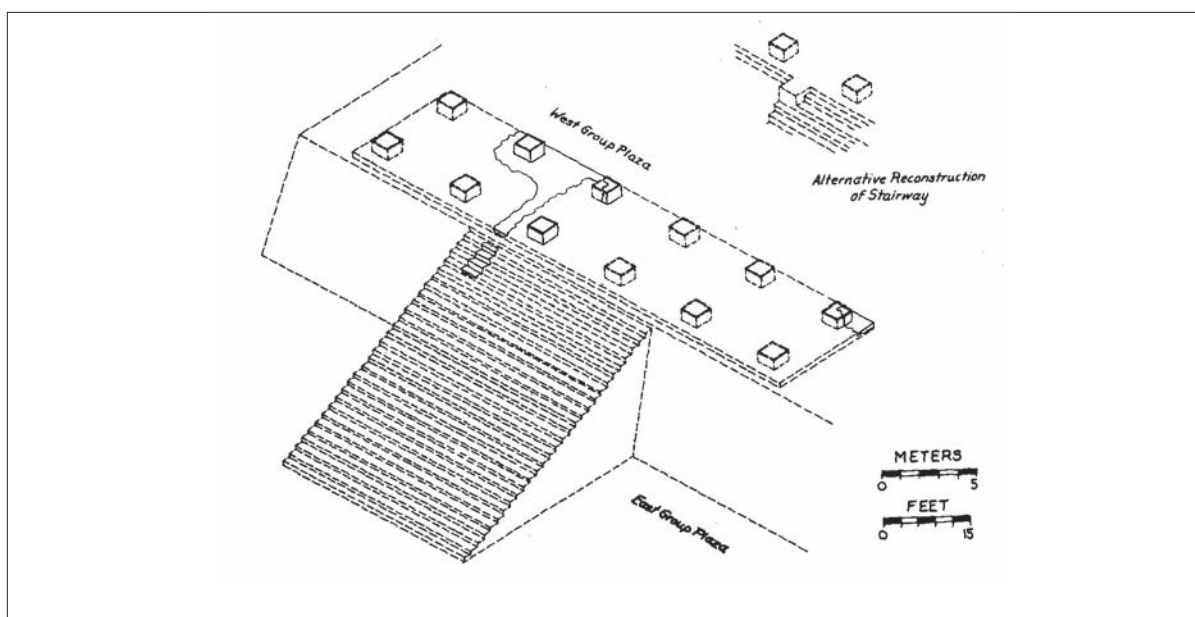
Figure 10.13 Isometric reconstruction of Structure O-18, based on minor excavation and contours of debris; alternative reconstruction at head of stairway based on position of Lintel 8, found as if in semi-position as face of masonry block; roof of structure presumably thatch.

structures can be approached from a main court or plaza. Only one such, Structure O-18, has been examined with a little excavation. By way of exception, this is the only one in this situation at which the contours of the debris showed what sort of building had fallen to ruin. Of the others we can say only that they are not the ruins of vaulted buildings. So far as masonry is concerned, this one consisted only of a building platform and masonry piers as indicated in Figure 10.13.

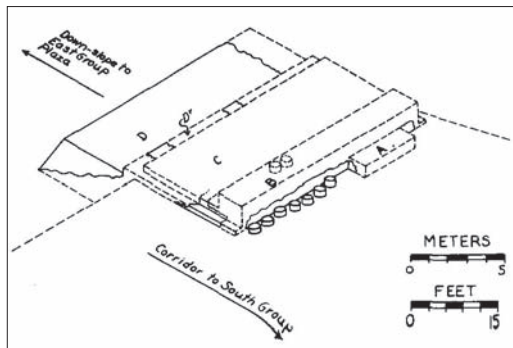
Figure 10.14 Isometric reconstruction of Structure O-7-1st, as seen from left rear corner. Original positions of two of seventeen disturbed altars suggested, others not shown.

As may be noted in Figure 10.14, we have labeled the main higher rear level of the platform Unit C. This is what was found exposed at the surface on either side of center only. At the center a deposit of earth and stone lay on it. This, Unit 4, the secondary mound, formed a sort of tongue of debris, which projected forward from the transverse ridge at the back. In the sections of Figure 10.15 the dotted surface lines pass through this deposit in each direction, the longitudinal one on a line about 1.4 m forward of the face of the bench-like Unit B. It was more sharply defined on the left side (right in the figure). Erosion had probably flattened out the front and right sides since, on the latter, the cists had been partly exposed.

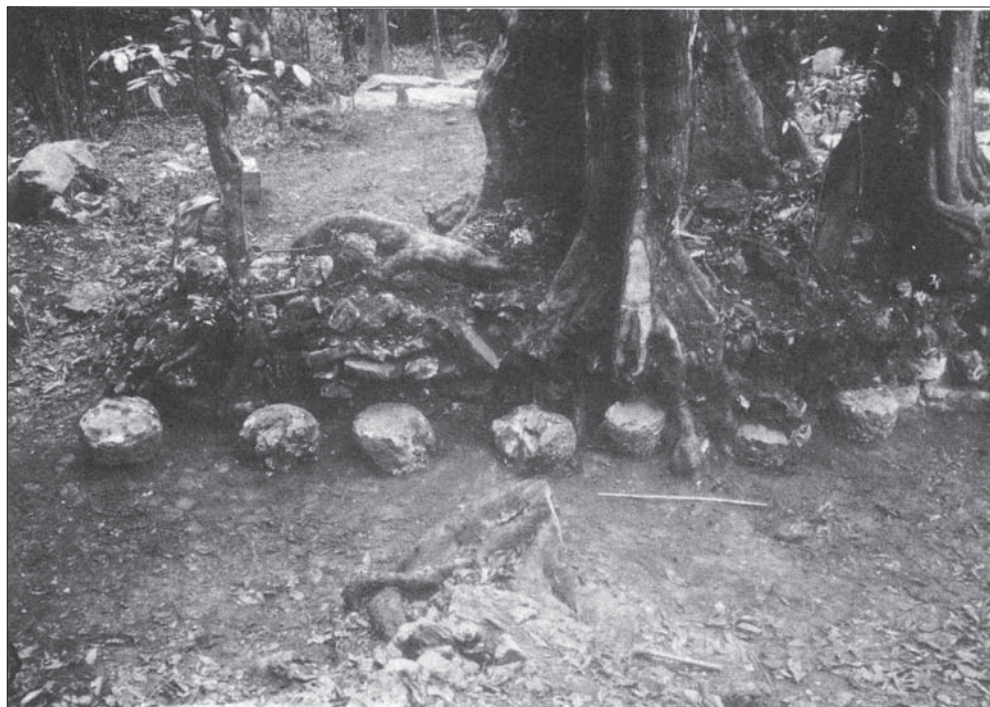
Figure 10.16 Row of seven altars in position on corridor; trees are on ruin of Unit B at rear of platform.

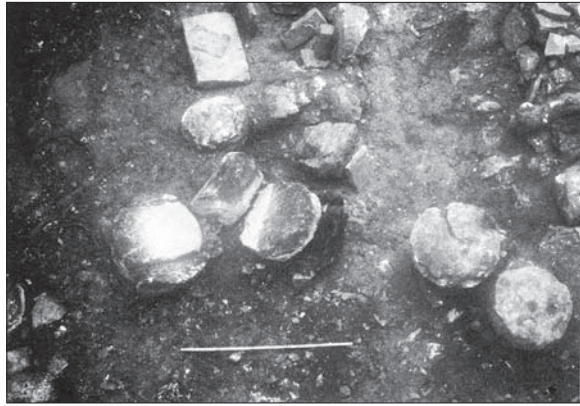
Figure 10.17 Rule on surface of Unit 4, excavated part is beyond nearest altars; looking down and toward right showing eight altars of Groups 2a, 3, and 4 in position; rectangular column replaced in Cist 1.

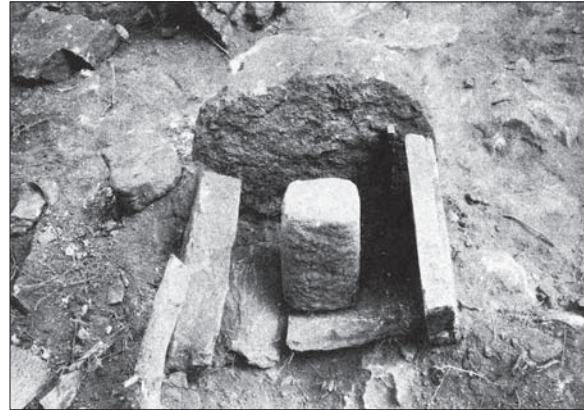
Figure 10.18 Rectangular column replaced in Cist 1 after removing earth from around it; note round altar at rear of cist; floor slab resting directly on fill stone of platform.

crude cists. At least one of these was not a burial cist since it contained a small erect rectangular stone column (Figs. 10.18, 10.19). There is good evidence that others contained cremated human remains, and that intentional disturbance of ancient round altars played a part in the burial rites of the cist-builders. Presumably these people were Indians, and there was nothing to suggest they were recent Lacandon, though the Lacandon left their typical censers elsewhere at the site.

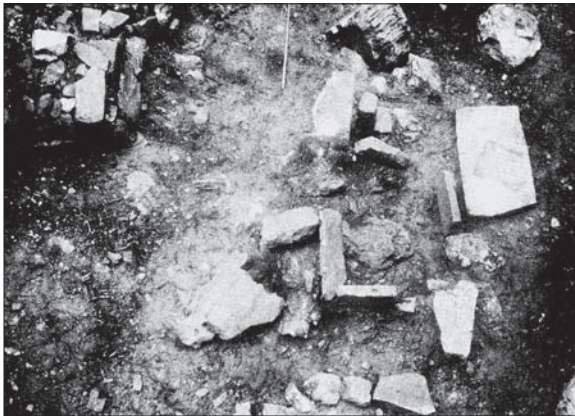
*Figure 10.19 Excavated part of Unit 4, looking down and to left; at right of photograph note Cists 1 and 2, probable cover slabs removed; altar of Group 3 at upper right; large fill stone, loose, behind Cist 2; Cist 3 at upper left, with cover slabs in place.*

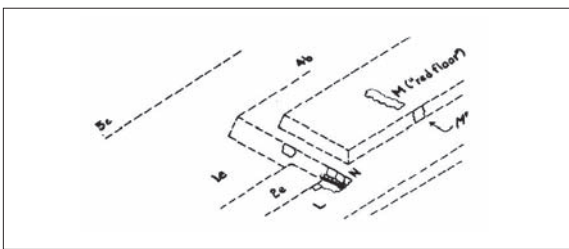
Figure 10.20 Isometric reconstruction: Structures V-1-3rd-A and B.

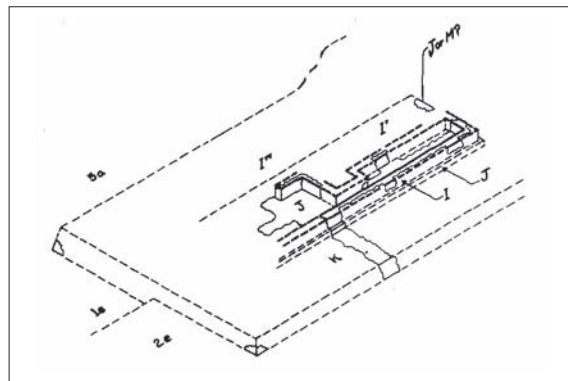
Figure 10.21 Isometric reconstruction: Structure V-1-2nd-B.

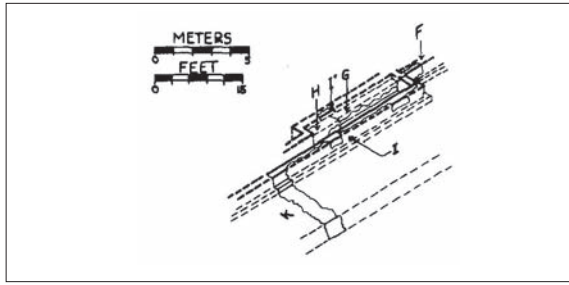
Figure 10.22 Isometric reconstruction: Structure V-1-2nd-A.

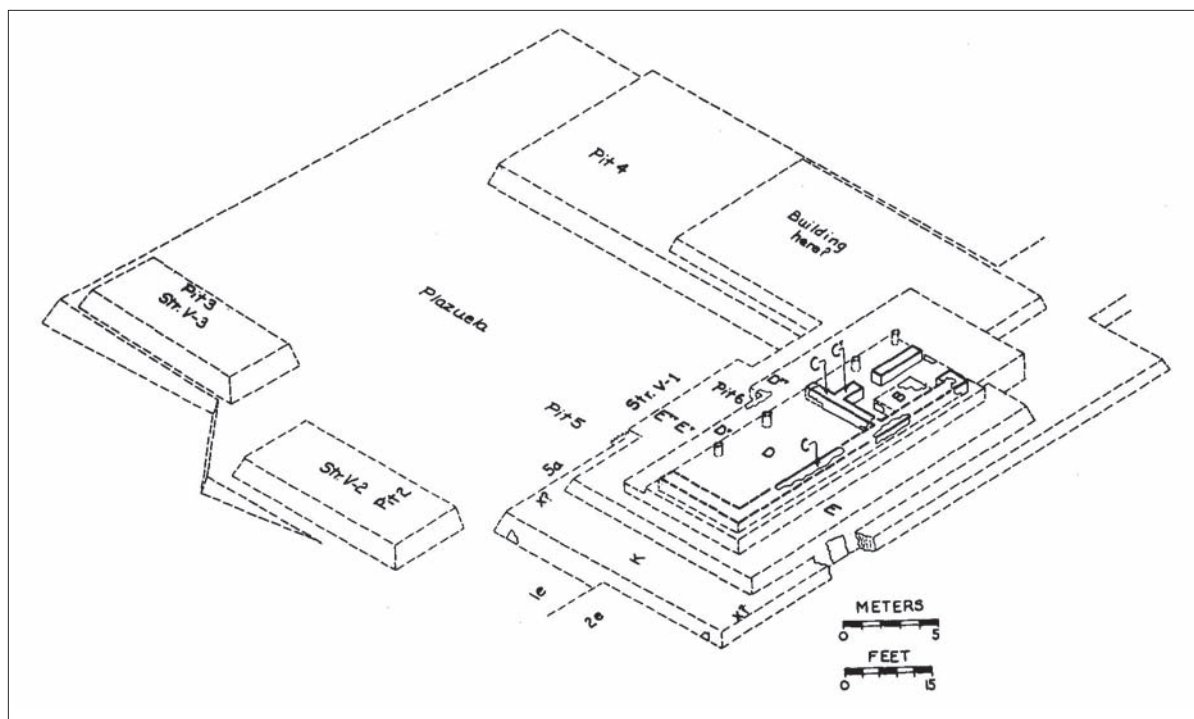
Figure 10.23 Isometric reconstruction: Structure V-1-1st-B (locating Pits 1-6).

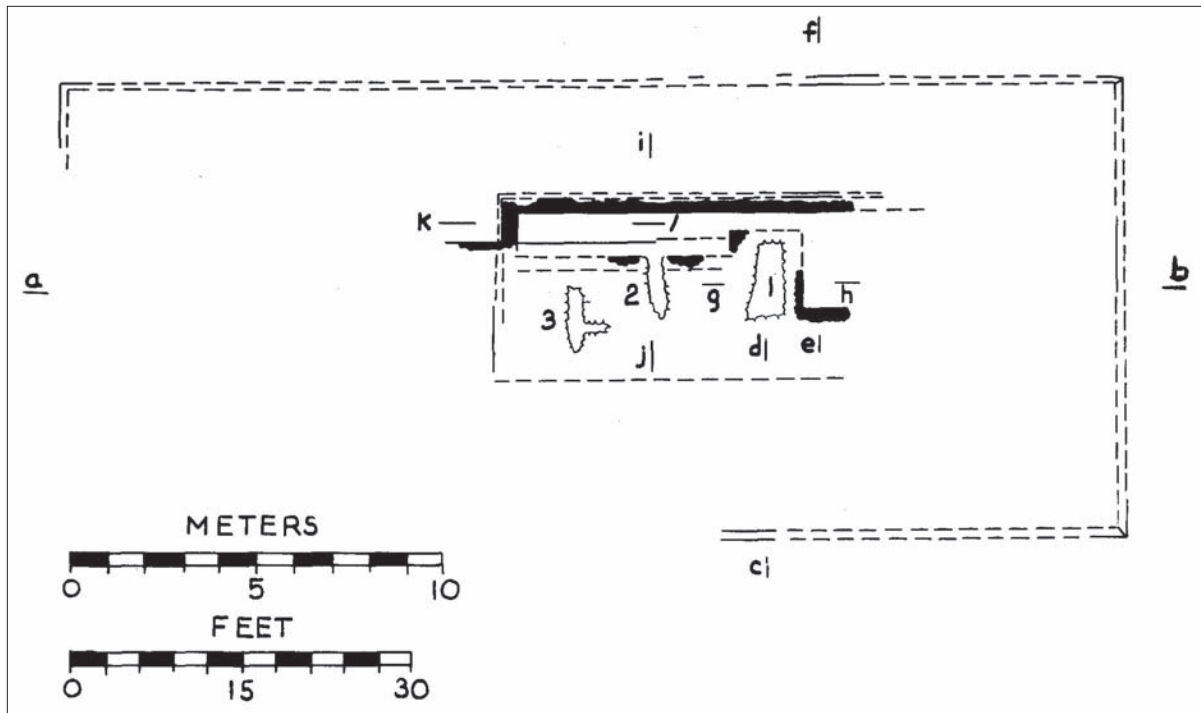
Figure 10.24 Plan: Structure V-1-2nd-B and -A (locating Sections A-B to K-L and Burials 1-3).

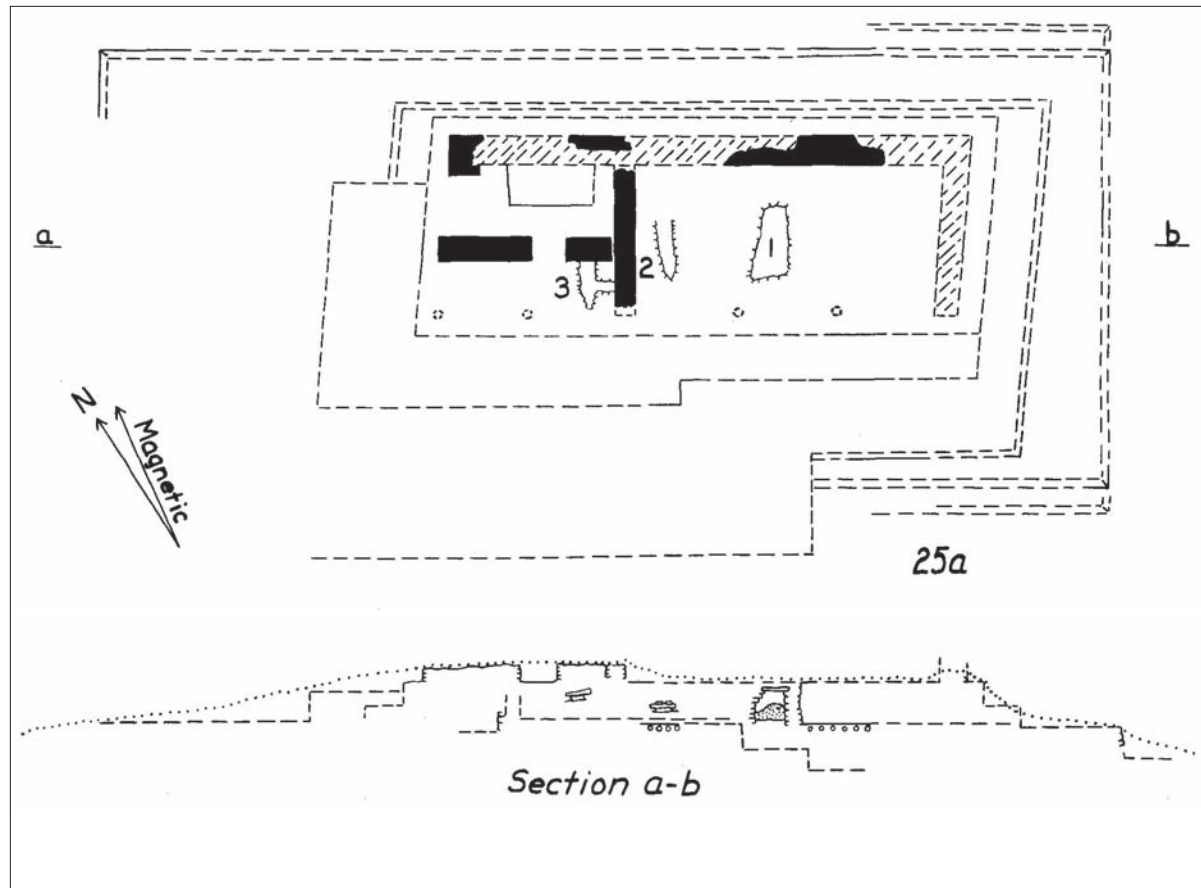
Figure 10.25 a. Plan: Structure V-1-1st-B (locating Sections A-B and Burials 1-3); b. longitudinal Section A-B through Strs. V-1-3rd, -2nd, and -1st and Burials 1-3.

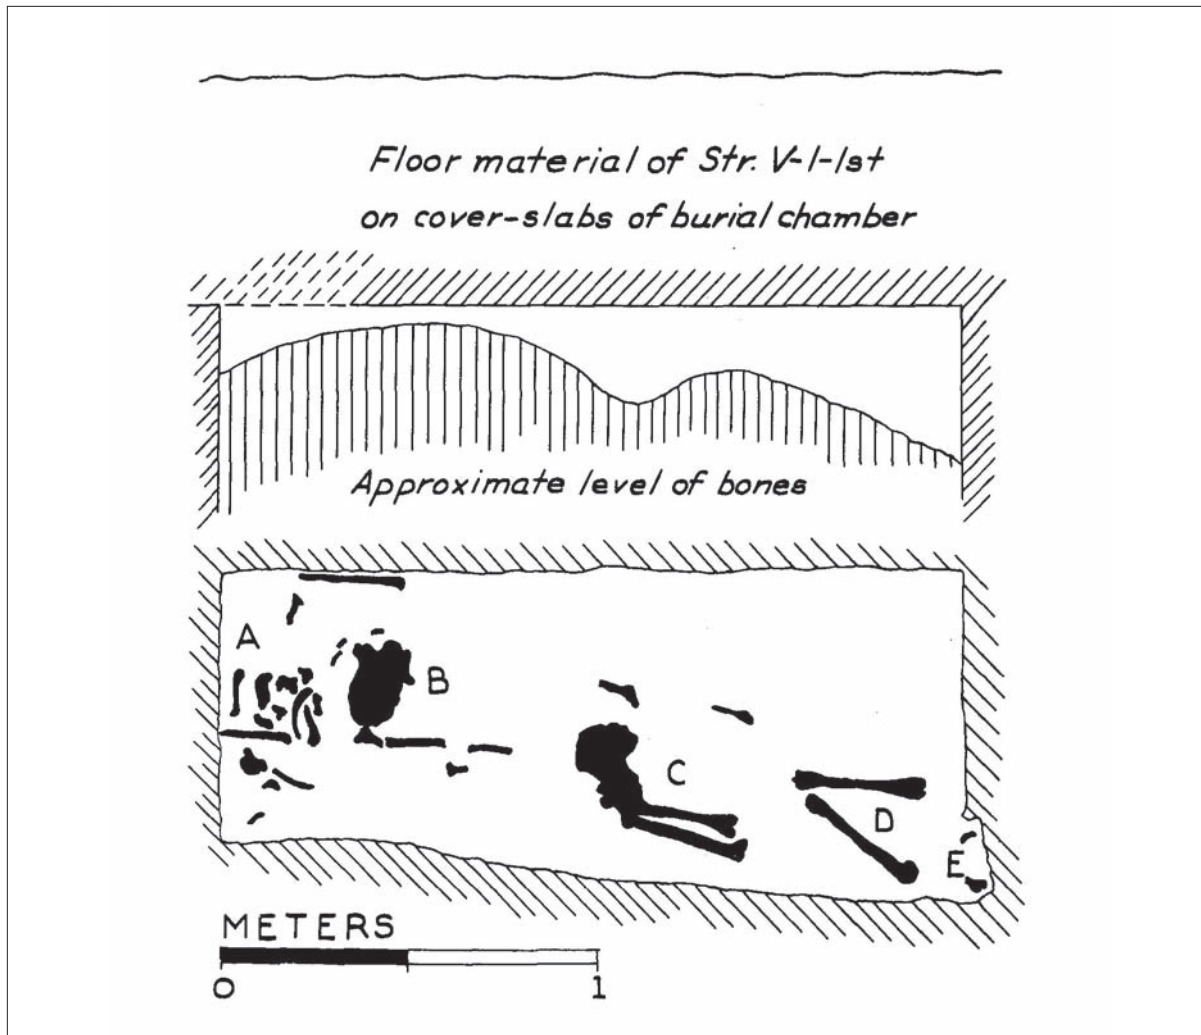
Figure 10.34 Plan and section of Burial 1, showing locations of certain bones after removal of many fragments.

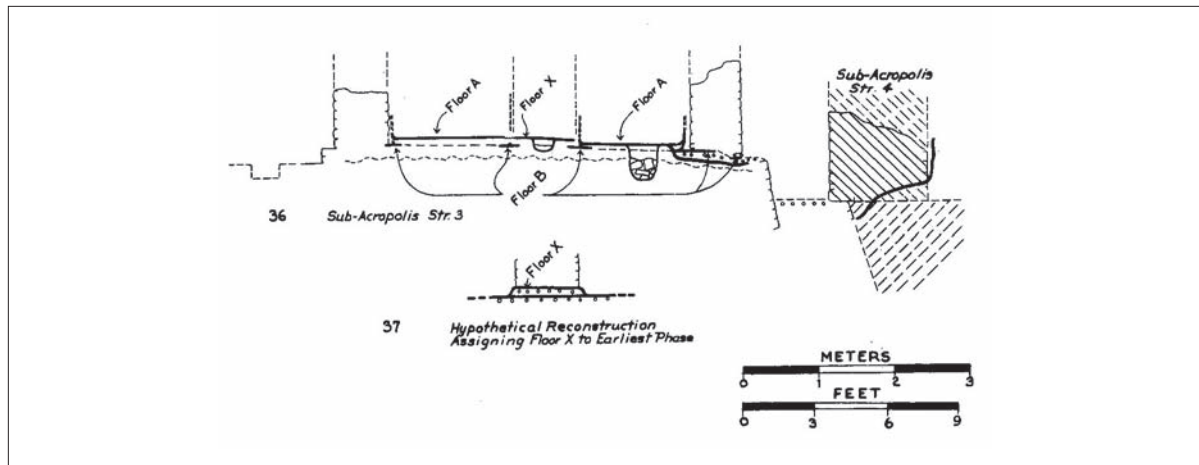
Figure 10.36 Cross section of Sub-Acropolis Structure 3 and remnant of Structure 4.

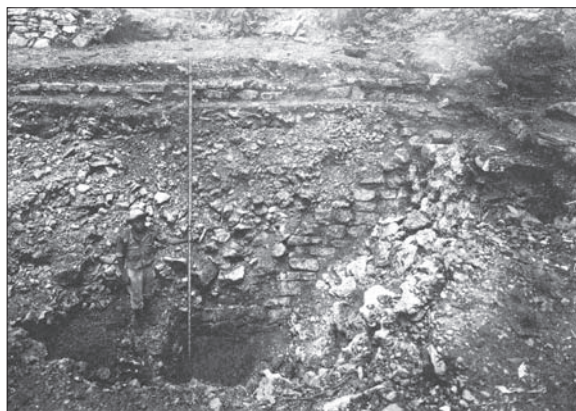
*Figure 10.38 Masonry at left front corner of Structure 3.*

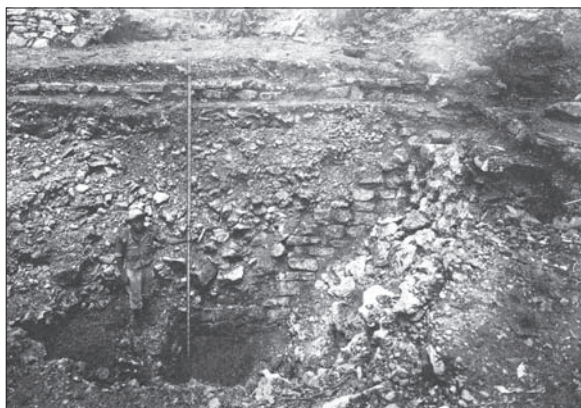
*Figure 10.39 Remains of building platform of Structure 3 and of facing of high terrace in Pit 2*

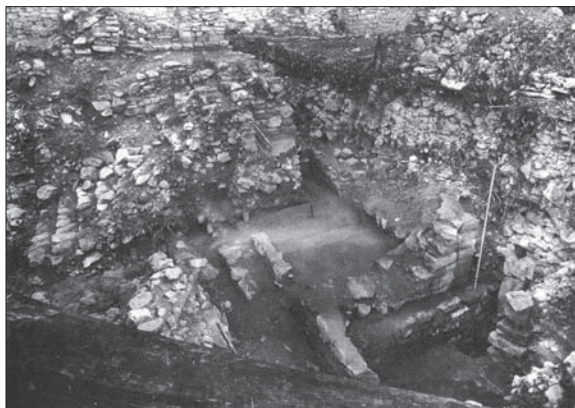
*Figure 10.40 General view of excavation showing Structure 3 below floor of Structure J-7-1st and -2nd; remnant of Structure 4.*

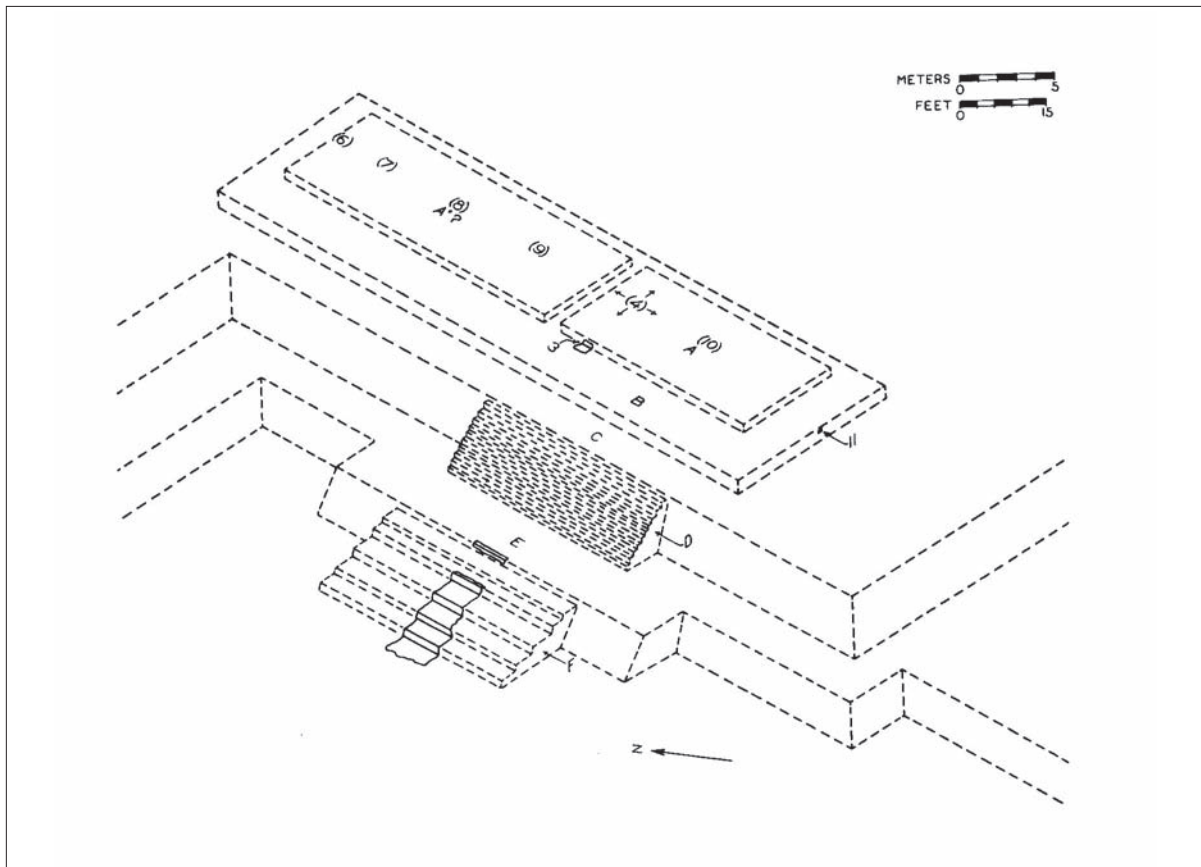
Figure 10.41 Isometric reconstruction of Structure P-6.

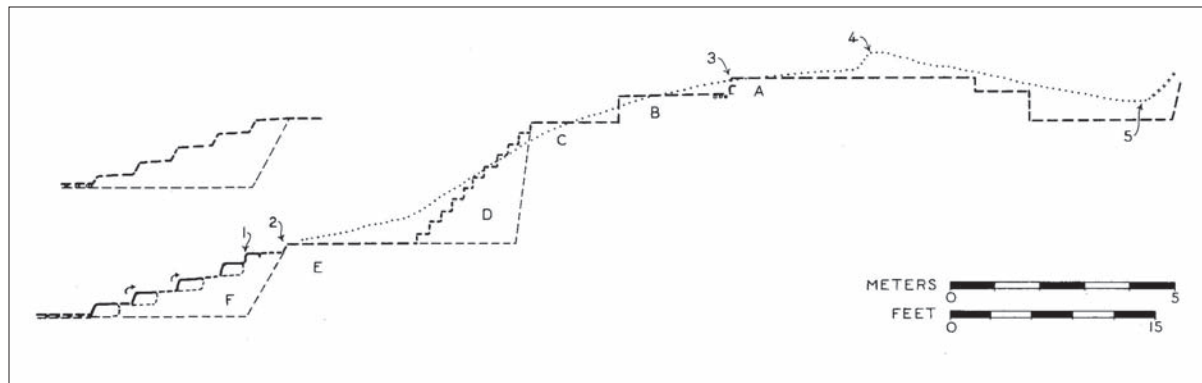
Figure 10.42 a. Cross section of Structure P-6; b. Hypothetical reconstruction of cross section of megalithic flight of stairway.

Figure 10.42b shows a hypothetical restored cross-section of the lower flight. In this the risers and treads are equalized. This is probably what was aimed at, except, perhaps, for a narrower fourth tread and a wider and lower fifth and final step. The actual measured section is followed in the three-dimensional drawing of Figure 10.41. Even here it appears necessary to postulate five deep-tread steps, rather than the four suggested on the map. As the reconstructed section of Figure 10.42b stands, the front of each step rises 30 cm and slopes

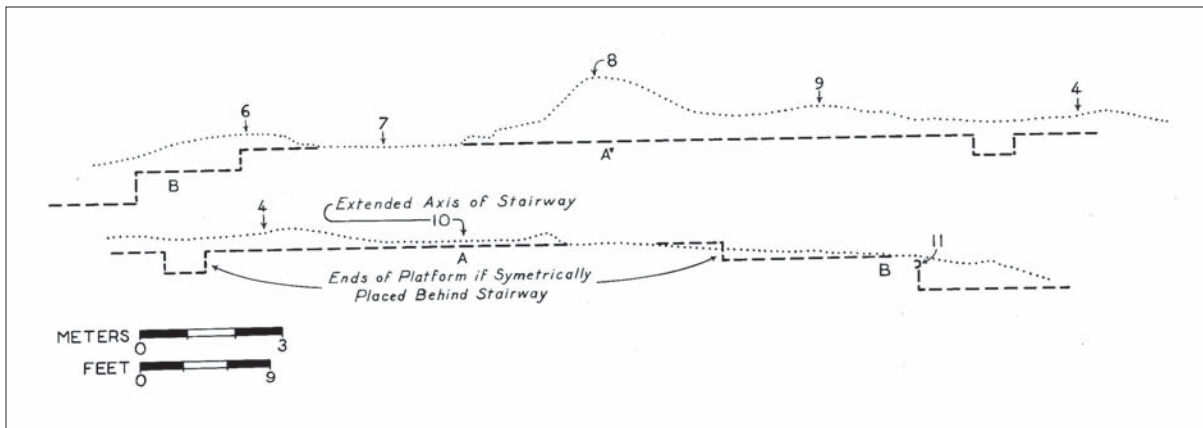
Figure 10.43 Longitudinal section (in overlapping segments).

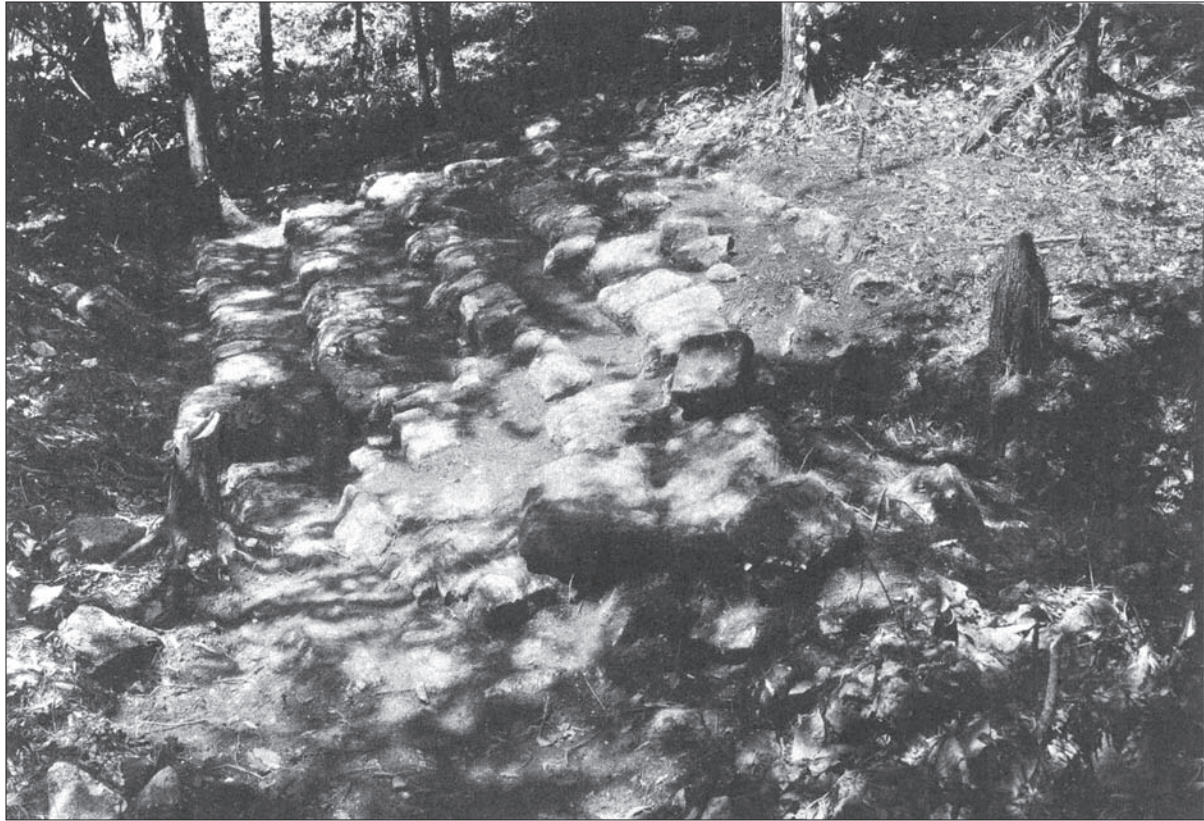
*Figure 10.44 Megalithic lower flight of stairway.*

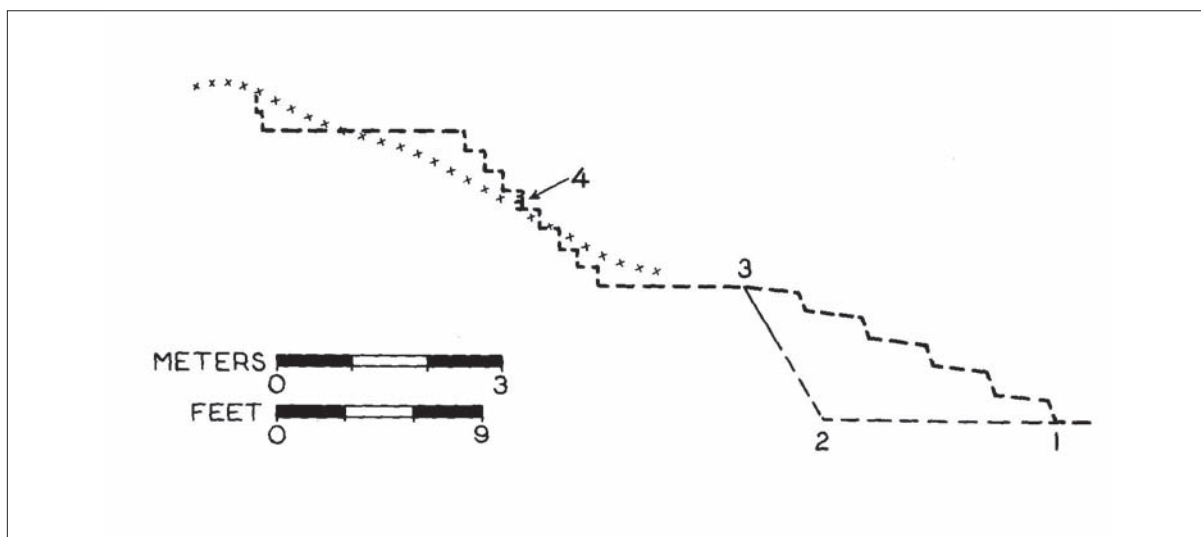
Figure 10.45 Composite cross section of Structure O-2.

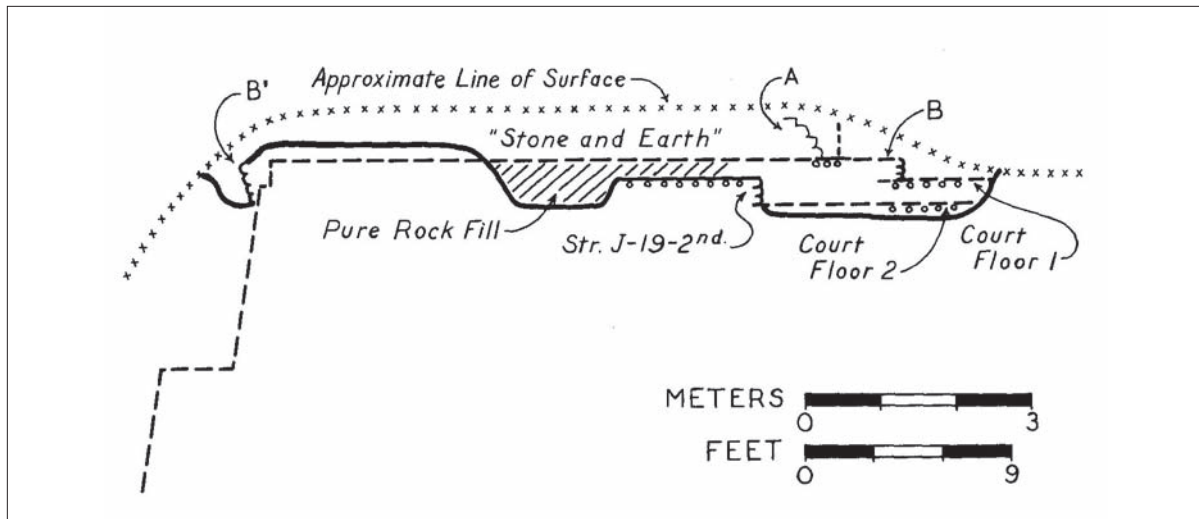
Figure 10.46 Cross section of Structure J-19.

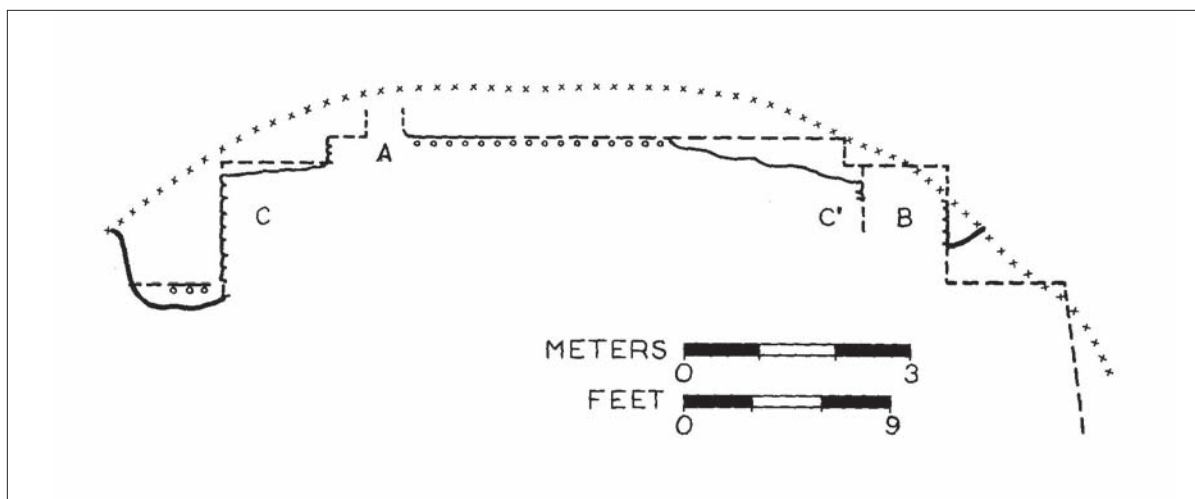
Figure 10.47 Cross section of Structure J-24.

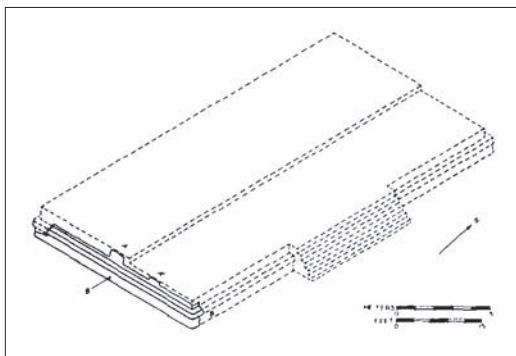
Figure 10.48 Partial isometric reconstruction of Structure S-5.

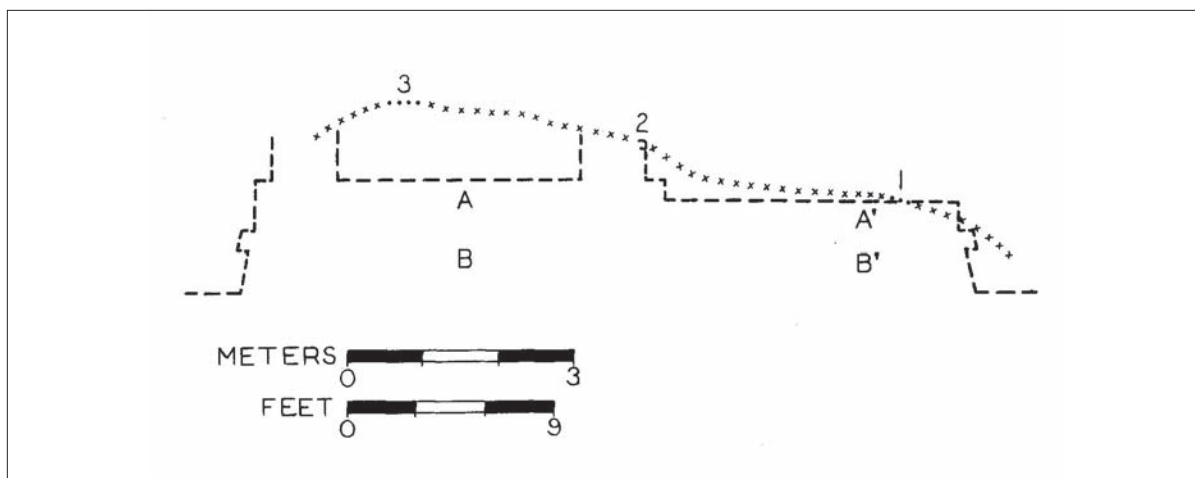
Figure 10.49 Composite cross section of Structure S-5.
