Stucco Relief from Structure XIX, Palenque

by: Marcia Valle Rangel and Juan Alfonso Cruz Becerril

Site: Palenque, Group of the Cross

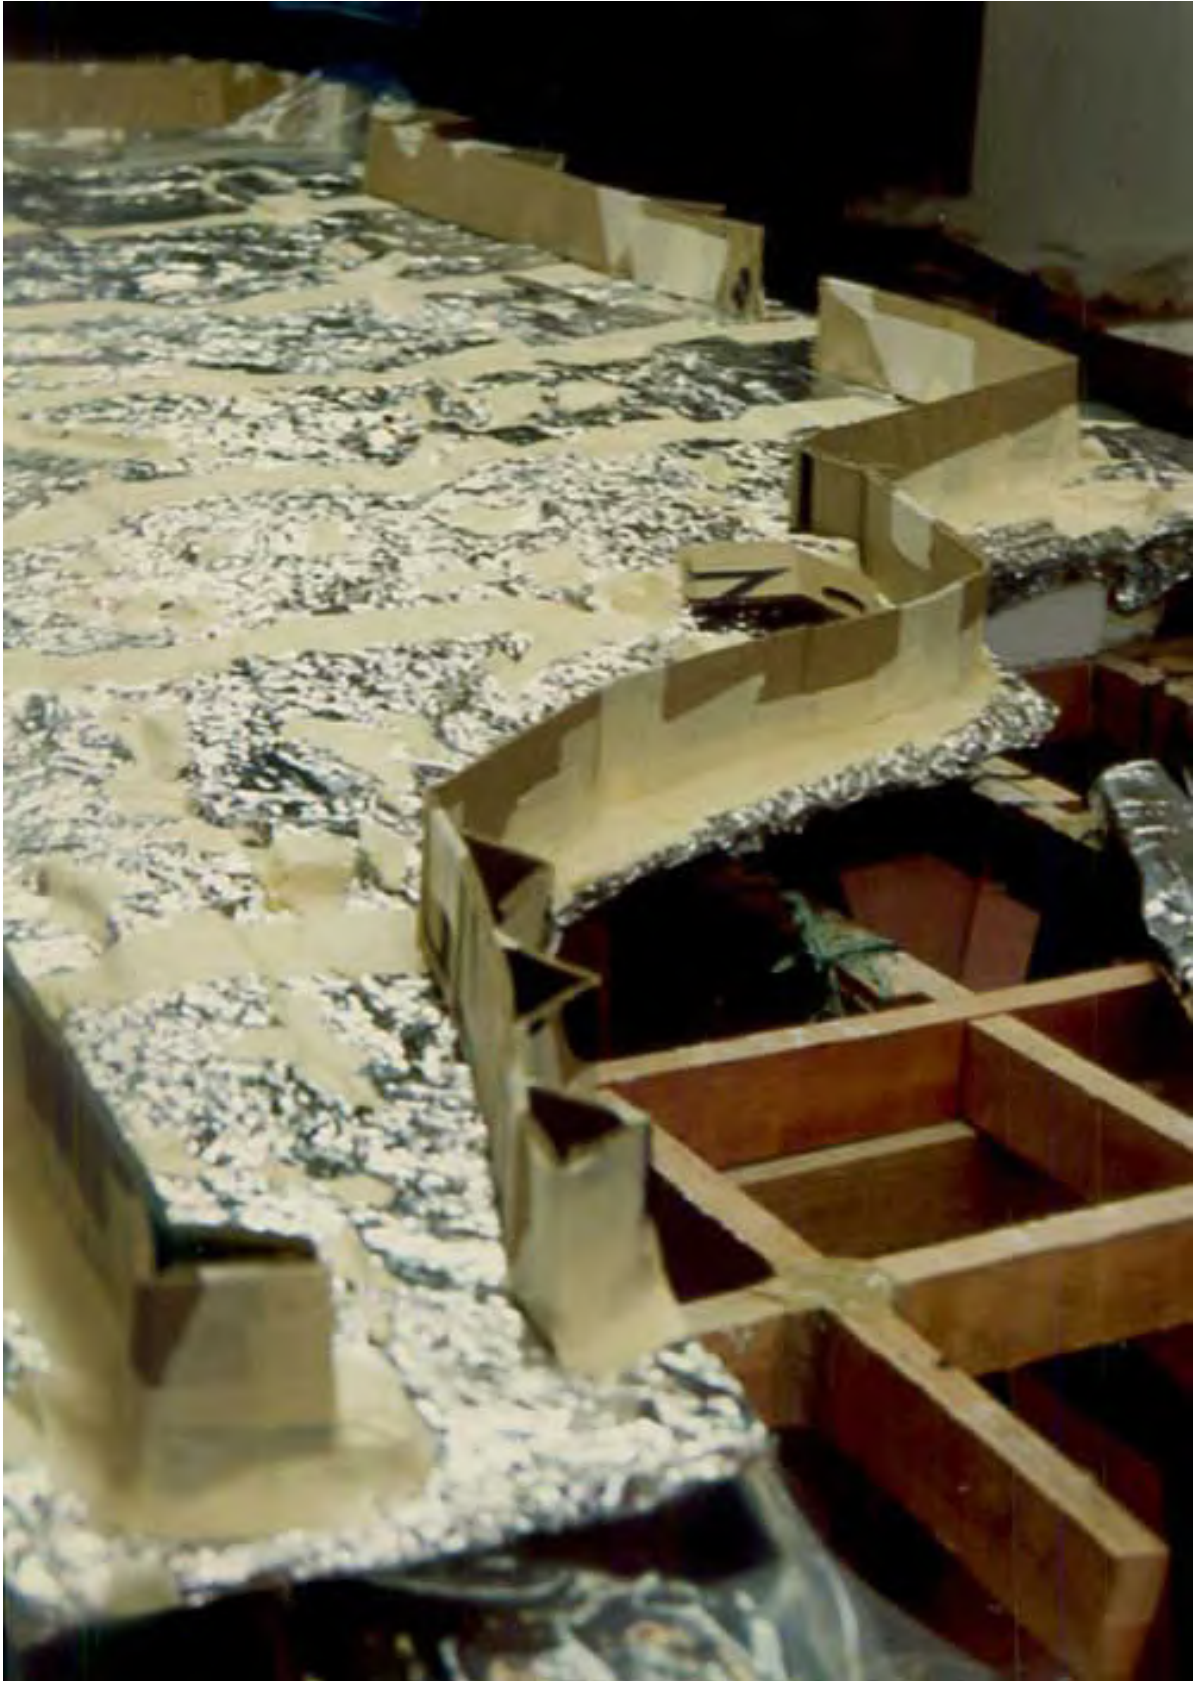
Photo 65. Partitions for retaining the polyurethane foam layer

This was uniformly applied on the entire surface of the relief, which had been previously partitioned to hold the resin in place (see [photo 65](#)); once the layer had fully reacted, it formed a hard and enduring surface that absorbed movement, additionally providing the advantage of having the precise shape of the relief, so it did not move (see [photo 66](#)).

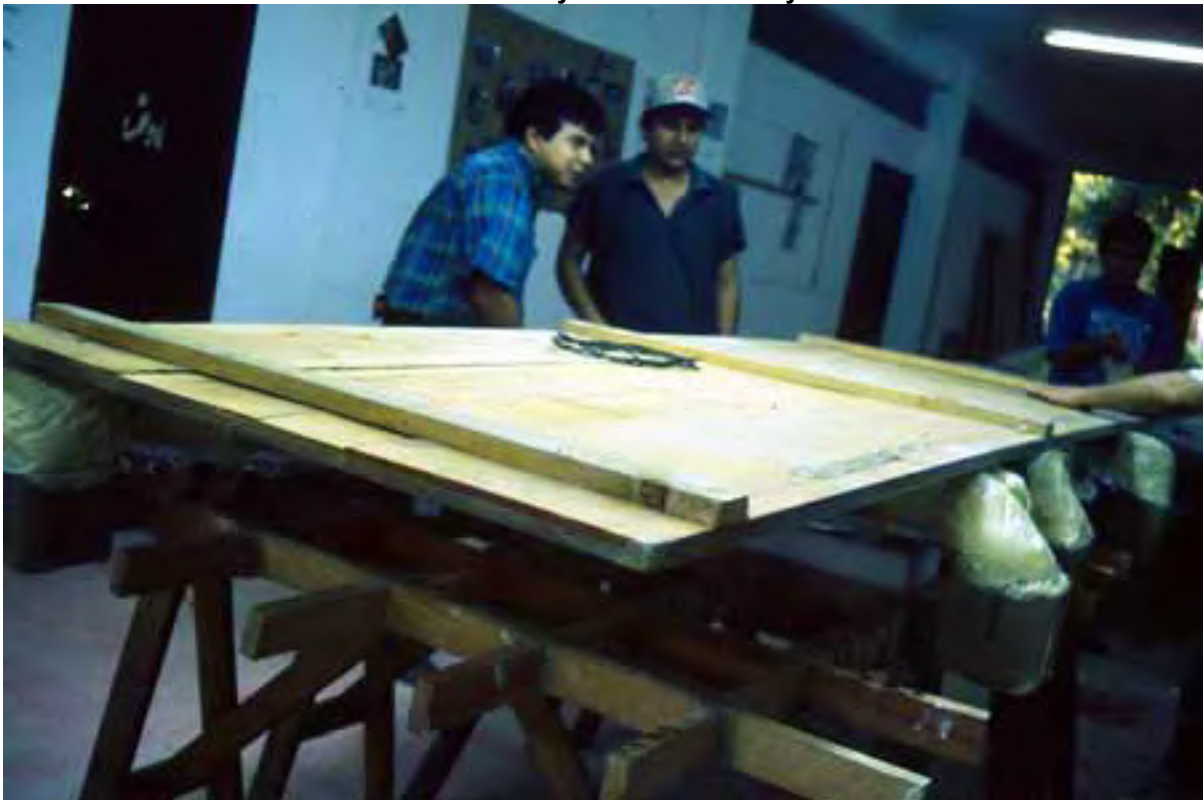
Photo 67. Placement of plank for turning over the stucco panel

On top of the polyurethane foam, a plank was positioned and tied up to the wooden frame, and then the entire stucco panel was turned over (see [photo 67](#)), enabling us to proceed with the necessary treatments on its back, to prepare the piece to receive its permanent support (see [photo 68](#)).

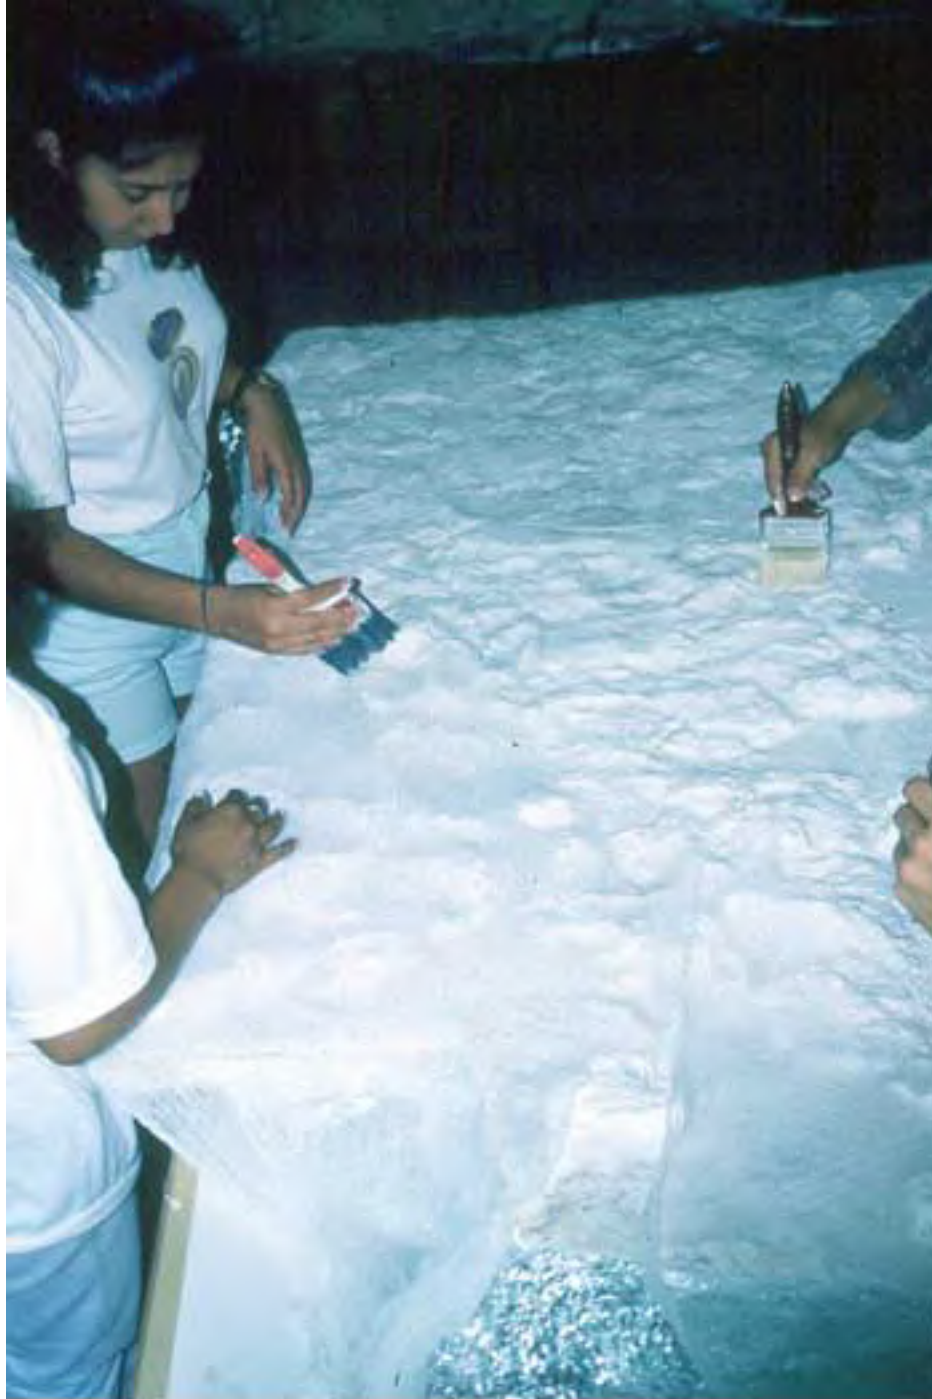
Photo 71. Application of the reversible layer

As an insulating and reversible layer, a cheesecloth cover was applied using calcium caseinate as adhesive agent, and subsequently an additional folded cover was applied using once more cheesecloth and calcium caseinate as an adhesive agent; both were applied with a brush (see [photo 71](#) and [photo 72](#)).
