8 Ballcourts

Linton Satterthwaite

1 BALLCOURT TERMINOLOGY

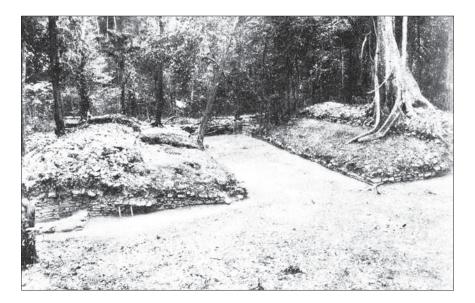
Figure 8.23 General view of West Group Ballcourt, from south to west. Structure K-6a at observers left, Structure K-6b at observer's right; Stela 39, at base of temple Structure K-5-1st shows through trees in background. Aside from bench tops, structure tops are untouched, except for bushing, and for trench through Structure K-6a.

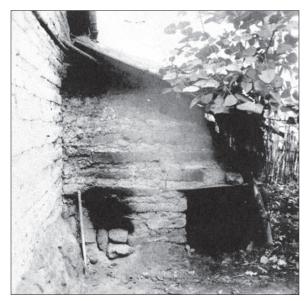
Figure 9.6 Modern sweat house No. 2 at Chichicastenango, Guatemala, showing smoked area above opening plugged with stones.

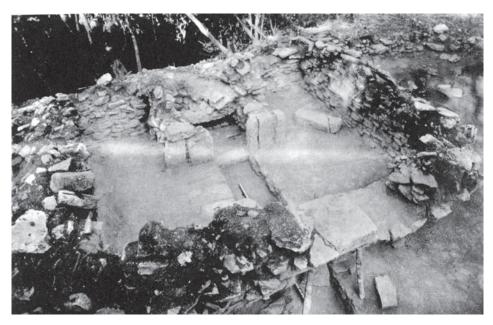
Figure 9.16 Looking down on sweat room; rod lies in original sunken passage (as in Phase B); base of sherd wall of Phase A still in place within firebox; fragments of lintel moved and fitted together to observer's right of firebox.

The entire front of the firebox in Structure N-1 (Fig. 9.16) up to the level of a lintel over its opening, consisted of slab-like massive stones set on end. In Structure P-7 both jambs of the door-like firebox opening were of single, large stones set on end (Fig. 9.64); and in Structure S-2 this was the case with one of the two sides of the corners of the opening (Fig. 9.34). This on-end sort of construction is thus found in all three of the fireboxes known, but is completely unknown elsewhere at the site,

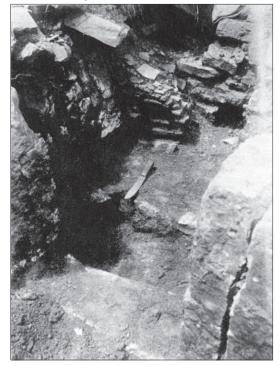
Figure 9.20 Interior of firebox seen through its front opening; floor dug out behind sill of Structure N-1-1st to show earlier sill (Unit L) behind it, at point of knife; remnant of sherd wall and right side wall above and left of knife in picture; masonry of rear wall of sweat room at upper right; whiteness of side wall due to brushing its calcined surface.

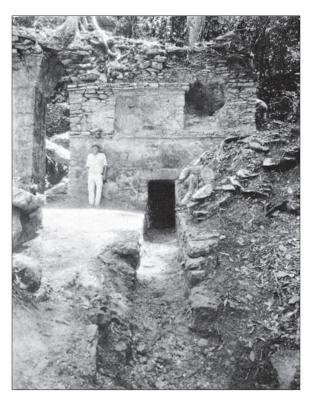
Figure 9.62 Structure P-7-1st-B, front façade of sweat room (door sill of Structure P-7-1st-A removed; man stands on excavated portion of floor of enclosing building).

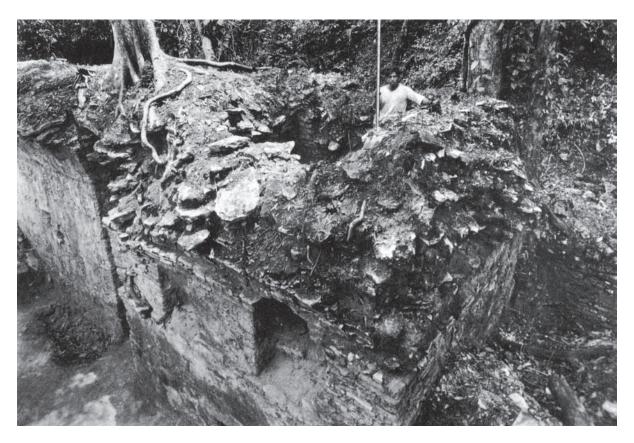
Figure 9.69 Ruin of semivaulting over sweat room, Structure P-7-1st, seen from front left corner; workman holds rod, marked in centimeters, on floor of chamber (the roof of sweat room); debris in chamber has been cleared.
