PIEDRAS NEGRAS ARCHAEOLOGY, 1931–1939

Piedras Negras Preliminary Papers Piedras Negras Archaeology: Architecture

Linton Satterthwaite, Jr., Mary Butler, and J. Alden Mason

Edited by John M. Weeks, Jane Hill, and Charles Golden

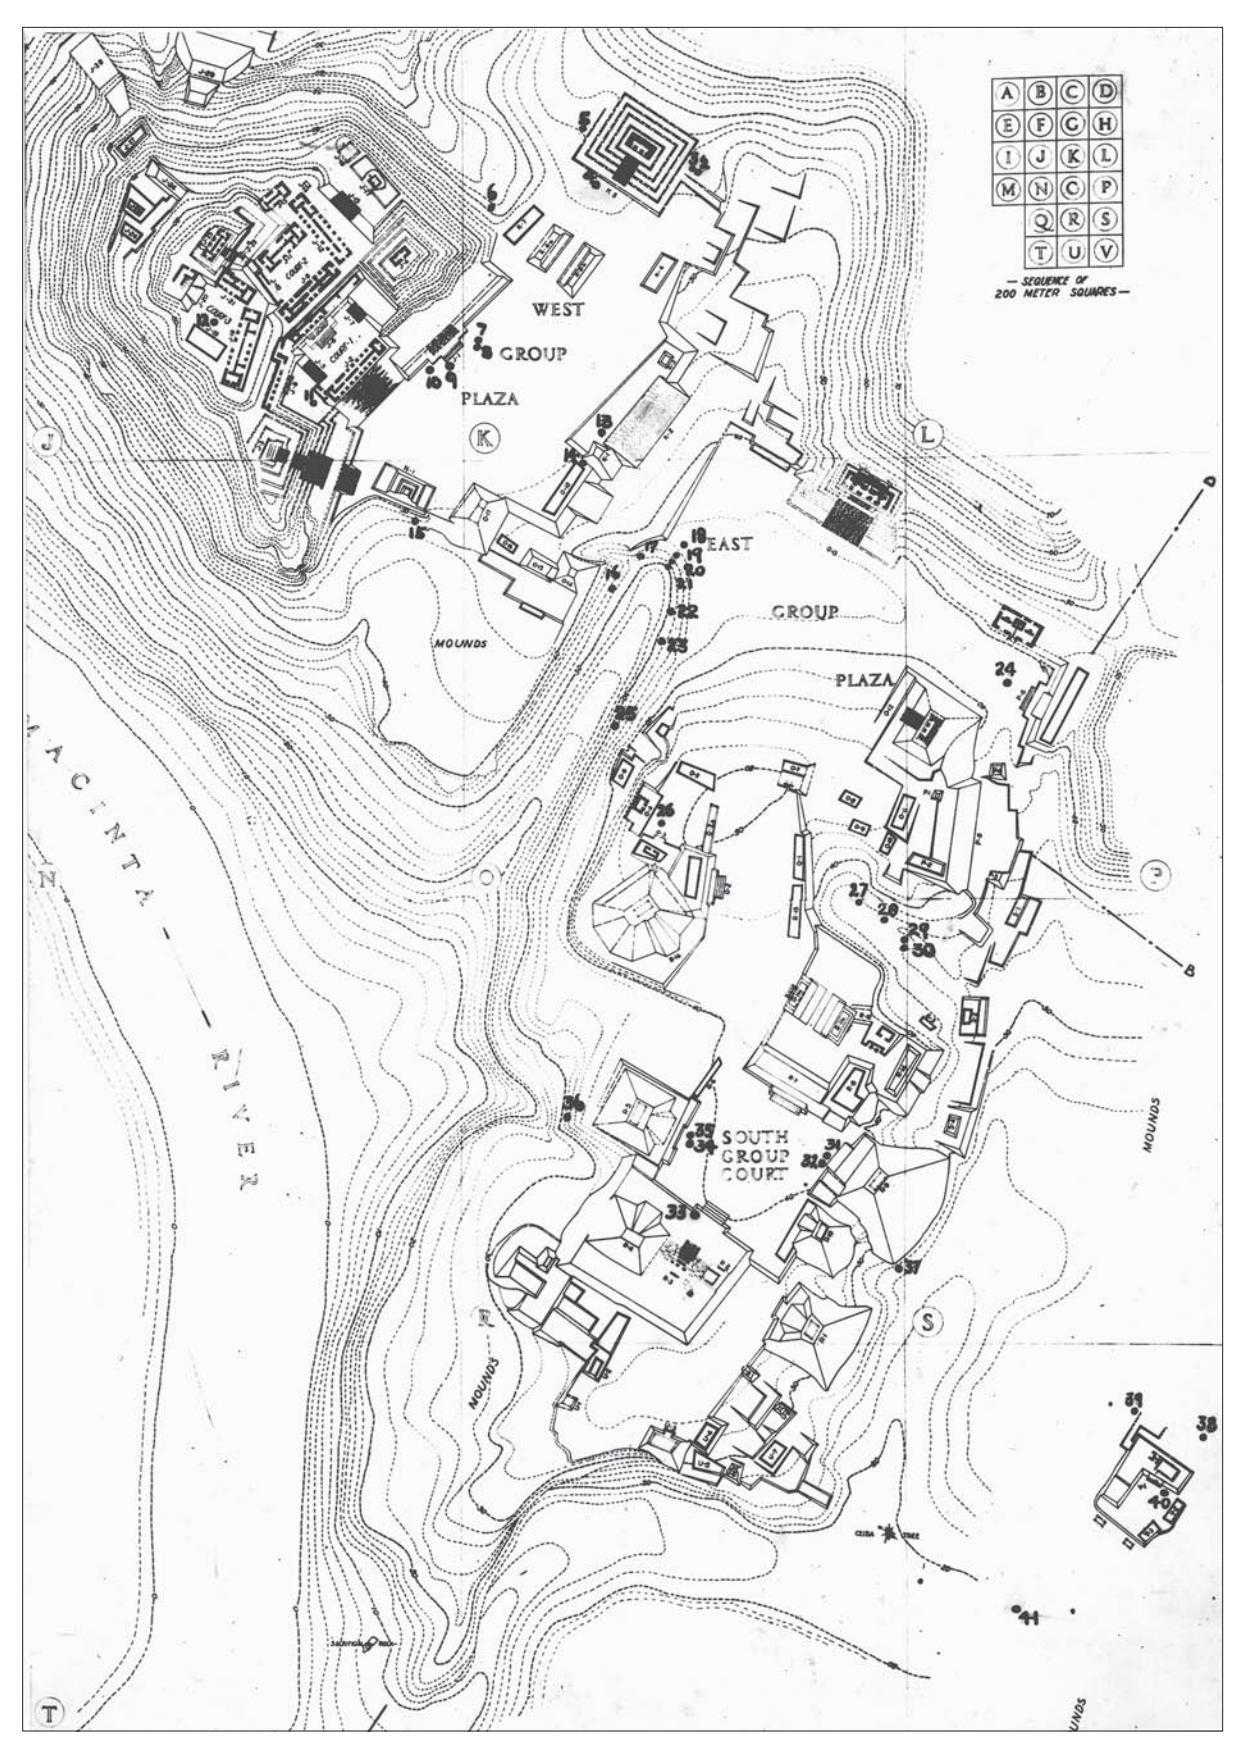
Figure 4.10 Part of the plan of the city of Piedras Negras, showing locations of pottery test pits.

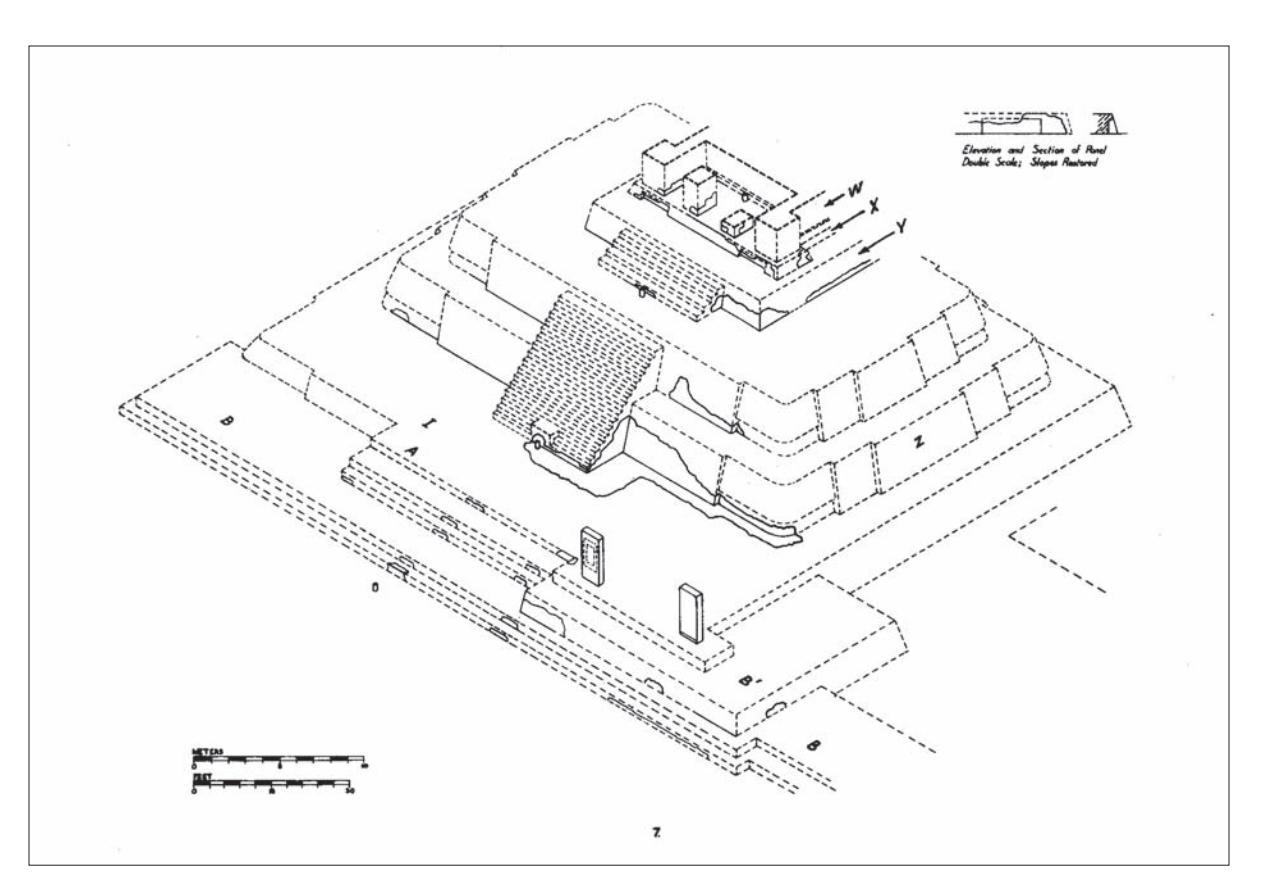
Figure 7.7 Isometric reconstruction: Phase A of Series One. Letters refer to units described in text. Unit A also constitutes Phase A of Series Two. Rear of upper units not reconstructed; Elevation and section of panel; double scale, slopes restored.

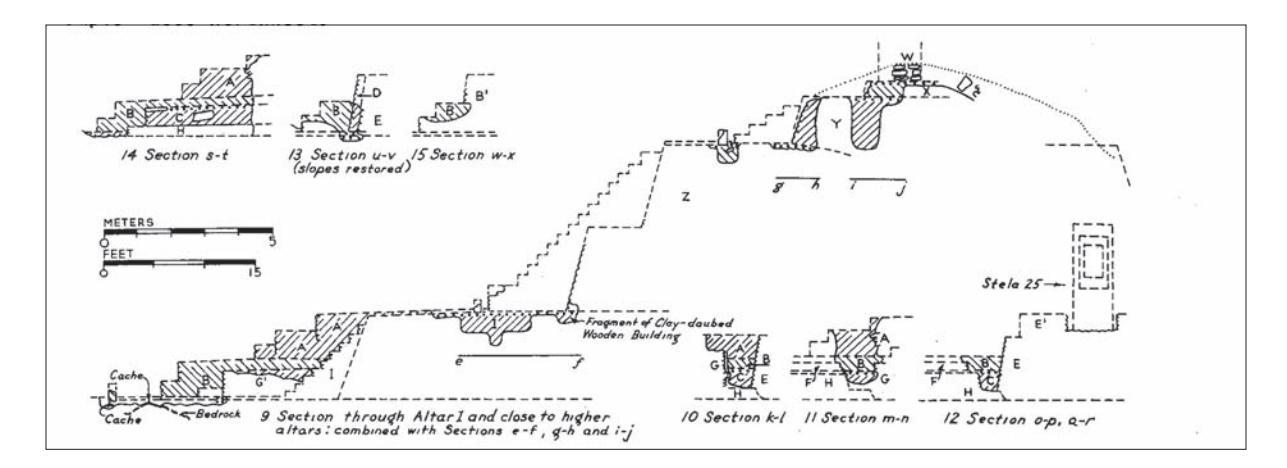
Figure 7.9–15 Composite section, including Sections E-F, G-H, I-J (9); Section K-L (10); Section M-N (11); Composite section, Sections O-P and Q-R. The latter passes through Stela 25 cist, the stela restored to position (12); Section U-V (13); Section S-T. This drawing shows positions of the two fragments of small plain stela as found in Unit C (14); SectionW-X (15).

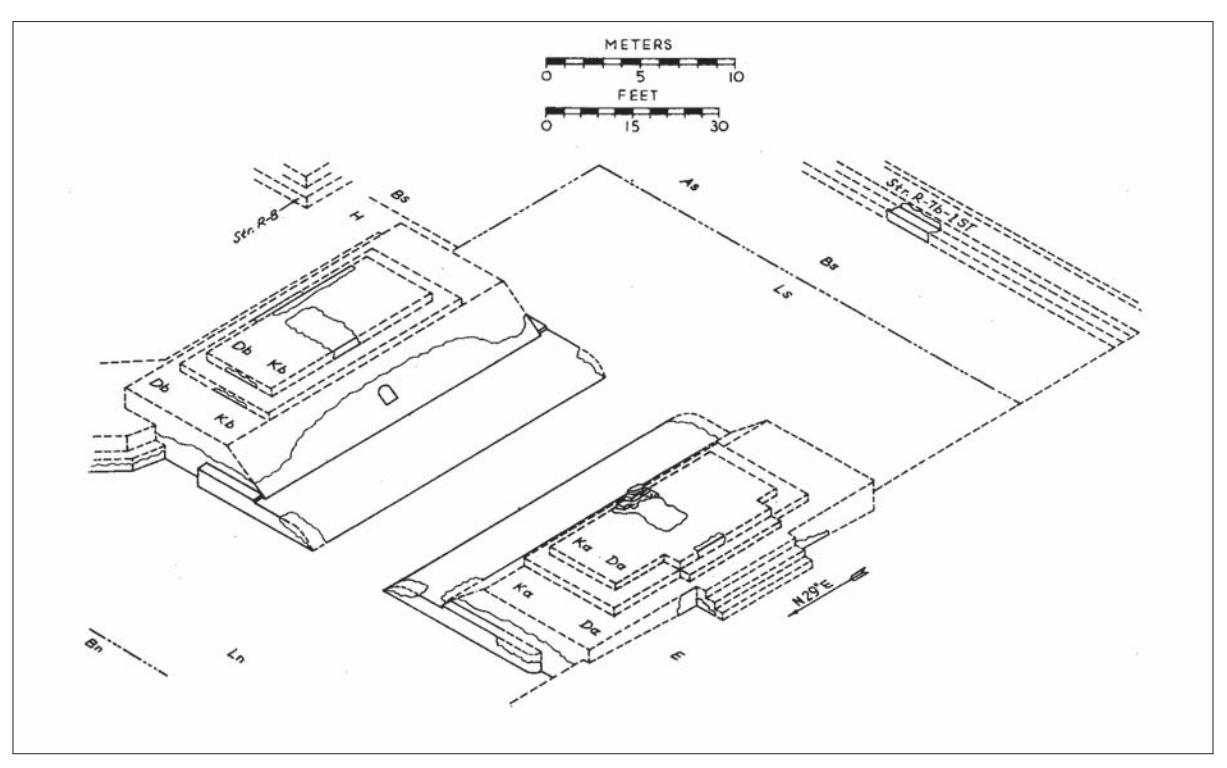
Figure 8.2 Isometric reconstruction: Structure R-11-1st-B (Units E, Da, Db, Bn, and Bs).

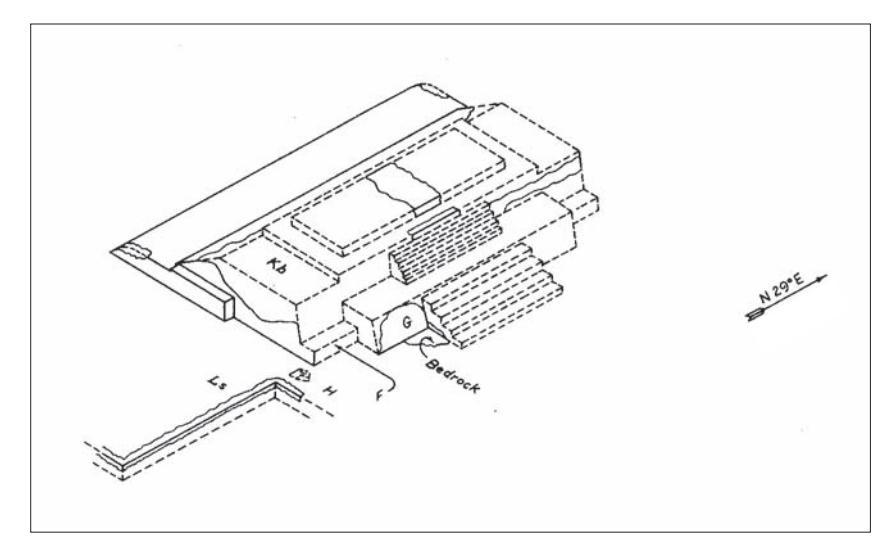
Figure 8.3 Isometric reconstruction: Structure R-11-2nd-A (Units H, G, and F). Rear of Structure R-11b in this phase.

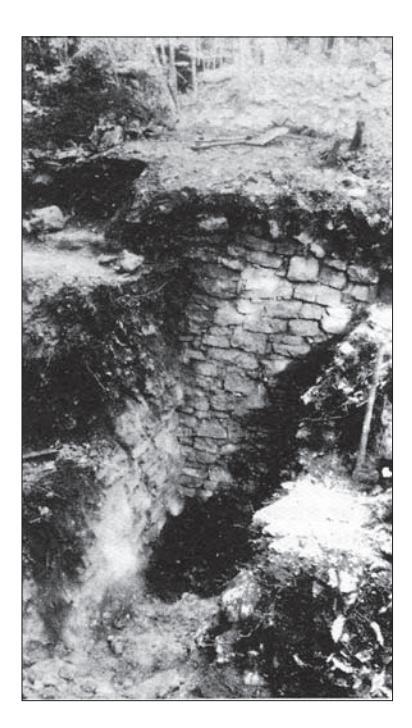
Figure 8.16 Trench through late fill and debris of R-11b and Structure R-12 to show earliest rear wall and remnant of stair sidewall of Structure R-11b (R-11-2nd-B phase).

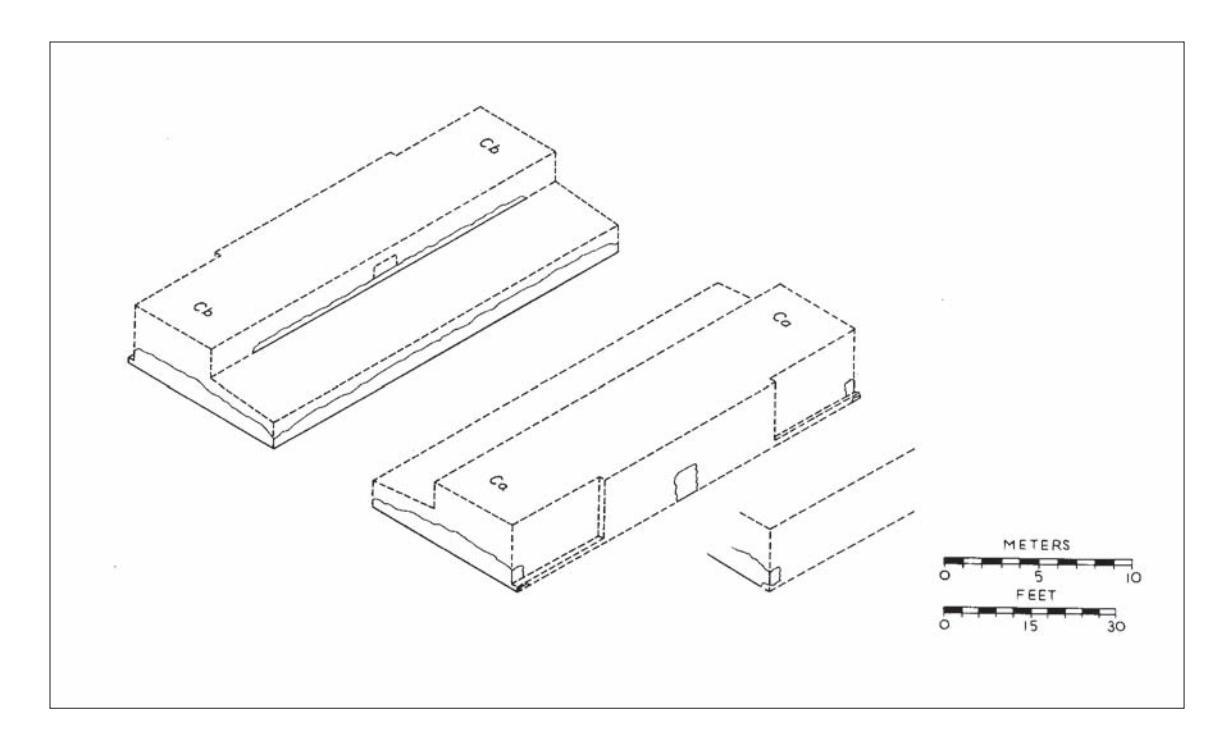
Figure 8.17 Isometric reconstruction Phase C of West Group Ballcourt Structure K-6a at right, Structure K-6b at left, with alley between. At extreme right, alternative reconstruction of rear of Structure K-6a.

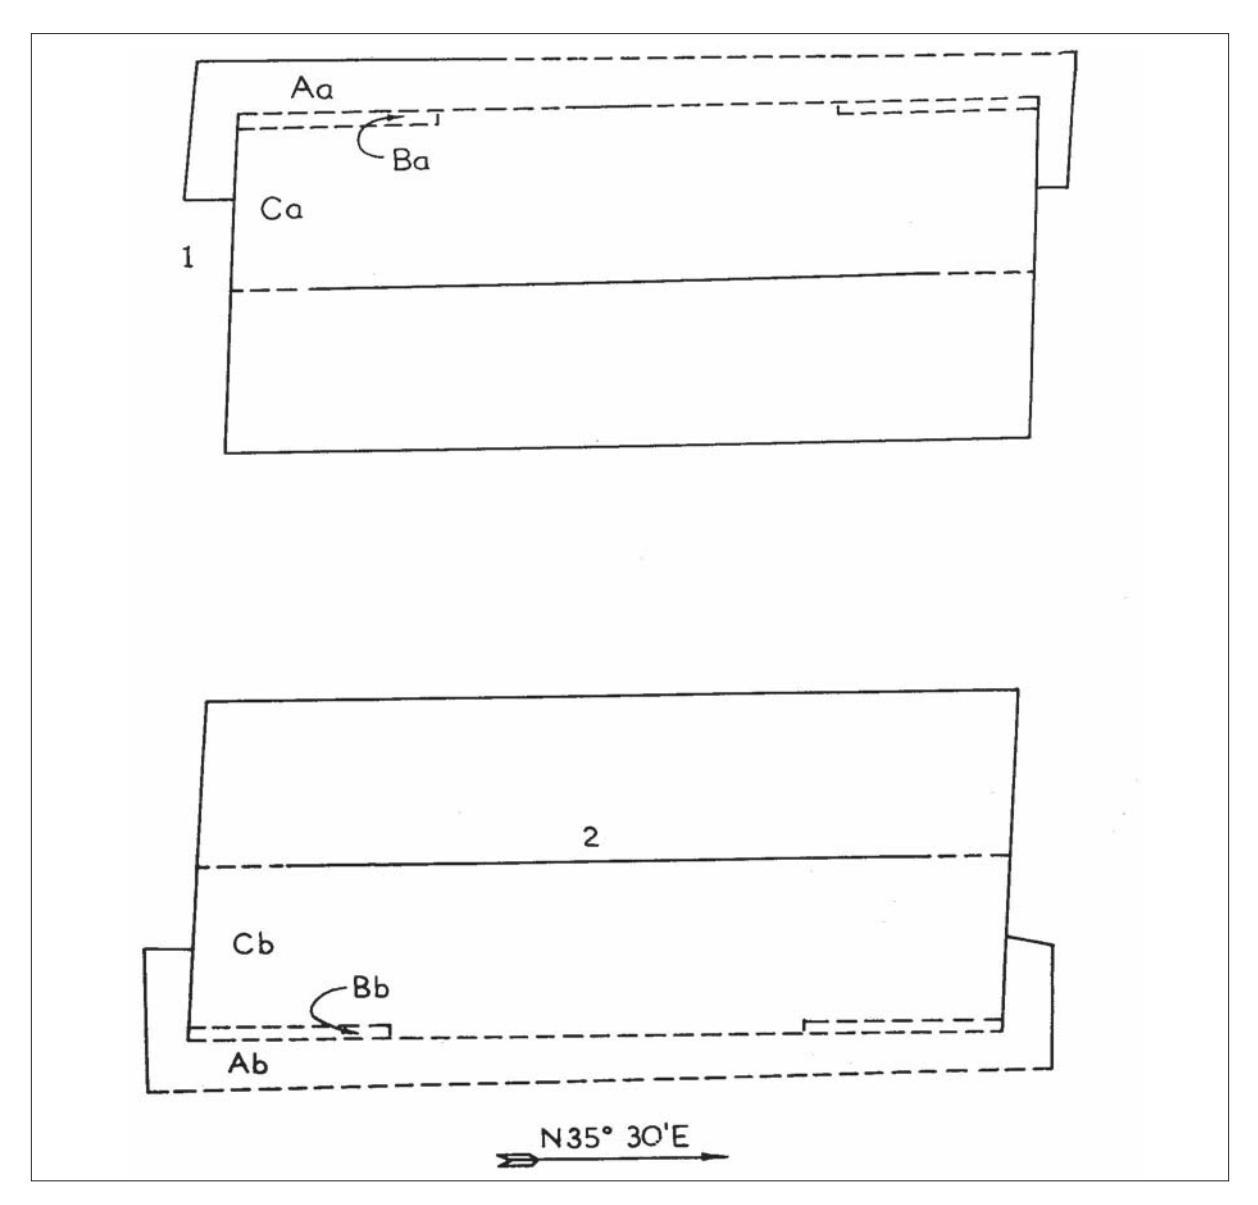
Figure 8.20 Plan of West Group Ballcourt, Structure K-6a at top, K-6b below with alley between. Lettered units of all phases are shown.

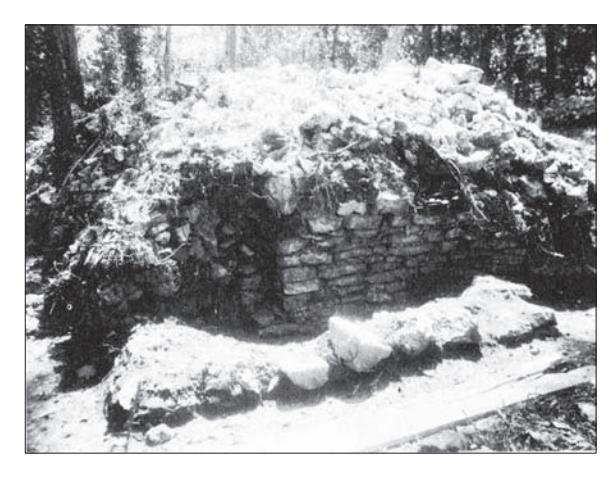
Figure 8.24 Southerly outer corner of Unit Ca exposed by cutting through debris of Unit Aa, lowest stones of which remain in foreground.

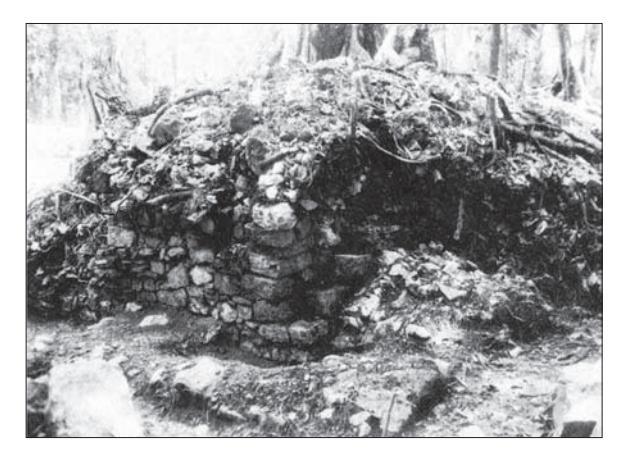
Figure 8.25 Corresponding corner of Unit Cb and lowest stones of Unit Ab. Note in this figure and in Figure 8.24 that corners of units Ca and Cb fail to reach base surfaces; stones of Units Ba and Bb may be seen in situ.

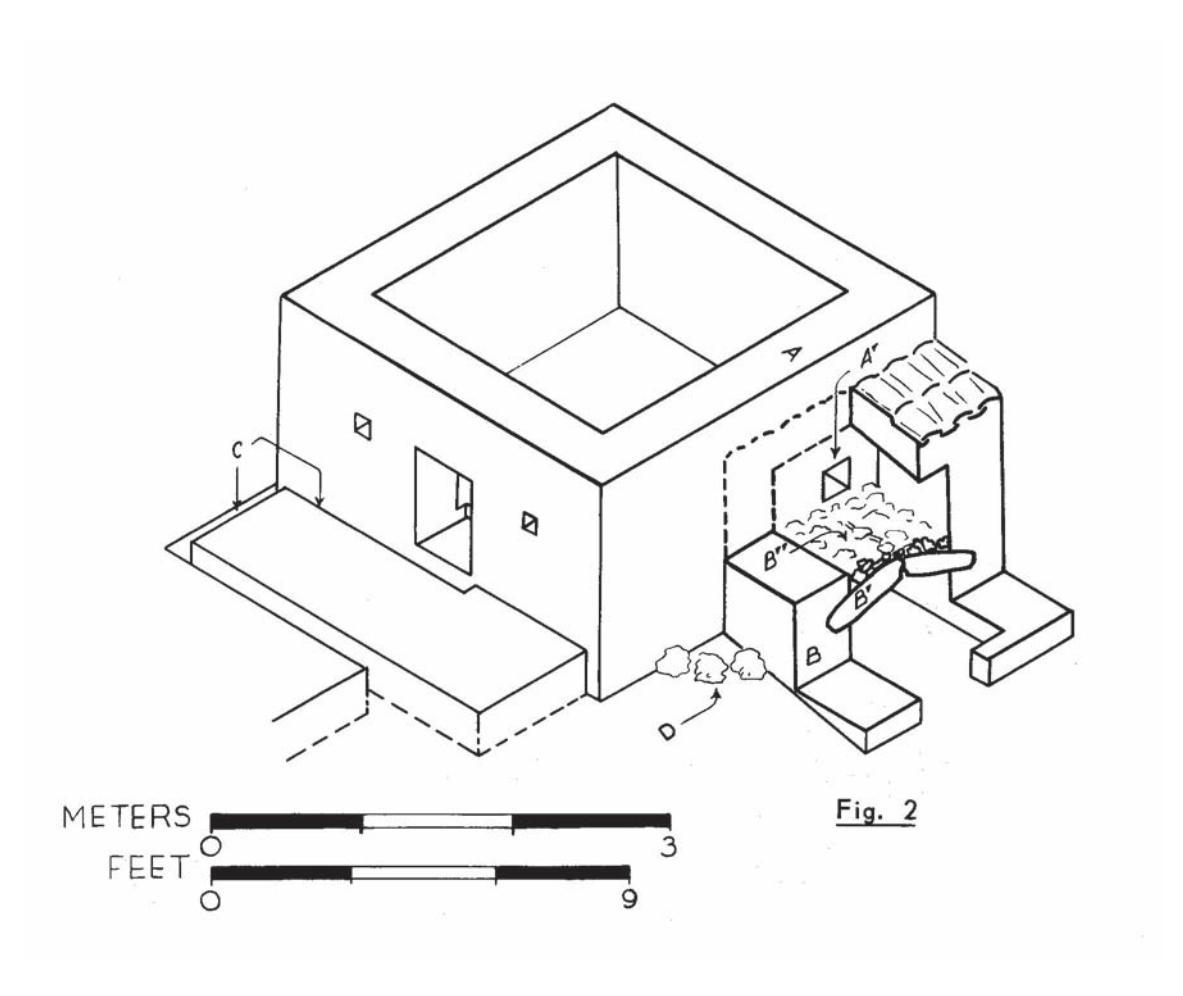
Figure 9.2 Modern sweat house at Tepoztlán, Mexico, based on Cresson (1938) (isometric drawing combined with cross section; stones at D form extra fireplace for heating water; drain at C reaches narrow, low doorway.

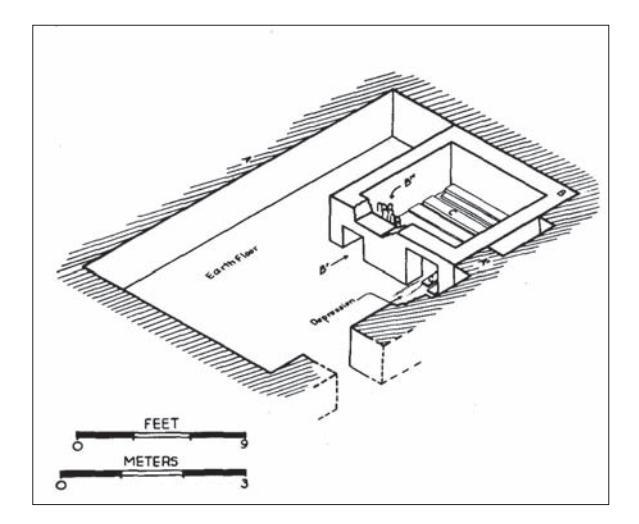
Figure 9.4 Modern sweat house No. 1 at Chichicastenango, Guatemala (isometric drawing combined with cross section showing plan); steam-screen of roofing tiles at B".

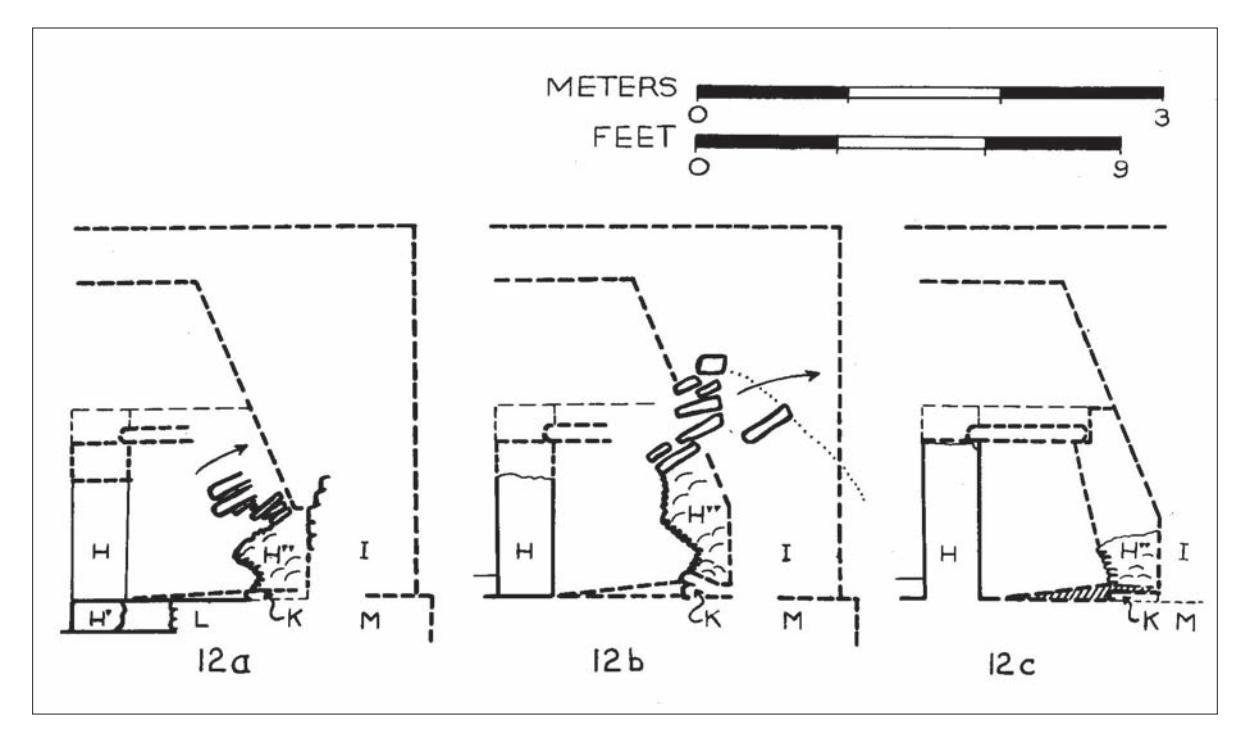
Figure 9.12 Cross sections through firebox, Structure N-1-1st-A, with what is known of earlier phases.

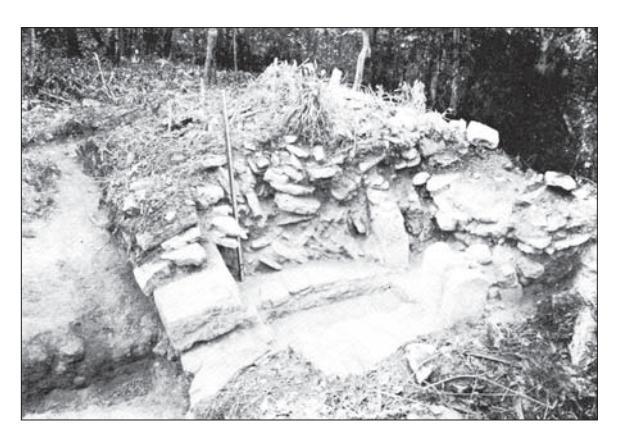
Figure 9.14 Partly excavated sweat room and firebox, Structure N-1-1st-A; rod on sweat room floor, lintel in place at left; note sunken passage running from firebox sill to lower left of picture.

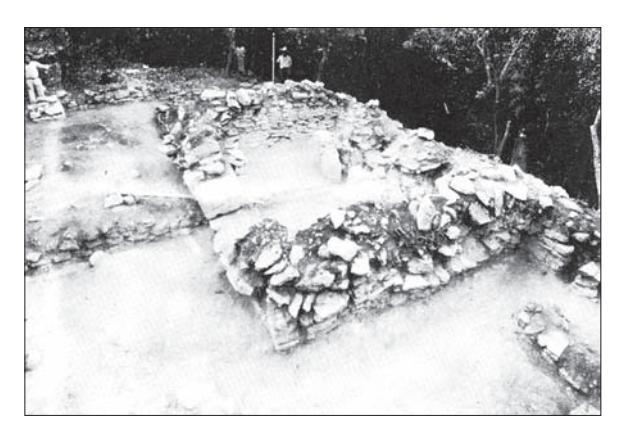
Figure 9.15 View similar to that of Figure 9.14, but from greater distance and after further excavation; man to left stands beyond right front pier of enclosing building; pier and remnant of bench at observer's extreme right.

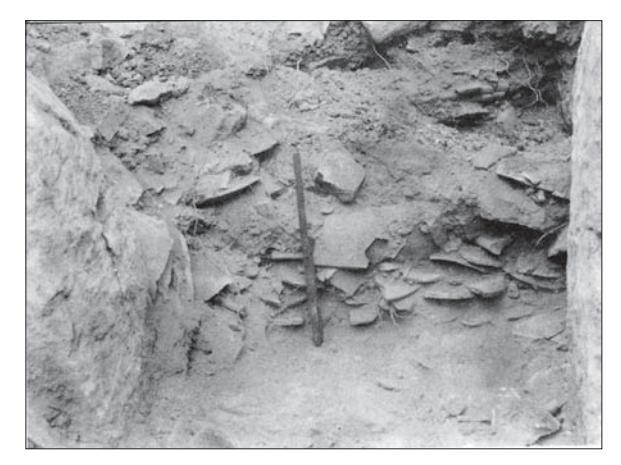
Figure 9.18 Longitudinal cut section through debris in firebox; note closely packed sherds in quantity, fallen from sherd wall still to be reached.

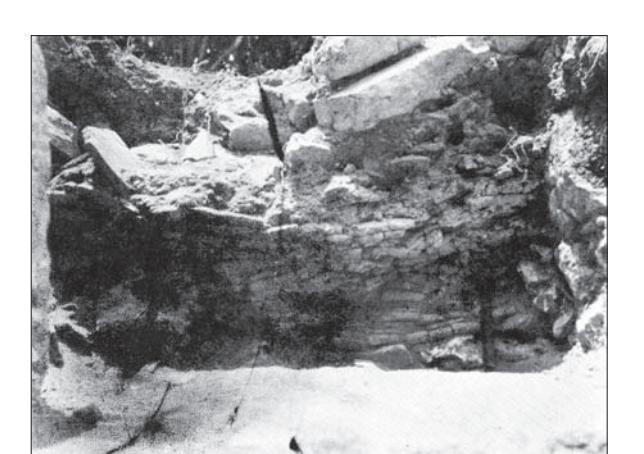
Figure 9.19 Surviving base of sherd wall at rear of firebox behind sherds of Figure 9.18.

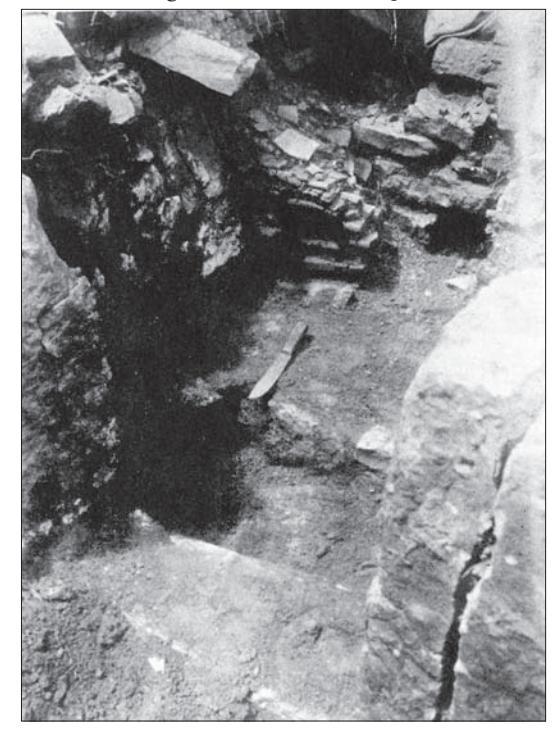
Figure 9.20 Interior of firebox seen through its front opening; floor dug out behind sill of Structure N-1-1st to show earlier sill (Unit L) behind it, at point of knife; remnant of sherd wall and right side wall above and left of knife in picture; masonry of rear wall of sweat room at upper right; whiteness of side wall due to brushing its calcined surface.

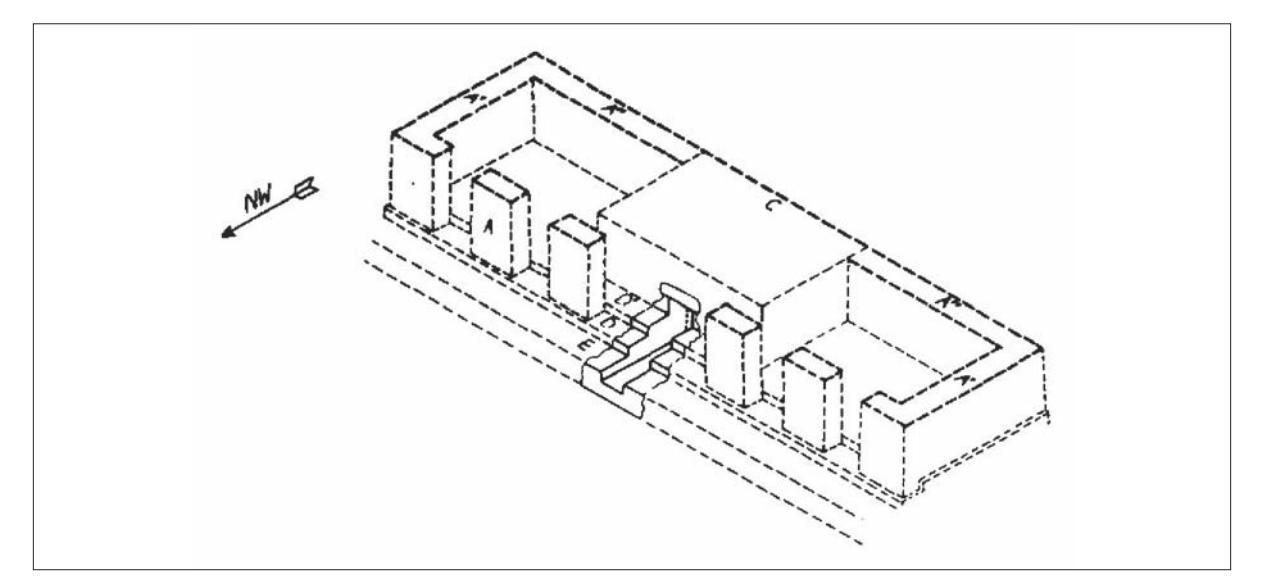
Figure 9.25 Isometric reconstruction of Structure S-19, showing supposed plan of enclosing building (thatch roofed?) with hypothetical flat airtight room over sweat room.

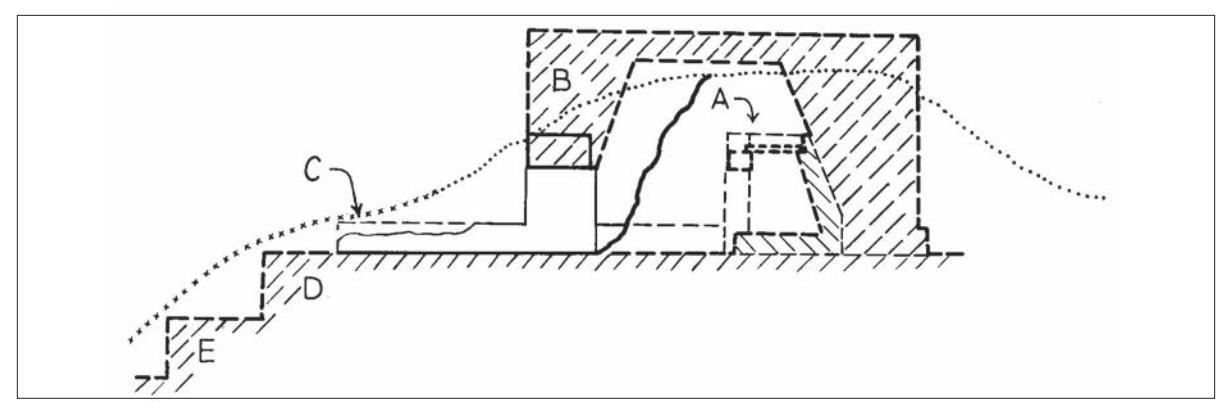
Figure 9.35 Cross section at center with reconstruction, Structure S-4.

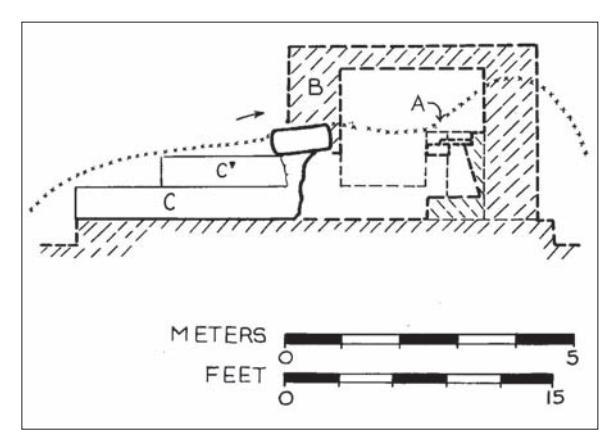
Figure 9.36 Cross section at center with reconstruction, Structure R-13.only).

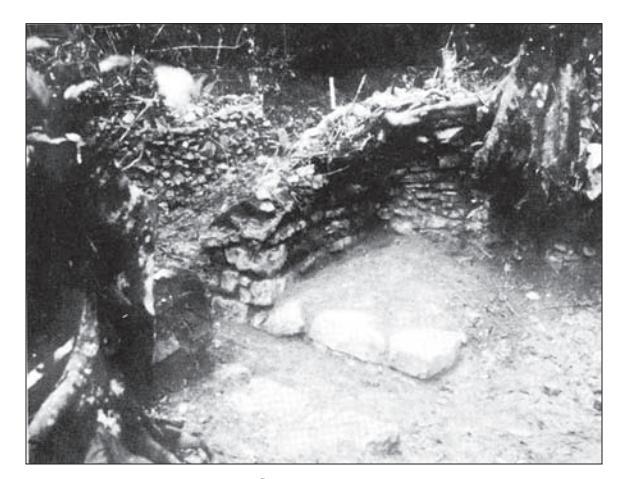
Figure 9.37 Interior of sweat room, Structure J-17, showing sunken passage leading to doorway at observer's left, firebox believed to have occupied area at lower right.

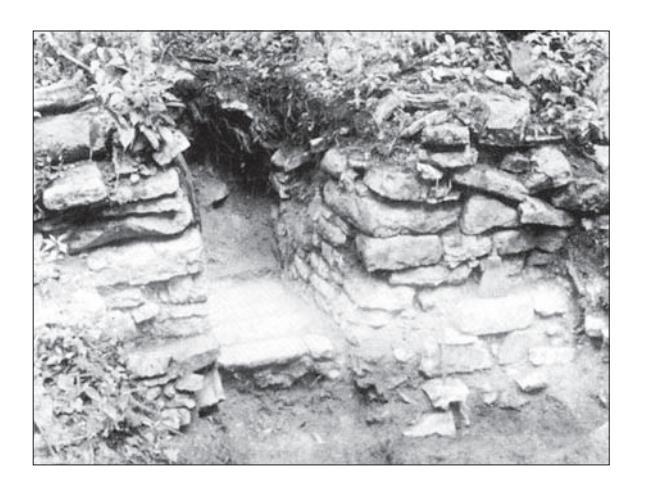
Figure 9.38 Doorway and sunken passage of sweat room, Structure O-4; note slab floor of passage damaged at front; halves of broken lintel removed from doorway during excavation.believed to have occupied area at lower right.

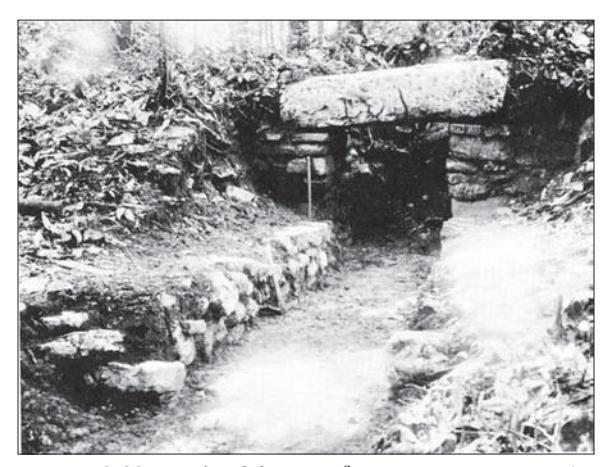
Figure 9.39 Lintel and doorway of sweat room, Structure S-4, from front; sunken passage outside sweat room in foreground.

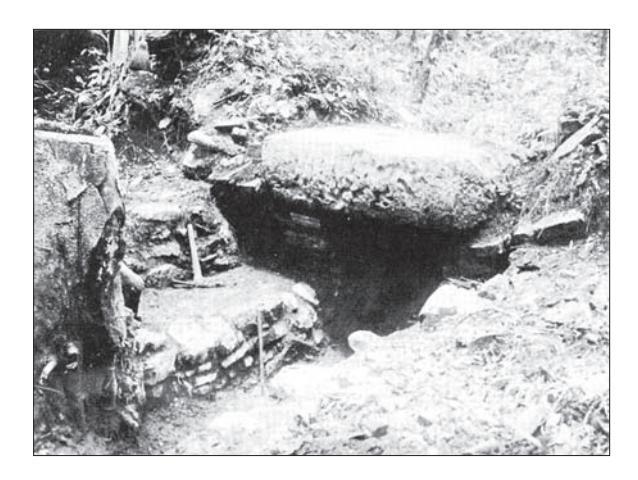
Figure 9.40 Lintel and doorway of sweat room, Structure R-13, seen at an angle from front; rule stands against right side of sunken passage, pick against wall of Unit C' (No excavation behind front face of lintel, which was found exposed as shown).

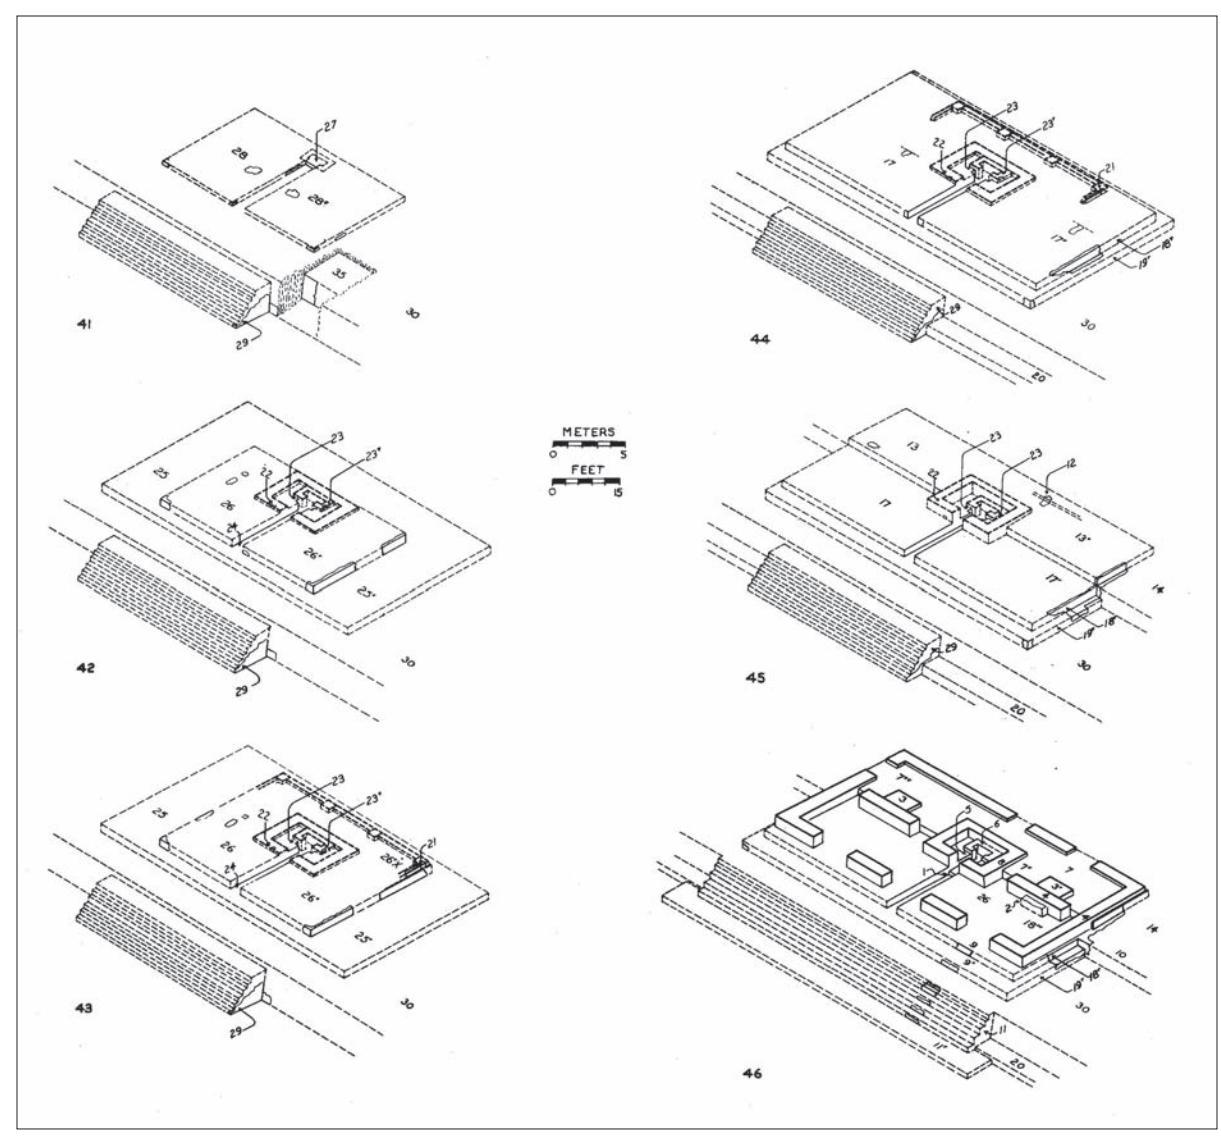
Figure 9.41–46 41—Isometric reconstruction of Structure P-7-3rd (Units 30-27); basal platform (Unit 30) cut out to show relation to basal platform of Strs. P-7-4th-B and –A (Unit 35); plan of firebox suggested without physical evidence. 42—Isometric reconstruction of Structure P-7-2nd-F (Units 26-22). 43—Isometric reconstruction of Structure P-7-2nd-E (Units 26X-21). 44—Isometric reconstruction of Structure P-7-2nd-C (Unit 17, plaster with turn ups to missing masonry); drawing shows survivals from prior phase (Str. P-7-2nd-D) not illustrated elsewhere, as follows: step-terrace (Unit 20); short extension to Unit 25 (Unit 19); probable extent of building platform modified by Unit 18 and hidden below plaster of Unit 17. 45—Isometric reconstruction of Structure P-7-2nd-A (Units 14-12); Units 16 and 15 of prior phase (Str. P-7-2nd-B) illustrated in cross section of Figure 9.53 only. 46—Isometric reconstruction of Structure P-7-1st-A (Unit 1, with Units 11-2 surviving from Structure P-7-1st-B or prior phase).

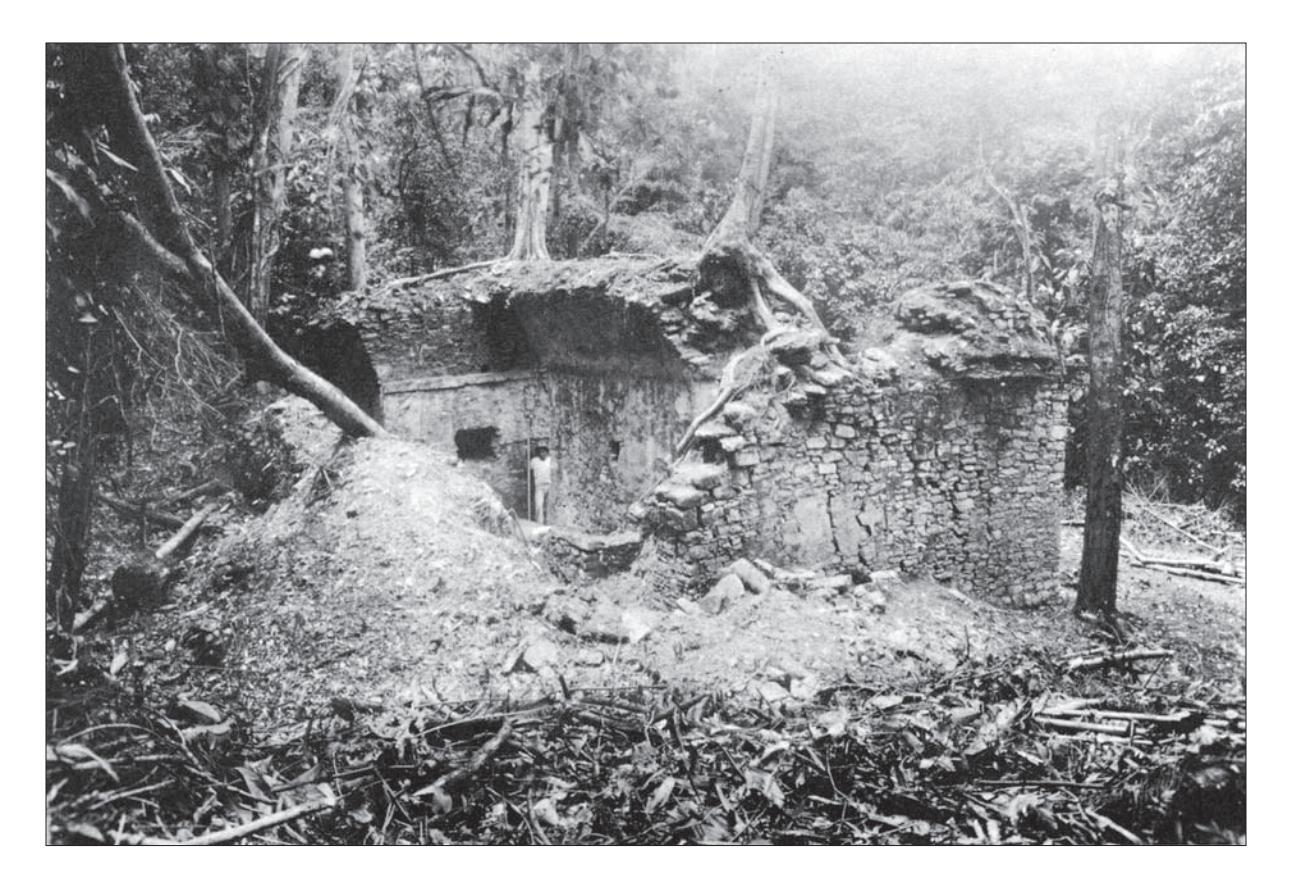
Figure 9.63 Structure P-7-1st, seen from right rear (N), showing (from observer's left to right); sweat room with post-Columbian large hole, small drainage hole, and superimposed semivaulting; rear face of right medial wall and semivaulting; outer face of end wall of enclosing building from jamb of side doorway to right front corner.

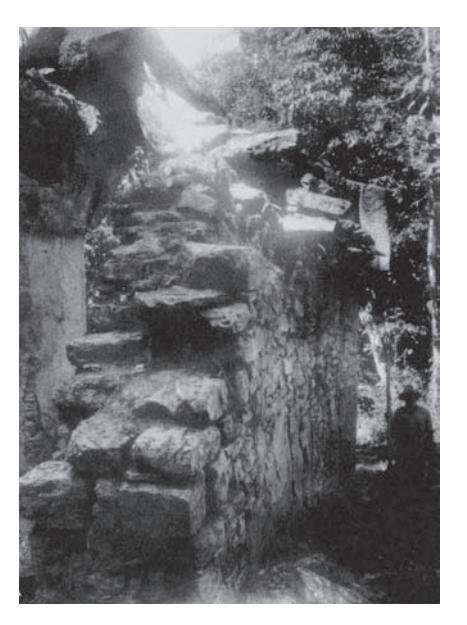
Figure 9.67 Broken section through right end of wall of enclosing building, Structure P-7-1st; squared blocks at lower left and in jamb of doorway.

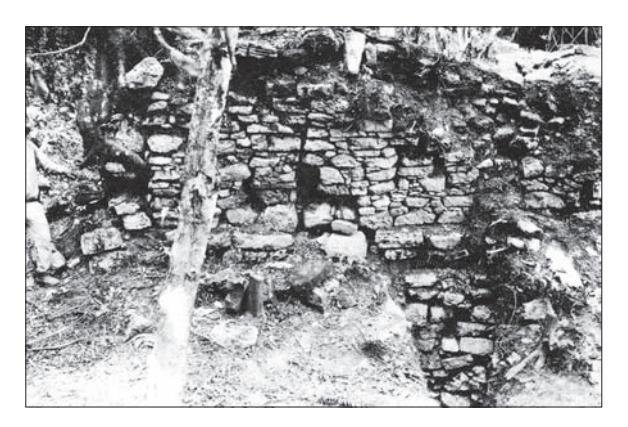
Figure 10.7 Masonry of all units, at rear. Face of Unit C shows only in pit. Man's foot is near left rear corner of Unit B (Str. F-3).

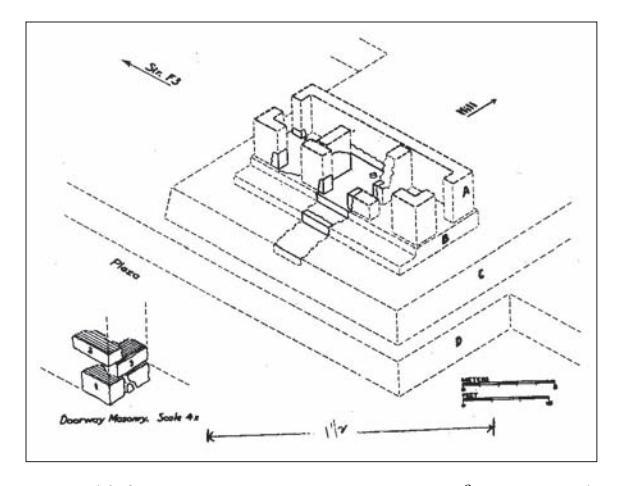
Figure 10.8 Isometric perspective reconstruction of Structure F-4; at lower left, sketch of corner stones in doorway at four times the given scale.

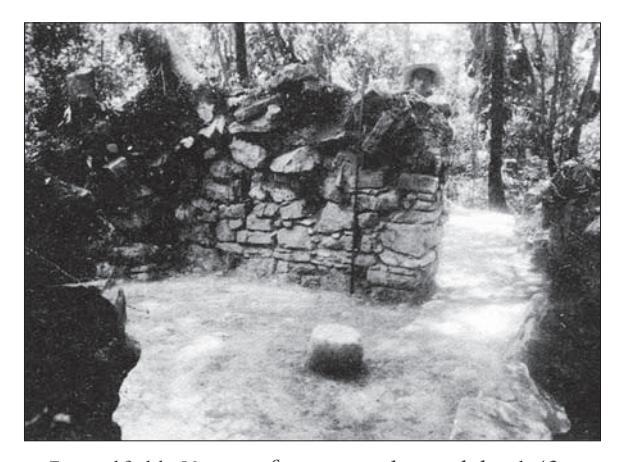
Figure 10.11 Masonry of partition; rule extended to 1.42 m, rests on floor and leans against it. Portable altar in situ in middle room, man in right room (Str. F-4).

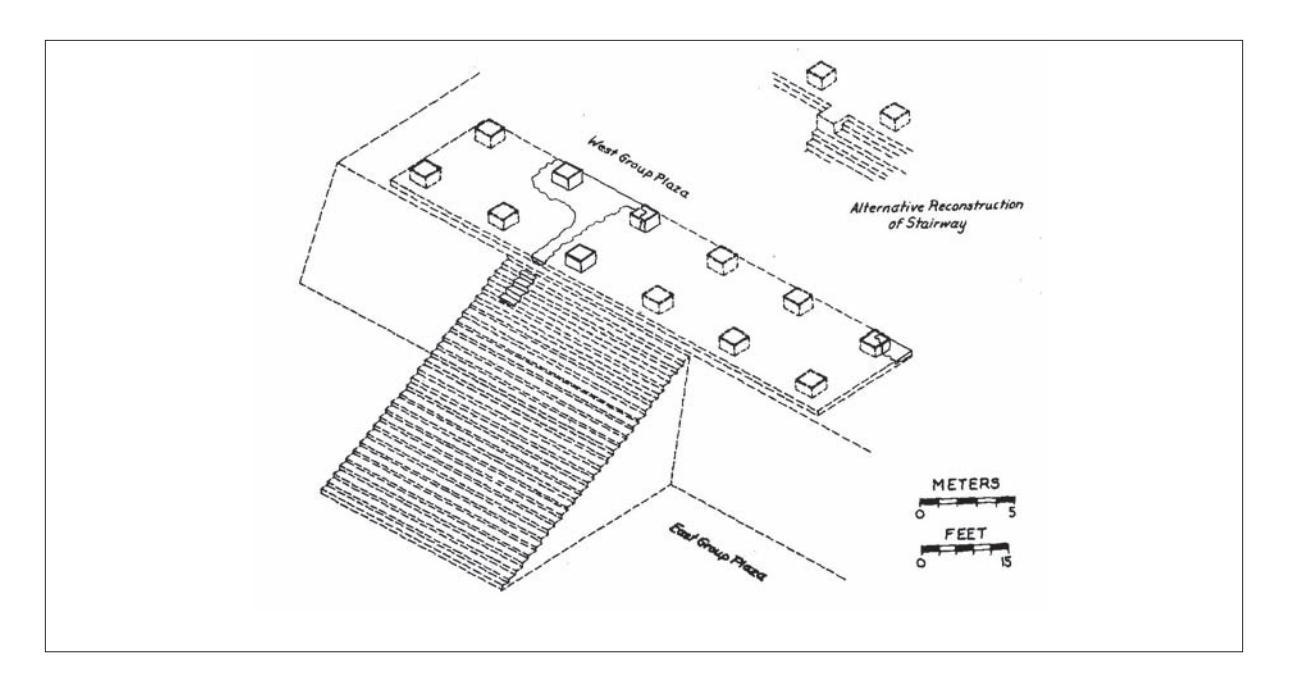
Figure 10.13 Isometric reconstruction of Structure O-18, based on minor excavation and contours of debris; alternative reconstruction at head of stairway based on position of Lintel 8, found as if in semi-position as face of masonry block; roof of structure presumably thatch.

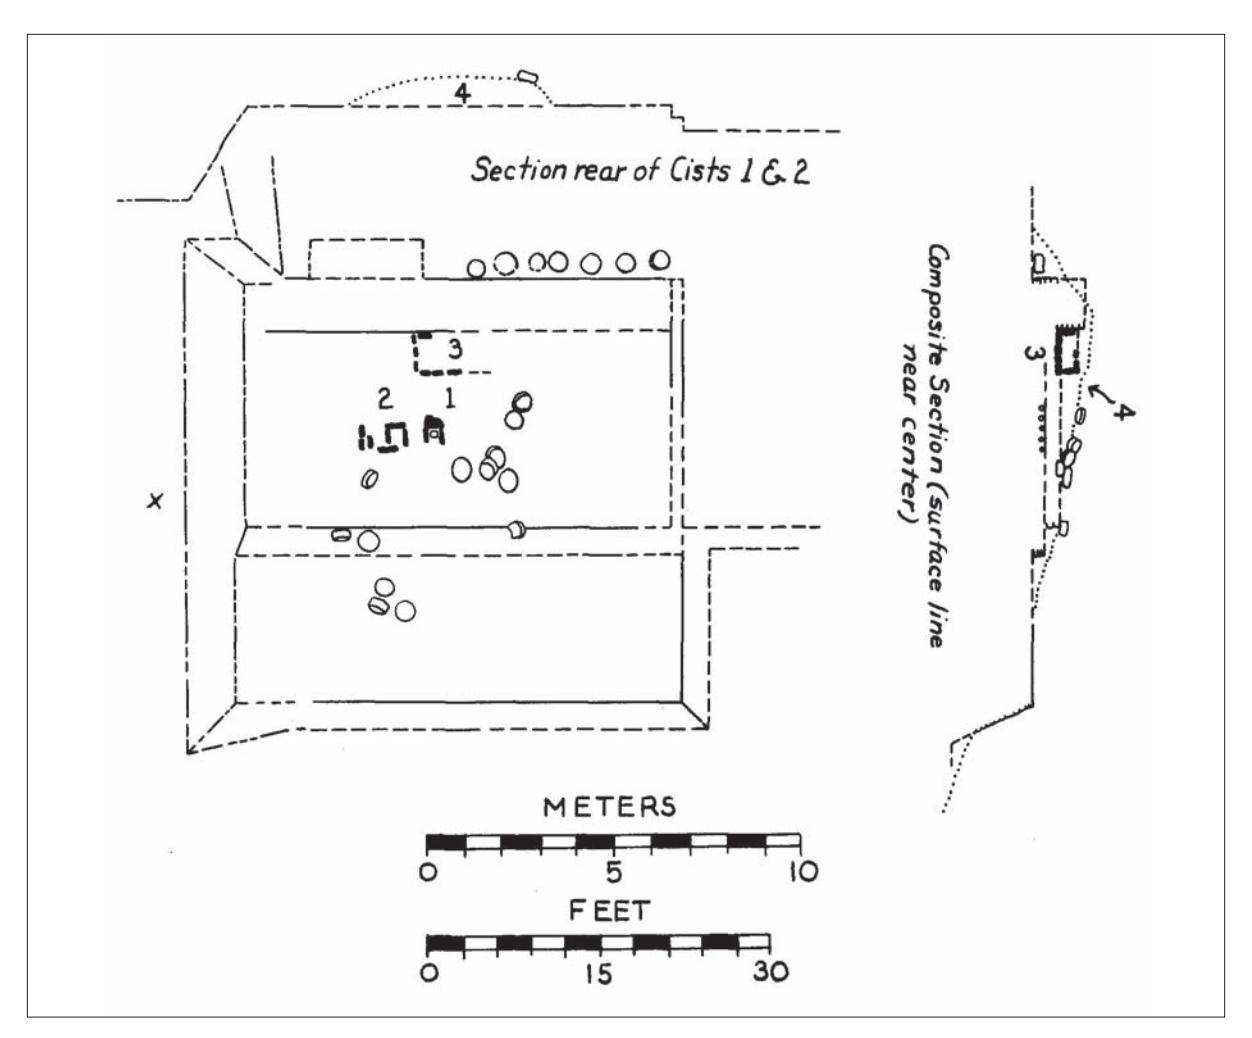
Figure 10.15 Plan of Structure O-7, all period numbers are unit designation of cist period.
