PIEDRAS NEGRAS ARCHAEOLOGY, 1931–1939

Piedras Negras Preliminary Papers Piedras Negras Archaeology: Architecture

Linton Satterthwaite, Jr., Mary Butler, and J. Alden Mason

Edited by John M. Weeks, Jane Hill, and Charles Golden

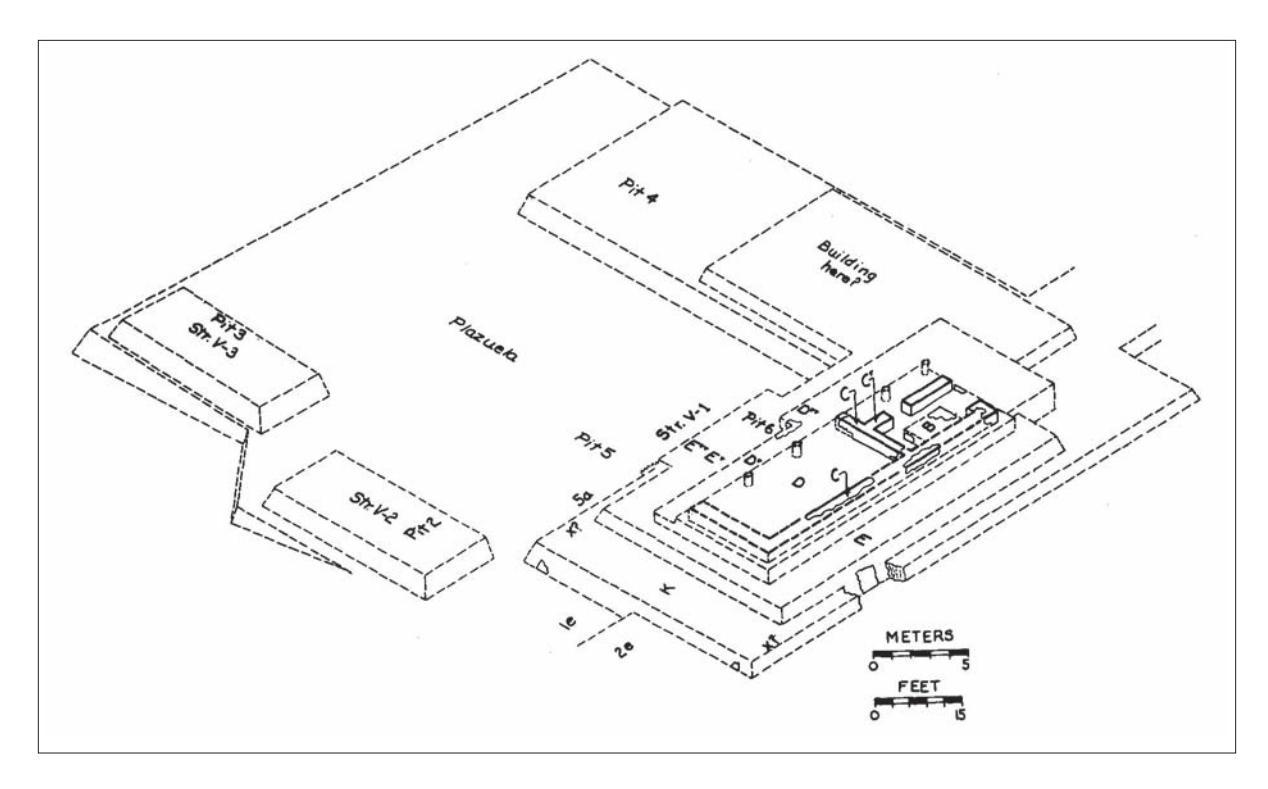
Figure 10.23 Isometric reconstruction: Structure V-1-1st-B (locating Pits 1-6).

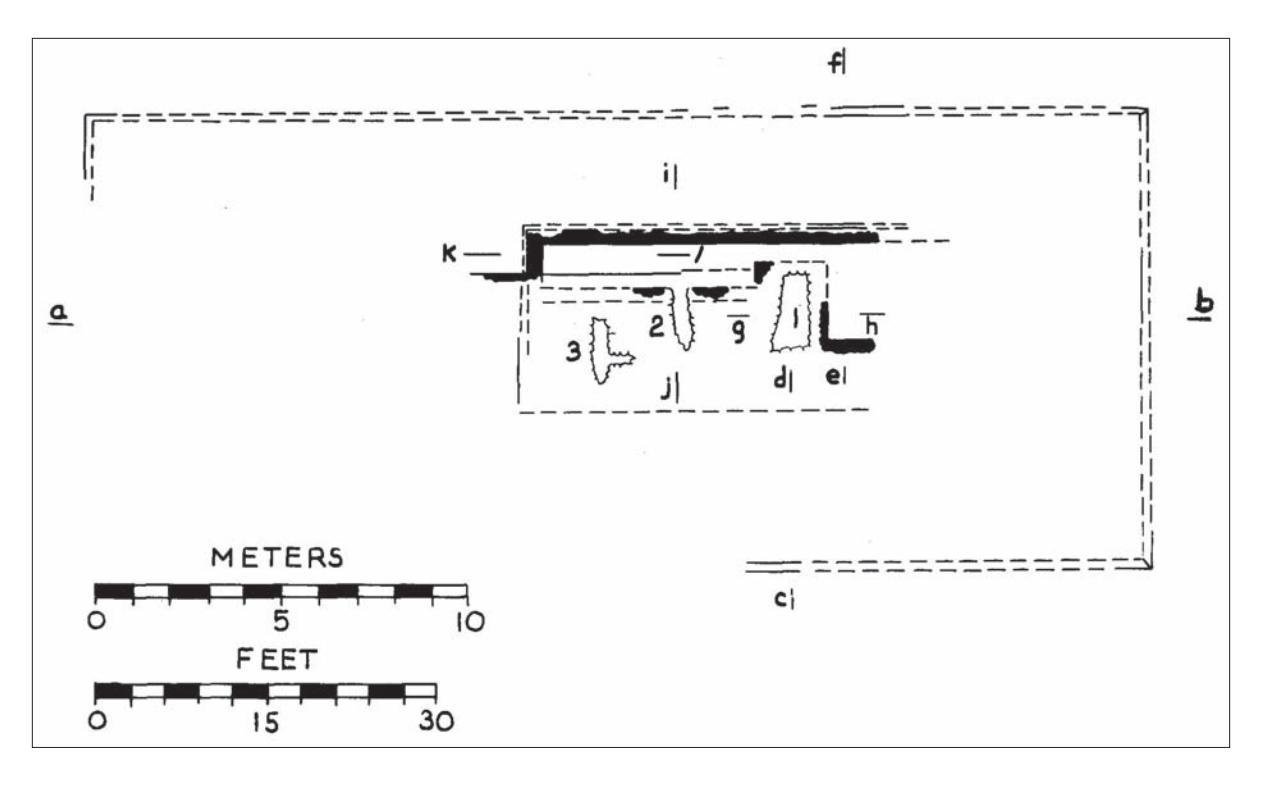
Figure 10.24 Plan: Structure V-1-2nd-B and –A (locating Sections A-B to K-L and Burials 1-3).

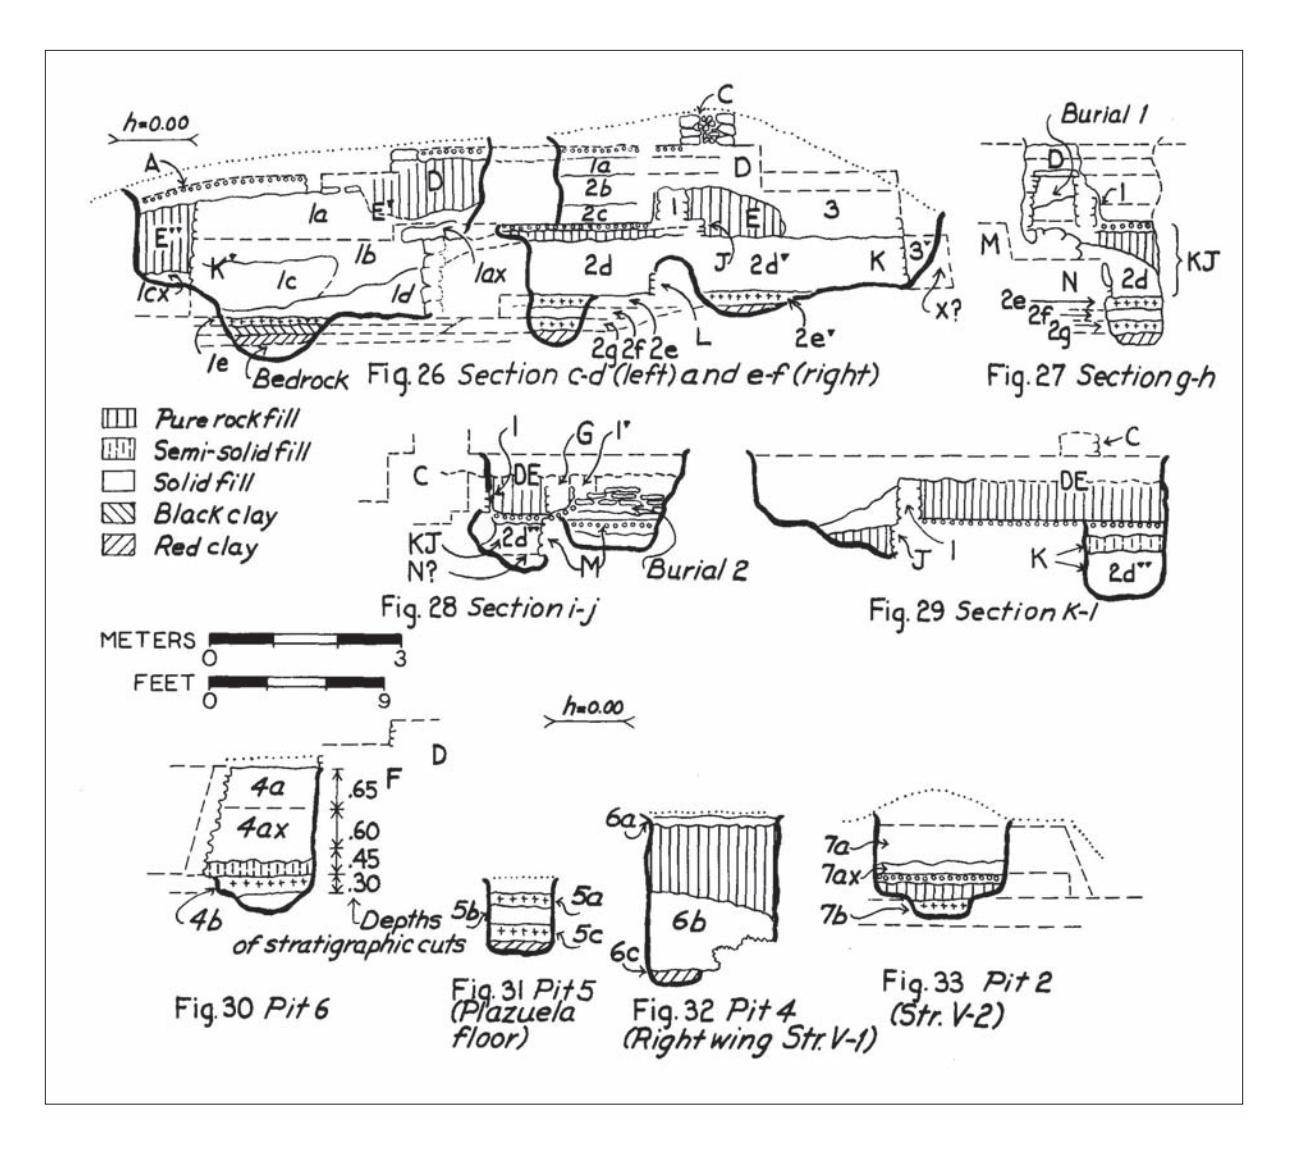
Figure 10.26–10.33 26—Composite front-rear section (Sections C-D and E-F). 27—Longitudinal section through units of all structural periods, with cross section through Burial 1 (Section G-H). 28—Rear-front section through units of all structural periods, with section through Burial 2 (Section K-L). 29—Longitudinal section through units of StructureV-1-1st and narrow right room of StructureV-1-2nd-B (Section K-L). 30—Front-rear section of Pit 6 through units of all structural periods. 31—Section of Pit 5 through floors of plazuela. 32—Section of Pit 4 through right wing of main platform of StructureV-1. 33—Section of Pit 2 in mound of StructureV-2.

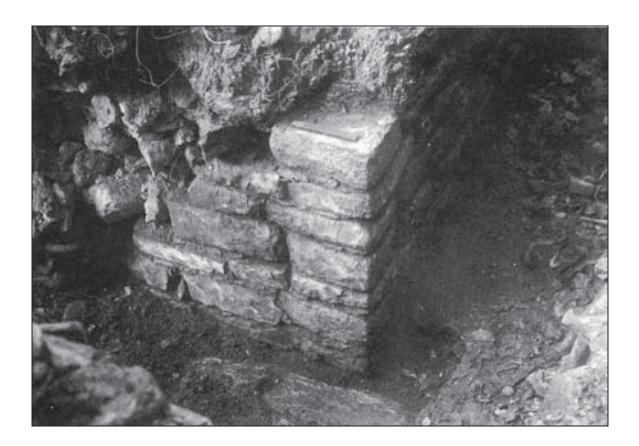
Figure 10.37 Hypothetical reconstructed section, medial wall of Structure 3-C.

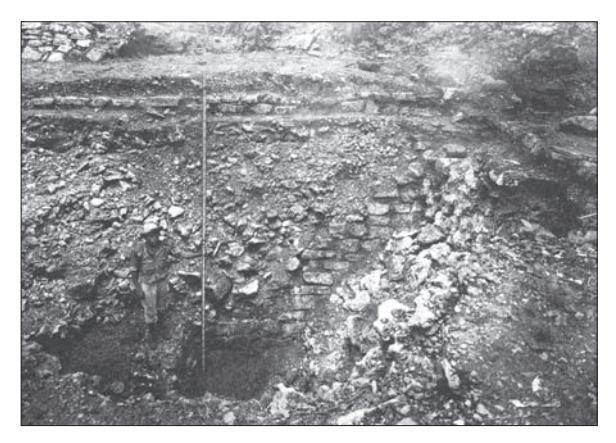
Figure 10.38 Masonry at left front corner of Structure 3.

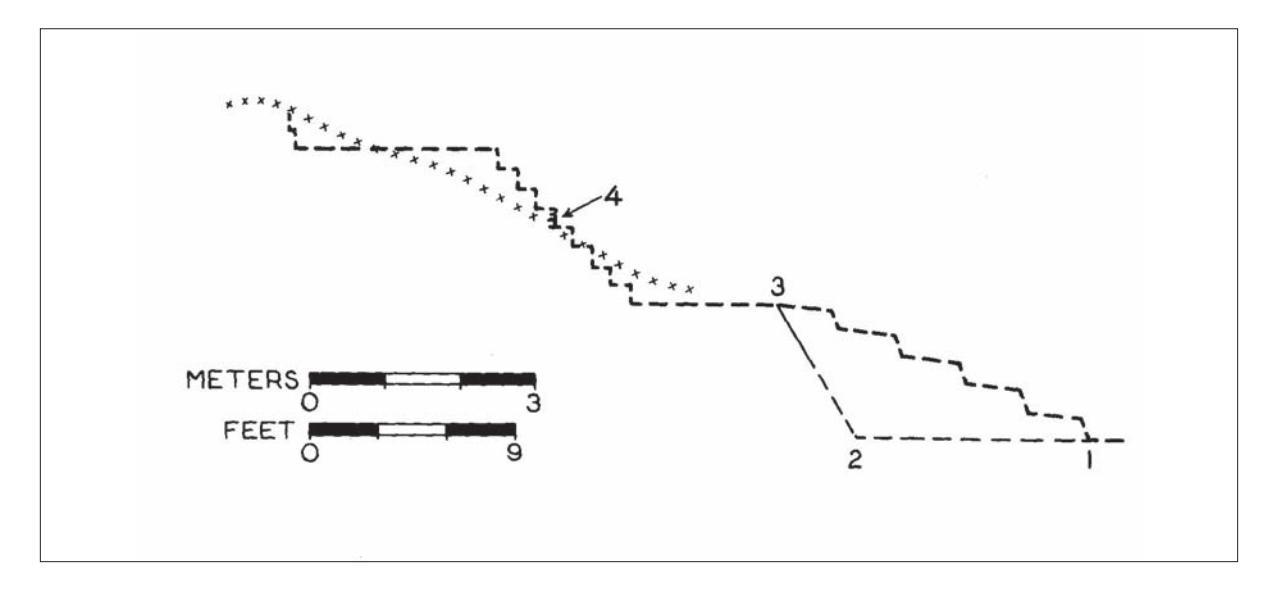
Figure 10.45 Composite cross section of Structure O-2.

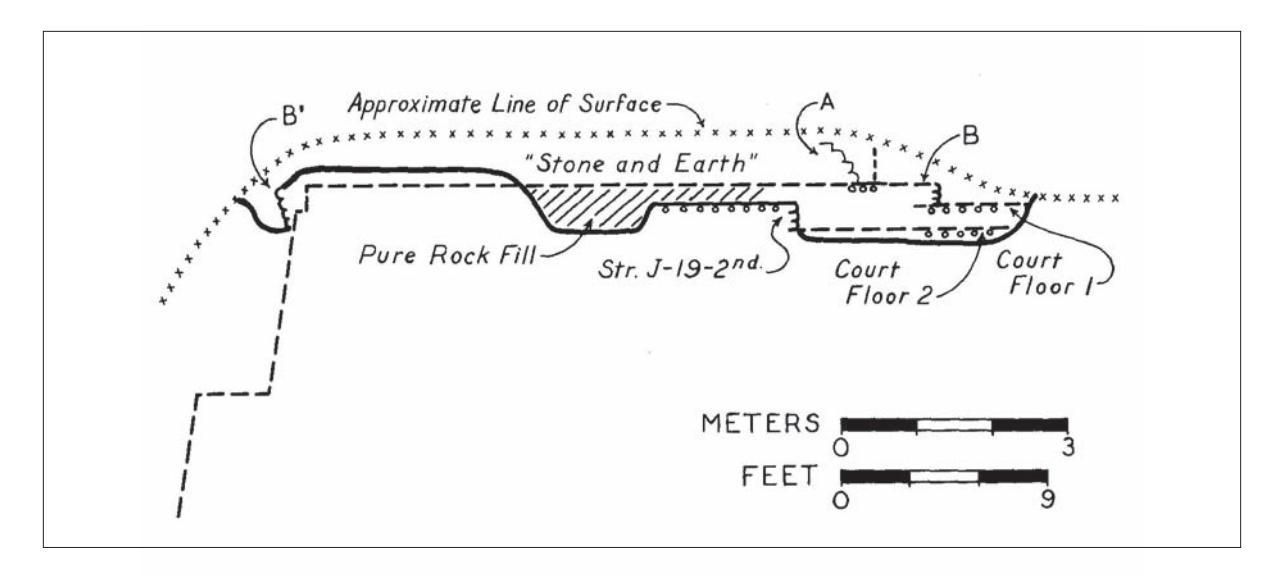
Figure 10.46 Cross section of Structure J-19.
