# PIEDRAS NEGRAS ARCHAEOLOGY, 1931–1939

# Piedras Negras Preliminary Papers Piedras Negras Archaeology: Architecture

Linton Satterthwaite, Jr., Mary Butler, and J. Alden Mason

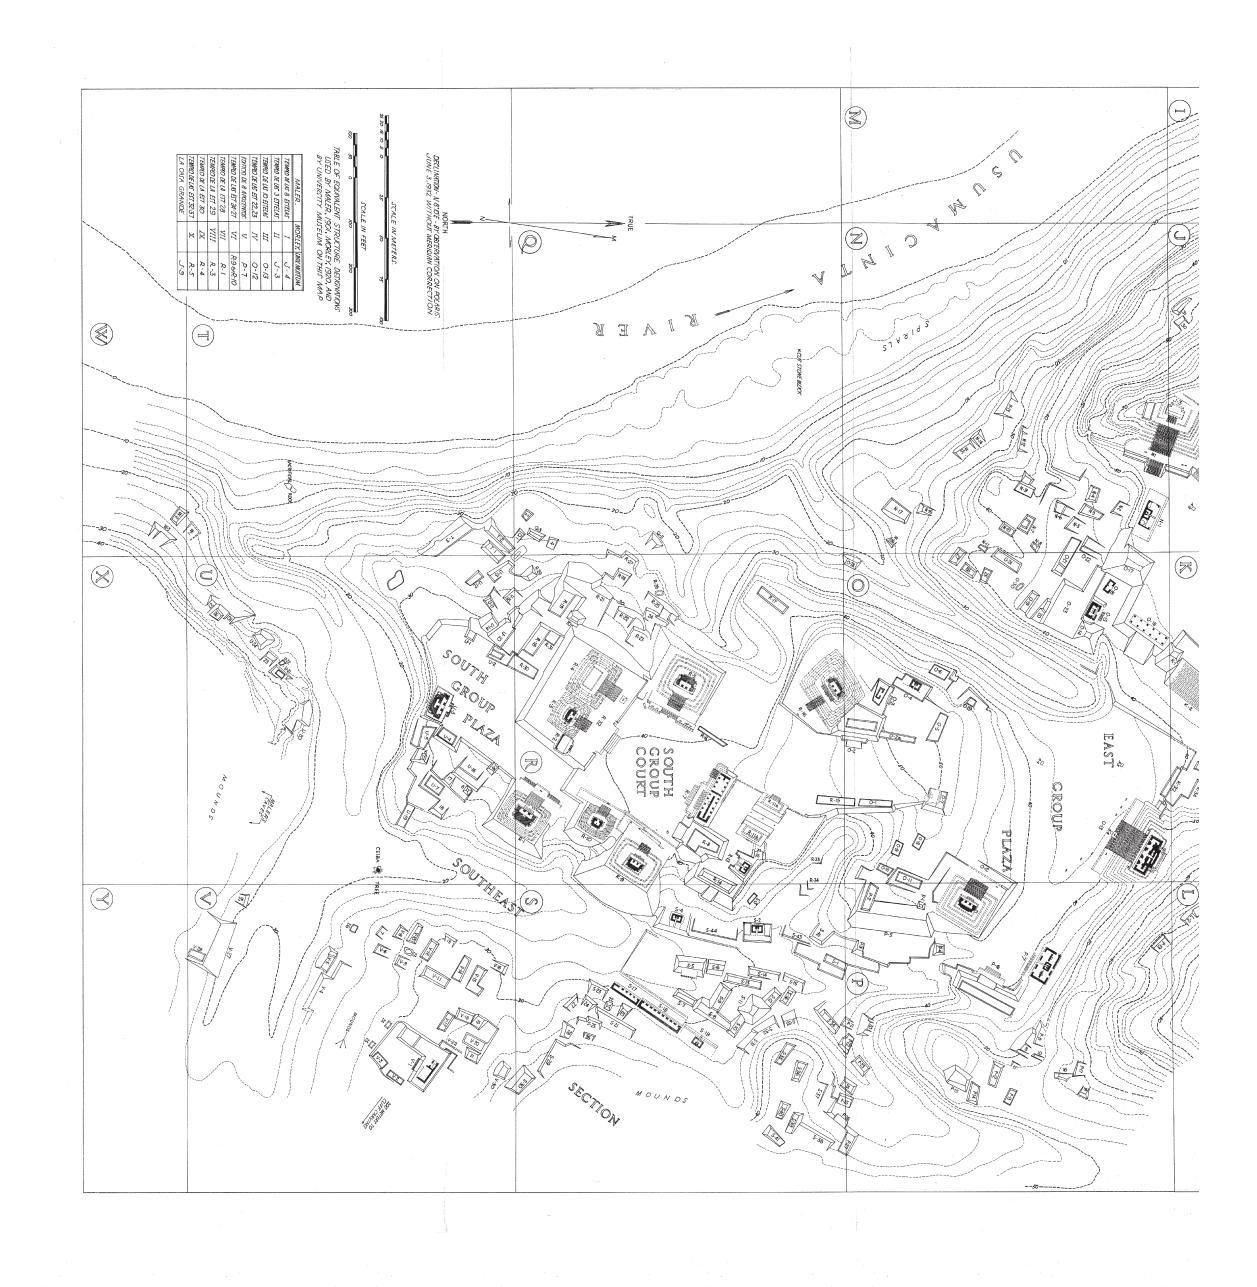
Figure 1.1 Ruins of Piedras Negras, Department of Petén, Guatemala (see also Appendix 6 for enlarged map sections).

The 1931 Eldridge R. Johnson Expedition of the University Museum, University of Pennsylvania, had the tremendous advantage of a copy of a third map of the city, made by Oliver G. Ricketson, Jr. for the Carnegie Institution of Washington. This was supplied to us, together with much helpful information and advice, by Dr. Morley, and enabled us to finds all the major features in the South, East and West Groups, with the greatest of ease. This map was the only one used during the 1931 season. That season, during which we were constantly crossing and recrossing the area covered, and clearing large areas, demonstrated the desirability of a completely new survey with a transit. This was to show the shapes, heights, orientation and assemblage of all terraces, platforms, mounds, and standing structures, small as well as large, and was to include peripheral areas not thus far recorded. This was about half completed in 1932 by Mr. Fred Parris, the Expedition's architect, and his work thus far is reproduced in Figs. 1.1 and 1.2.

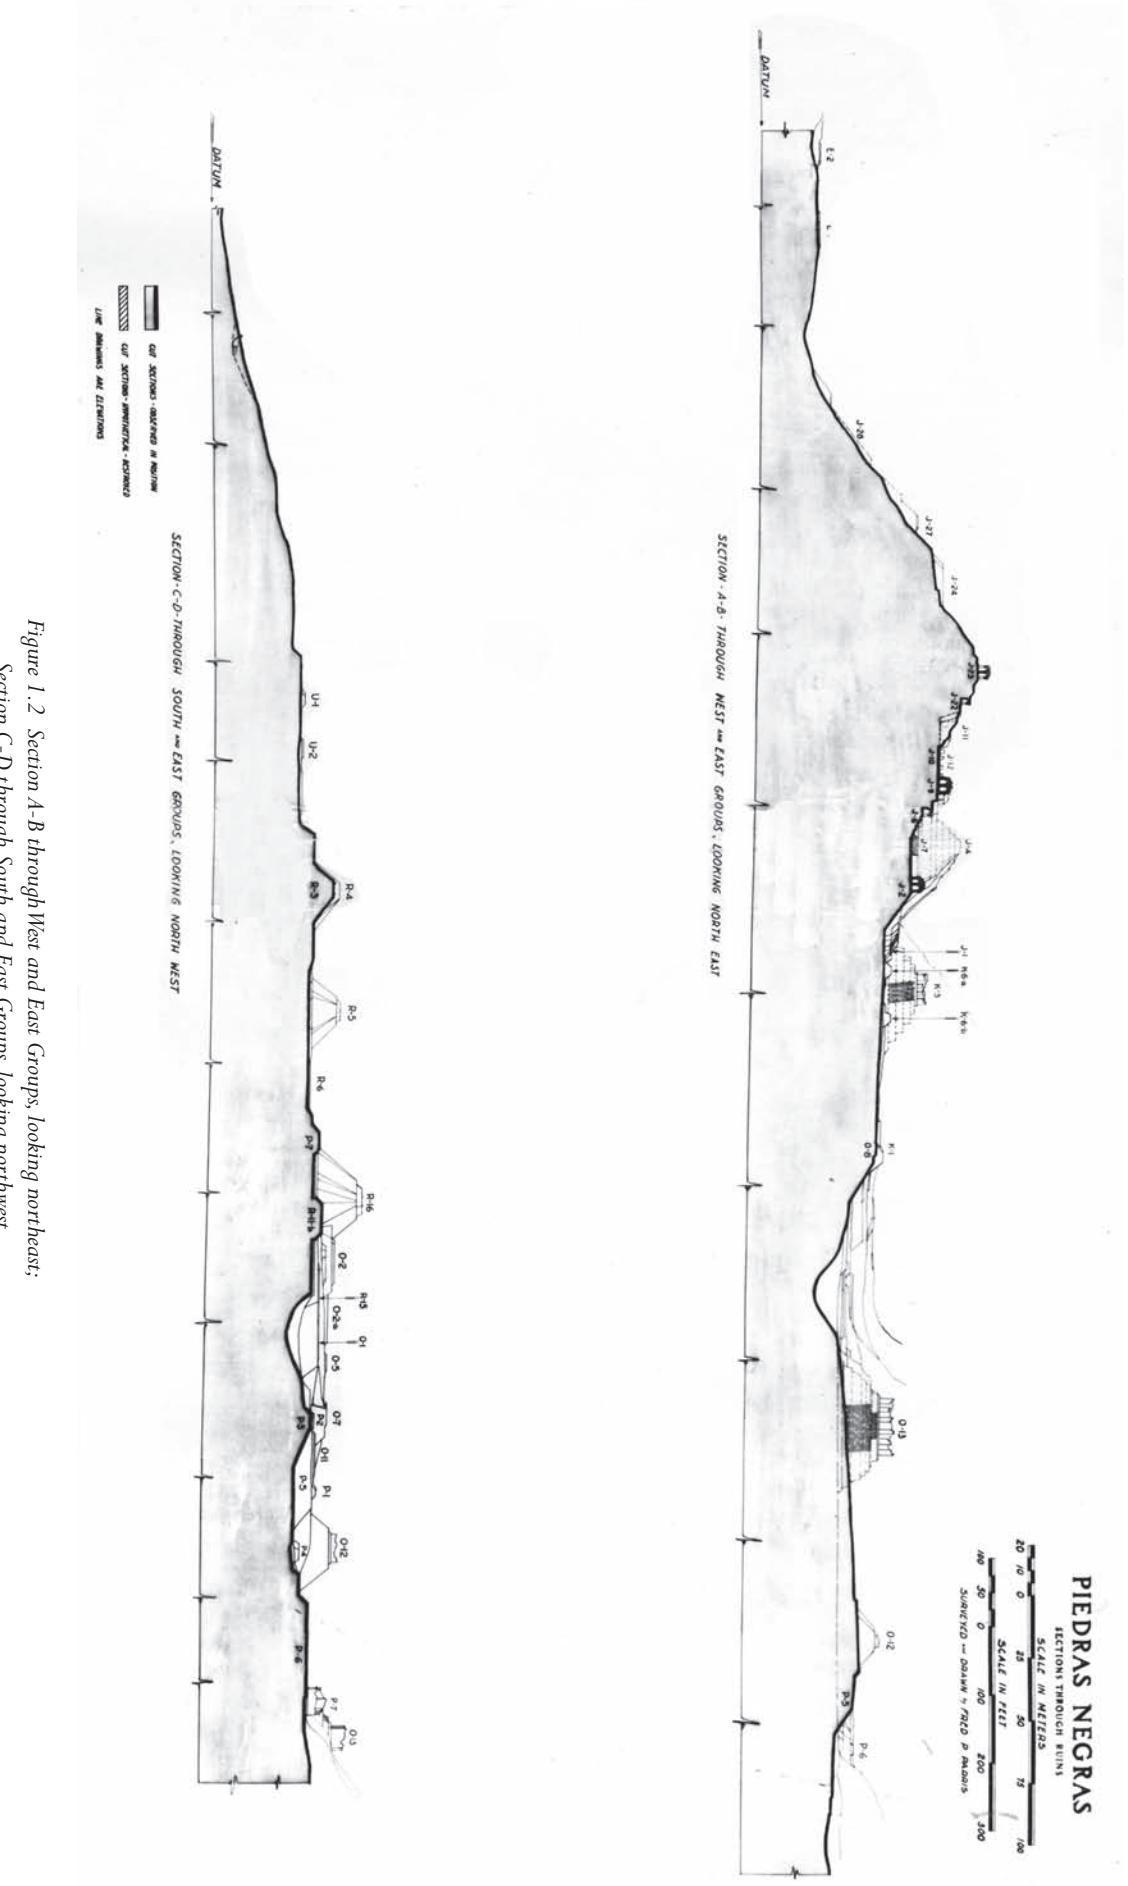
Section C-D through South and East Groups, looking northwest.

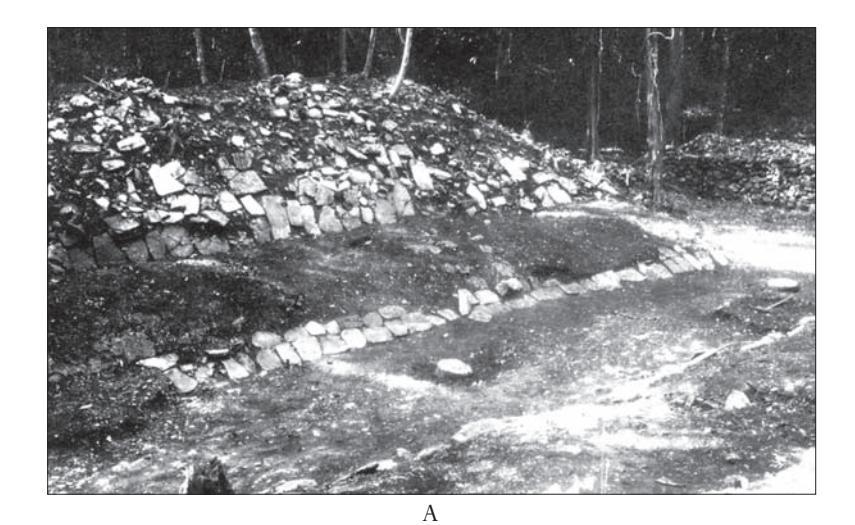
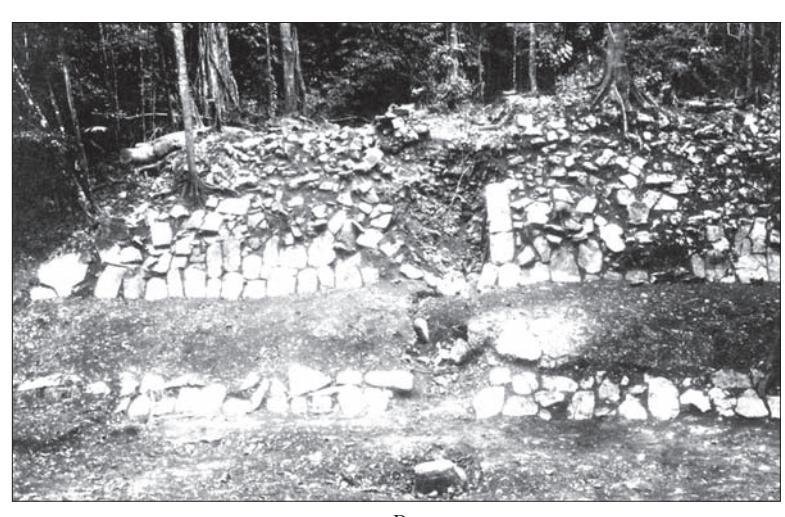
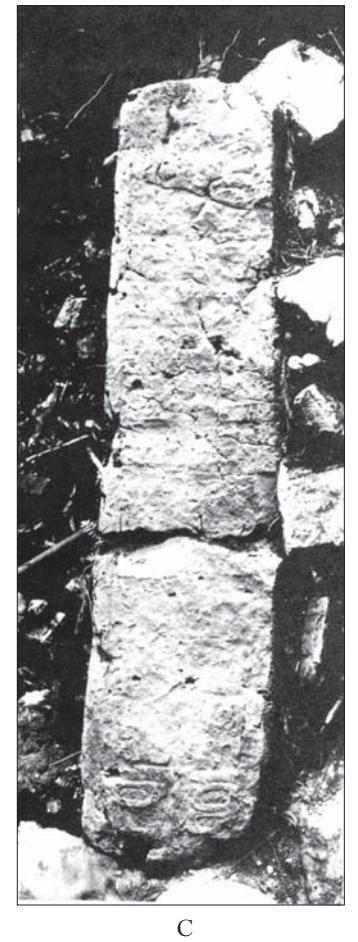
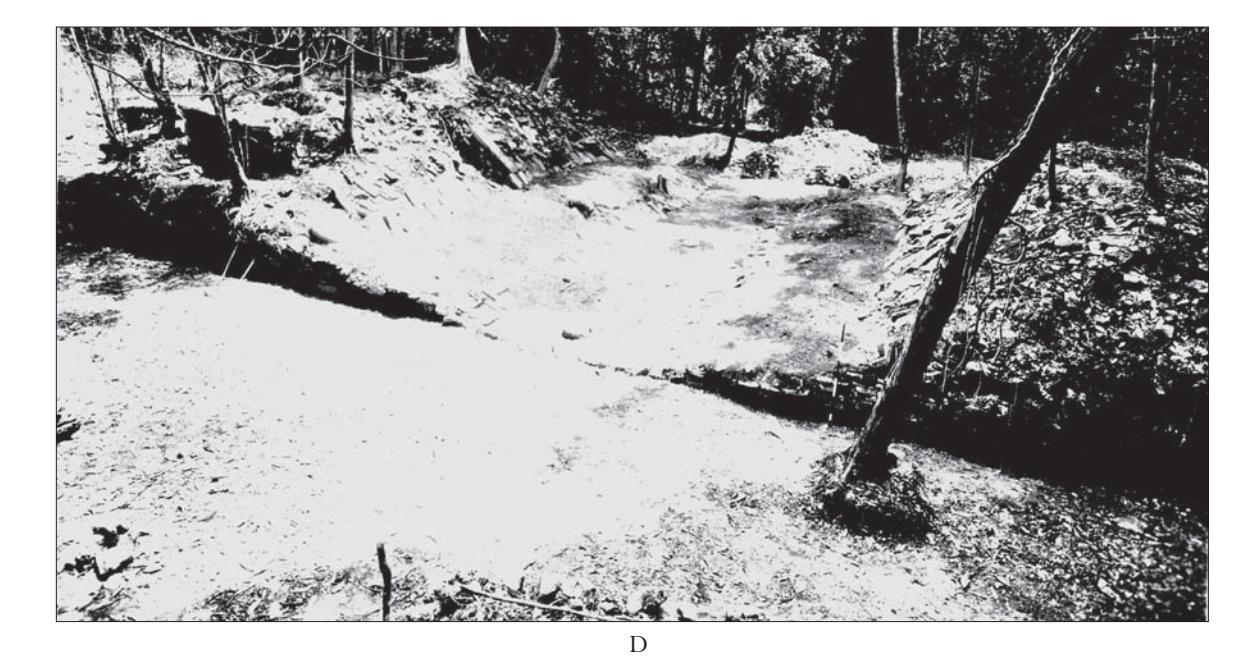
Figure 2.1 a. Structure R-11-b from the northerly end of R-11-a. The large and supposedly sculptured slab may be seen just to the right of the vertical line cutting the stump in the left foreground; b. Structure R-11-a from the top of R-11-b at center; c. Stela 45, in situ, with trench on left; d. both structures, from southern end field.

For some reason the architects were especially concerned about the juncture of this platform with the alley pavement, and laid a double row of small stone slabs along the entire length of each platform, which aided us greatly in locating corners. These appear in the photographs, Figure 2.1a-c, and Figure 2.3a, and

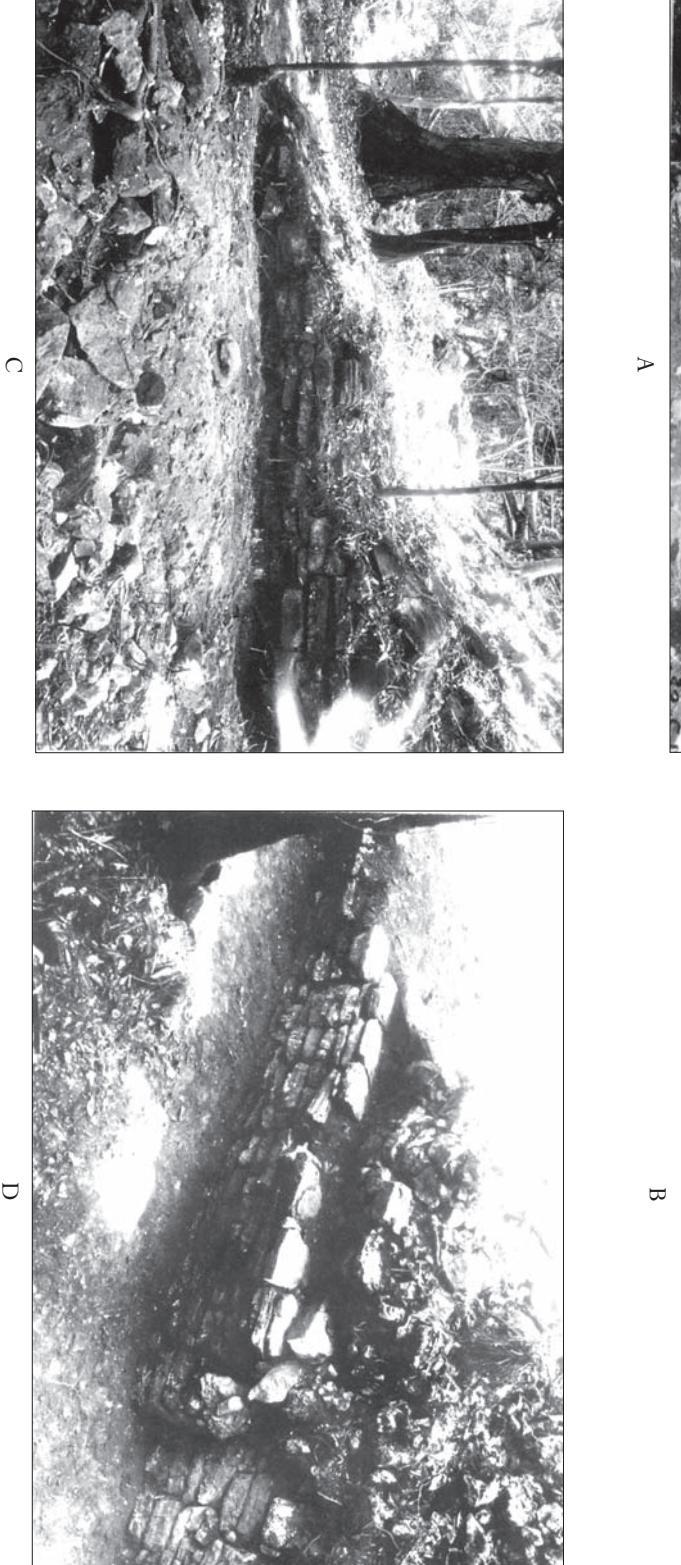
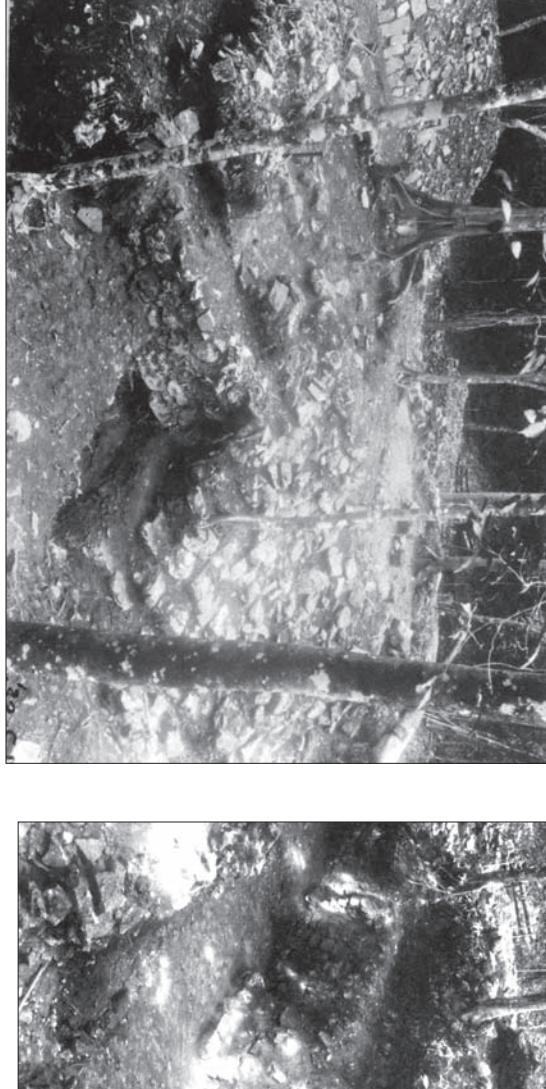
Figure 2.2 a. Rear of Structure R-11-a, showing stairway resting on earlier platform which passes under R-11-a, from north; b. rear of Structure R-11-b, showing junction with R-12, terracing, bench or altar (left center) and early battered stairway construction wall beyond bench, from northeast; c. Structure R-11-a showing end of inner platform, from northeast; d. Structure R-11-b, showing raised platform wing and main end wall, from south.

Possibly there was an approach to the top from the peculiar platform, Structure R-12, which runs into it at an angle. We did not excavate on the top of this latter structure. It is about 1 m high, the side walls terraced. (Fig. 2.2b).

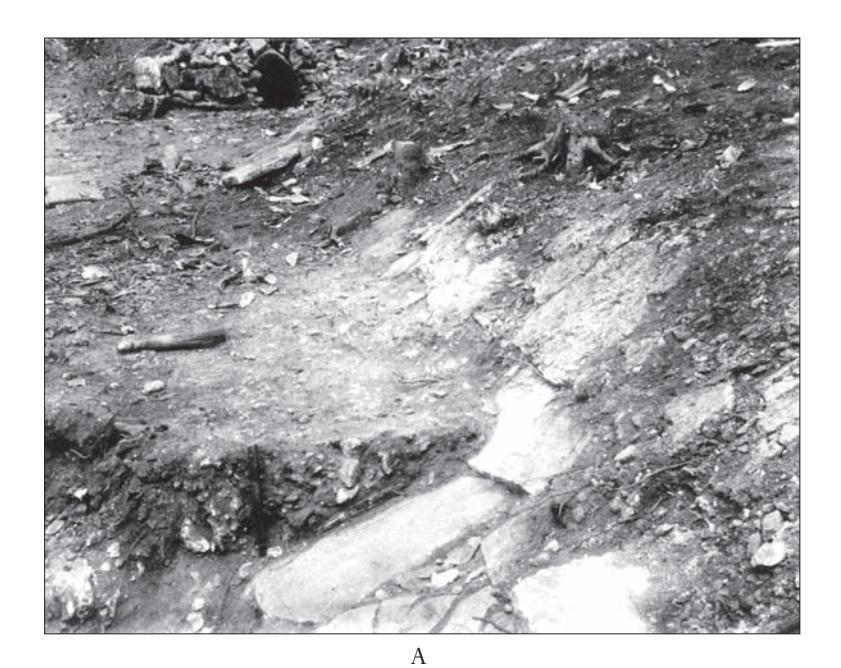
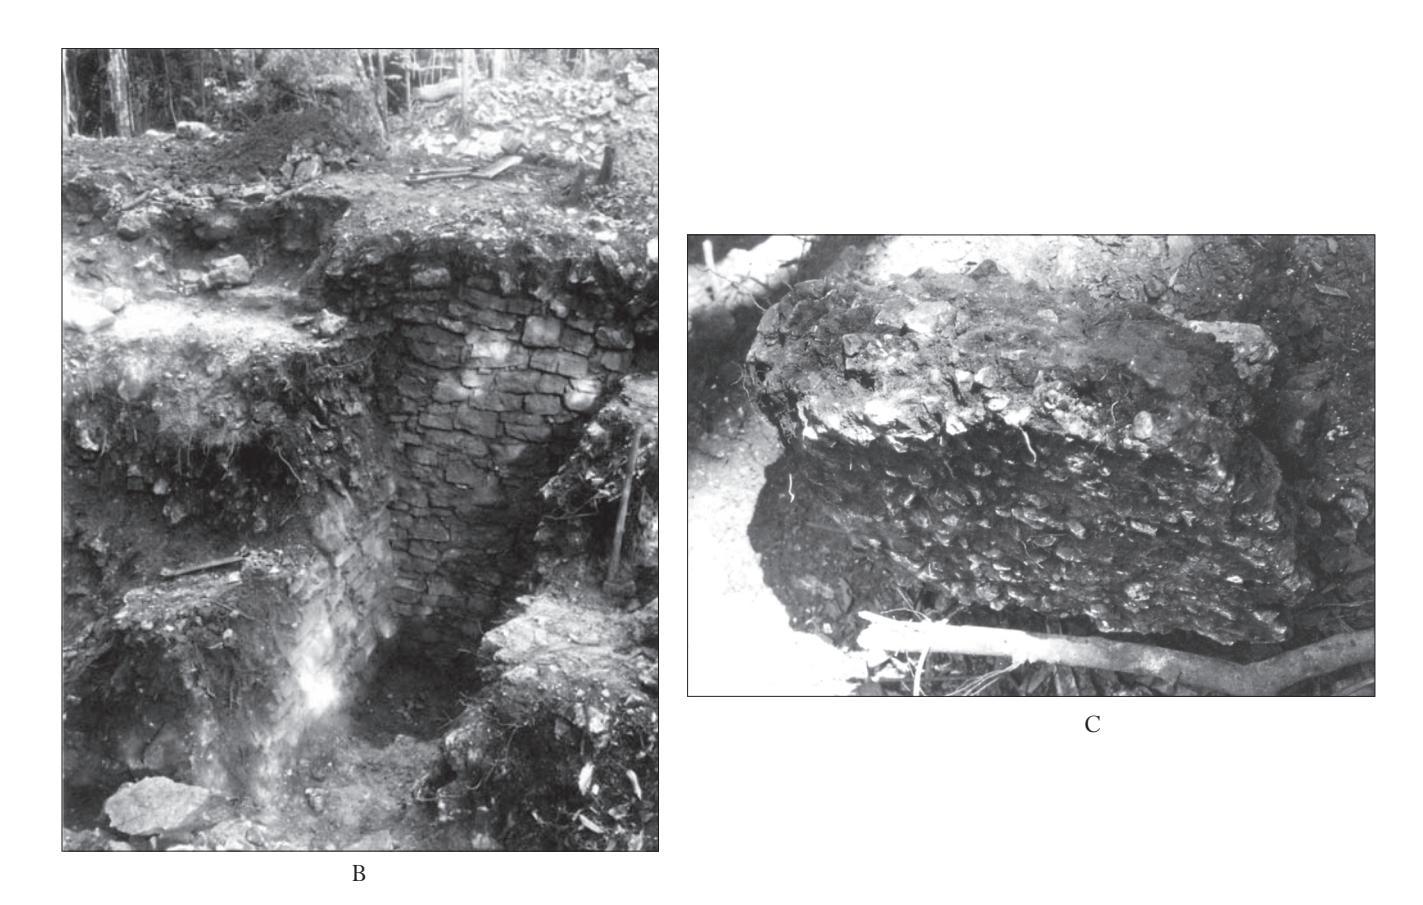
Figure 2.3 a. Section cut through alley floor, showing edge of inner platform and basal slabs; b. Structure R-11-b showing steeply sloping early rear wall, with early stairway side wall at left, rough chinked dry wall of medium-sized stones, from southeast; c. Structure R-11-a showing sample of concrete floor from inner platform, former surface to left.

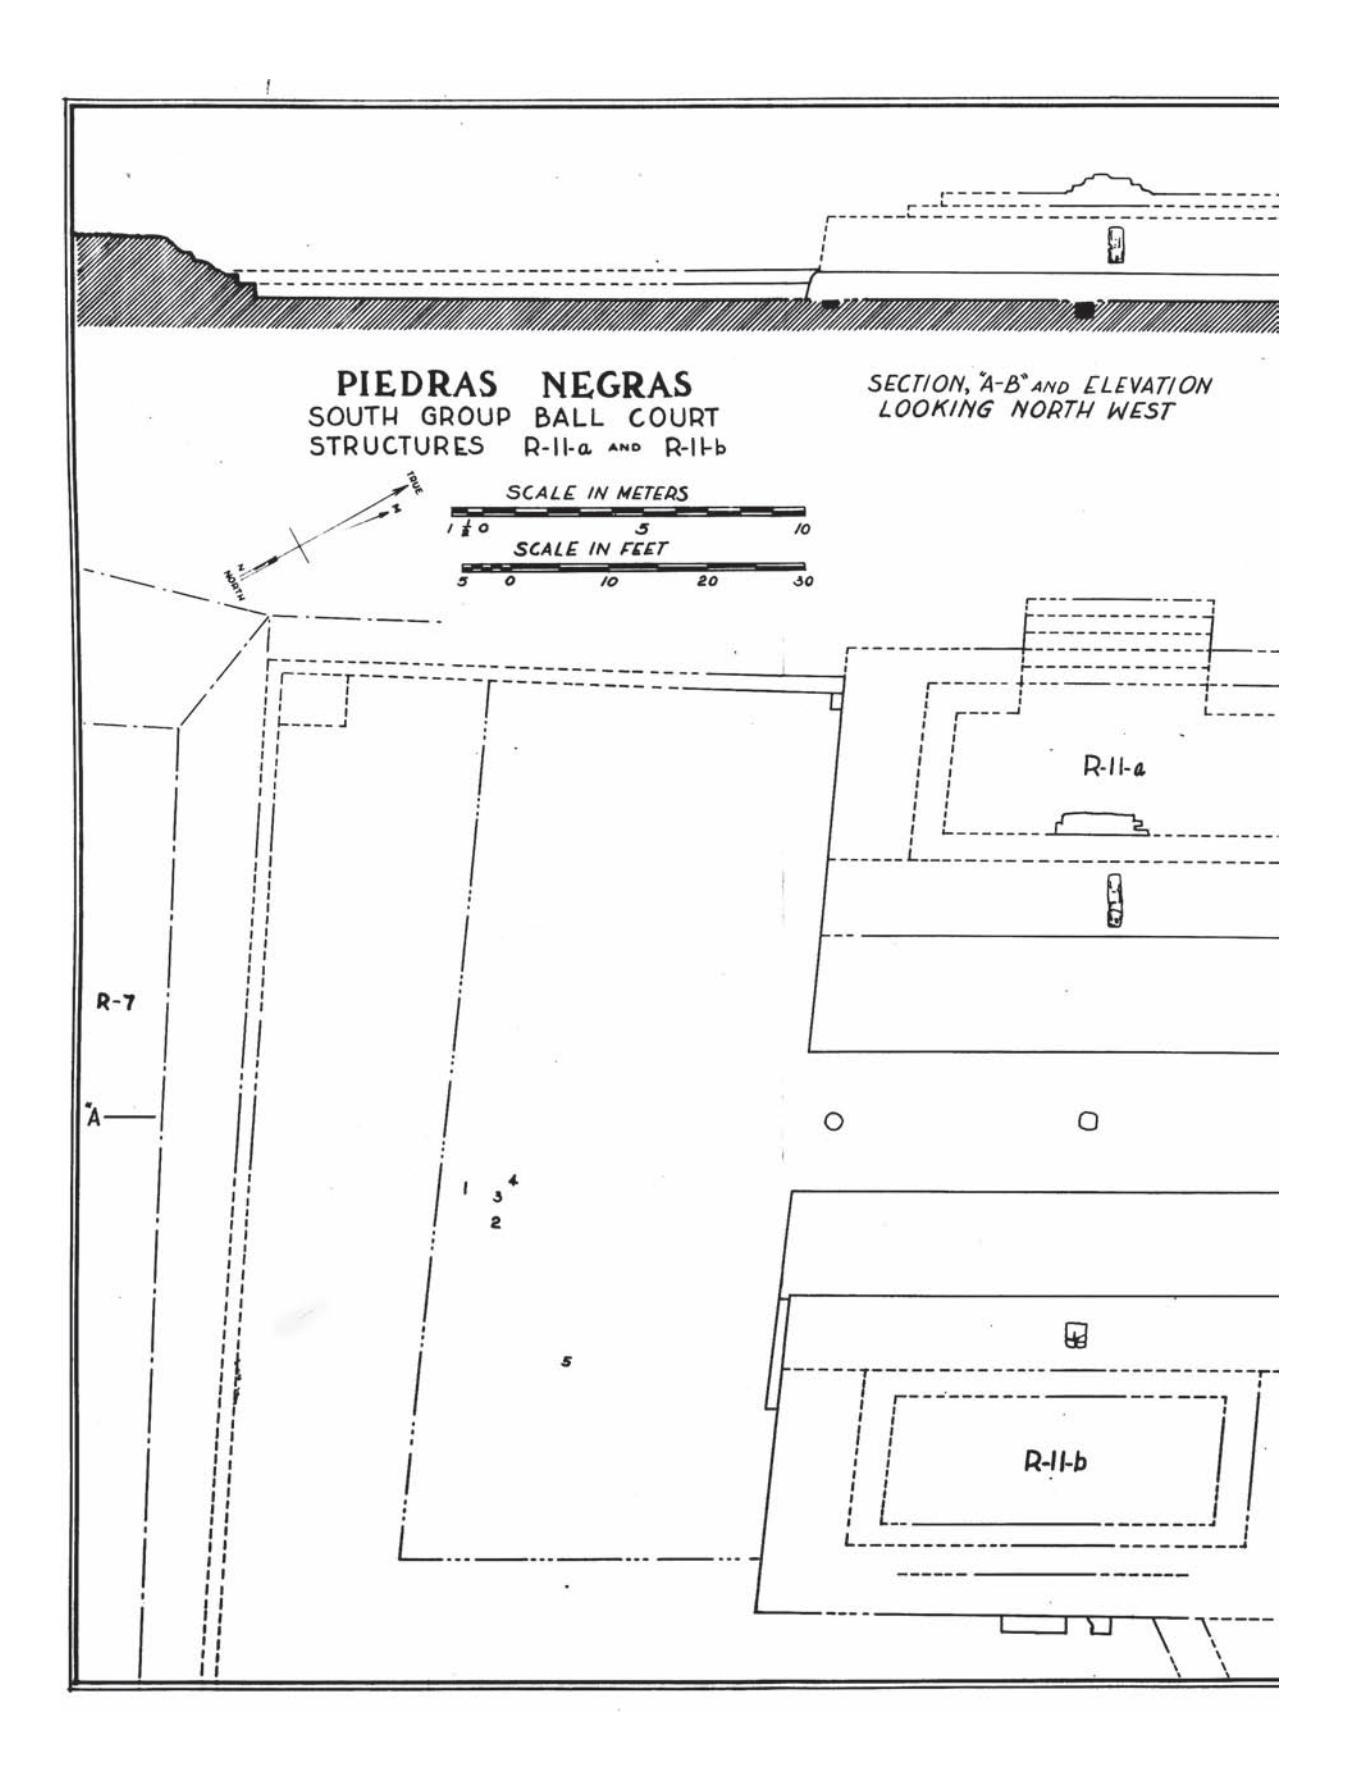
Figure 2.4 Piedras Negras South Group Ballcourt Structures R-11-a and R-11-b; Section A-B and elevation looking northwest; cross section through central stone at right angles to A-B.

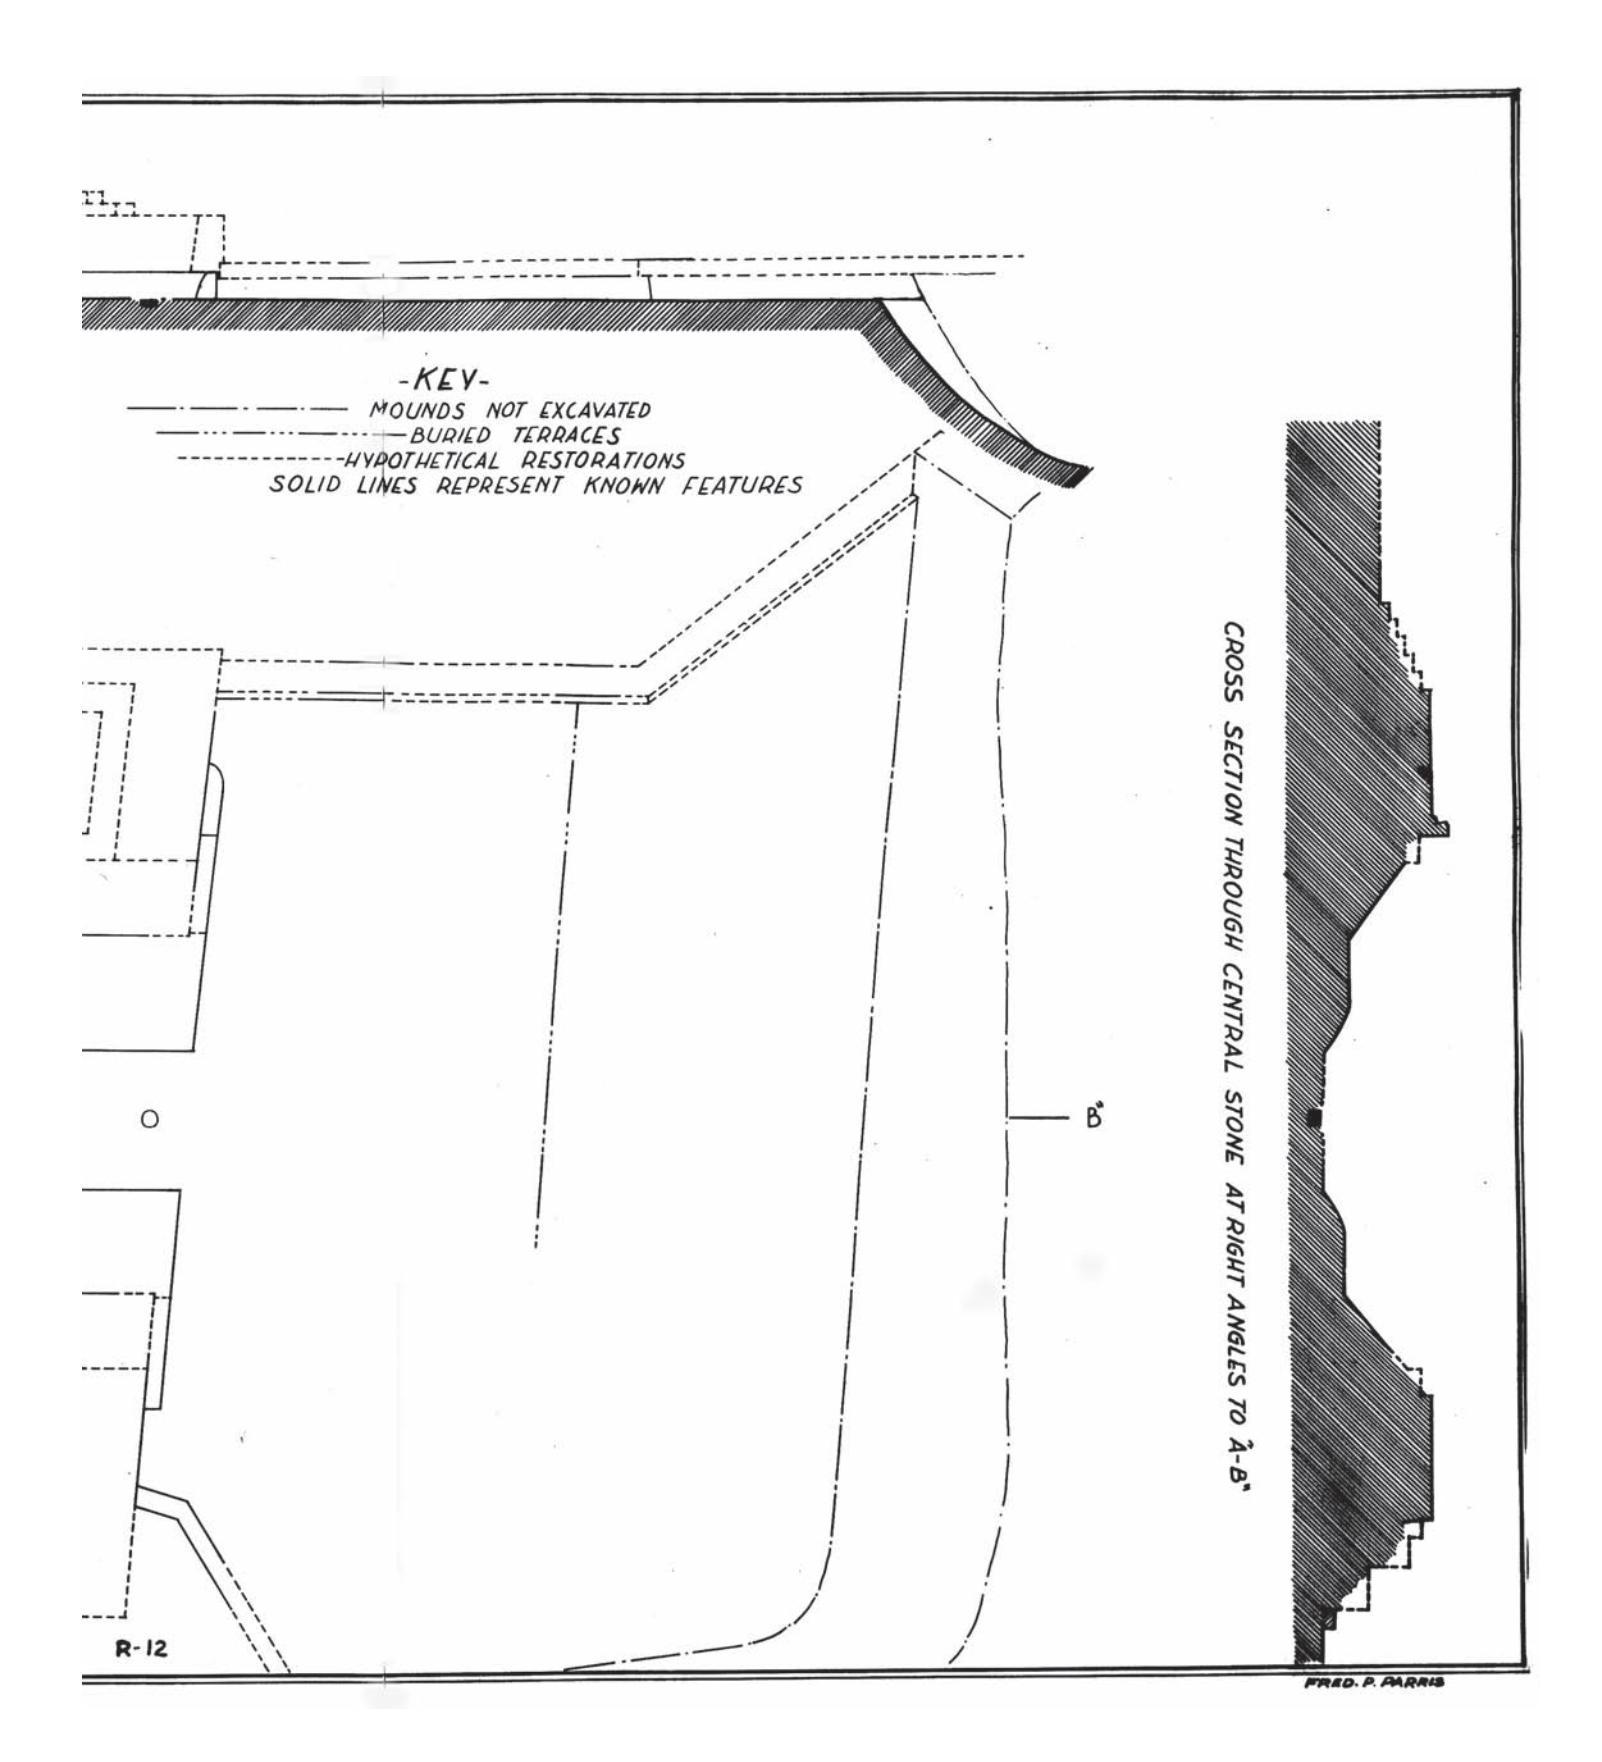
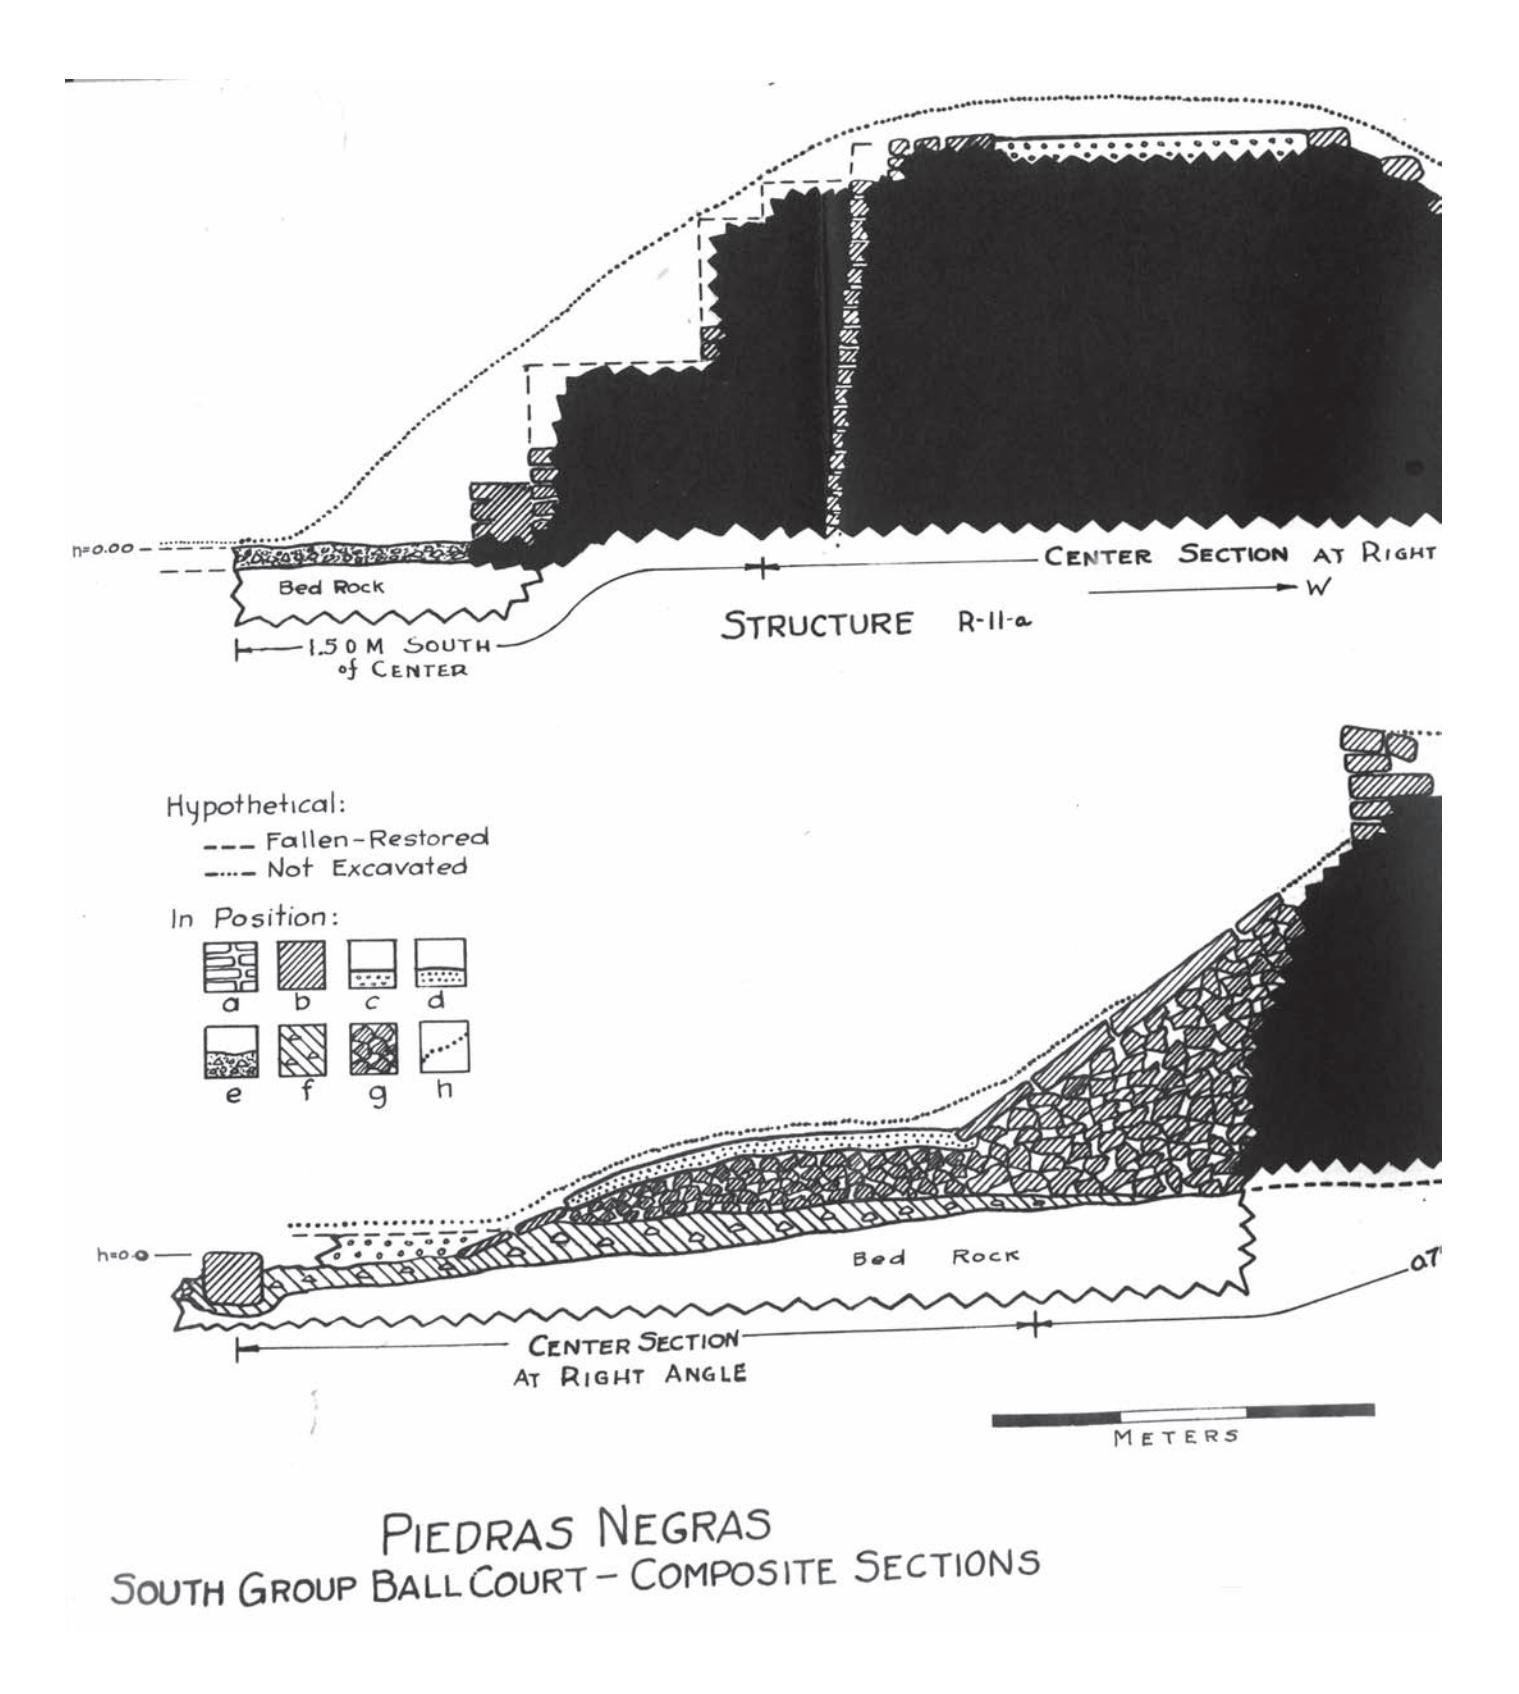
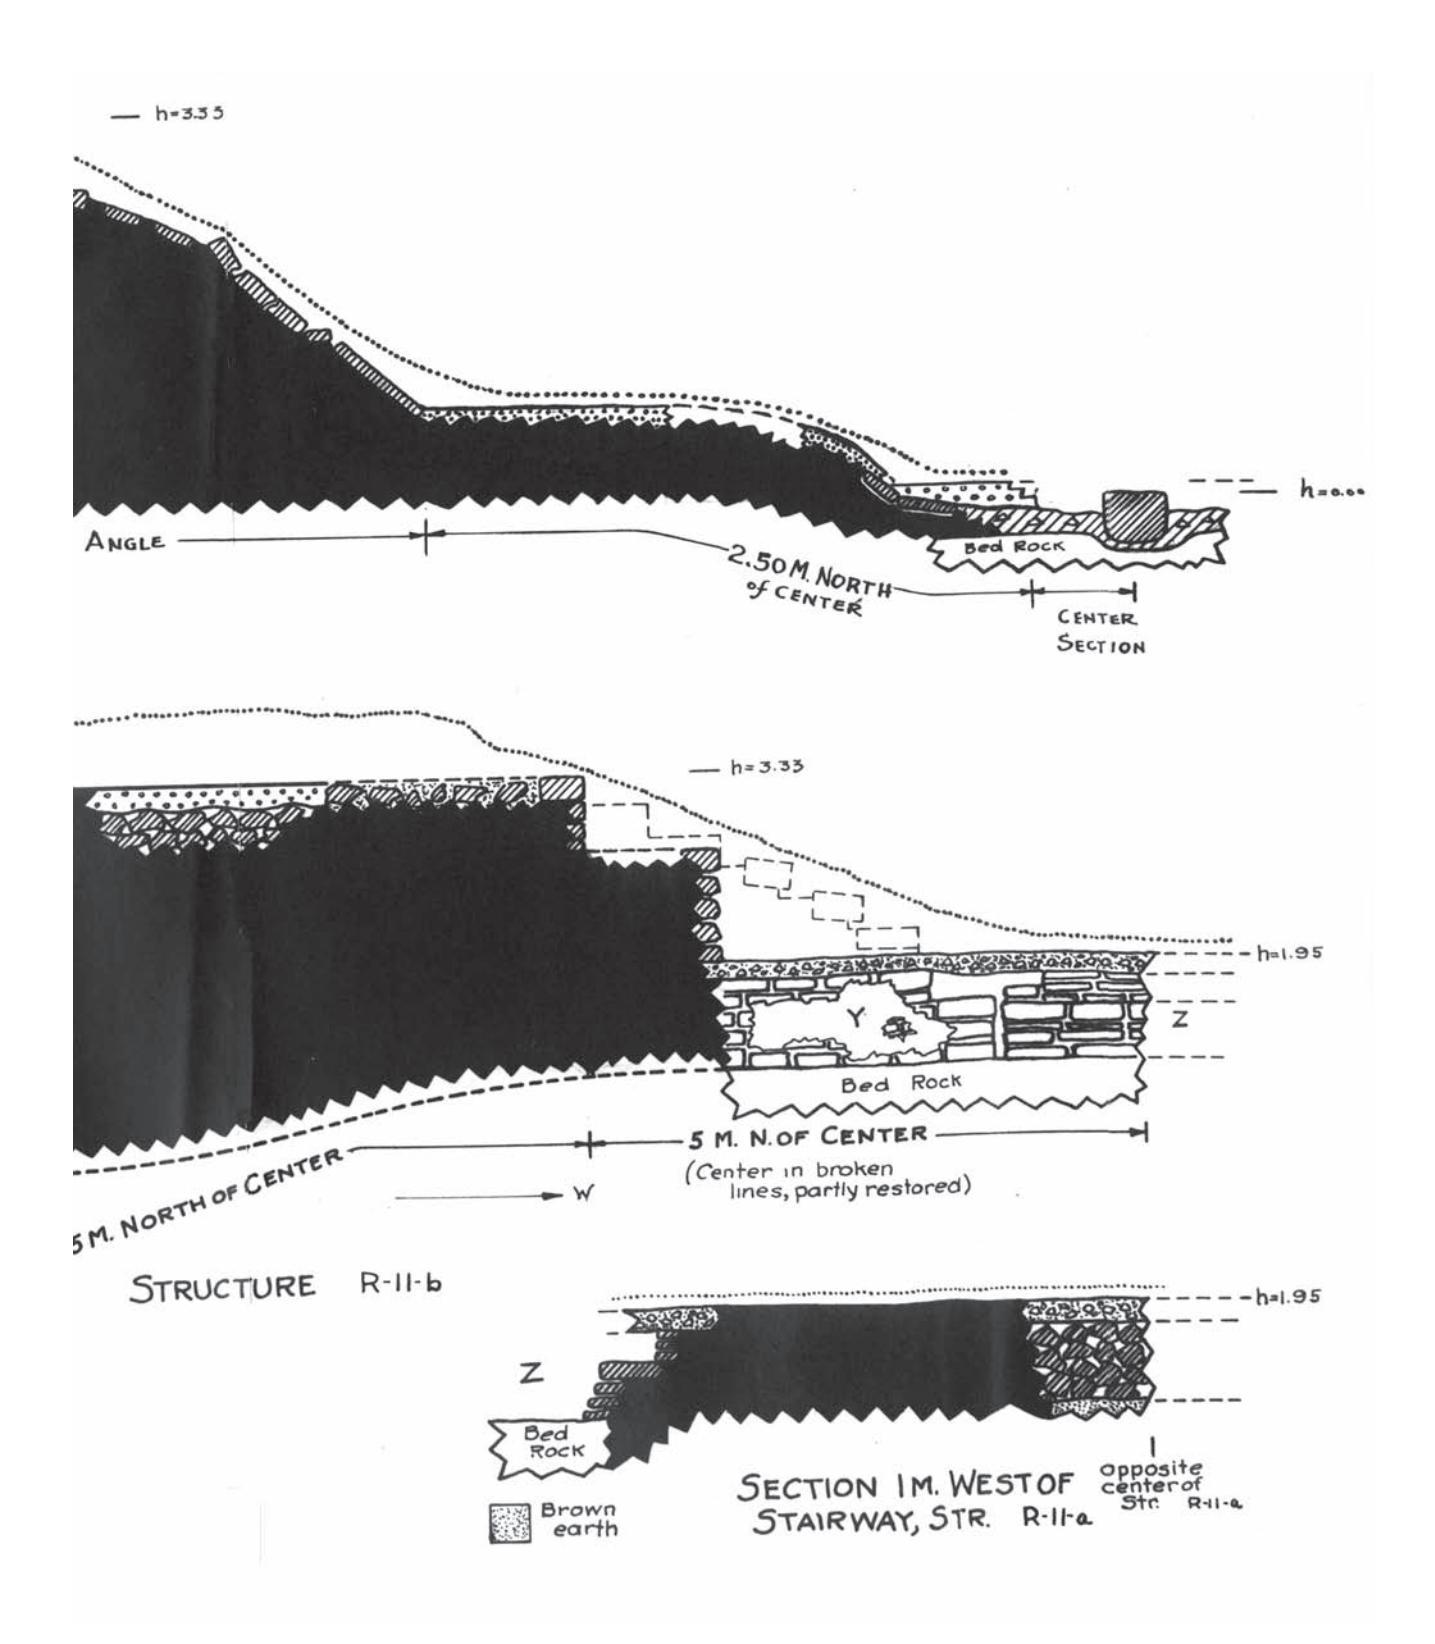
Figure 2.5 Piedras Negras South Group Ballcourt, composite sections.

modern combination of cut and fill for obtaining a level surface. Except over the area of pure rock fill, the actual foundation of the pavement was a solid fill of earth and small broken rock ("f" in the key, Fig. 2.5).

in section in Figure 2.5a, b. The lower row, sloping up toward the platform, was buried under the alley pavement. The upper row carries this stone foundation from a point below the alley pavement to a point below the sloping side of the concrete cap of the platform, which overlaps it. Since the whole platform and alley at the section examined, rests on the same solid fill, one wonders why added foundation stability was desired along this line. This buried double line of slabs definitely does not belong to an earlier structure, unless all other vestiges of it, including the alley floor, were later removed, which is more than improbable. Lines of slabs in this position have been observed at several ball courts. Possibly they also were buried foundation constructions, and only to a small extent the surfaces of the platform slopes.

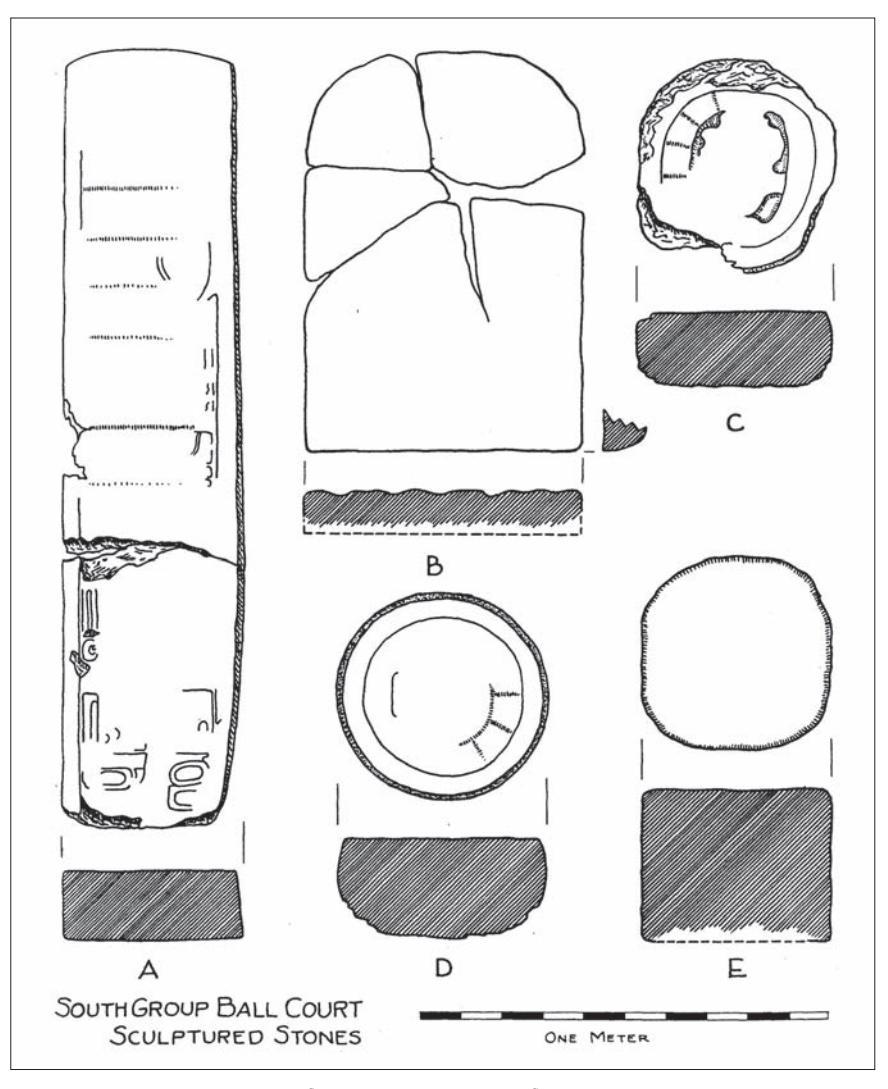
Figure 2.6 Field drawings of South Group Ballcourt field markers and sculptured stones.
