# PIEDRAS NEGRAS ARCHAEOLOGY, 1931–1939

# Piedras Negras Preliminary Papers Piedras Negras Archaeology: Architecture

Linton Satterthwaite, Jr., Mary Butler, and J. Alden Mason

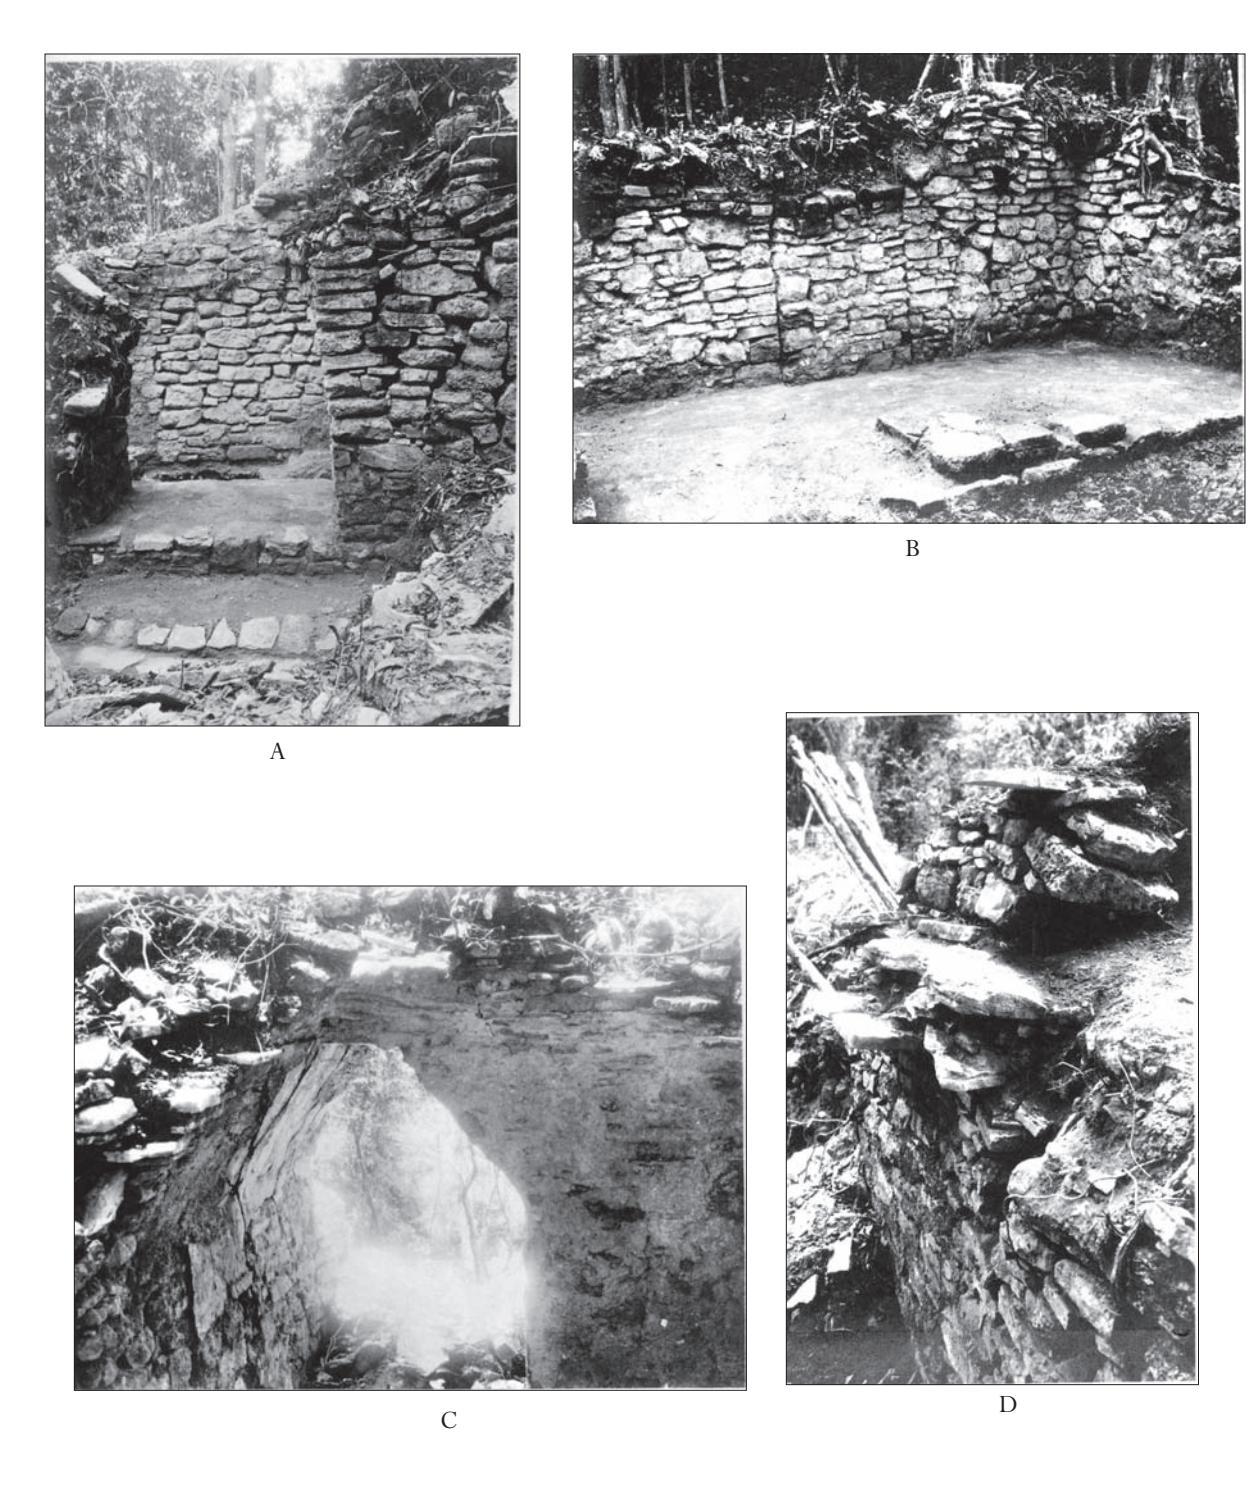
Figure 3.2 a. Structure J-2: looking to medial wall through southwesterly doorway of Room 2; b. Structure J-2: showing northeasterly end of Room 1, looking over remains of a pier, from the south; c. Structure J-2: looking through interior vaulted doorway, from Room 6; d. Structure J-2: portion of medial molding and upper zone near southwesterly corner from southwest and above.

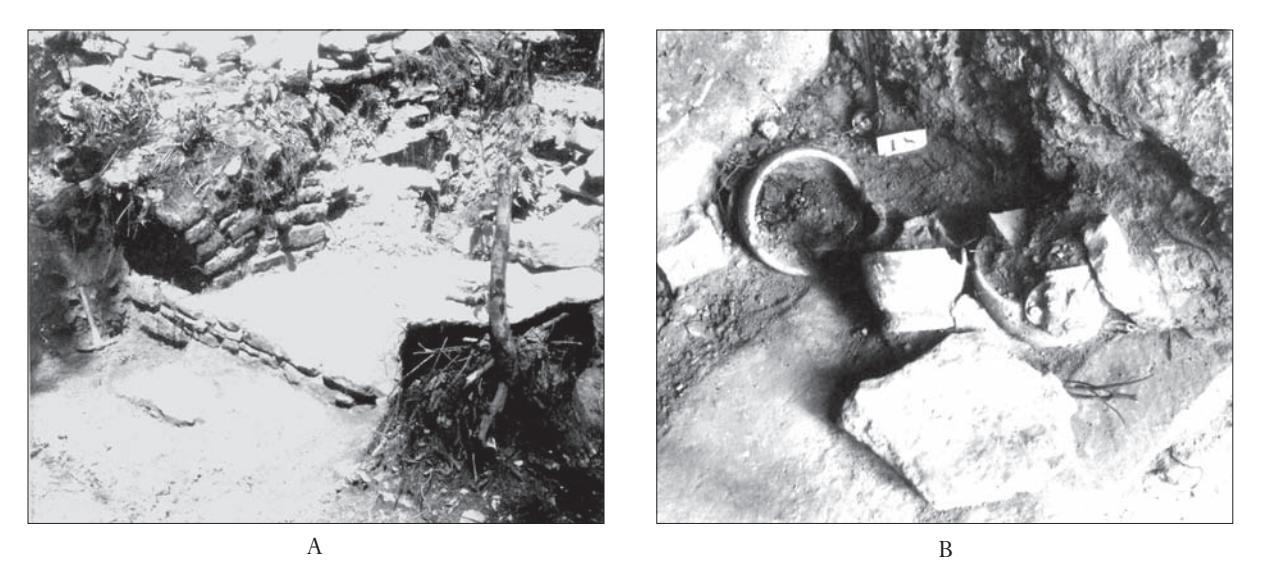
Figure 3.3 a. Structure J-2: pier, doorway, and plinth, Room 2, from west; b. Structure J-2: Room 3, Lacandon incense burners in place before removal; c. Structure J -2: cross section through wall, medial molding and upper zone shown in Plate 2.2.d;
d. Structure J-2: cross section through walls, floor, and fill, southwesterly end of Room 2, looking northeast.

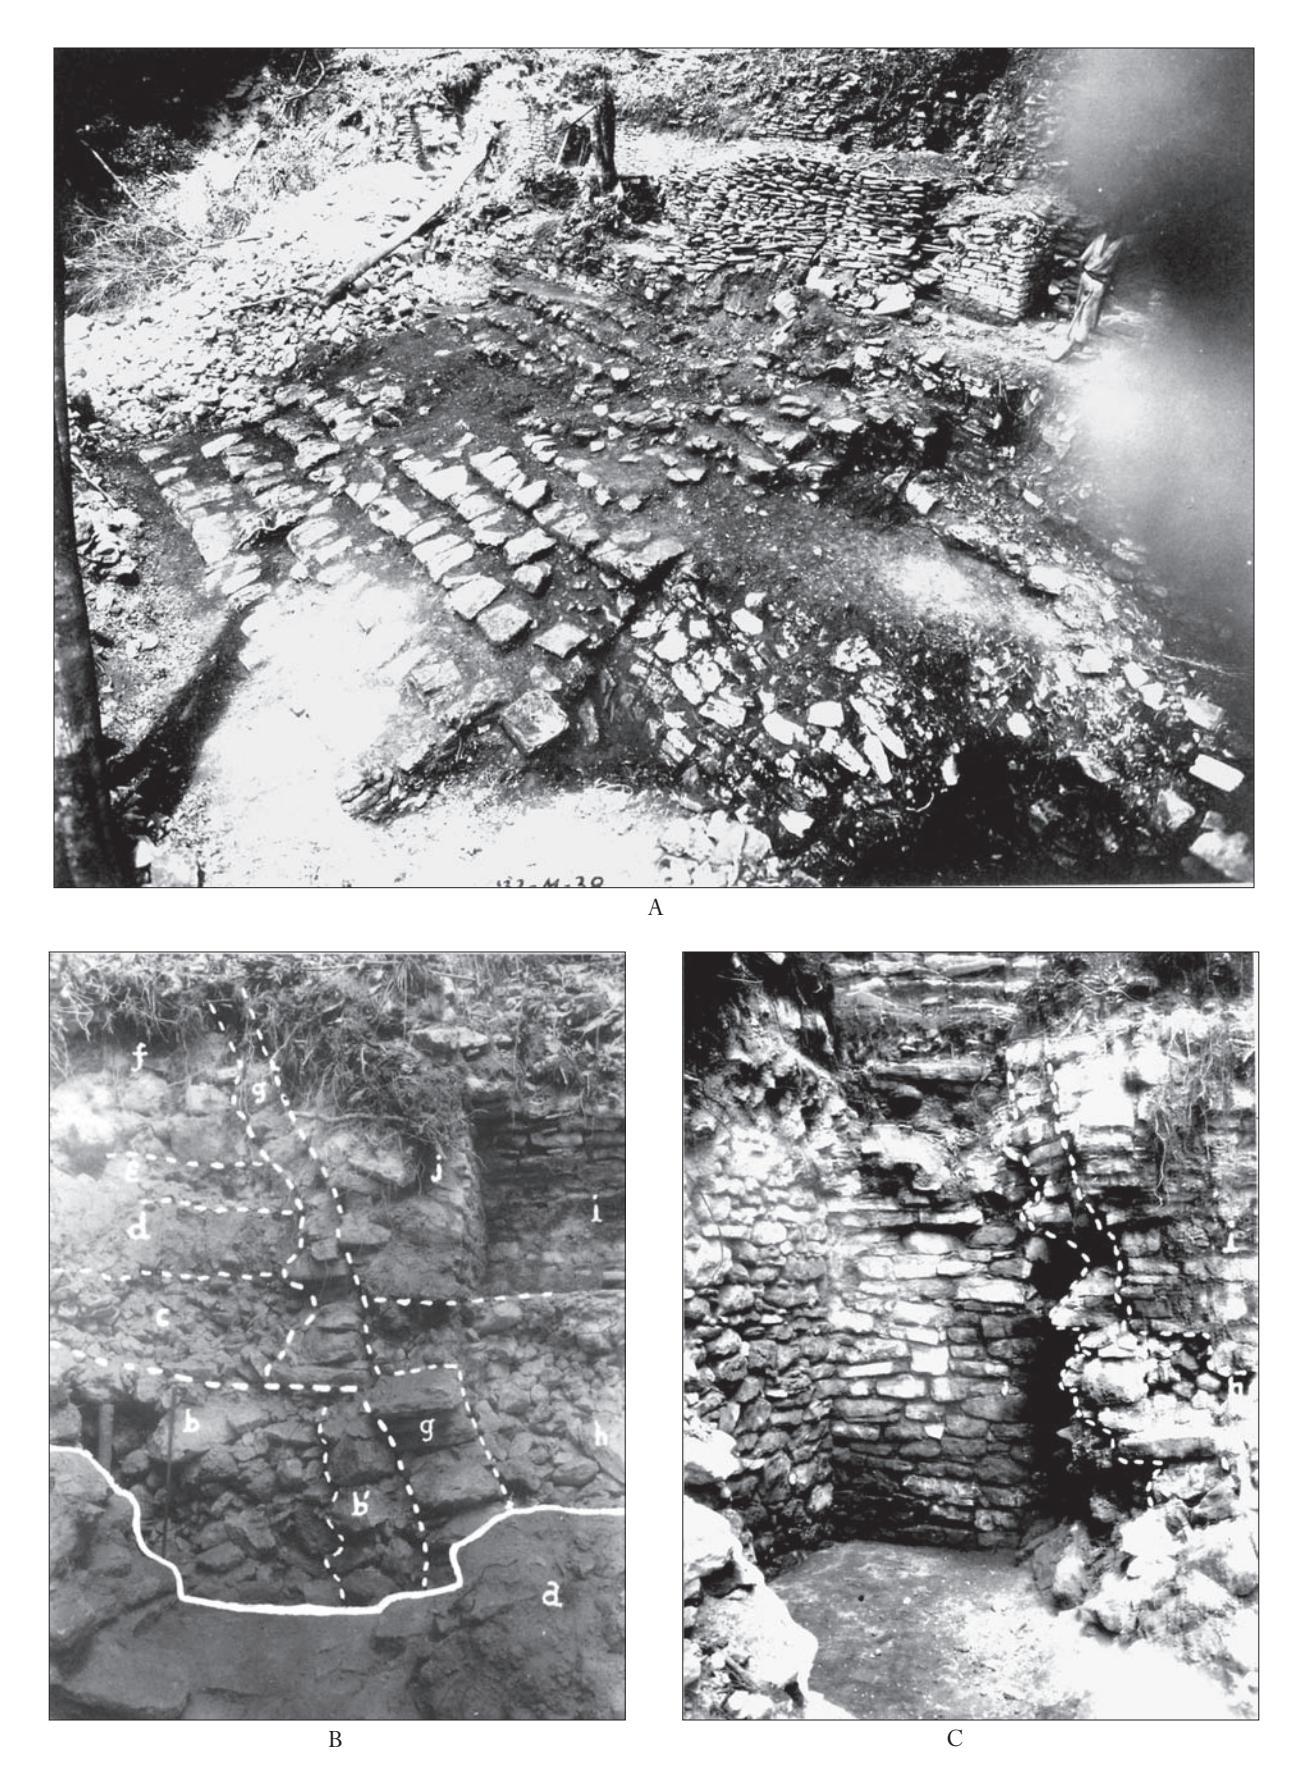
Figure 3.5 a. Structure J-6: exterior stairway from east and above; the rough dry wall at top of stairway was laid up in course of excavations; b. Structure J-6: section through end of Room 1-a and fill behind it, from southeast; c. Structures J-6 and J-6-2nd: same view as b, after removal of fill; corner of J-6-2nd is at left.

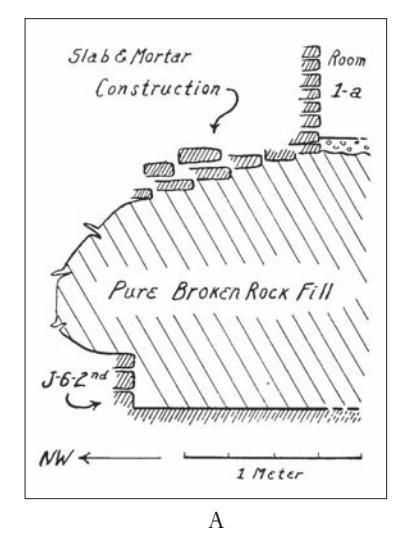
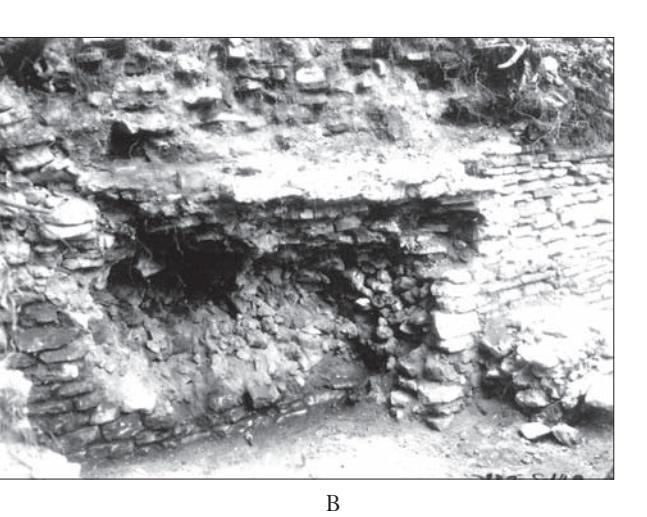
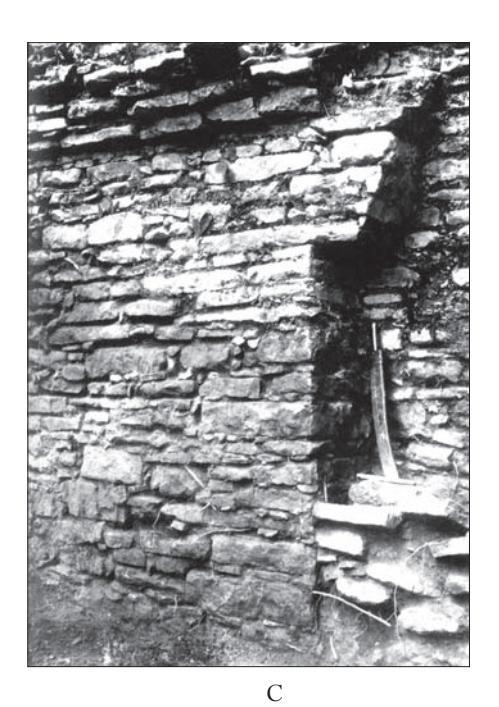
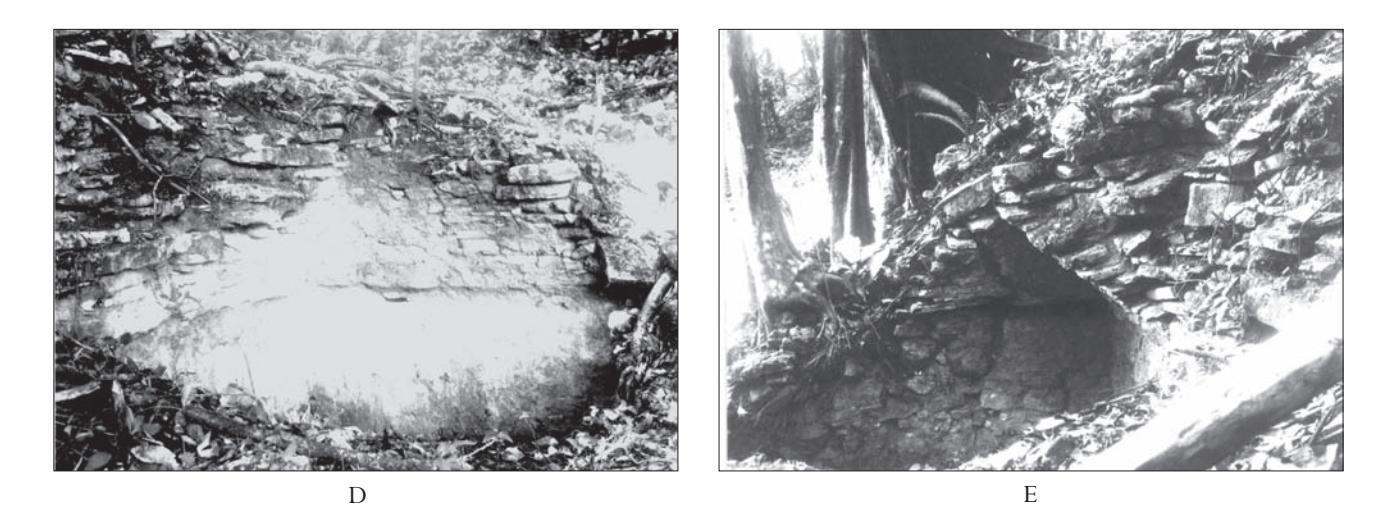
Figure 3.6 a. Structure J-6: cross section through parts of Room 1-a and Structure J-6-2nd, and fills; b. Structure J-6: view of construction shown in above section after removal of fill and northwesterly wall of Room 1-a, from south; remnant of stairway seen from behind at right; c. Structure J-6: Room 1, showing rear wall, main vault spring, end of niche of Throne 1, from east; d. Structure J-6: vaulting at northeasterly end of Room 3; arrow indicates position of beam socket, from south; e. Structure J-6: vaulting at southwesterly end of Room 3, from northeast.

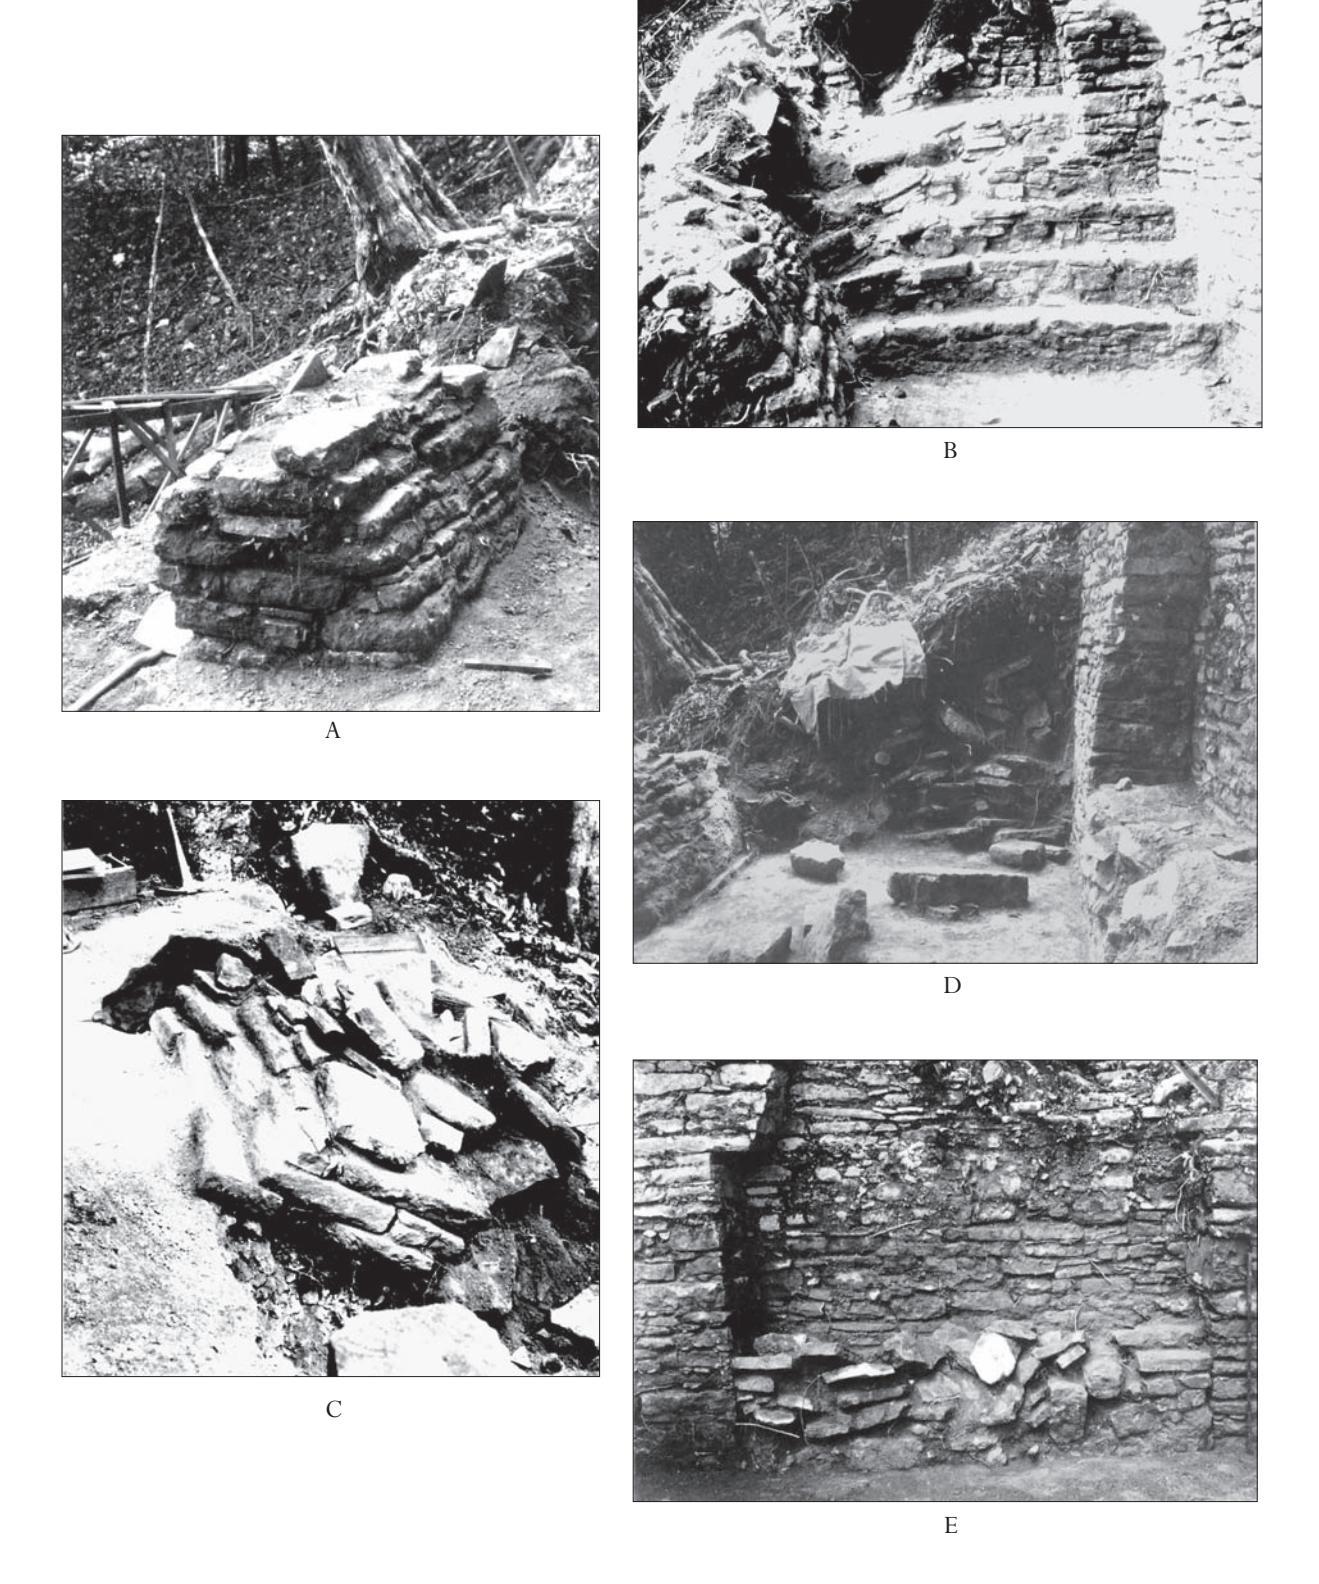
Figure 3.7 a. Structure J-6; pier in front of southwesterly end of niche, Room 1, from north (numbered 2 in text); b. Structure J-6: Room 1-a and stairway, from Room 1; c. Structure J-6: badly fallen pier in front of northeasterly end of niche, Room 1, from south (numbered 3 in text); d. Structure J-6: section through debris, Room 1, showing pier at left, fragments of Throne 1 in position on floor before removal, niche and bench on right, from northeast; e. Structure J-6: niche and supporting bench of Throne 1, with partly disrupted stones of bench in position as found; arrow indicates specialized offset slab at right.
