UNDERSTANDING THE ARCHITECTURE OF THE SOUTH SECTOR OF CHOCOLA, SUCHITEPEQUEZ

Oscar R. Gutiérrez

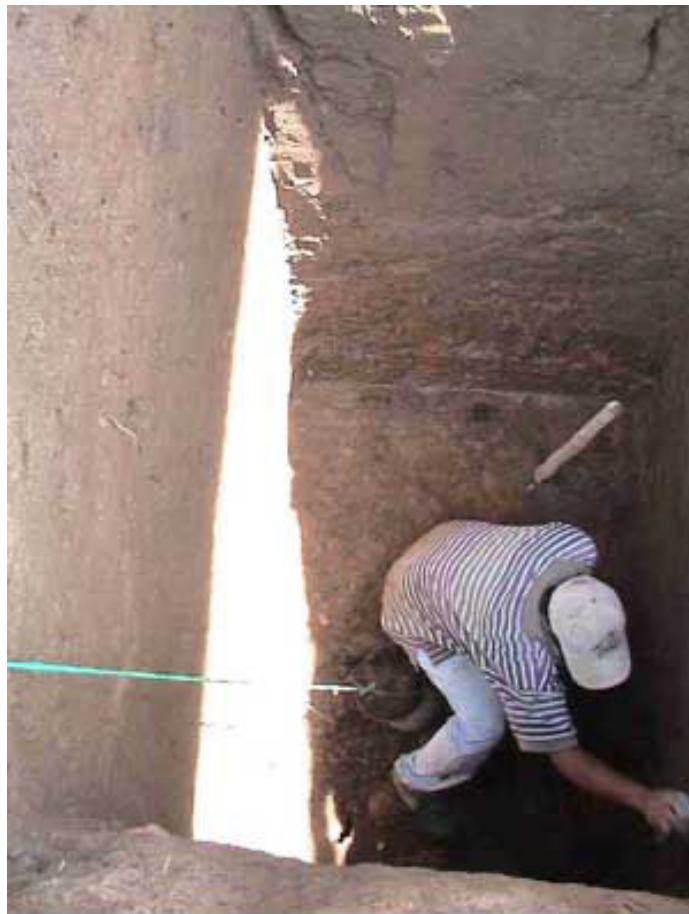
Figure 1. View of the exploration, Pit 5.

This however was not entirely true, as his reports only referred to outer profiles, diameters and heights, and included no information about form or how the strata that integrated Mound 2 were arranged (Figures 1 to 4). This would have been of help to establish several possible architectural forms.

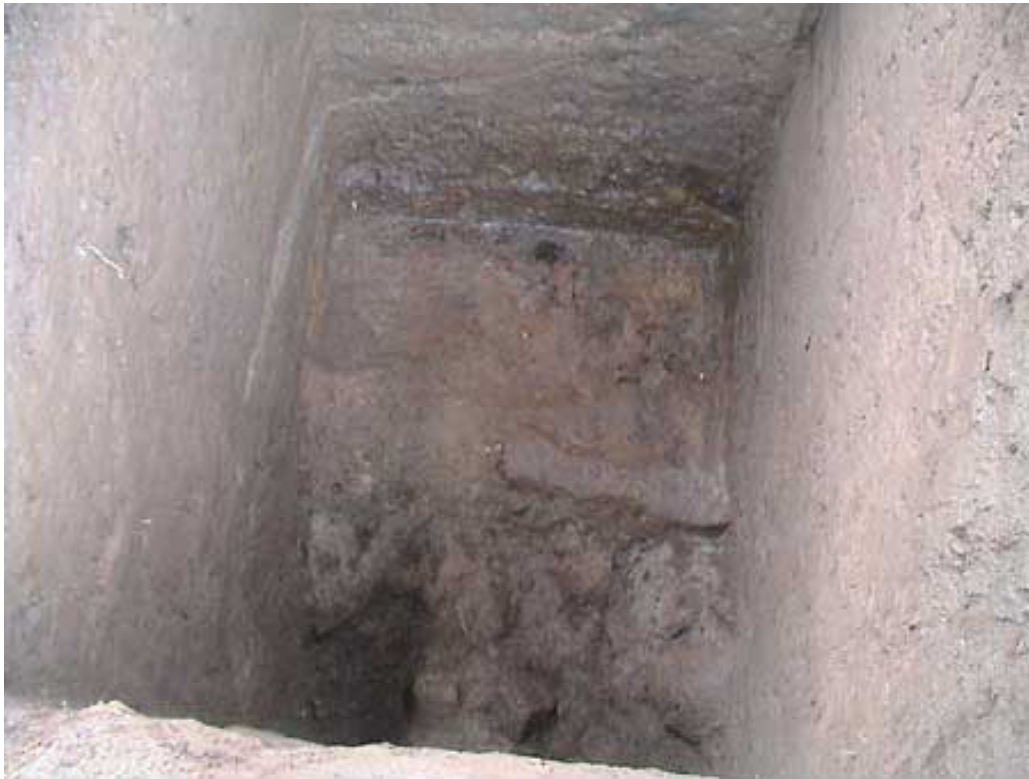
Figure 2. View of burnt stones.

The test pits in Cerro Partido presented construction materials in earth and mud of a greyish and light brown color, at times with reddish spots or black areas, notoriously burnt surfaces whose form is so far ignored, as well as the elaborating procedure. Surfaces exposed to heat show a constant thickness of approximately 0.02 m. At the inside of the burnt areas there were large water-worn stones (cobbles), the mortar was sand with mixes integrated by small stones present in the red, yellow or blue-green *taxca*, in other cases. This type of burnt area was also found in the earlier excavation of Cerro Partido, when they were exposed by Burkitt's works.

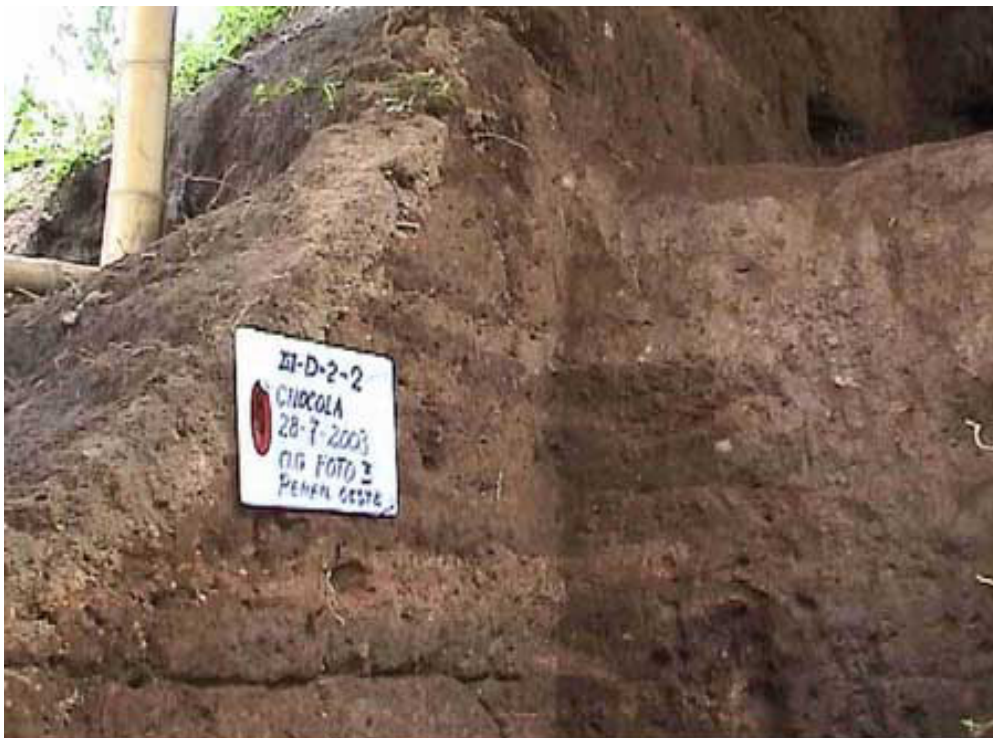
Figure 3. Strata, Mound 2.

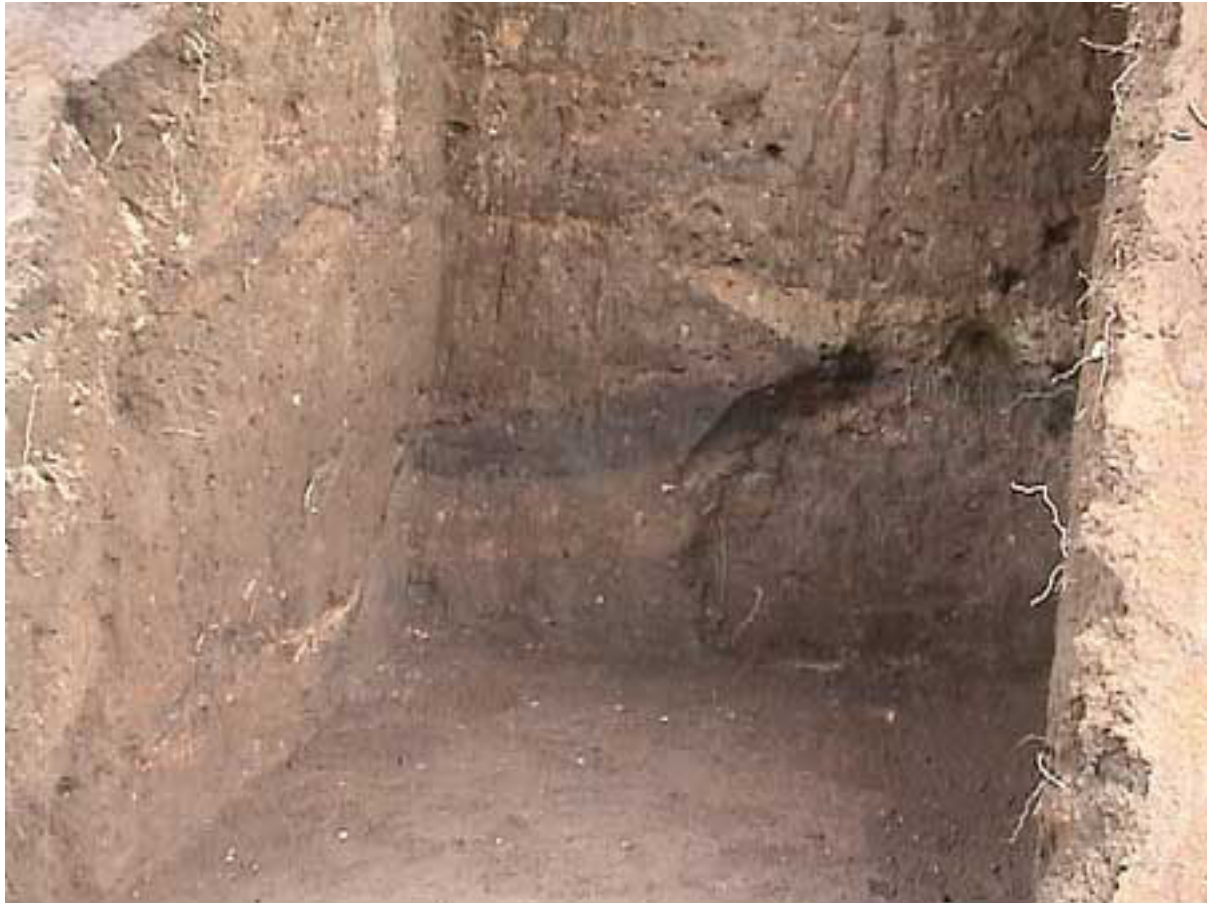
Figure 4. Differences of materials in the excavation profile.
