Stucco Relief from Structure XIX, Palenque

by: Marcia Valle Rangel and Juan Alfonso Cruz Becerril

Site: Palenque, Group of the Cross

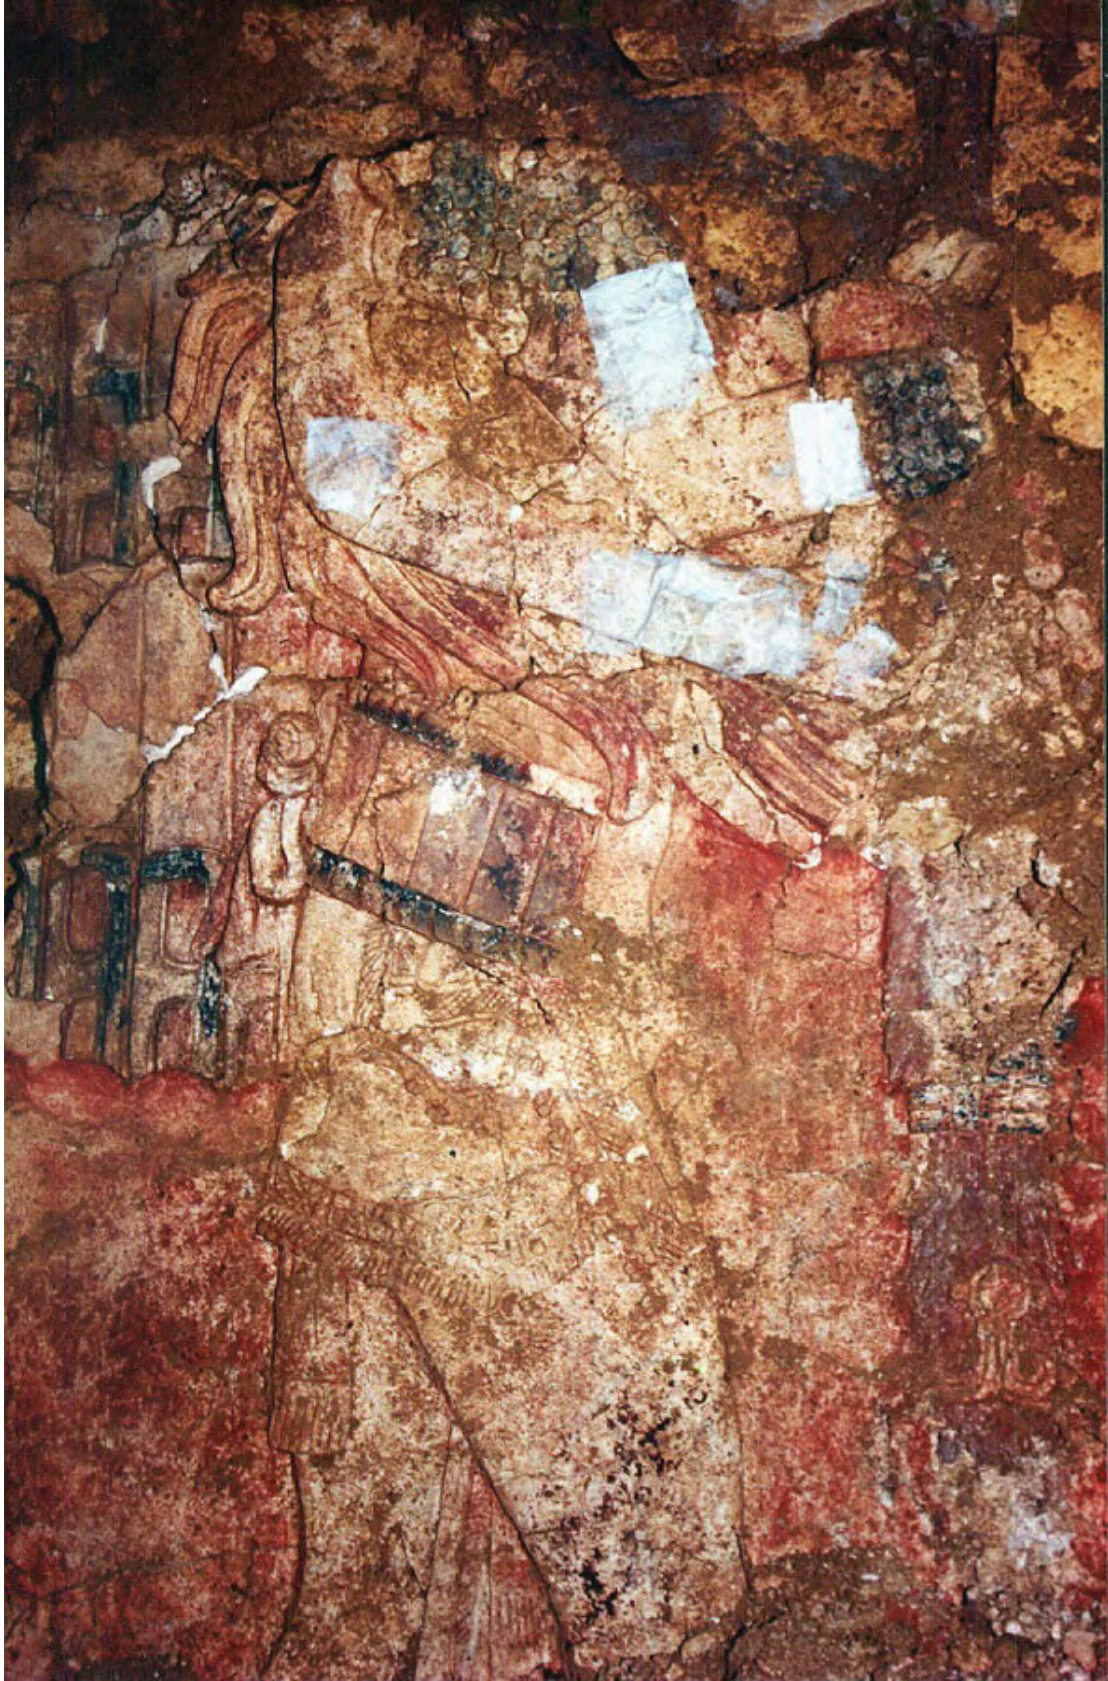
As the excavation work progressed, the remains of a molded stucco relief were uncovered, attached to the jamb of the central pilaster (see [photo 6](#)). Once the pilaster was completely liberated, we were able to fully appreciate the magnitude of this relief and its state of preservation (see [photo 7](#), below). Finally, upon the full liberation of the pilaster it was inferred that the approximate portion of the stucco relief in situ amounted to 40%, while the rest of it was mixed with the rubble (see [photo 8](#), shown below).

Photo 7. Stucco relief attached to pilaster

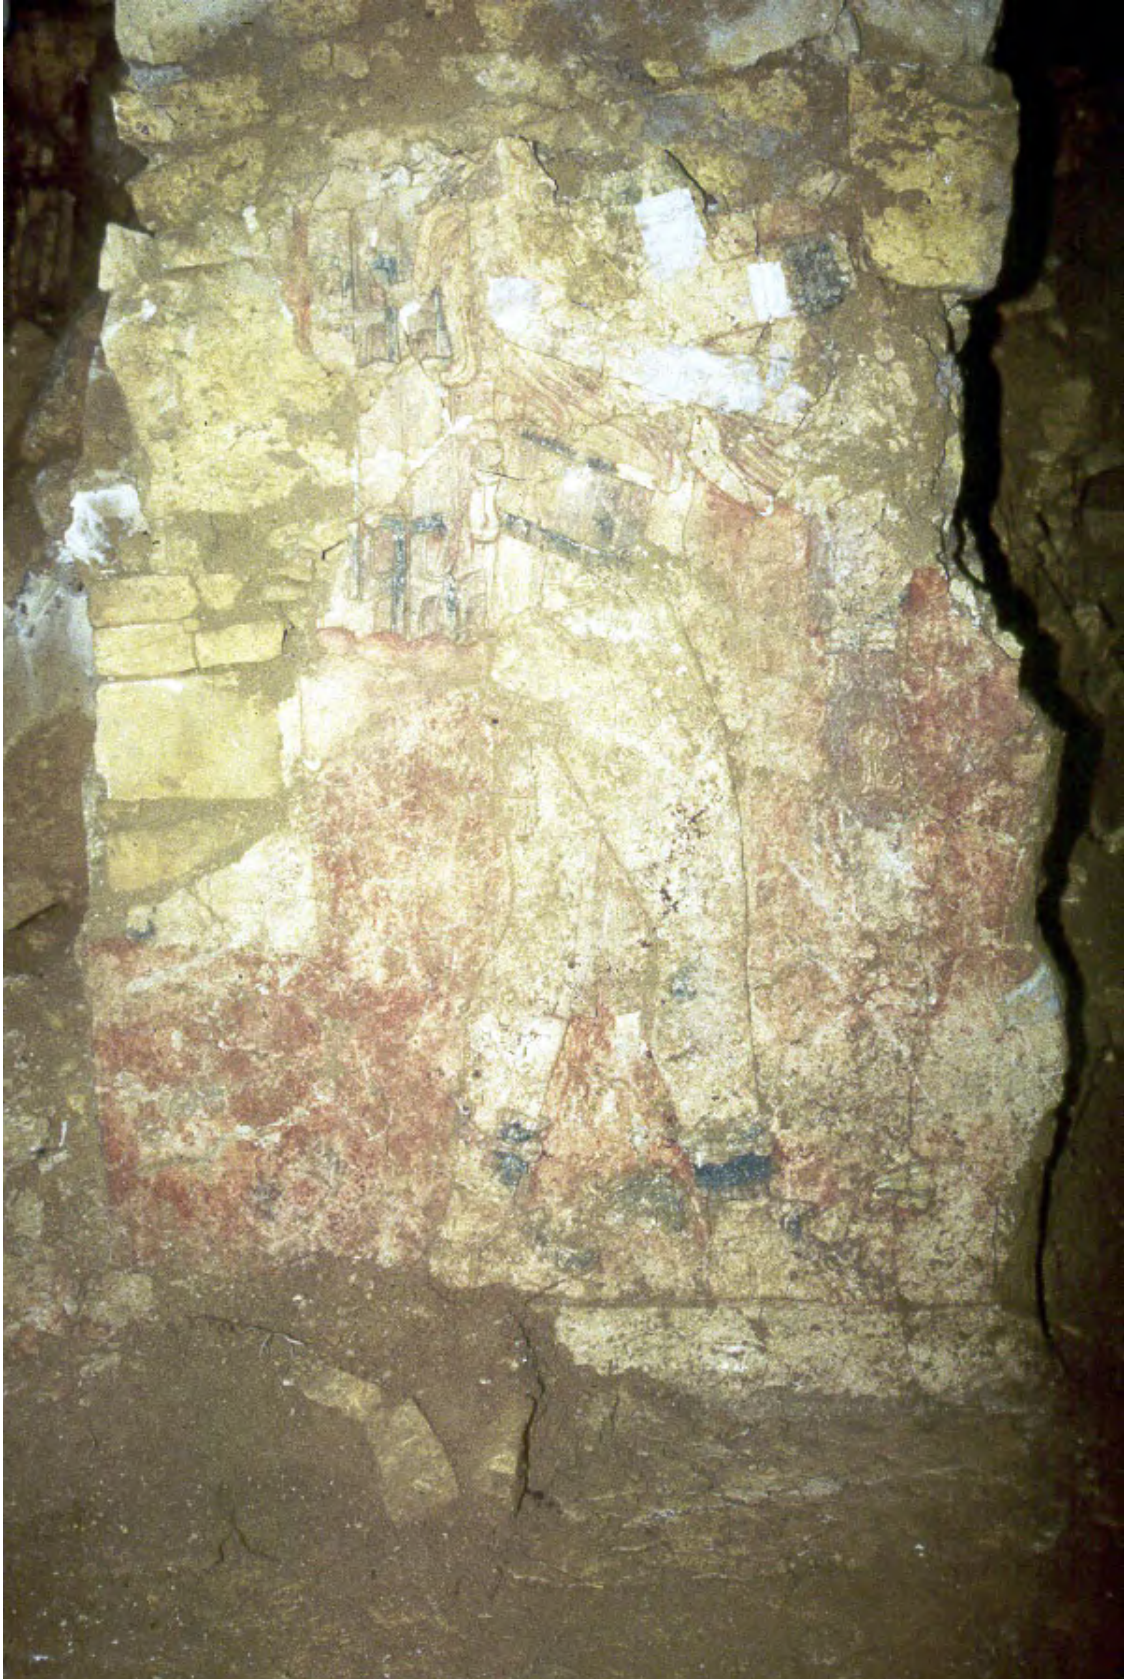
Photo 8. Stucco relief attached to pilaster

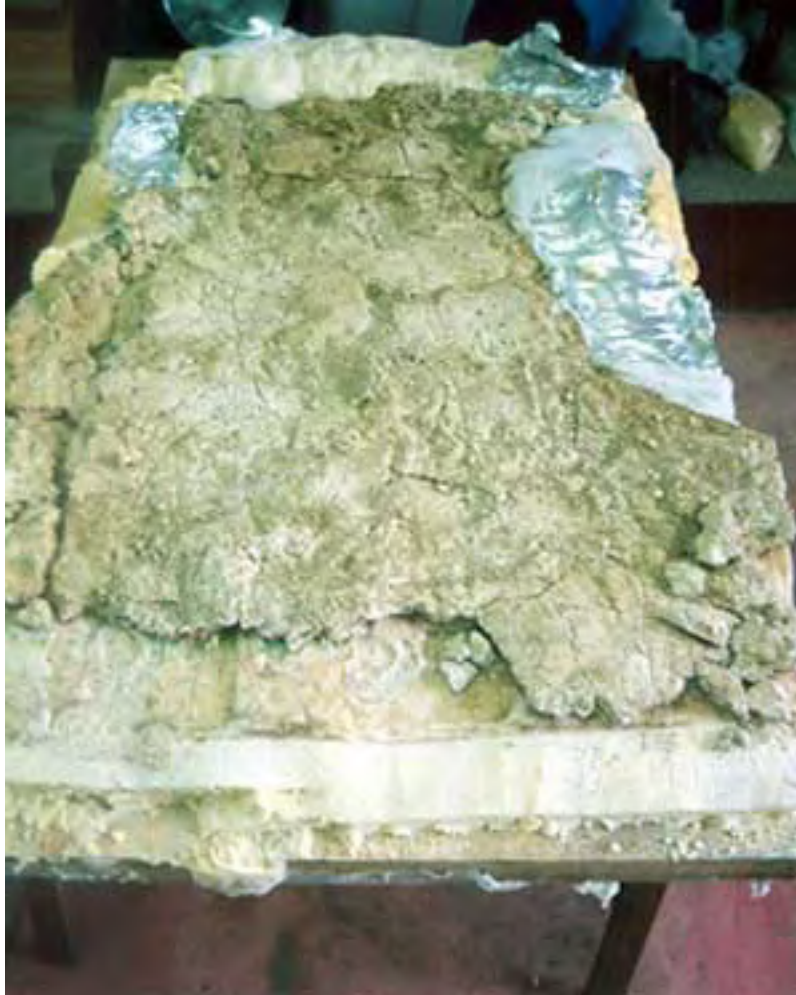
Photo 16. Reverse of detached fragment of the stucco relief

- Once all the materials were taken to the lab, they were sorted according to their point of origin, separating those that were found among the rubble (see [photo 14](#), and [photo 15](#)), and the fragments detached from the pilaster (see [photo 16](#)); then, according to this classification the processes of cleaning, consolidation and assembly of the fragments was undertaken, according to the requirements of each piece. Later, a separation and preliminary grouping of materials was carried out depending on shapes, colors, paste types and their thickness (see [photo 17](#), and [photo 18](#)).

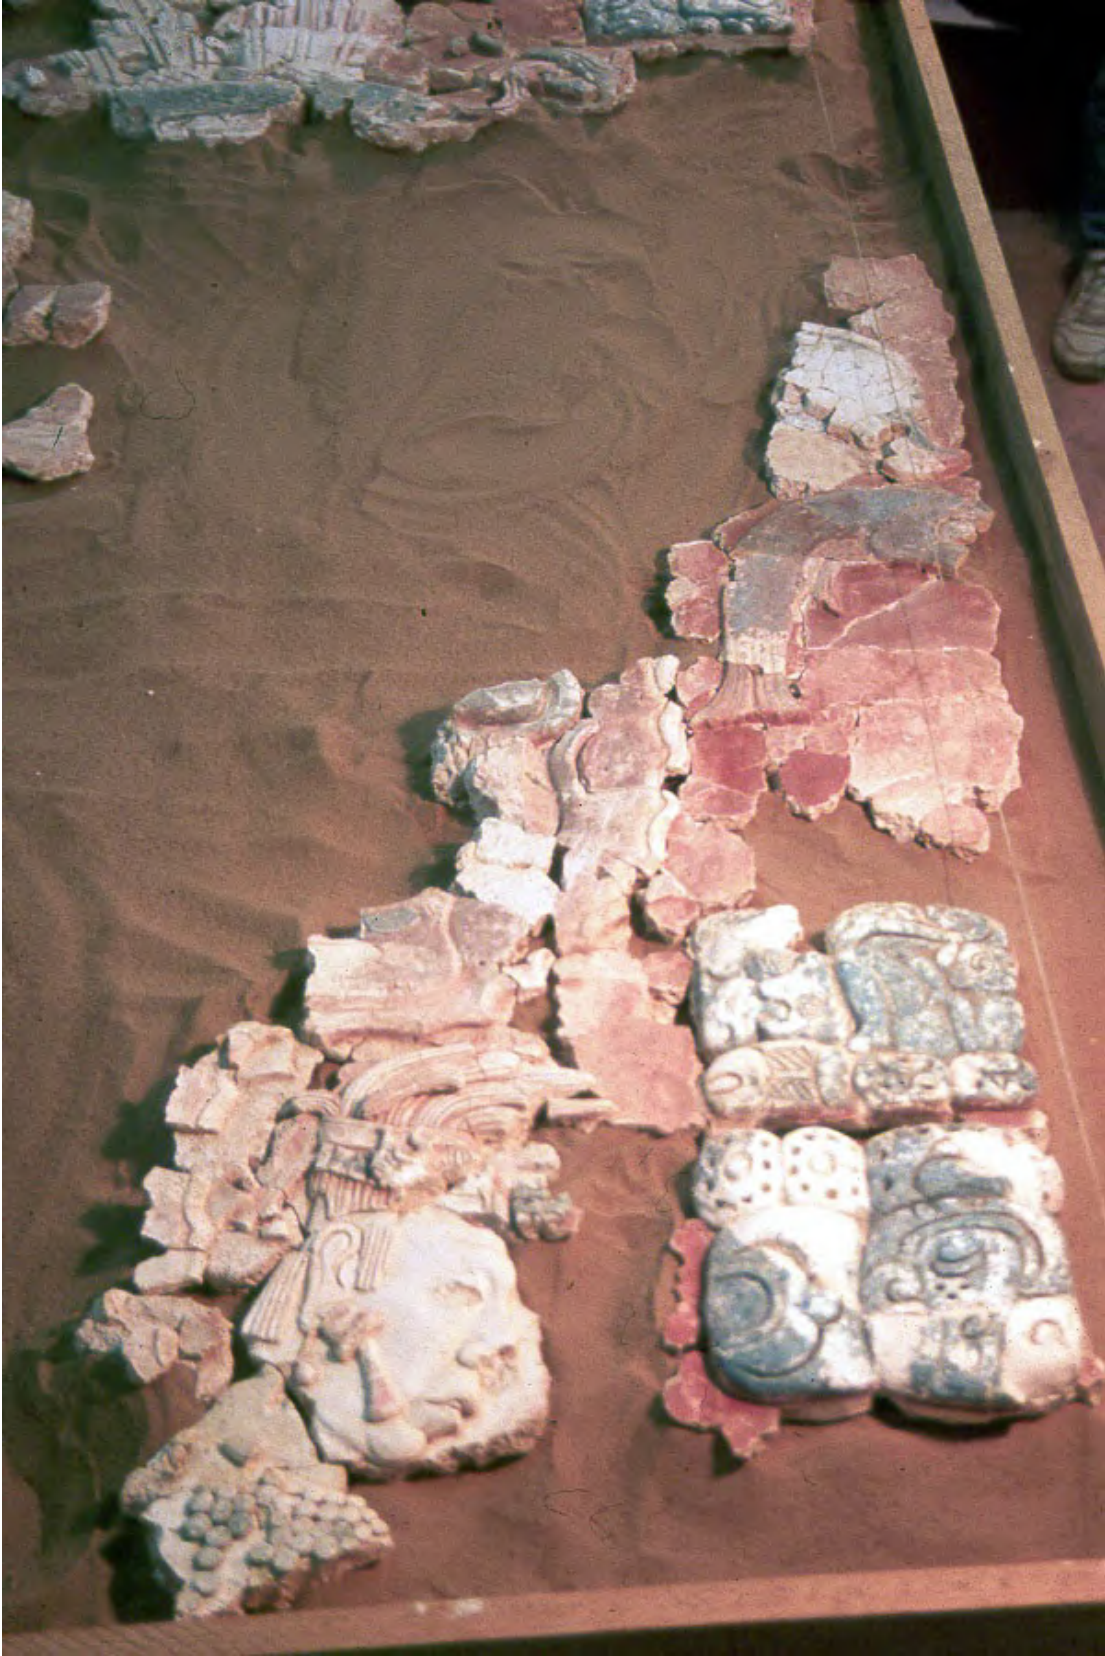
Photo 50. Assemblage of fragments forming blocks

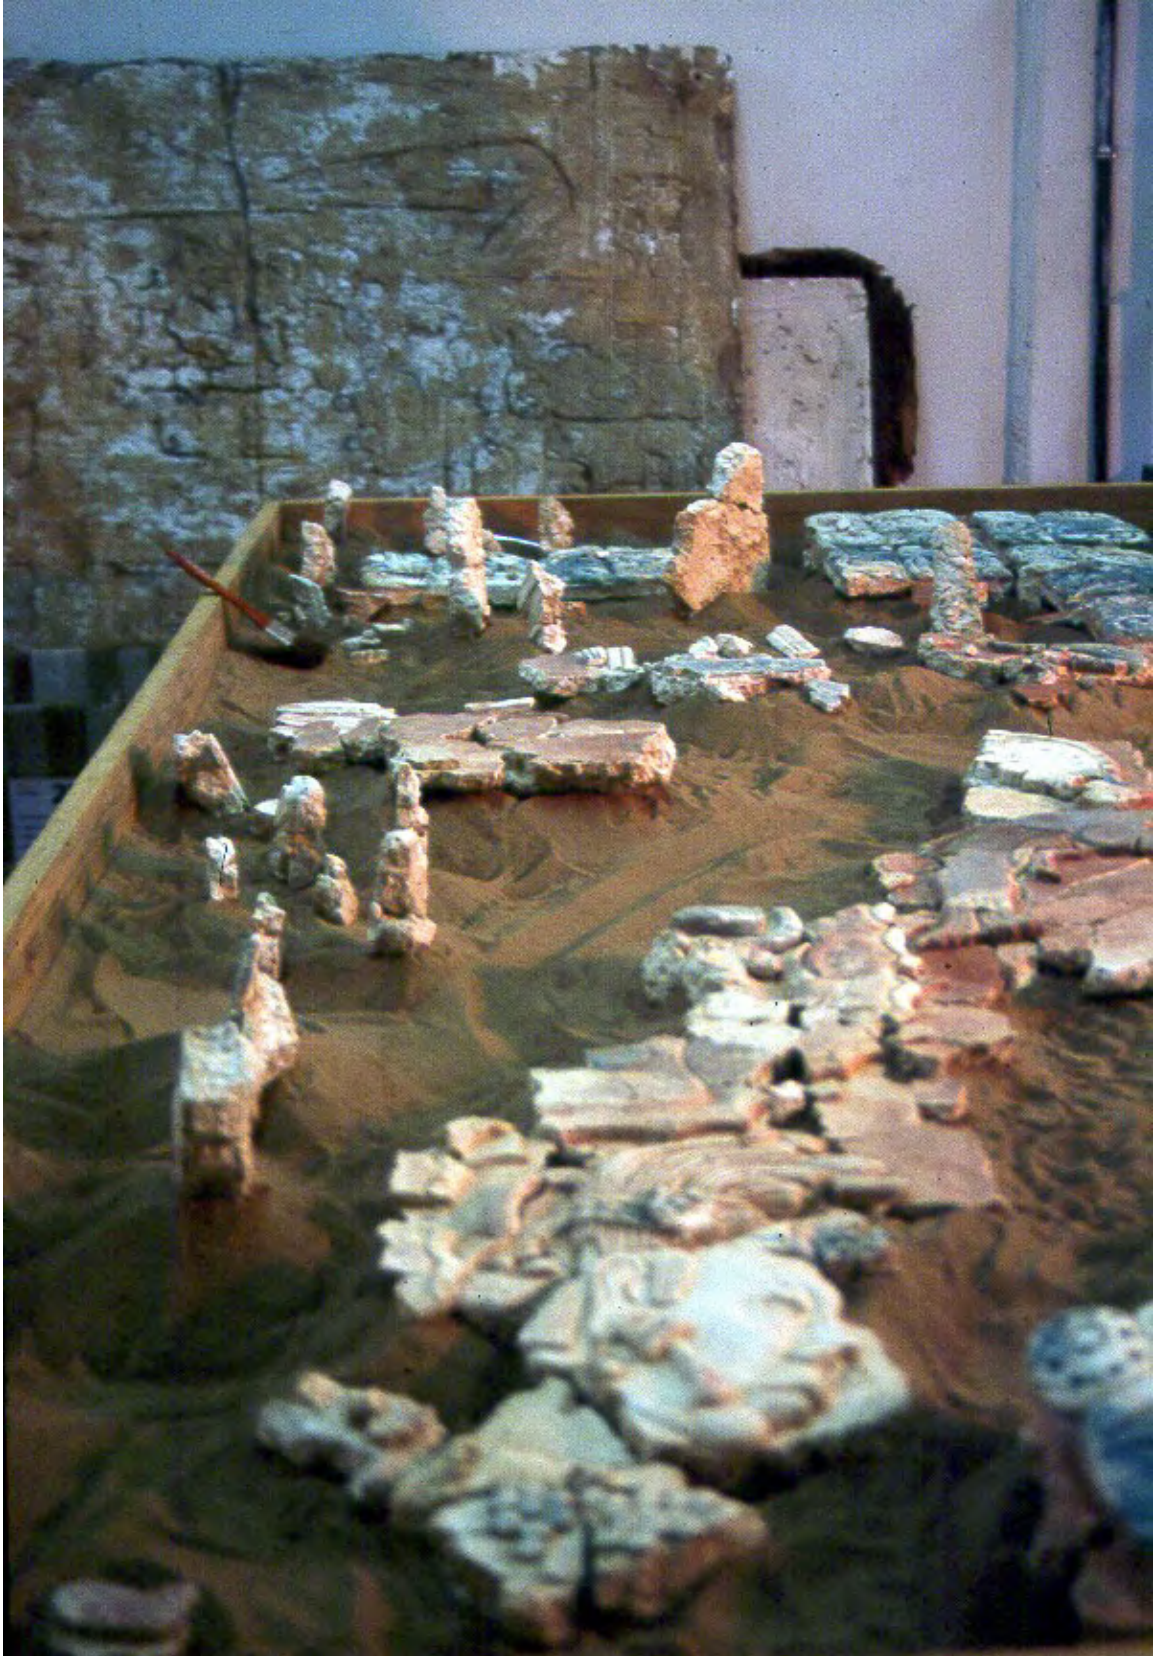
Photo 51. Assemblage of fragments and placement in the sand bed

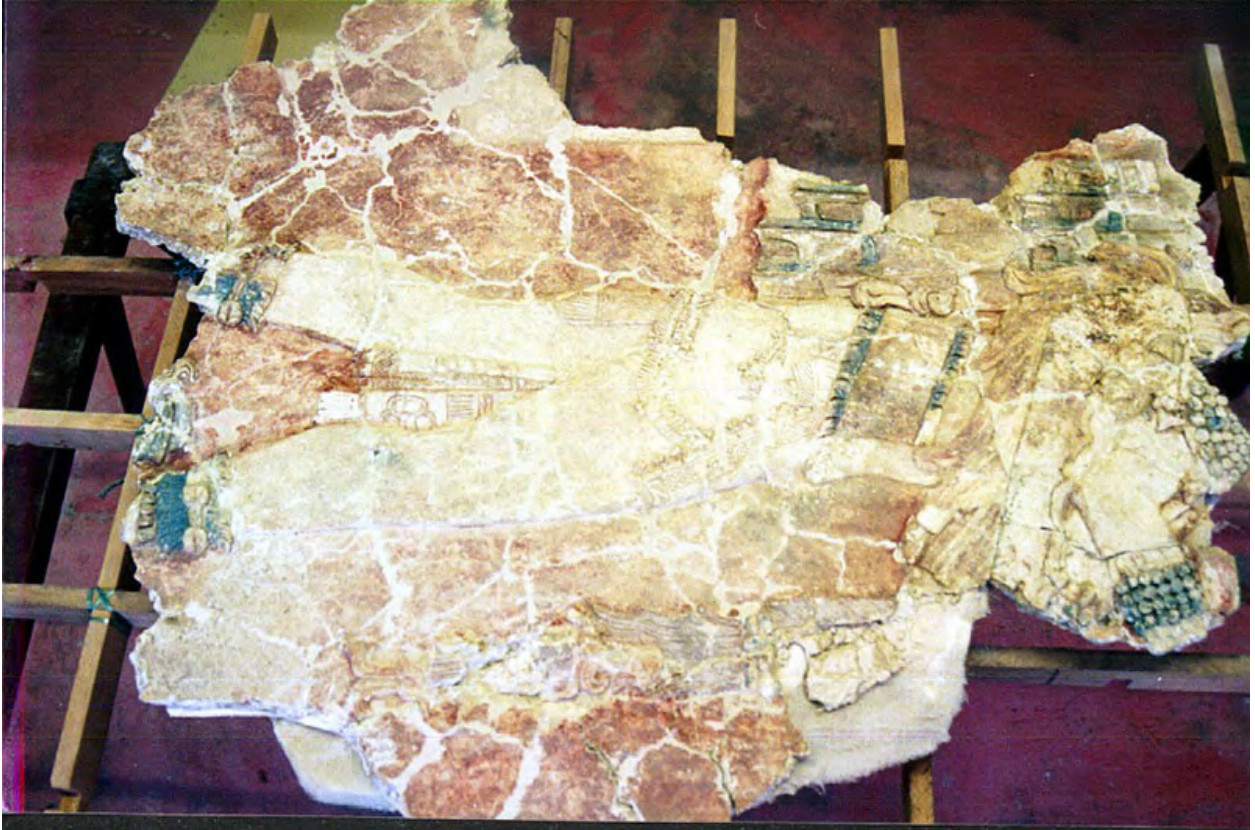
Photo 52. Wooden frame as a support

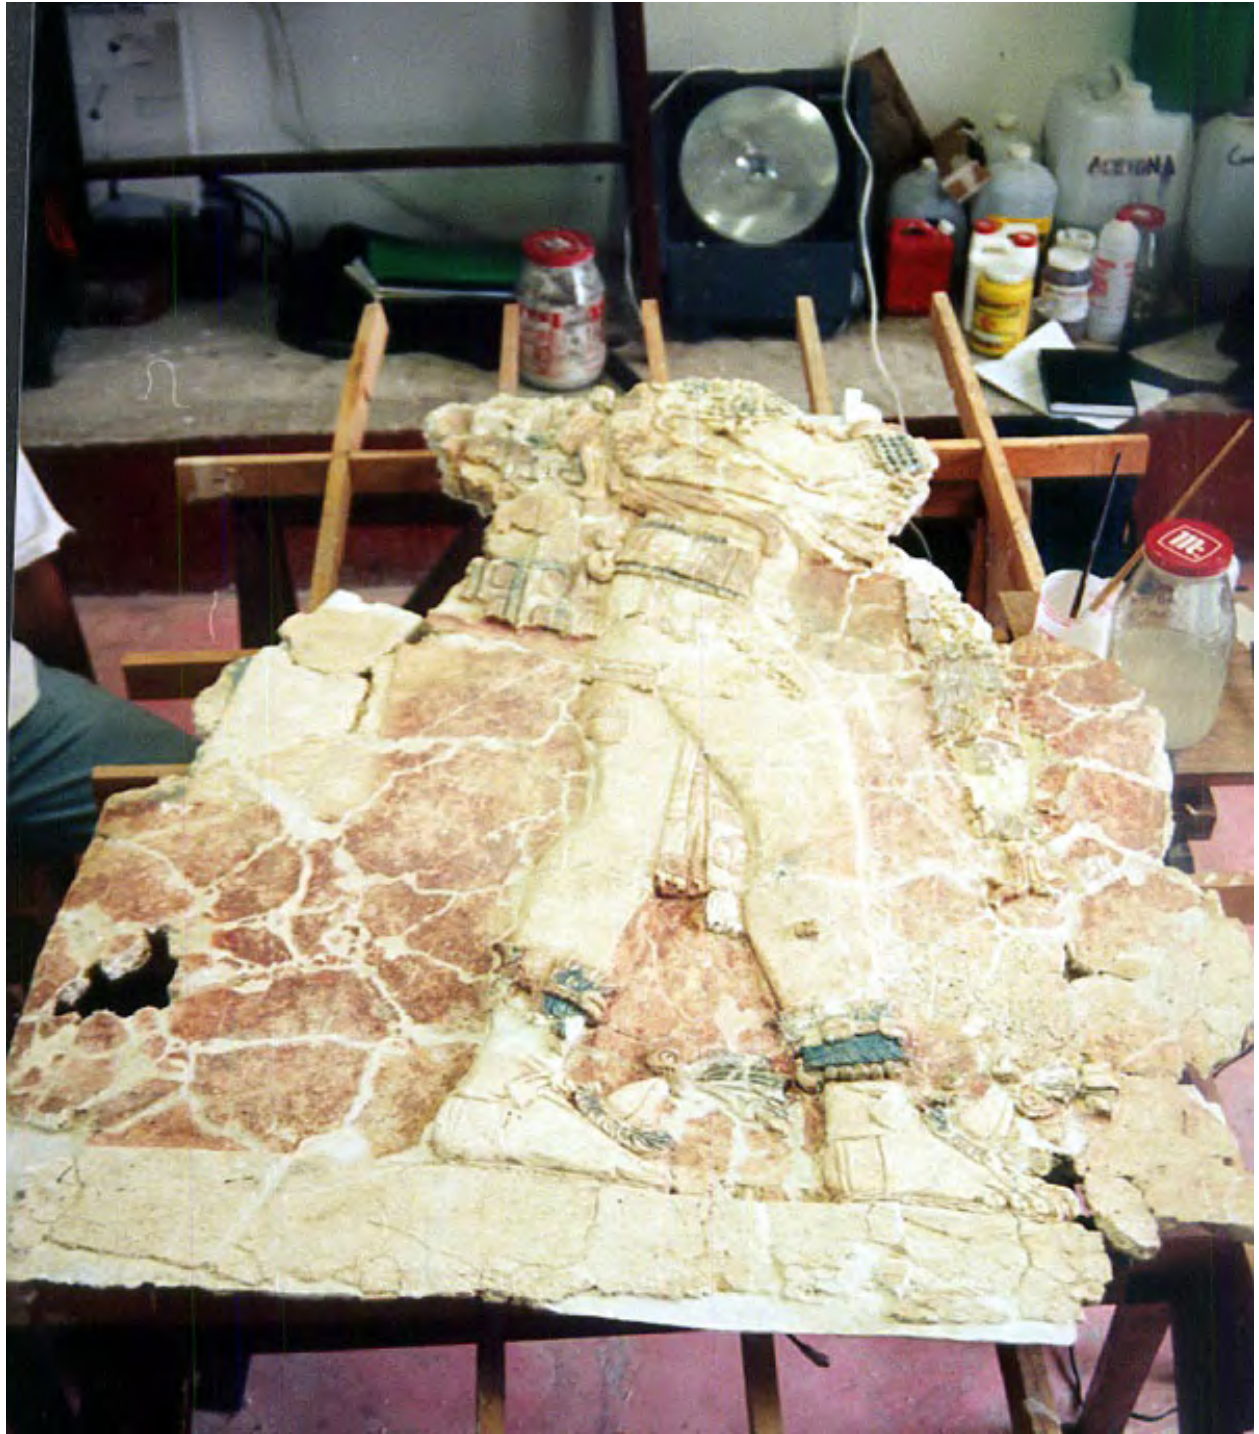
Photo 53. Joining of fragments on both sides

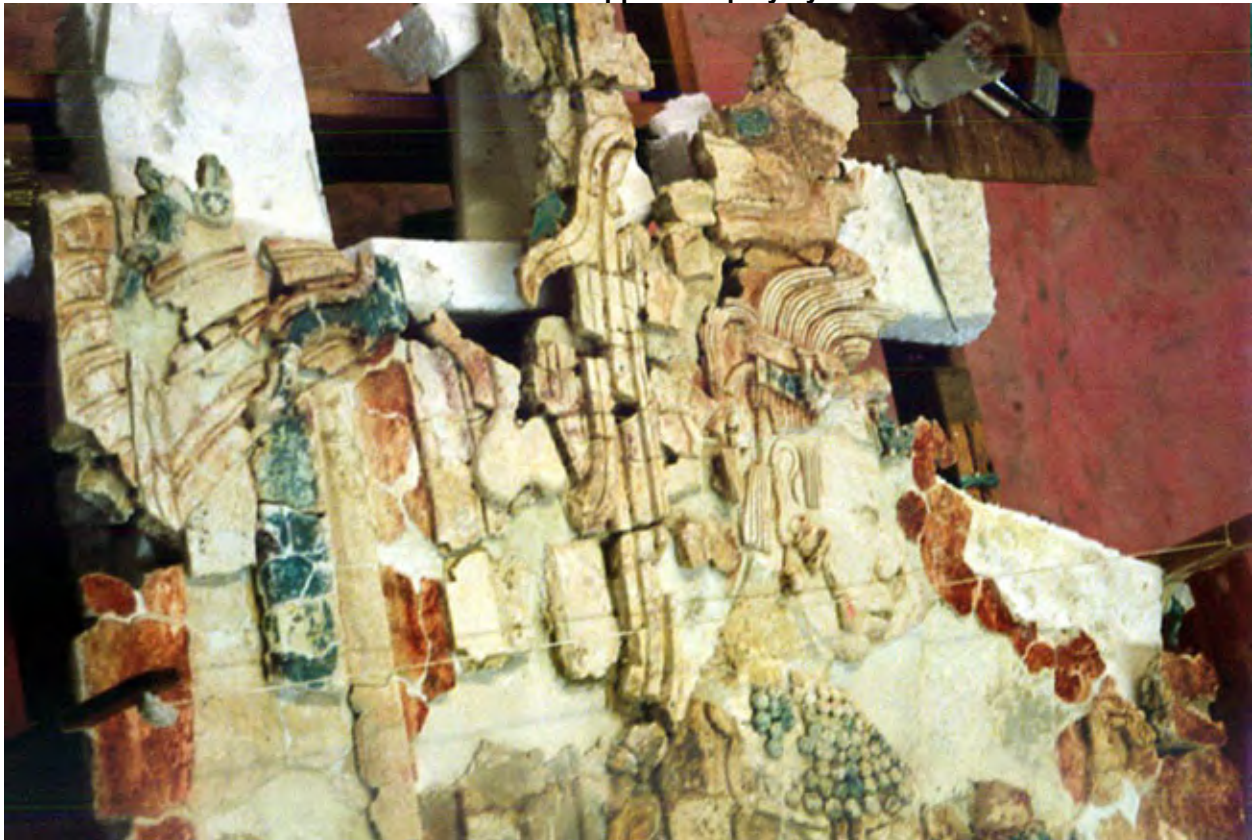
Photo 55. Joining of fragments

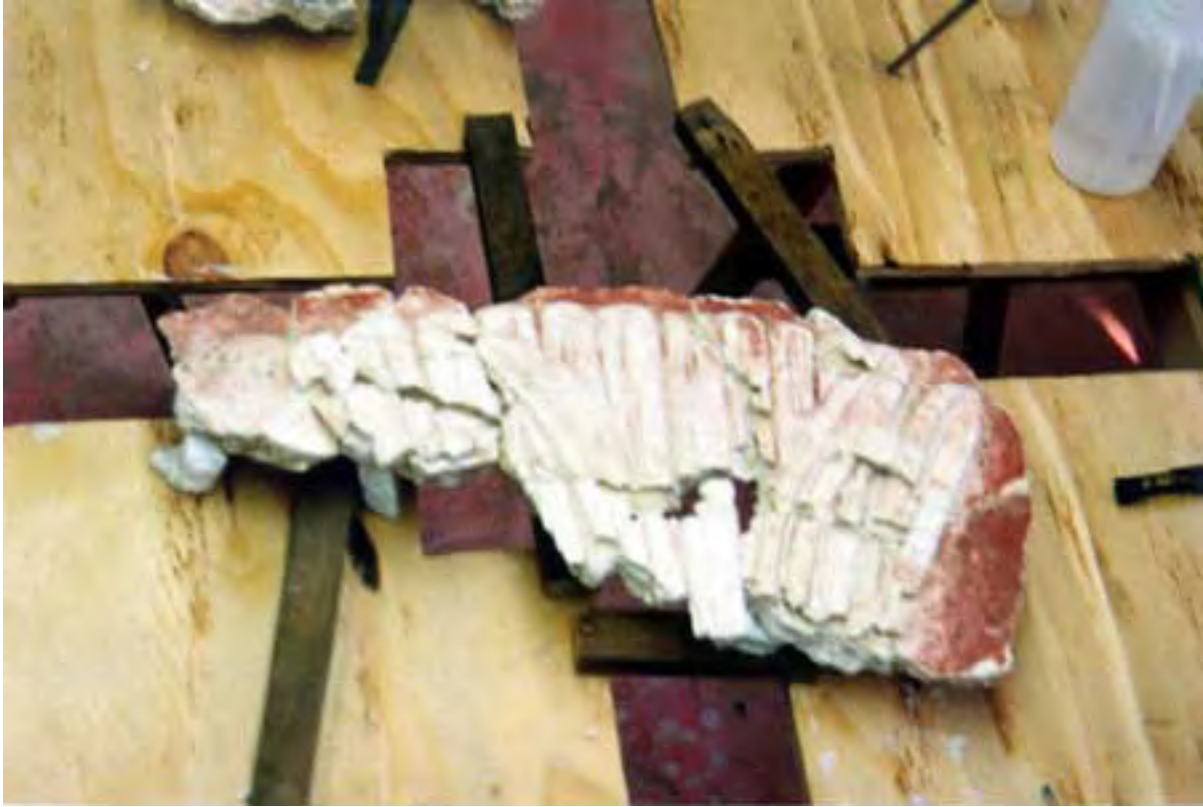
Photo 56. Joining of fragments

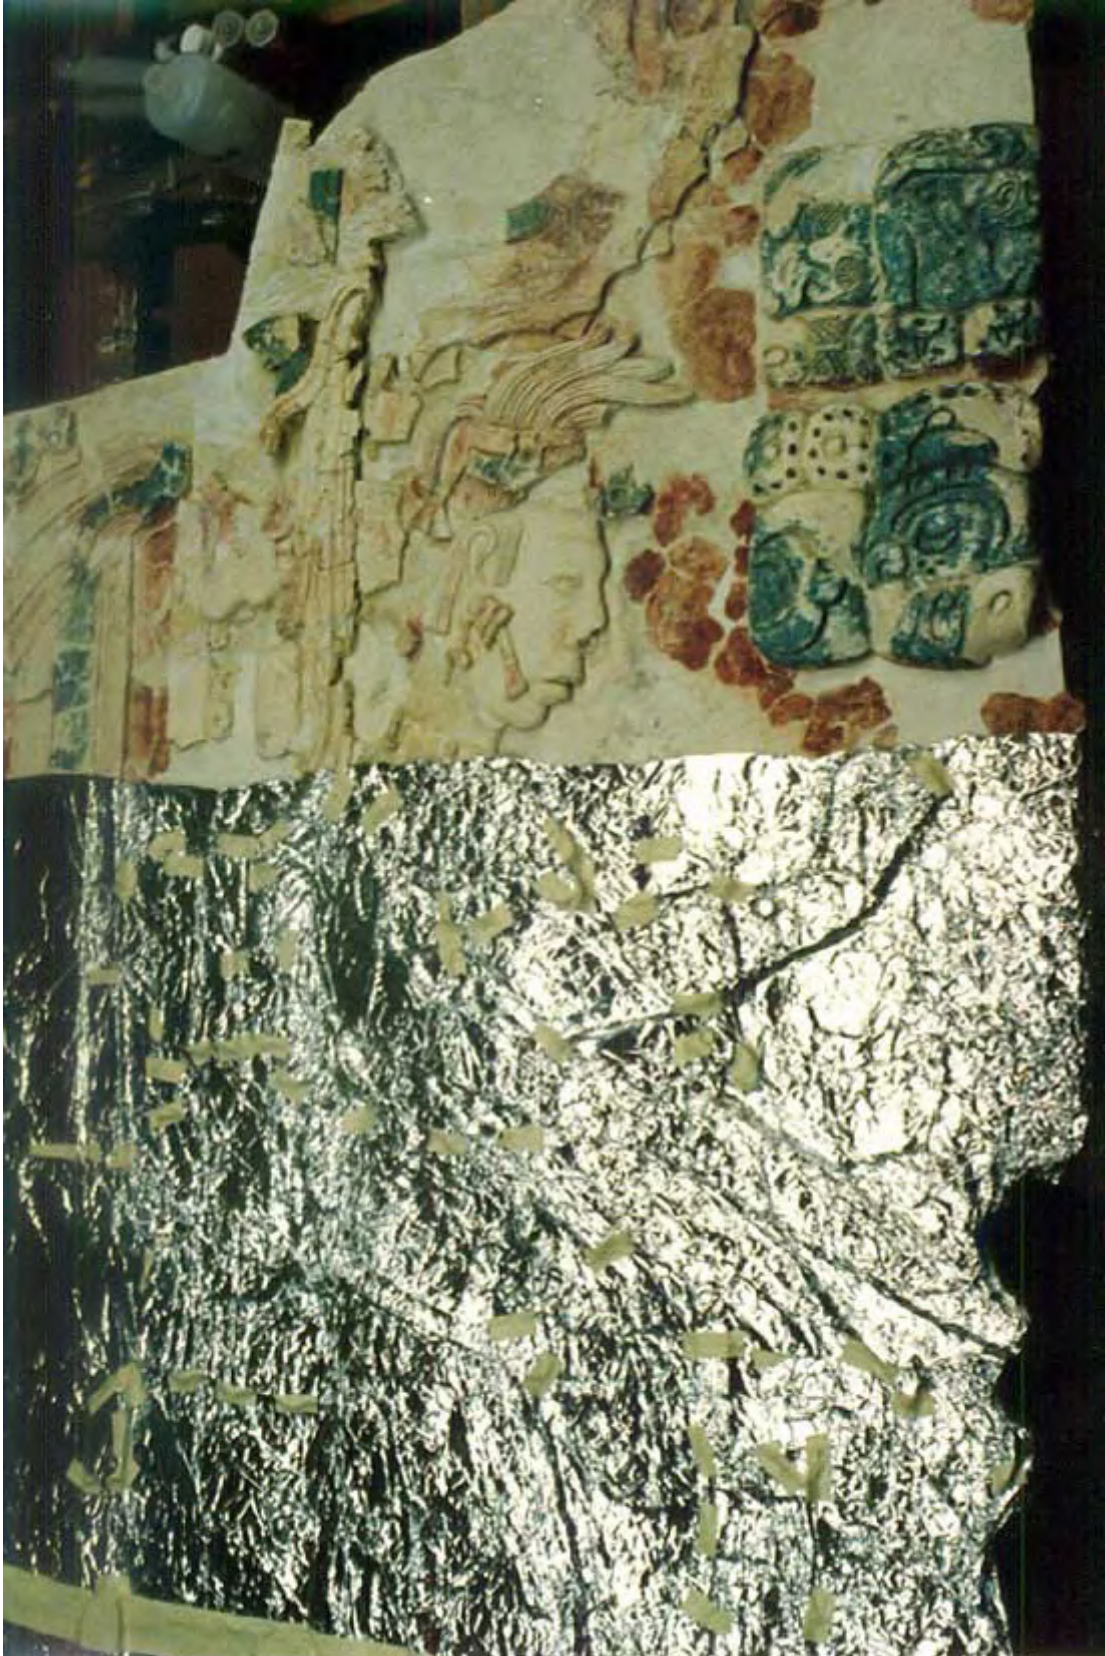
Photo 63. Protection covers with aluminum foil

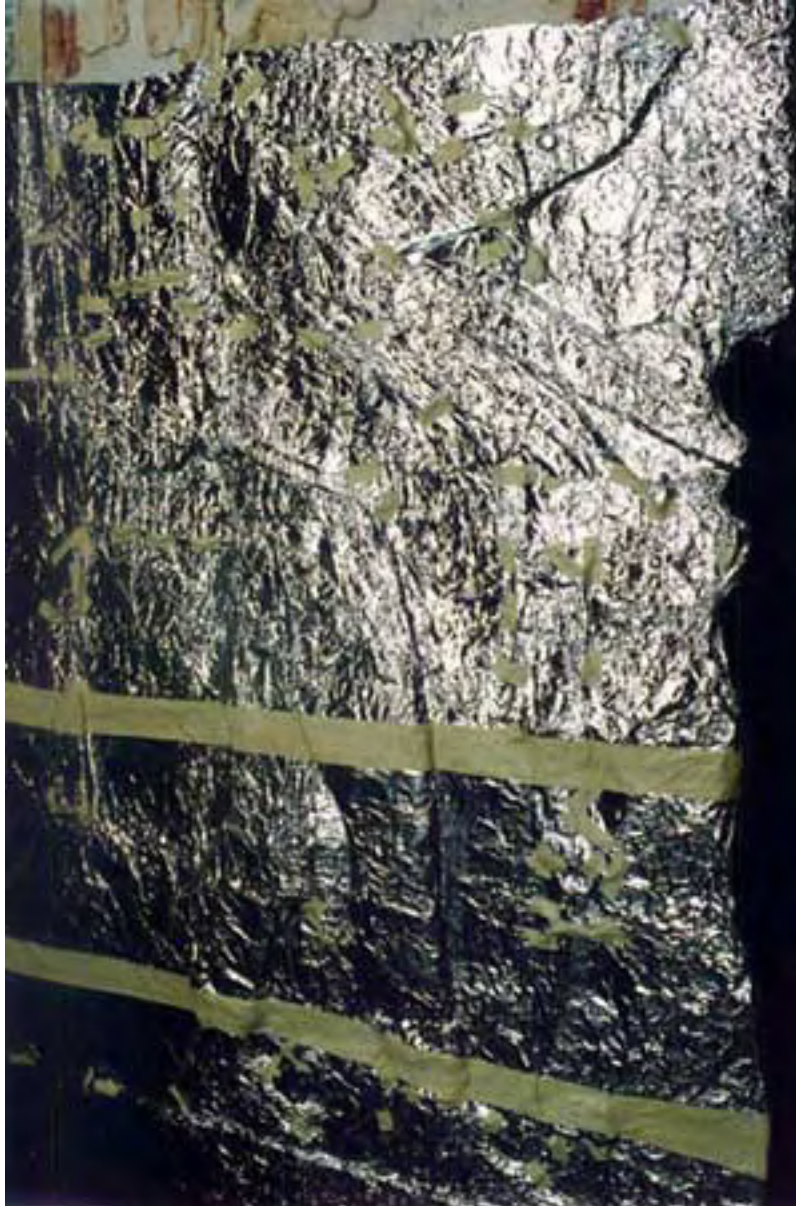
Photo 64. Protection covers with aluminum foil

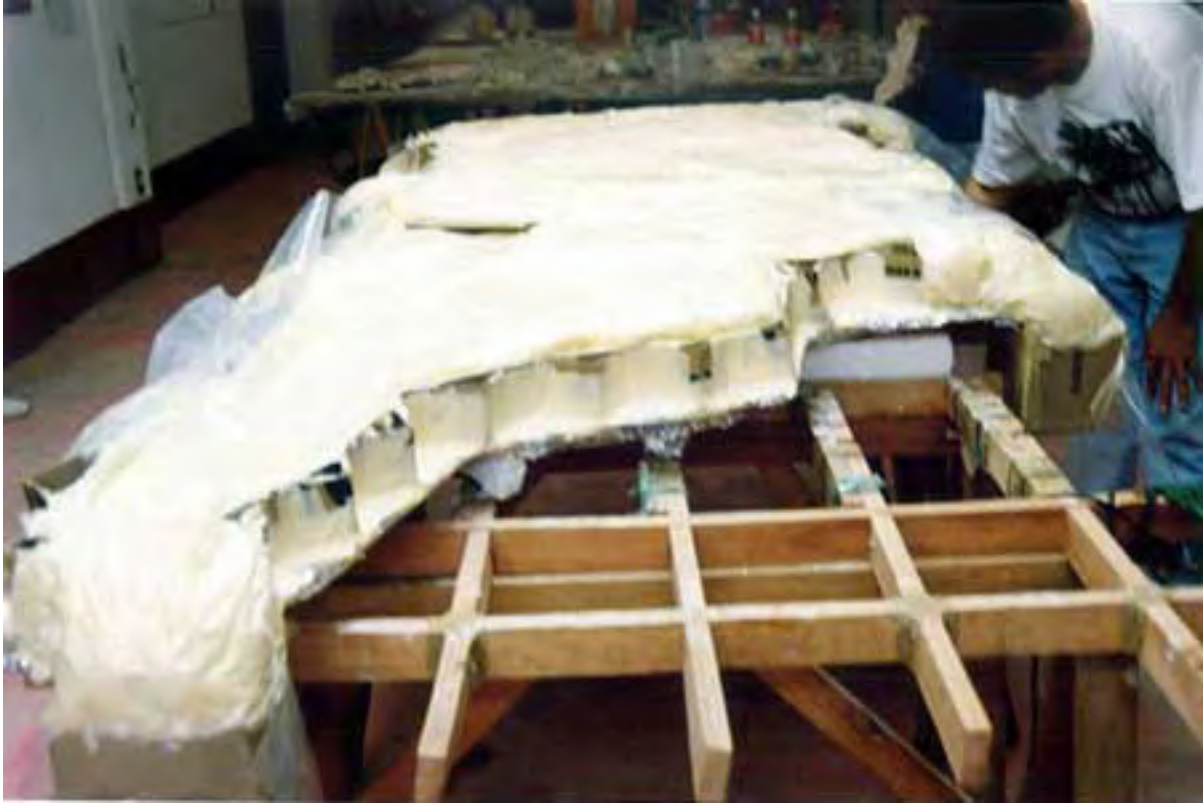
Photo 66. Polyurethane foam layer

This was uniformly applied on the entire surface of the relief, which had been previously partitioned to hold the resin in place (see [photo 65](#)); once the layer had fully reacted, it formed a hard and enduring surface that absorbed movement, additionally providing the advantage of having the precise shape of the relief, so it did not move (see [photo 66](#)).

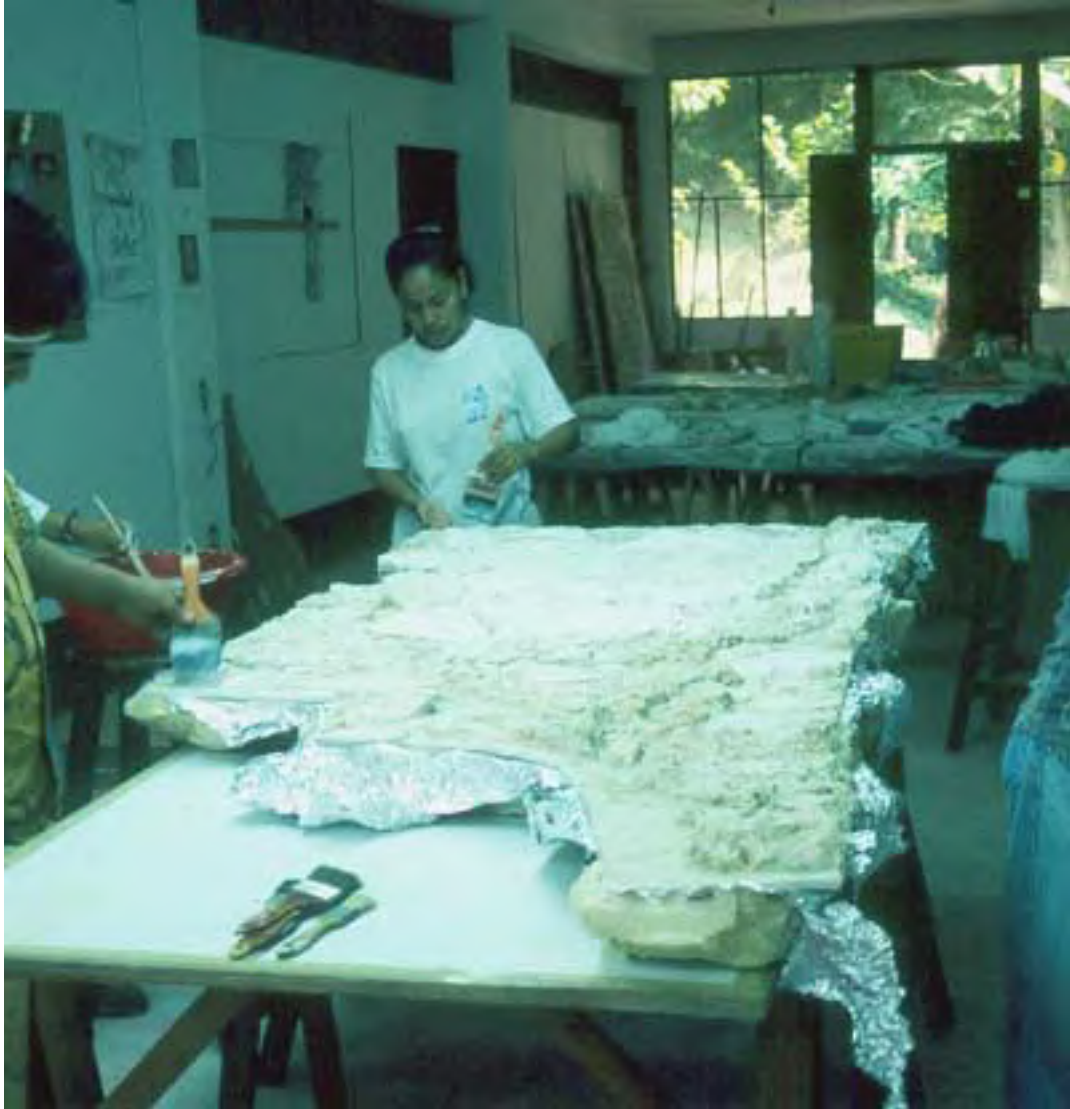
Photo 70. Application of the calcium caseinate layer

This layer was applied with a brush trying to fully cover every single space with this solution (see [photo 70](#)).

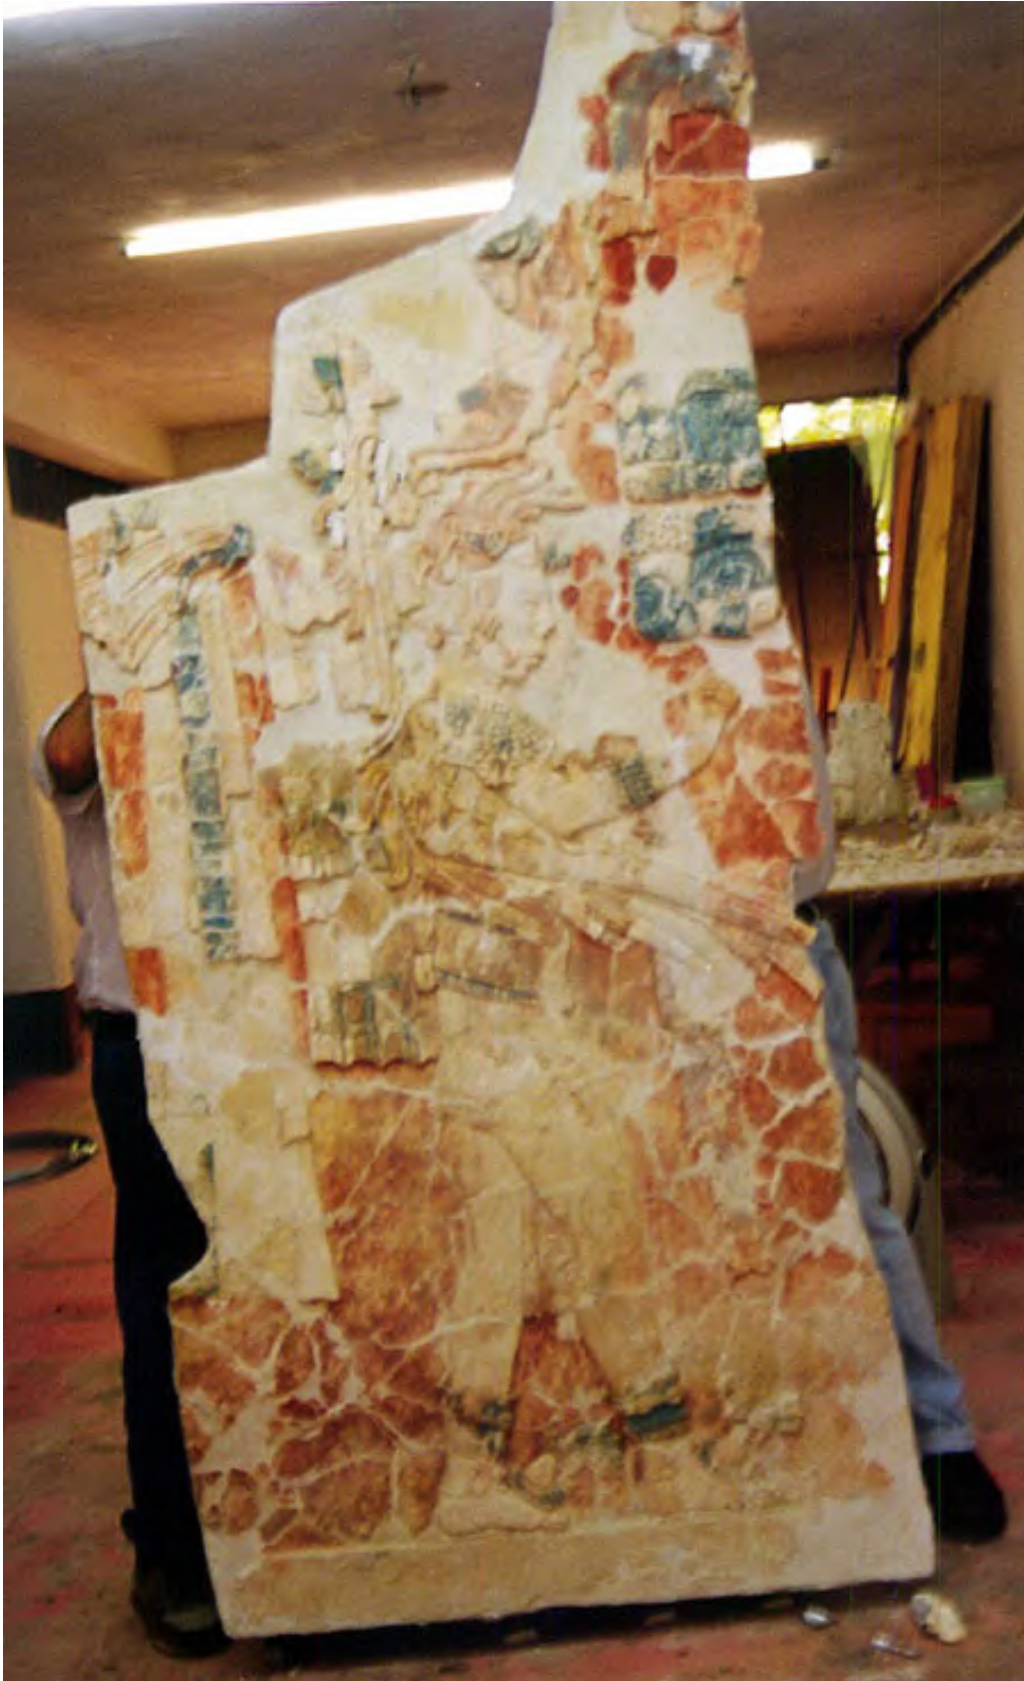
Photo 75. Pigment fixation

The pigment was fixed so that it wouldn't fade away with the passing of time, as a consequence of abrasion or friction of any sort (see [photo 75](#)).

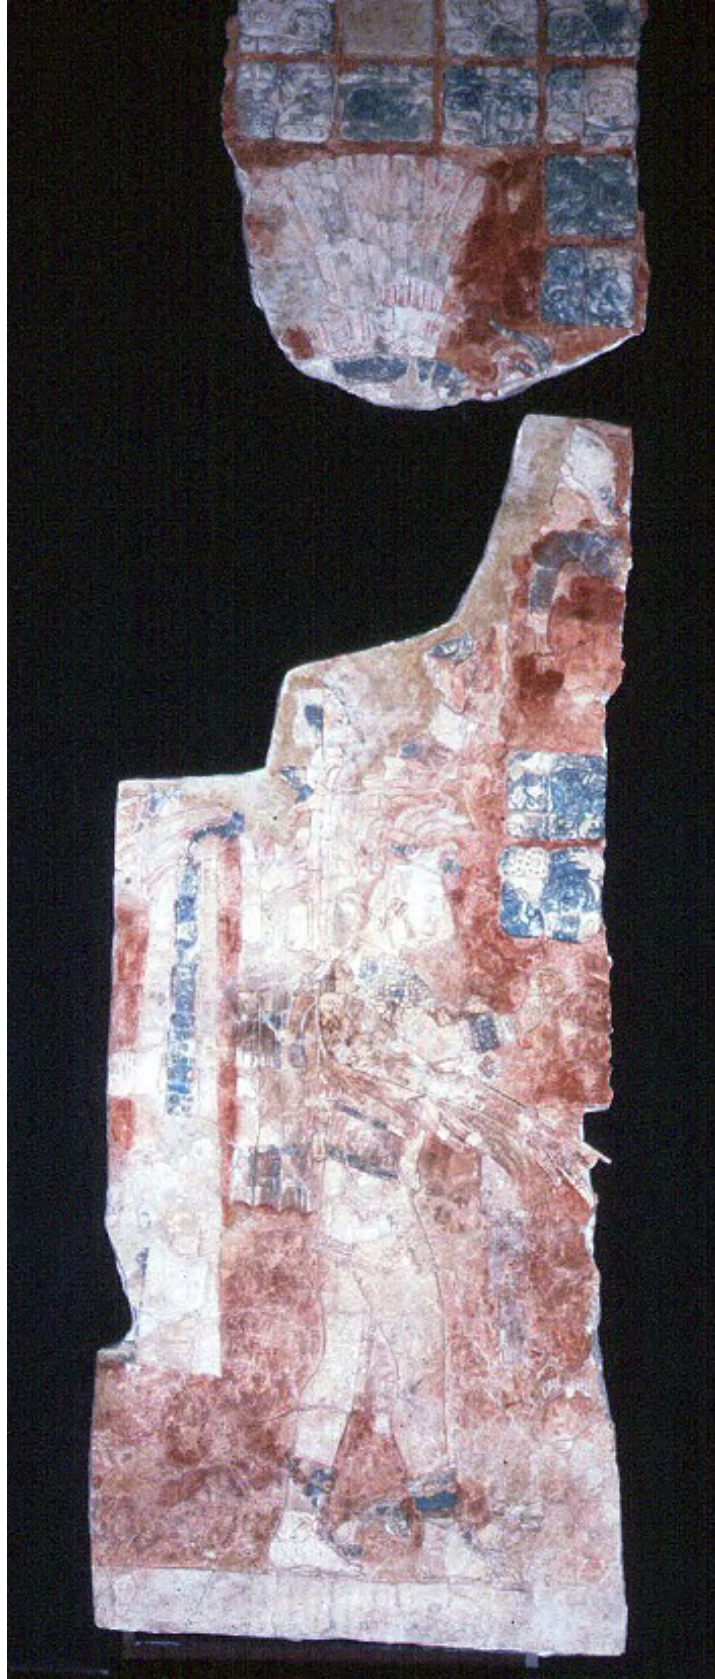
Photo 77. End of process
